August 29, 2025

**Re: Enbridge Gas Inc. ("Enbridge Gas")  
Ontario Energy Board ("OEB") File No.: EB-2022-0248  
Mohawks of the Bay of Quinte and Shannonville Community Expansion  
Project ("Project")**

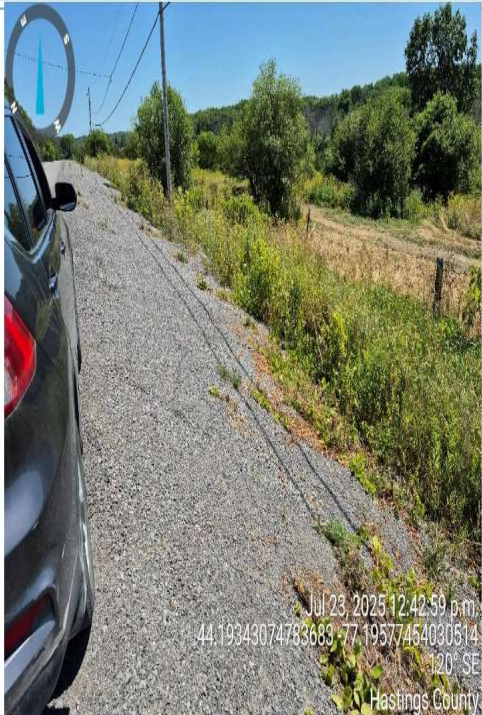
| ID # | Location | Site Condition | Additional Work Recommended (Y/N) | Comments/Recommendations | Representative Photo (July 23, 2025) |
|---|---|---|---|---|---|
| 25 | Across from 621 York Road | ROW is gravelled and in good condition. Area restored to pre-construction conditions. | N | No issues to report at time of inspection. | <p>Jul 23, 2025 12:42:59 p.m.<br/>44.19343074783683 -77.19577454030814<br/>120° SE<br/>Hastings County</p> |

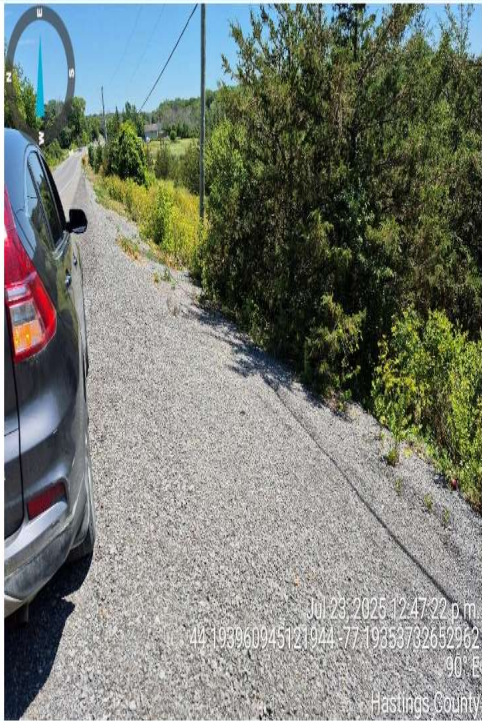
| ID # | Location | Site Condition | Additional Work Recommended (Y/N) | Comments/Recommendations | Representative Photo (July 23, 2025) |
|---|---|---|---|---|---|
| 26 | Between 621 and 683 York Road | ROW is gravelled and in good condition. Area restored to pre-construction conditions. | N | No issues to report at time of inspection. | <p>Jul 23, 2025 12:47:22 p.m.<br/>44.193960945121944 -77.19353732652962<br/>90° E<br/>Hastings County</p> |

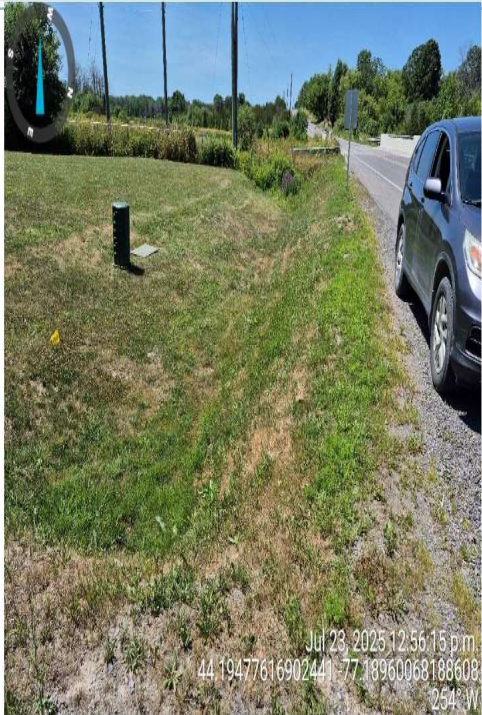
| ID # | Location | Site Condition | Additional Work Recommended (Y/N) | Comments/Recommendations | Representative Photo (July 23, 2025) |
|---|---|---|---|---|---|
| 29 | East of bridge at Marysville Creek | ROW is gravelled and in good condition. Some areas of dry grass due to weather conditions. Area restored to pre-construction conditions. | N | No issues to report at time of inspection. | |

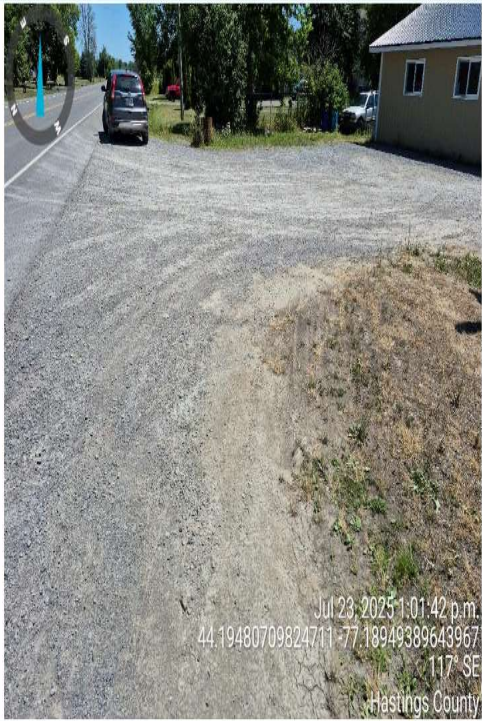
| ID # | Location | Site Condition | Additional Work Recommended (Y/N) | Comments/Recommendations | Representative Photo (July 23, 2025) |
|---|---|---|---|---|---|
| 30 | 722 York Road | Driveway is gravelled and in good condition. Area restored to pre-construction conditions. | N | No issues to report at time of inspection. | |

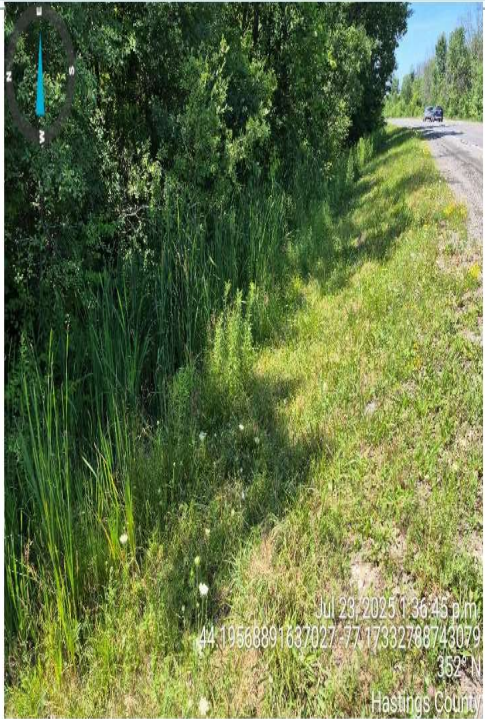
| ID # | Location | Site Condition | Additional Work Recommended (Y/N) | Comments/Recommendations | Representative Photo (July 23, 2025) |
|---|---|---|---|---|---|
| 41 | York Road west of 1096 York Road | Area restored to pre-construction conditions. | N | No issues to report at time of inspection. | <p>Jul 23, 2025 1:36:45 p.m.<br/>44.19568891637027 -77.17332708743079<br/>362° N<br/>Hastings County</p> |

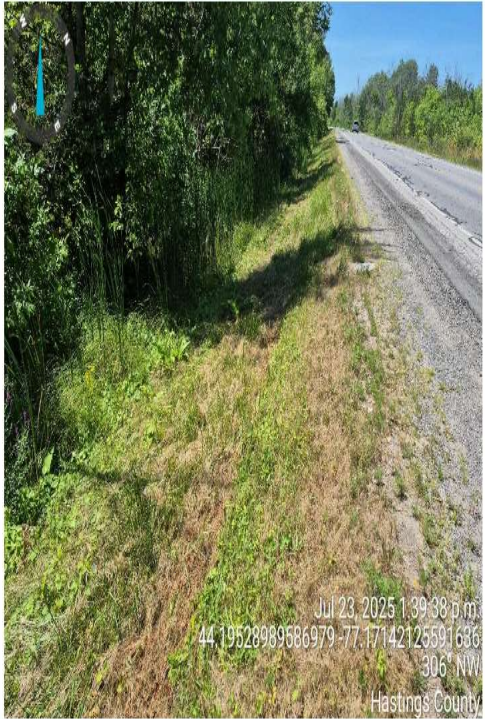
| ID # | Location | Site Condition | Additional Work Recommended (Y/N) | Comments/Recommendations | Representative Photo (July 23, 2025) |
|---|---|---|---|---|---|
| 42 | York Road, west of 1096 York Road | Area restored to pre-construction conditions. Some dry vegetation due to weather conditions. | N | No issues to report at time of inspection. | <p>Jul 23, 2025 1:39:38 p.m.<br/>44.19528989586979 -77.17142125591636<br/>306° NW<br/>Hastings County</p> |

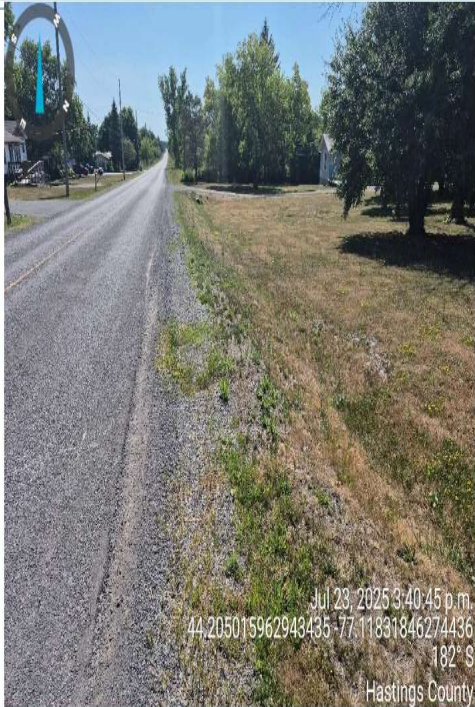
| ID # | Location | Site Condition | Additional Work Recommended (Y/N) | Comments/Recommendations | Representative Photo (July 23, 2025) |
|---|---|---|---|---|---|
| 77 | 375 Lower Slash Road | Area restored to pre-construction conditions. Dry vegetation due to weather conditions. | N | Reseed as necessary. | <p>Jul 23, 2025 3:40:45 p.m.<br/>44.205015962943435 -77.11831846274436<br/>182° S<br/>Hastings County</p> |

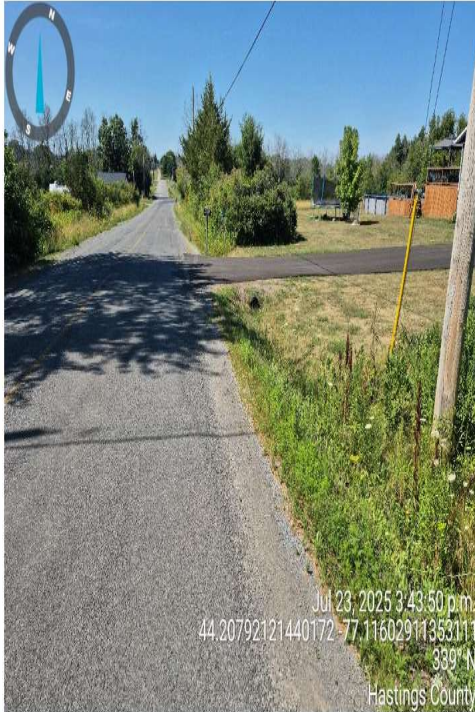
| ID # | Location | Site Condition | Additional Work Recommended (Y/N) | Comments/Recommendations | Representative Photo (July 23, 2025) |
|---|---|---|---|---|---|
| 78 | 453 Lower Slash Road | Area restored to pre-construction conditions. | N | No issues to report at time of inspection. | <p>Jul 23, 2025 3:43:50 p.m.<br/>44.20792121440172 -77.11602911353111<br/>339° N<br/>Hastings County</p> |

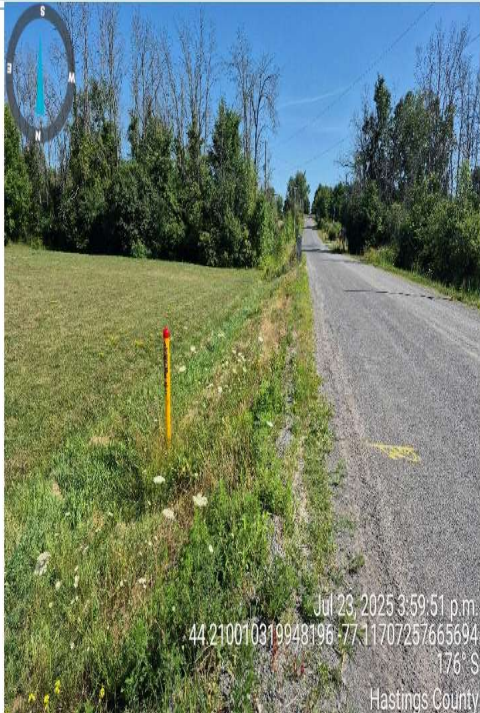
| ID # | Location | Site Condition | Additional Work Recommended (Y/N) | Comments/Recommendations | Representative Photo (July 23, 2025) |
|---|---|---|---|---|---|
| 79 | 22 Homeland Drive | Area restored to pre-construction conditions. | N | No issues to report at time of inspection. | |

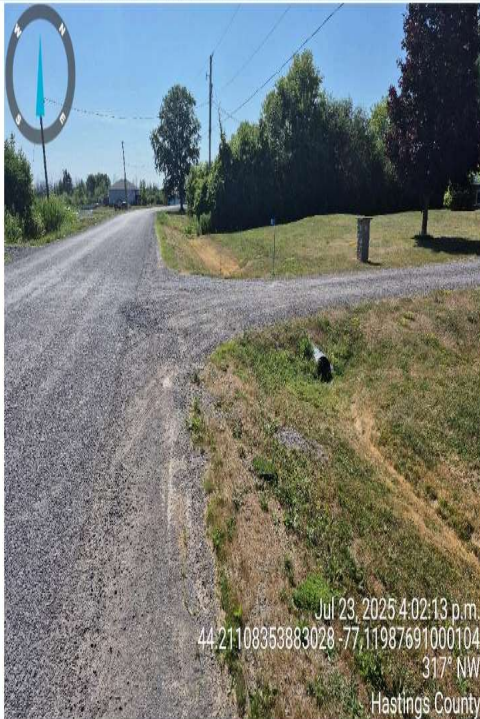
| ID # | Location | Site Condition | Additional Work Recommended (Y/N) | Comments/Recommendations | Representative Photo (July 23, 2025) |
|---|---|---|---|---|---|
| 80 | 82 Homeland Drive | Area restored to pre-construction conditions. Dry vegetation due to weather conditions. | N | No issues to report at time of inspection. | |

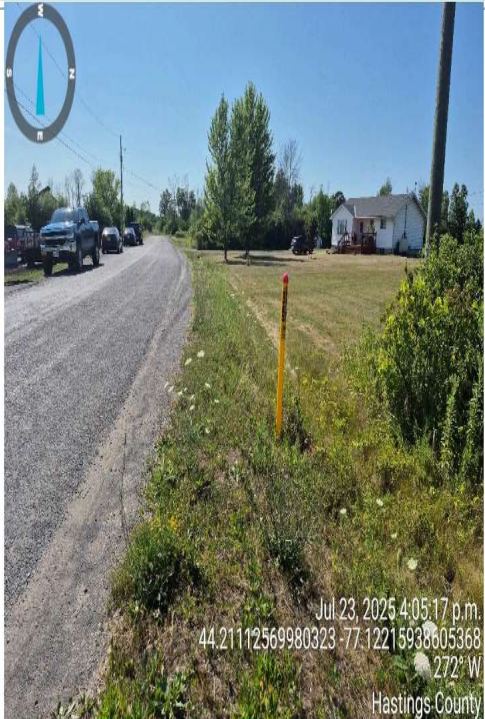
| ID # | Location | Site Condition | Additional Work Recommended (Y/N) | Comments/Recommendations | Representative Photo (July 23, 2025) |
|---|---|---|---|---|---|
| 81 | 138 Homeland Drive | Area restored to pre-construction conditions. | N | No issues to report at time of inspection. | <p>Jul 23, 2025 4:05:17 p.m.<br/>44.21112569980323 -77.12215938605368<br/>272° W<br/>Hastings County</p> |

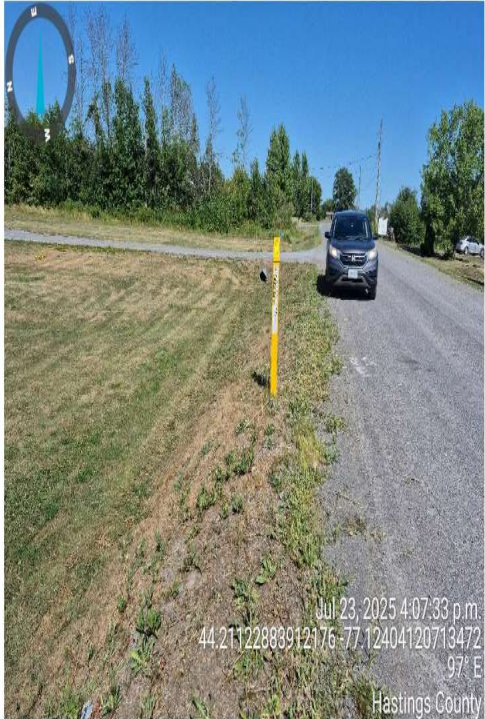
| ID # | Location | Site Condition | Additional Work Recommended (Y/N) | Comments/Recommendations | Representative Photo (July 23, 2025) |
|---|---|---|---|---|---|
| 82 | 152 Homeland Drive | Area restored to pre-construction conditions. Dry vegetation due to weather conditions. | N | No issues to report at time of inspection. | <p>Jul 23, 2025 4:07:33 p.m.<br/>44.21122888912176 -77.12404120713472<br/>97° E<br/>Hastings County</p> |

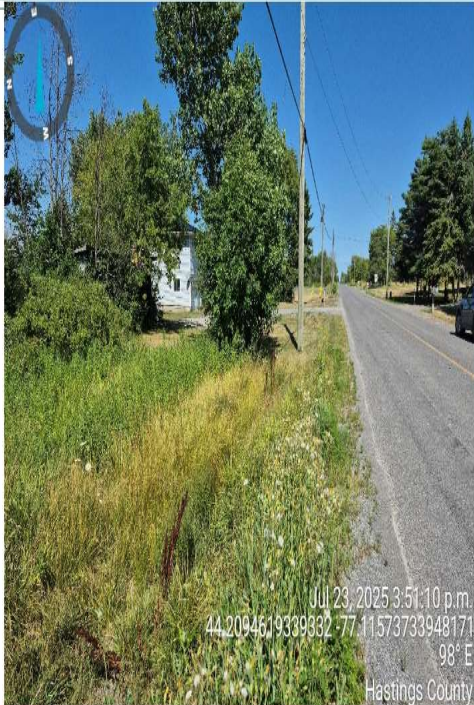
| ID # | Location | Site Condition | Additional Work Recommended (Y/N) | Comments/Recommendations | Representative Photo (July 23, 2025) |
|---|---|---|---|---|---|
| 83 | 511 Lower Slash Road | Area restored to pre-construction conditions. | N | No issues to report at time of inspection. | <p>Jul 23, 2025 3:51:10 p.m.<br/>44.2094619339832 -77.11573733948171<br/>98° E<br/>Hastings County</p> |

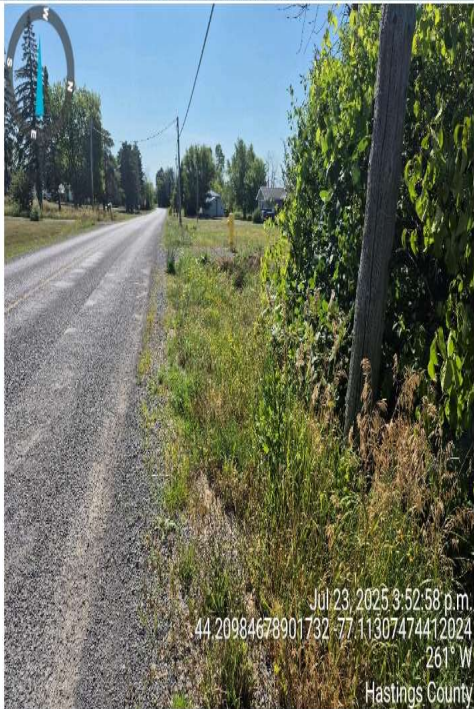
| ID # | Location | Site Condition | Additional Work Recommended (Y/N) | Comments/Recommendations | Representative Photo (July 23, 2025) |
|---|---|---|---|---|---|
| 84 | Across from 546 Lower Slash Road | Area restored to pre-construction conditions. | N | No issues to report at time of inspection. | <p>Jul 23, 2025 3:52:58 p.m.<br/>44.20984678901732 -77.11307474412024<br/>261° W<br/>Hastings County</p> |

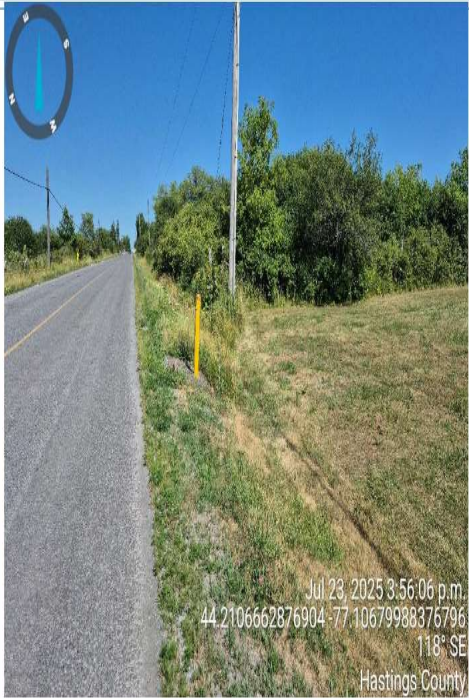
| ID # | Location | Site Condition | Additional Work Recommended (Y/N) | Comments/Recommendations | Representative Photo (July 23, 2025) |
|---|---|---|---|---|---|
| 85 | 632 Lower Slash Road | Area restored to pre-construction conditions. | N | No issues to report at time of inspection. | |
