**IN THE MATTER OF the *Ontario Energy Board Act, 1998*,
S.O. 1998, c. 15, (Schedule B);**

**AND IN THE MATTER OF an application by London
Hydro Inc. for an order approving just and reasonable
rates and other charges for electricity distribution to be
effective May 1, 2009.**

**London Hydro Inc. (“London Hydro”) Responses to
Ontario Energy Board Staff Interrogatories**

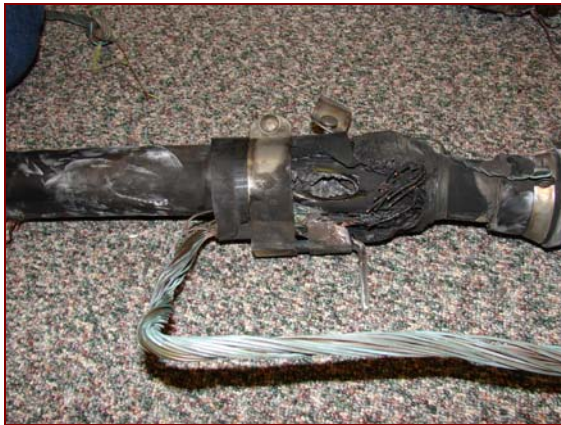
Figure 1, Cable fault on the 19M25 (2007)

While a H/O was in place on the 19M26 feeder, the breaker at the TS operated. After one unsuccessful attempt to close the breaker, an automated switch was used to restore most of the customers. The Line department inspected the overhead lines back to the station and found a cable fault at the riser on the red phase. The termination was replaced. Approximately 150,000 customer minutes of interruption were saved using the automated switch.

This failure occurred in a similar manner to the one from last August¹ on the 19M25 riser. The cable failed below the termination under the 3M mounting bracket, which inadvertently contacted the concentrics that were tied together underneath the bracket. This arrangement was identified to have been done incorrectly since it creates multi-point bonding of the concentrics: one at the TS and one at the riser due to contact with the bracket which is grounded. The similarity of the two failures can be easily seen in the two photos above. The existing installations that were completed incorrectly were identified and are in the process of being redone by isolating from ground the CN at the riser. No further action required.

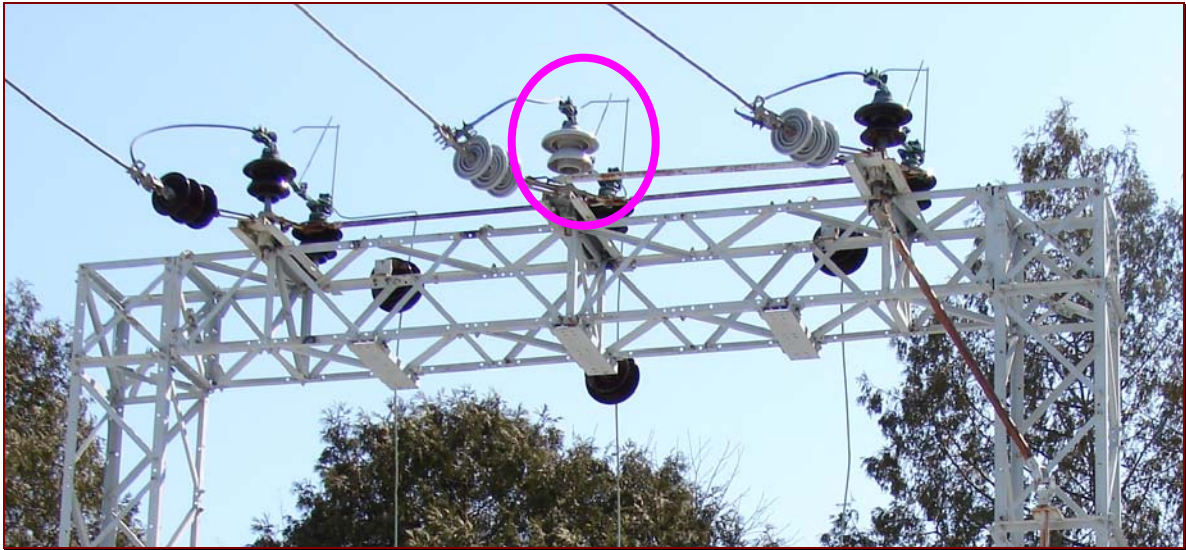
Figure 1, Gang operated switch 35T1-L

At SUB-35, a porcelain insulator on the middle phase of the gang operated switch 35T1-L flashed over and was completely destroyed, according to staff on duty that day. In an attempt to backfeed 35F1 by using the adjacent feeder 93F1, the breaker at SUB-93 opened up. The substation had to be isolated because of the single-phasing condition. Afterwards, all three feeders at SUB-35 were picked up. The station was restored after eight hours while the Line Department reconstructed the phase that had blown, replacing one of the large stand-off insulators of an old, horizontally-mounted load-break switch (as illustrated below).

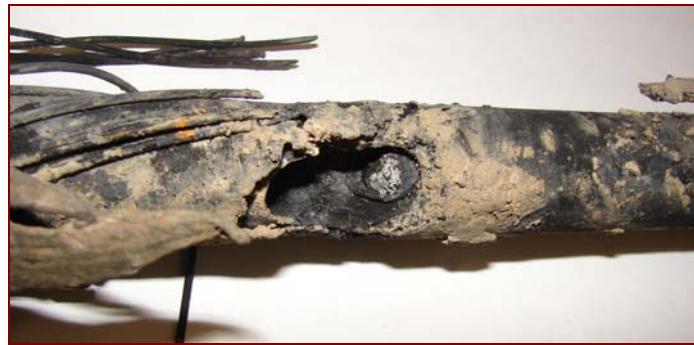
Figure 1, Aluminium core melted from failure

- A stress cone had been found defective at TE 1850 originally;
- Two feeders (26M42 and 26M55) were paralleled to complete switching, to maintain supply to a three-phase transformer (TE 4946) from the same bus at Talbot TS;
- A fused switch was closed in to pick up the load after isolation of the presumed fault location causing both feeders to trip;
- Hi-potting the cable did not provide any indication; the fault was an ‘open-circuit’ rather than short-circuit (the conductor completely vaporized – see Figure 1 below);
- Picking up segments of circuit in incremental steps eventually led to the fault location but only after the 26M55 tripped one more time;
- Fuses were found blown in four switching enclosures that chain through the subdivision, including LC 4267 – one of the original solid-dielectric units – which is only programmable with fuse dials.

The cable was #1/0 AL, 28 kV XLPE installed in 1973.

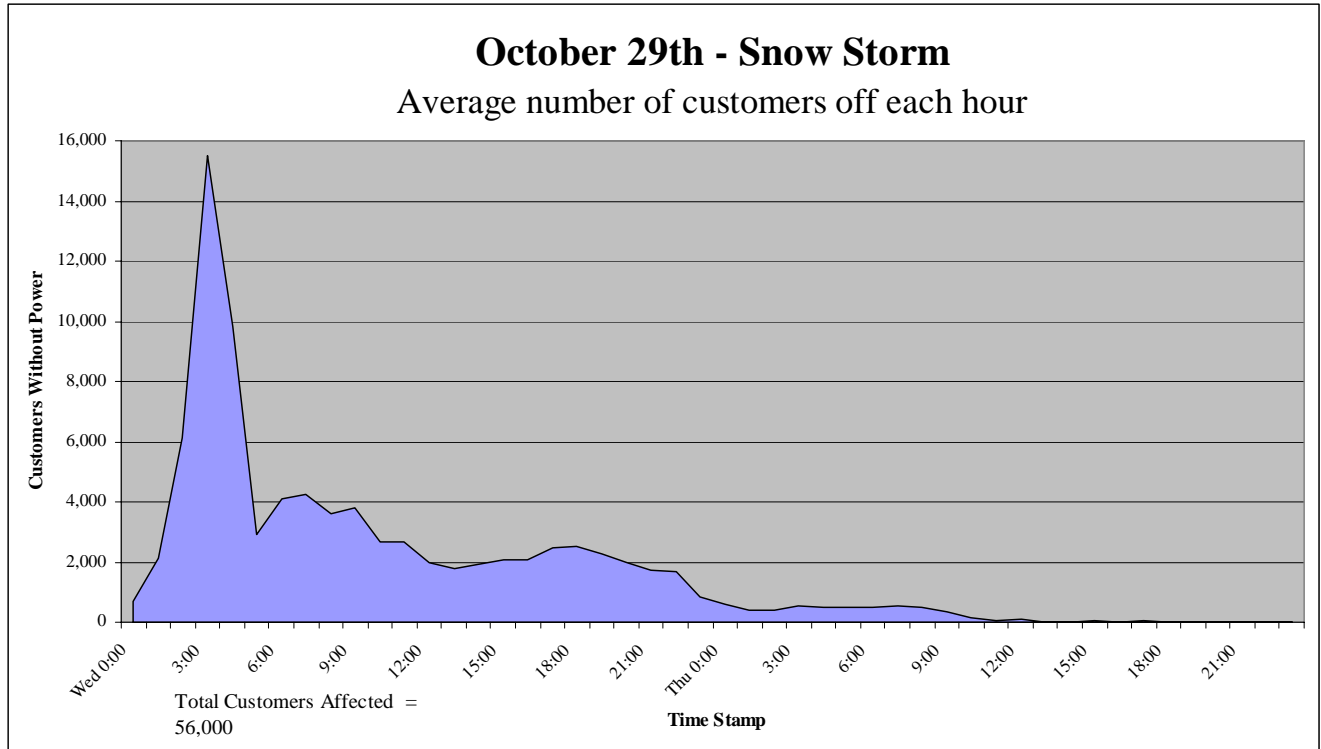
- London has not seen such a severe storm since April 2003 (when a devastating ice storm also had serious effects on the overhead infrastructure). The graph below depicts the average number of customers who were without power during the storm per hour. Restoration took place until well into the second day following the storm. The storm data will be included in the annual OEB reporting on reliability. No action is required.

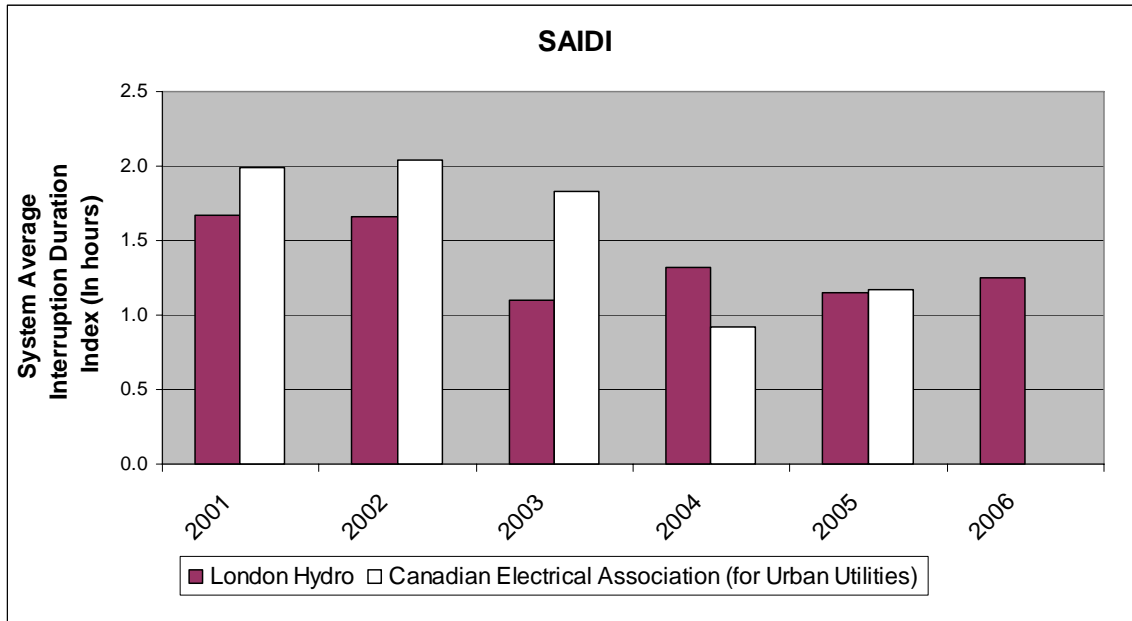
Figure 1, SAIDI Performance – London Hydro vs. Other Urban Utilities

The chart in Figure 1 illustrates London Hydro's SAIDI performance compared with the national average³ of other urban utilities over the last five years. After a sudden reduction in the CEA benchmark in 2004 (Hydro Quebec withdrew their participation), in the following year, the national average worsened by 25%. Although London Hydro is 9% higher than the year before, we managed to stay close to the most recently published CEA urban utility average. The CEA statistics for 2006 will not be available until later on in the year.

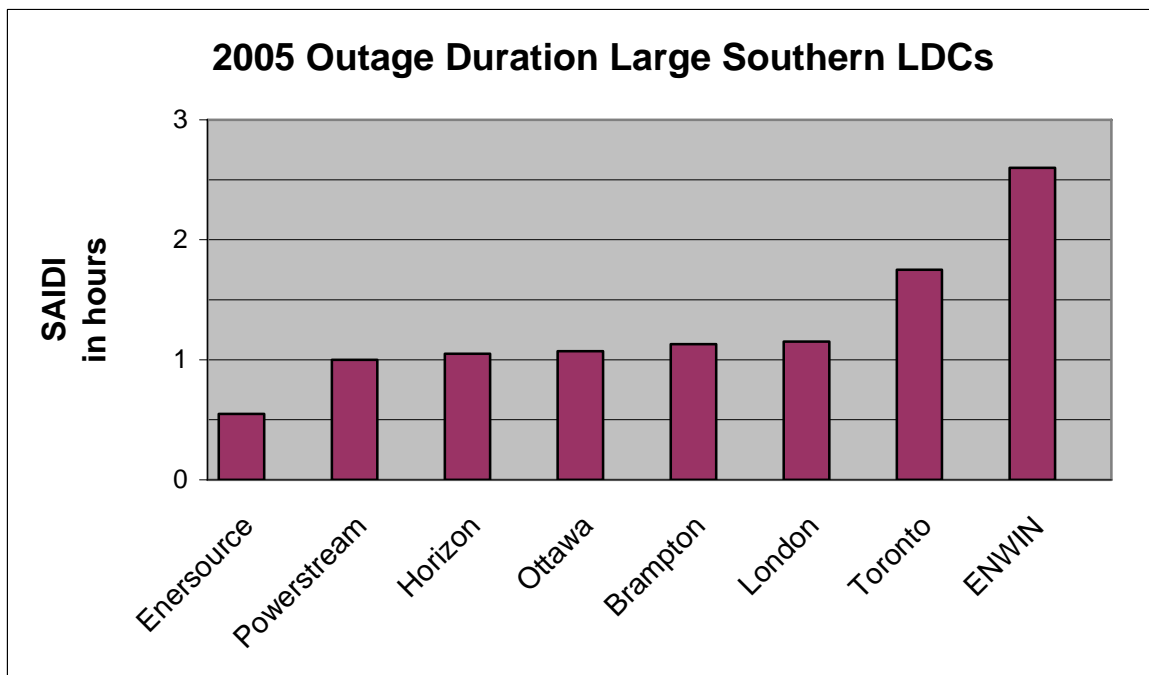
Figure 2, SAIDI Performance – London Hydro vs. large southern LDCs

The following chart compares London Hydro’s SAIDI to the Large Southern LDC cohort group that the OEB proposed in early 2007.

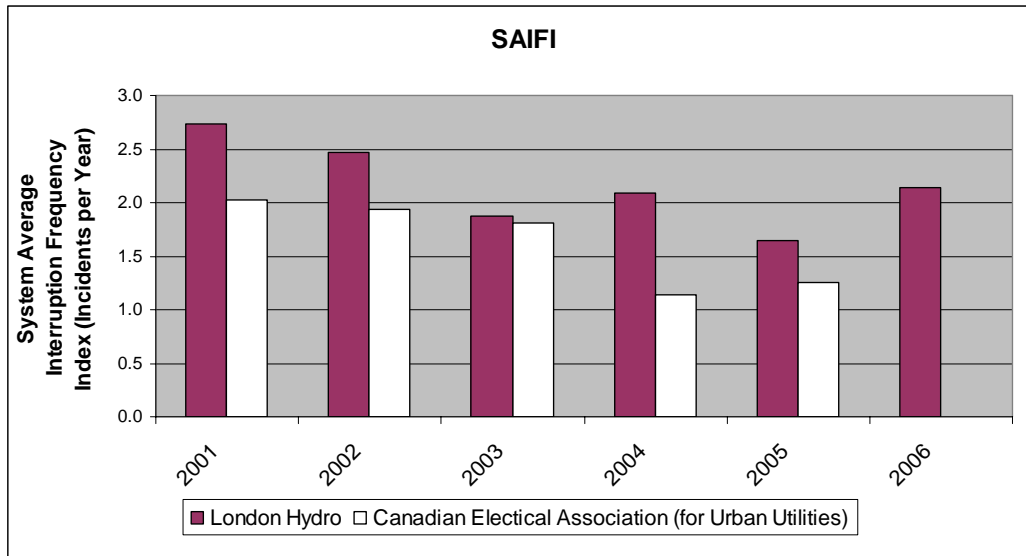
Figure 3, SAIFI Performance – London Hydro vs. Other Urban Utilities

Figure 3 shows our performance compared to the national average of other local distribution utilities over recent years. The national average in SAIFI has always been better than ours, so it is expected that in 2006 our decreased performance will still lag behind the number published by CEA.

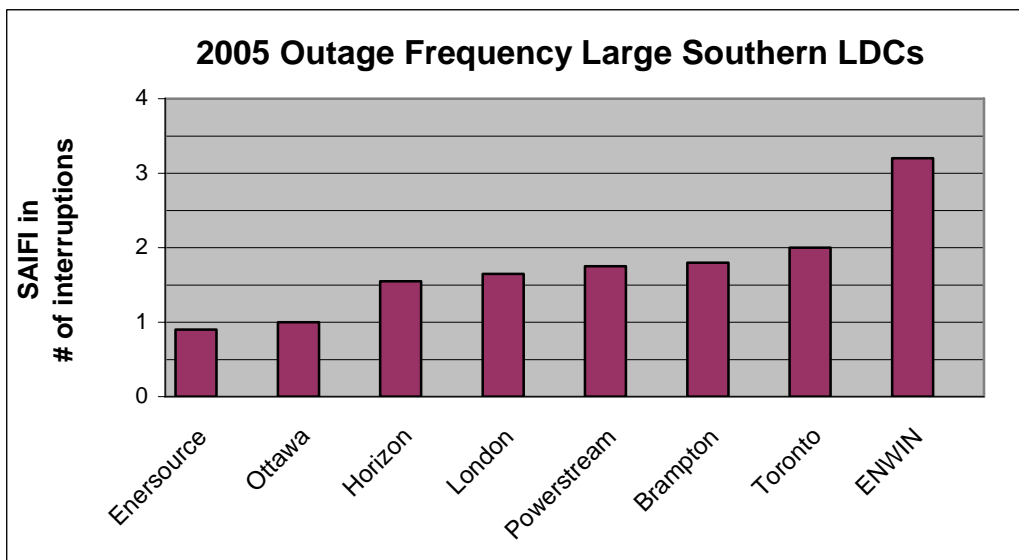
Figure 4, SAIFI Performance – London Hydro vs. large southern LDCs

The following chart compares London Hydro’s SAIFI to the Large Southern LDC cohort group that the OEB proposed in early 2007.

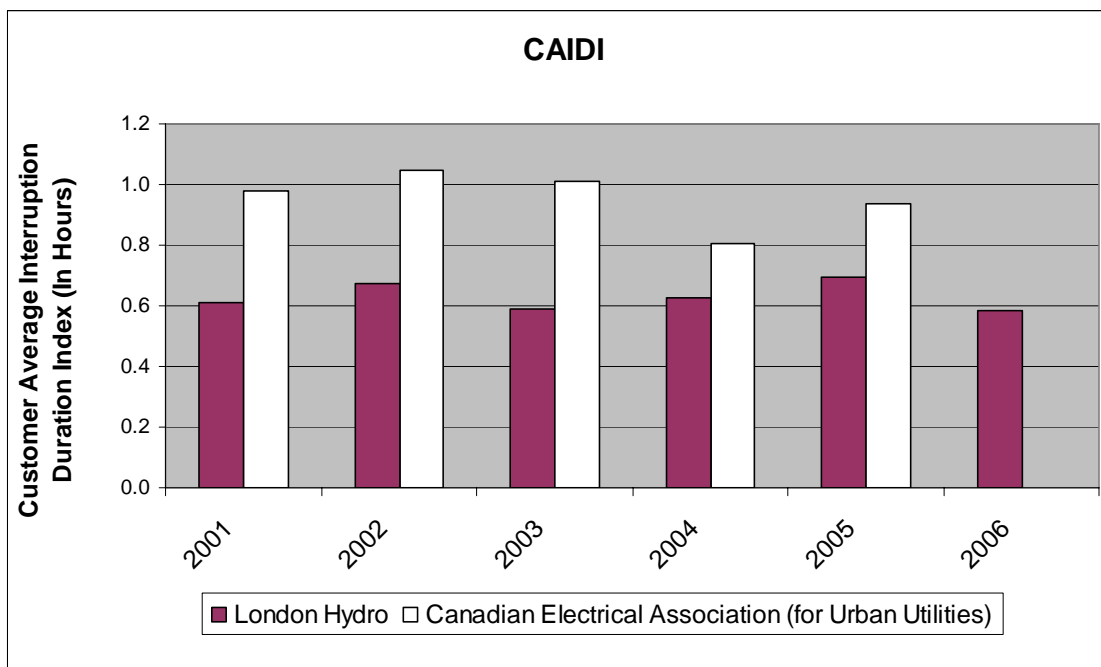
Figure 5, CAIDI Performance – London Hydro vs. Other Urban Utilities

As it can be seen in Figure 5, our performance versus the national average of comparable local distribution utilities over the last five years has always been better.

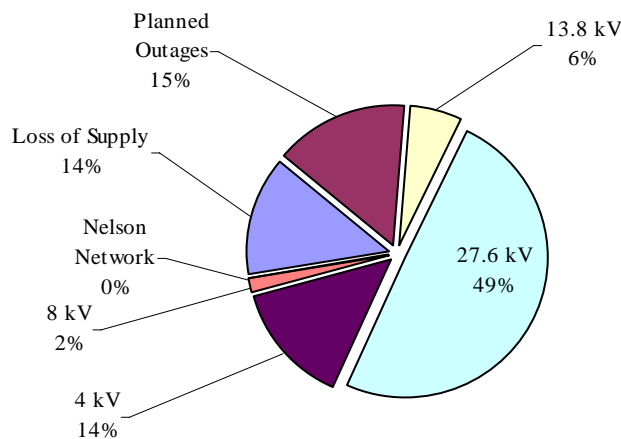
Figure 6, Interruption Duration (SAIDI) by Distribution Voltage

For many years now, one method utilized in the reliability analysis was to segment the outage duration and frequency according to voltage class, planned outages and loss of supply events. Figure 6 and Figure 7 clearly indicate that the 27.6 kV system should continue to remain the primary focus of reliability improvement measures. Since the majority of customers are being fed by this system, outages have more implications at this voltage level.

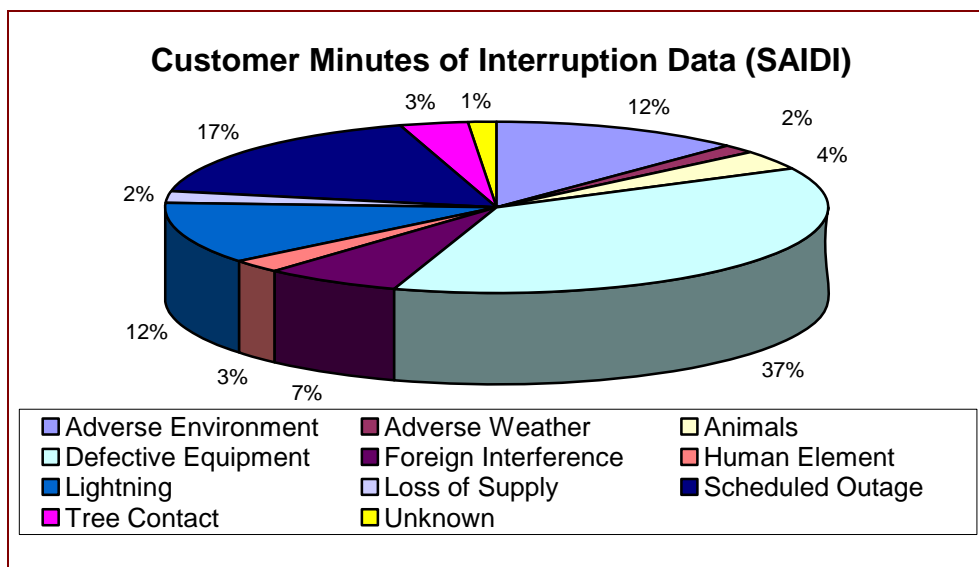
Figure 8, Customer Minutes of Interruption by Cause (SAIDI)

In 2006, the largest number of customer minutes of interruption (SAIDI), as shown in Figure 8, was due to failure of in-service system components (*defective equipment*). Unfortunately, this category continues to be the leading contributor to outage duration, regardless of its improving trend over the last decade. Compared to other causes, outages in this category tend to be more prolonged since equipment needs to be replaced in the field or isolated before power can be restored. The next two largest categories were *lightning* and *adverse environment*. Both of these will be discussed in more details in Sections 7.2.1 and 7.1.2 respectively.

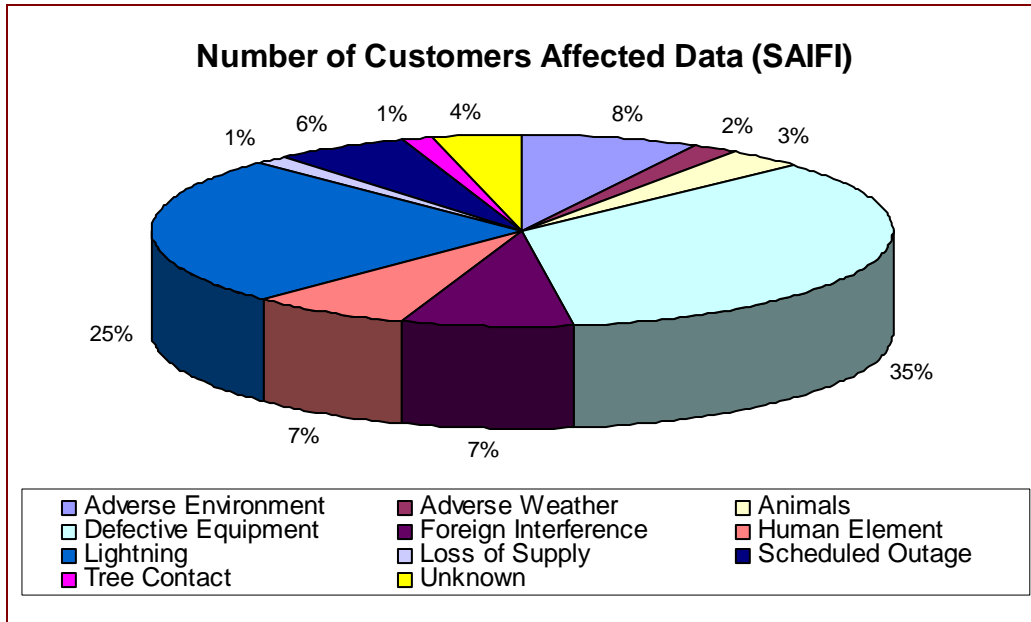
Figure 9, Number of Customers Affected by Cause (SAIFI)

Similar to outage duration, *defective equipment* had the same weight in terms of SAIFI. The breakdown of the number of customers affected (SAIFI) is illustrated in Figure 9. *Lightning* was the second worst category; the major events are discussed later.

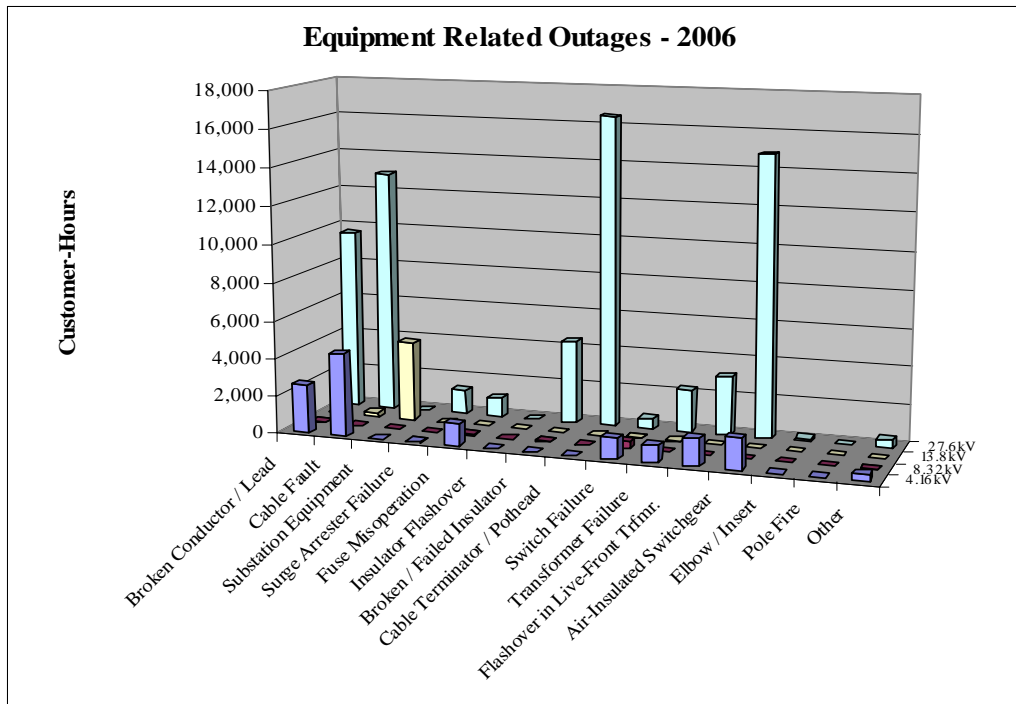
Figure 10, Customer Hours of Interruption by Equipment Type (SAIDI)

In Figure 10, the total outage time accumulated from two categories, namely *adverse environment* and *defective equipment*, is broken down by apparatus and voltage level. This has been a helpful tool in recognizing the type of equipment that is more problematic, and re-directing the efforts to take action before the same type of failure occurs again. It is, however, hard to stay “on top” since once the trends are recognized, the corrective works sometimes do not take place until after outages of the same nature are experienced. As well, depending on the scope, projects need to be budgeted over several years. Sometimes the trend drops off and the failures become less prominent and then, another problematic type of equipment with poor performance takes the spotlight.

A defective lead cable terminator on an egress cable at Wonderland TS, a very rare but high-impact event last year, resulted in a large “black-out” – as described by media⁵. Alone, this one event exceeded all other category totals in terms of duration. This incident is being addressed this year by replacing the last sections of lead egress cable at the transformer station with new polymeric cable.

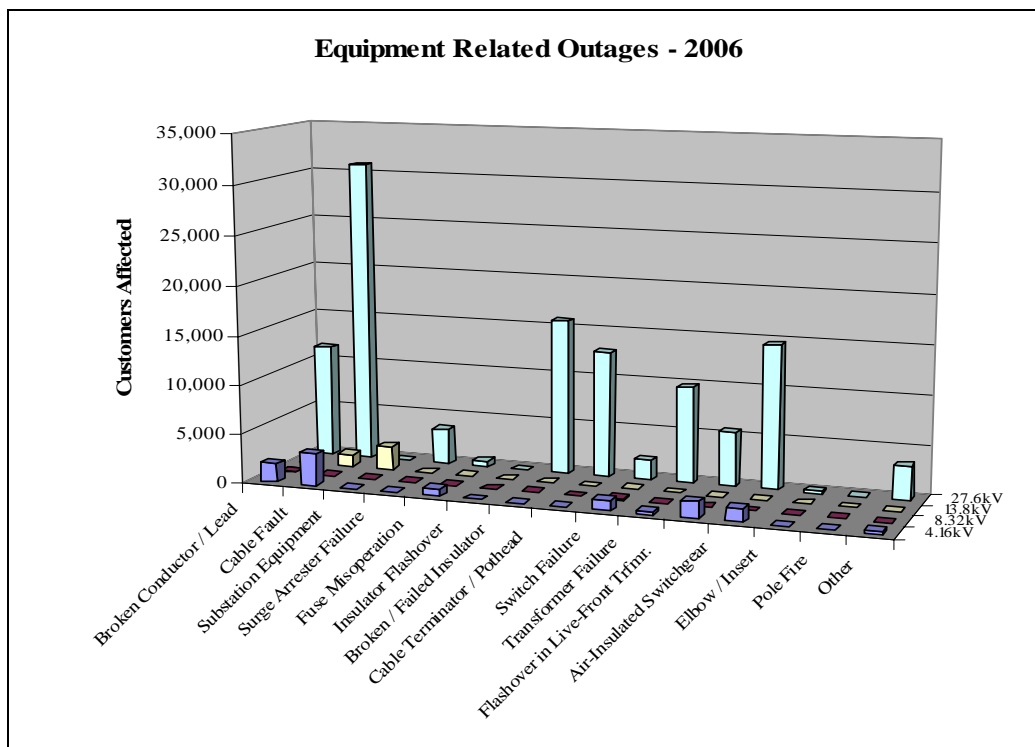
Figure 11, Customers Affected by Equipment Type (SAIFI)

Equipment related outages were responsible for 40% of SAIFI in 2006 compared to 33% last year. Not for the first time and not unexpectedly, the largest sub-cause was *cable faults*; numerous failures were experienced with 13 out of 25 resulting in breaker operations. Also, of the 13, four incidents occurred due to failures of station egress cable (both polymeric and lead).

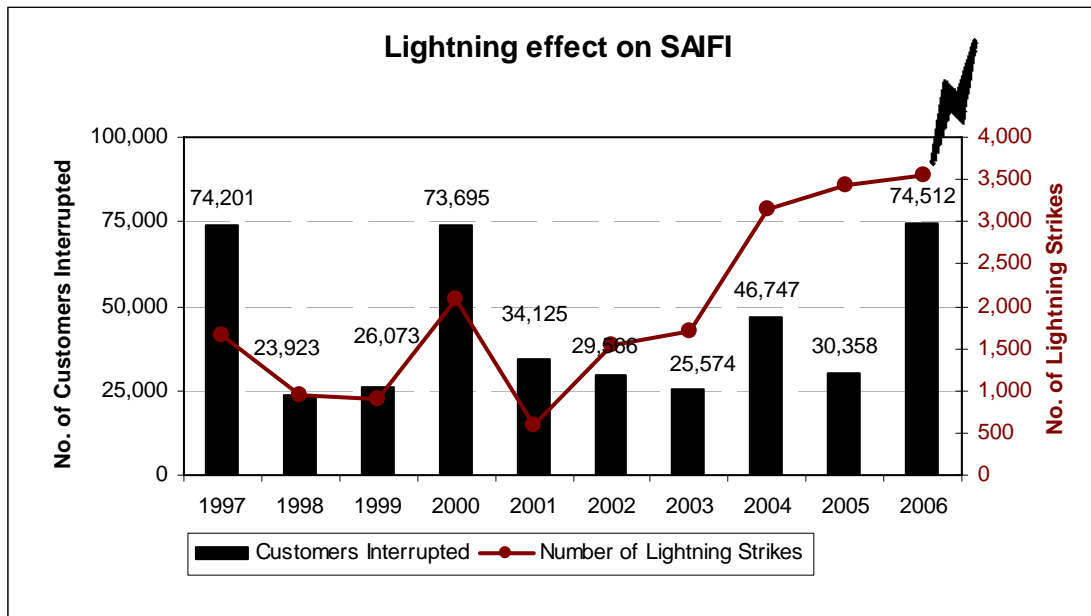
Figure 13, Correlation between no. of strikes and interrupted customers

To demonstrate the robustness of the infrastructure during extreme weather conditions, a simple calculation indicates that a lightning related outage was created for every 30 strikes that occurred throughout the year. Figure 13 depicts the correlation between lightning related interruptions and annual number of strikes. The year 2006 was no exception in how well the system responded to lightning activity; the response was excellent in the preceding years as well.

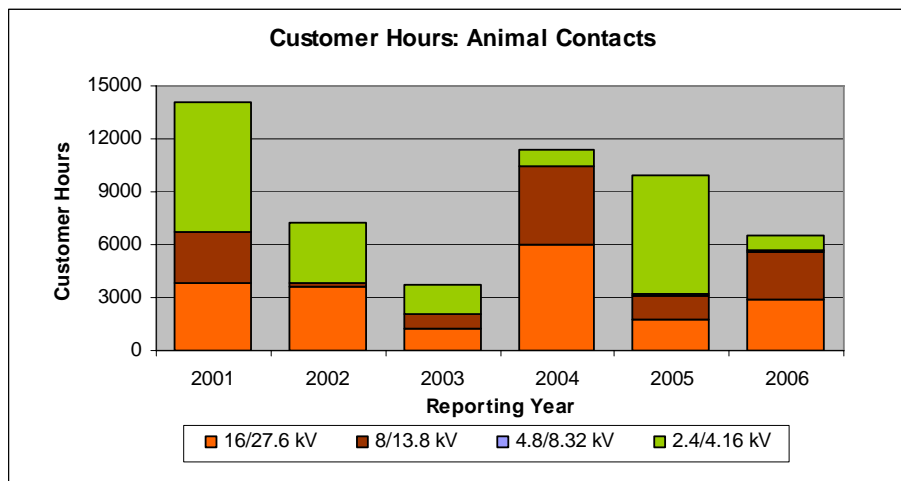
Figure 14, Animal-Caused Service Interruptions by Distribution Voltage Class

Two municipal substations had the largest animal related interruptions in 2001 (SUB-93) and 2005 (SUB-33). After remedies were implemented at both substations, the outage contribution on the 4 kV system is minimal compared to the 27.6 kV and the 13.8 kV systems, where the interruptions account for many more hours. Similar to 2004, in 2006 the majority of outage time on the 13.8 kV system was attributed to the 2K2 feeder, where non-insulated brackets are still present (see Figure 15 and 16). With no auto-reclosing function at the breakers on the 13.8 kV system, any animal contact has a higher probability to create a permanent outage. Nevertheless, there has been an overall decline in animal contact outages since 2004.

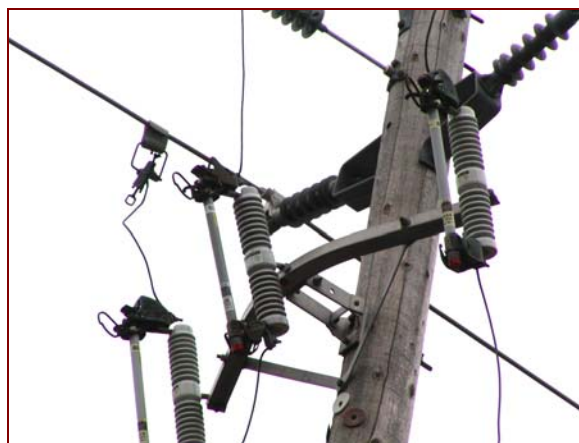
Figure 15, Non-insulated bracket at 5093 (2K2)

Bushing guards combined with insulated high-voltage cutout brackets continue to be the standard construction for any new installation at 27.6 kV and 13.8 kV. SAIFI is expected to naturally improve, since increased clearances should prevent animal contacts, thus avoiding breaker operations. The total number of animal contacts experienced in 2006 was in line with the five-year average of 70-75 incidents.

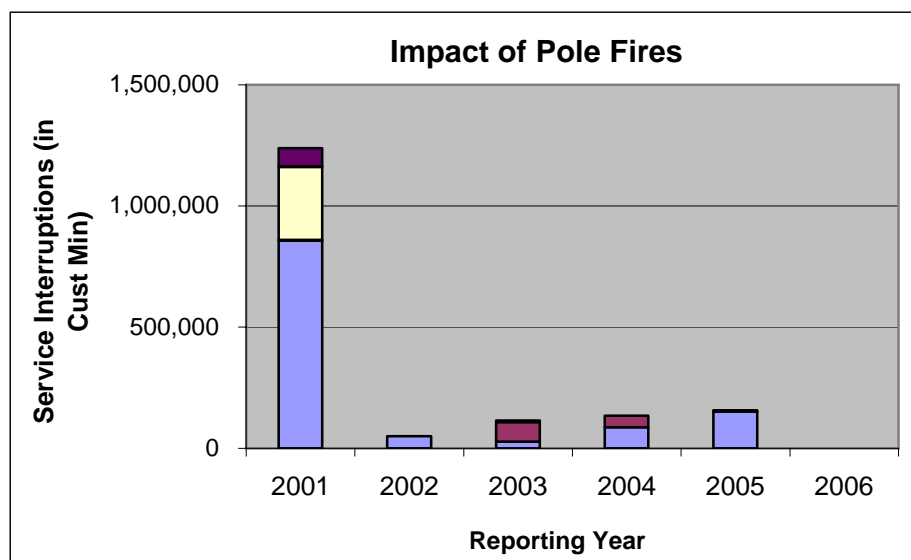
Figure 17, Service Interruptions Due to Pole Fires

No pole fires occurred in 2006. Figure 17 provides some insight into the frequency and impact of pole fires on London Hydro’s distribution system over the past five years. It is evident from the graph that the early pole fire replacement program yielded good results; the remaining part of the program will be carried out according to resource availability.

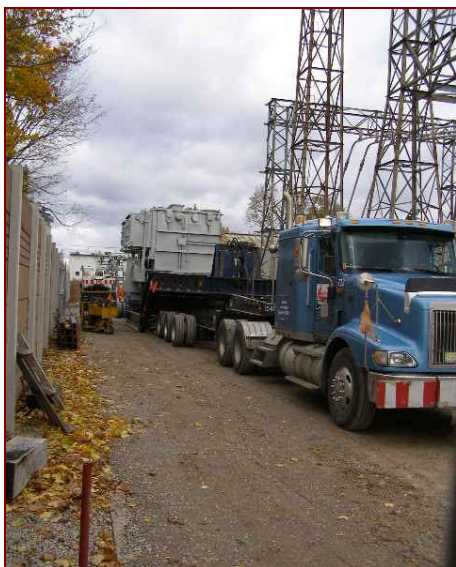
Fig 2 – Truck delivering new transformer

A contingency plan was immediately developed prior to the T4 replacement by HONI (i.e., 2 X 15MVA mobile transformers on site, re-instating a tie between “B-Q” and “J-Y”/“Q-P” buses). However, there was no need to implement any of the solutions; a new power transformer was successfully installed in place of T4 on October 29th, 2006. Pictures from the scene attest the complexity of the work. T4 was back in service by the end of November 2006.

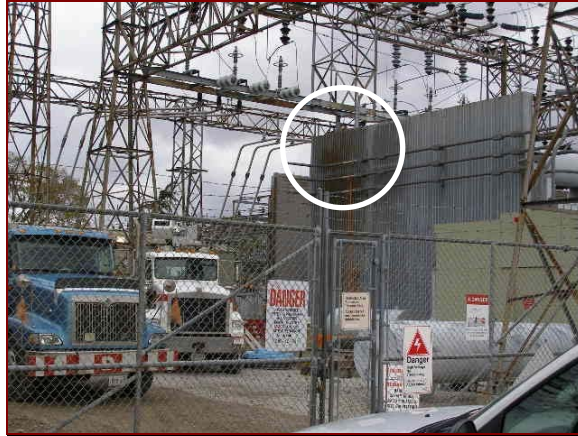
Fig 4 – Separation wall affected by the failure of T4

On Sunday, October 14th, 2006 at midnight, the T4 power transformer failed internally; at the same time its high gas alarm triggered the bus potential relay to trip off the T3 transformer as well. As a result, both “J-Y” and “K-P” buses supplied from the two transformers lost power. London Hydro had no ability to provide back up supply to the station during the course of the outage.

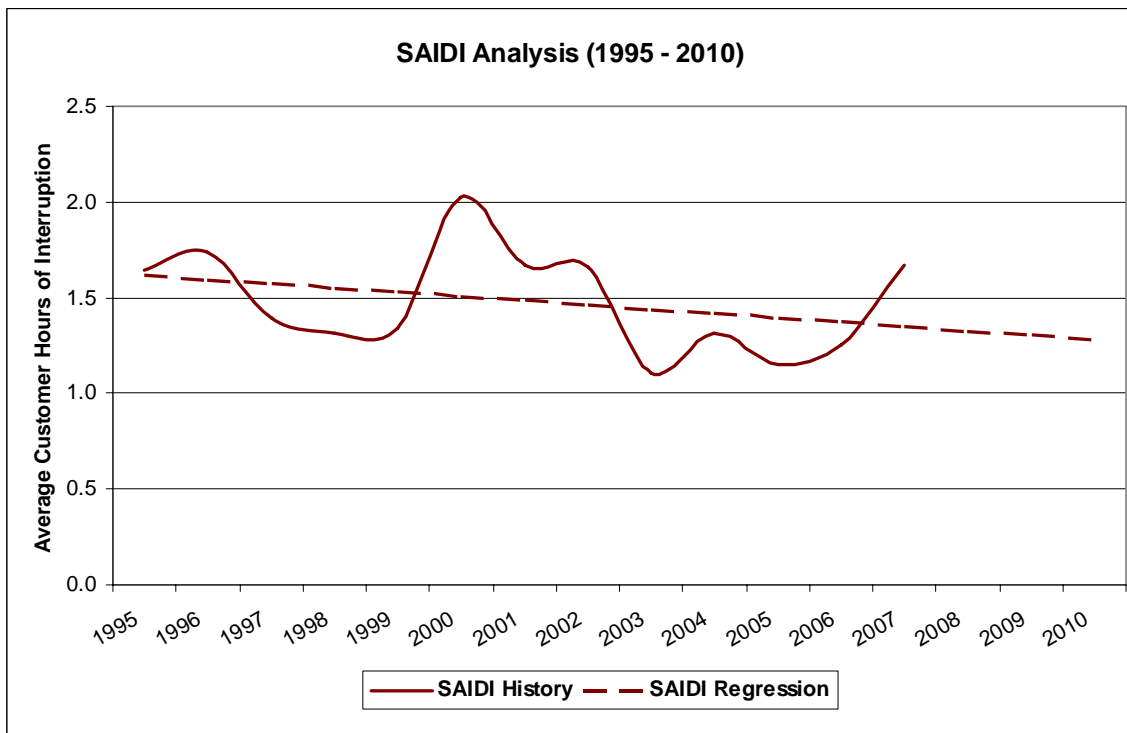
Figure 1, Linear Regression on SAIDI History

As illustrated in Appendix 5 of this report, the trend observed over the last 12 years indicates an overall improvement in SAIDI. In addition, a linear regression analysis⁵

using historic data (which excludes MEDs) and forecasting until year 2010 confirms the same positive trend in SAIDI (an overall reduction of 15%).

⁵ Linear regression is a statistical technique for finding the best fit linear relationship between two sets of numerical variables. In its simplest form it is meant to predict one set of variables (SAIDI future values) given a known set of variables (following years).

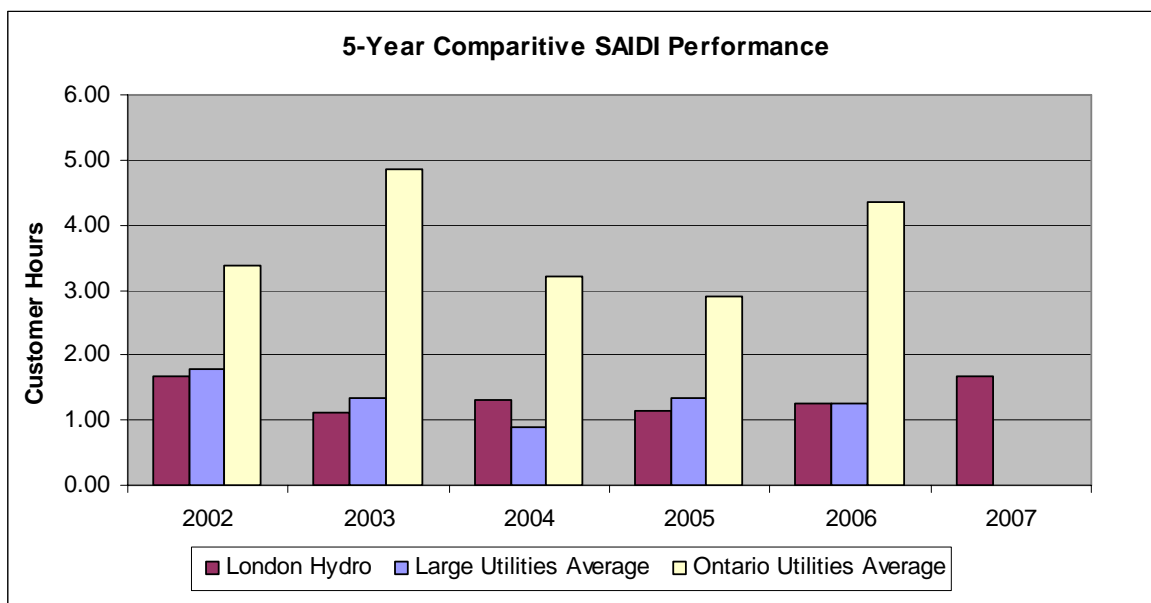
Figure 2, SAIDI Performance – London Hydro vs. other LDCs

Figure 2 compares London Hydro’s SAIDI performance for each of the last five years to the average value of a select group of larger Ontario utilities⁶, and to the average of all Ontario LDCs over the same time period.

As the chart clearly shows, London Hydro has demonstrated strong year-end SAIDI indices since 2002 in comparison to the provincial average and to equivalent peers.

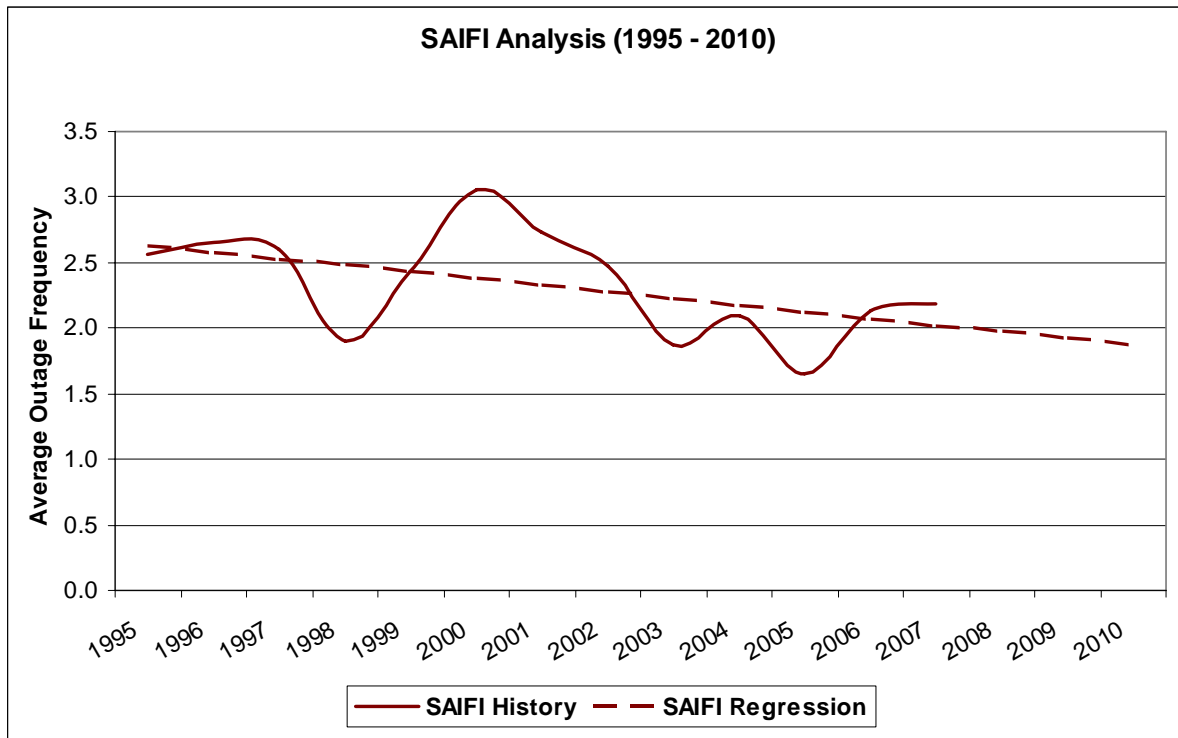
Figure 3, Linear Regression on SAIFI History

maintained in all the graphs to be able to determine each category’s contribution to the overall total. As the trend lines indicate, over the past 12 years almost all the categories have shown improvement. It should be emphasized that *defective equipment* continues to contribute the most to the unreliability of the system. Again, linear regression analysis using historic data forecasts a 20% decline in the SAIFI trend value by year 2010.

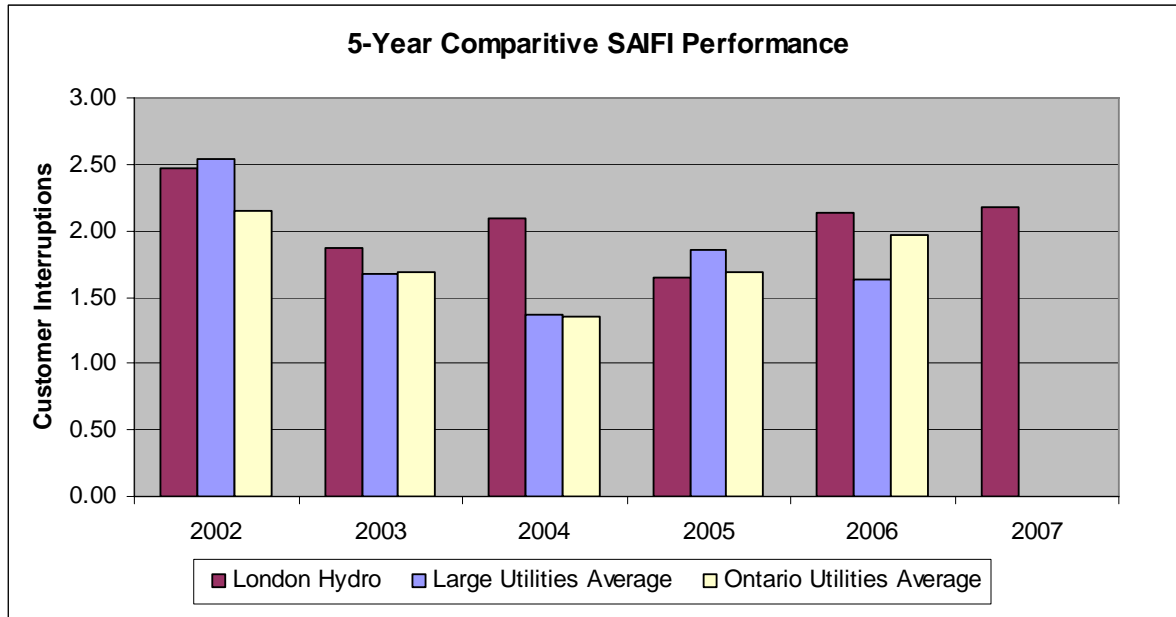
Figure 4, SAIFI Performance – London Hydro vs. Other LDCs

The following chart compares London Hydro’s SAIFI performance for the last five years to the average values of the same eight larger utilities used in the SAIDI comparison, as well as the average of all Ontario LDCs indices since 2002.

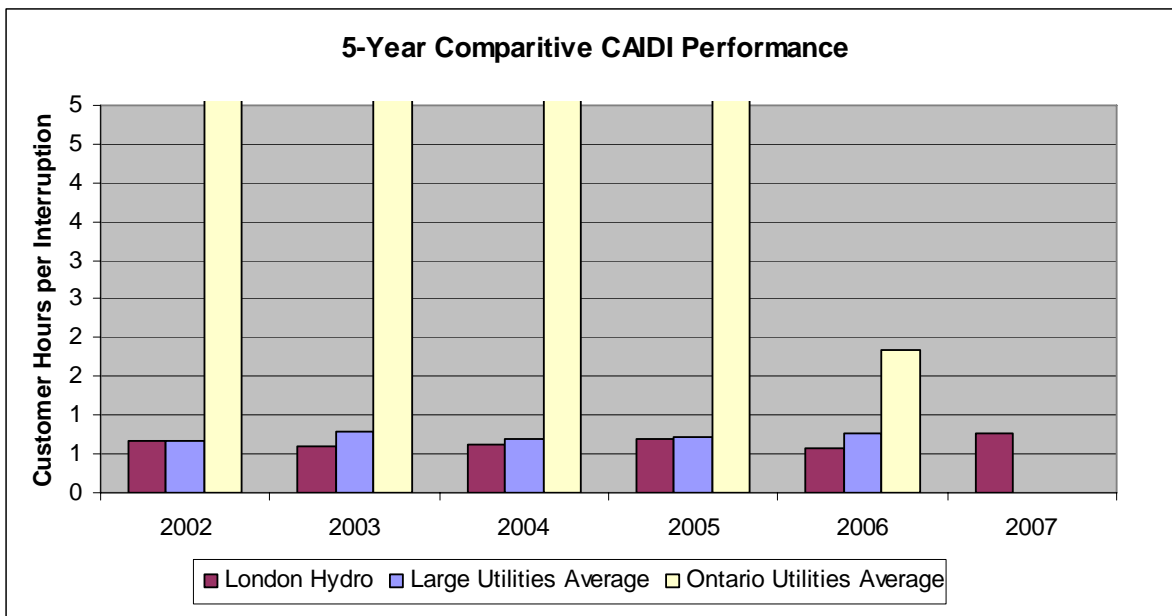
Figure 5, CAIDI Performance vs. other Ontario LDCs

Figure 5 illustrates London Hydro’s CAIDI performance compared to the average of the other larger utilities and the annual average of all the LDCs in Ontario over the course of the past five years. London Hydro has maintained a satisfactory response time since 2002, in line with comparable peer utilities.

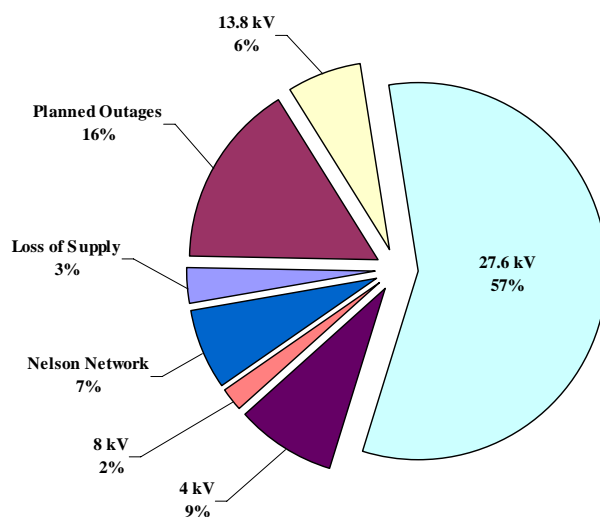
Figure 6, Interruption Duration (SAIDI) breakdown by Distribution Voltage

One reliability analysis approach that has aided in the targeting of investment over the years has been to segment the outage duration and frequency according to voltage class, planned outages and loss of supply events. As in previous years, the 27.6 kV system continues to remain the primary focus of reliability improvement measures, due to its size and its impact on the lower voltages. Figure 6 and Figure 7 indicate in which proportion each of the above components contributed to unreliability during 2007.

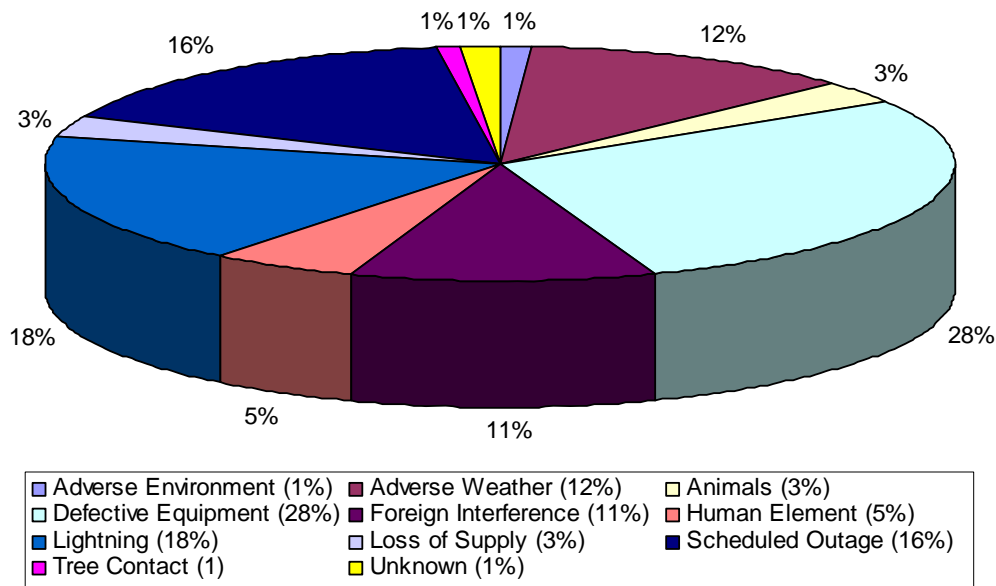
Figure 8, Proportion of Customer Minutes of Interruption (SAIDI) by Cause

In terms of outage duration, *defective equipment* contributed to unreliability with the largest number of customer minutes of interruption, as indicated in Figure 8. In spite of the improving trend over the past decade, failures of in-service system components continue to be the leading cause contributing to outage duration. Compared to other causes, outages in this category tend to be of longer duration, as the equipment often needs to be replaced before power is restored. *Lightning* and *scheduled outages* were the second and third largest contributors to SAIDI. Lightning-related outages and their effects are discussed in greater detail in Section 8.2.1.

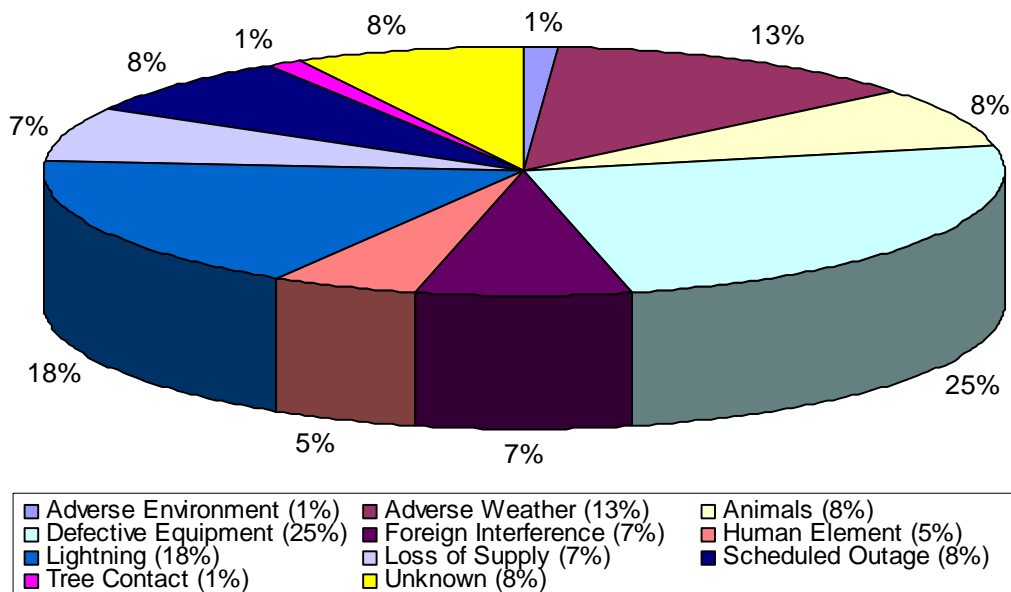
Figure 9, Proportion of Number of Customers Affected (SAIFI) by Cause

Defective equipment was also the largest category responsible for the frequency of the interruptions. Figure 9 illustrates the proportion of the number of customers affected in each category. *Lightning* and *adverse weather* were the second and third largest contributors to SAIFI. Many outages were caused by two severe storms during the month of June 2007, especially in the lightning category.

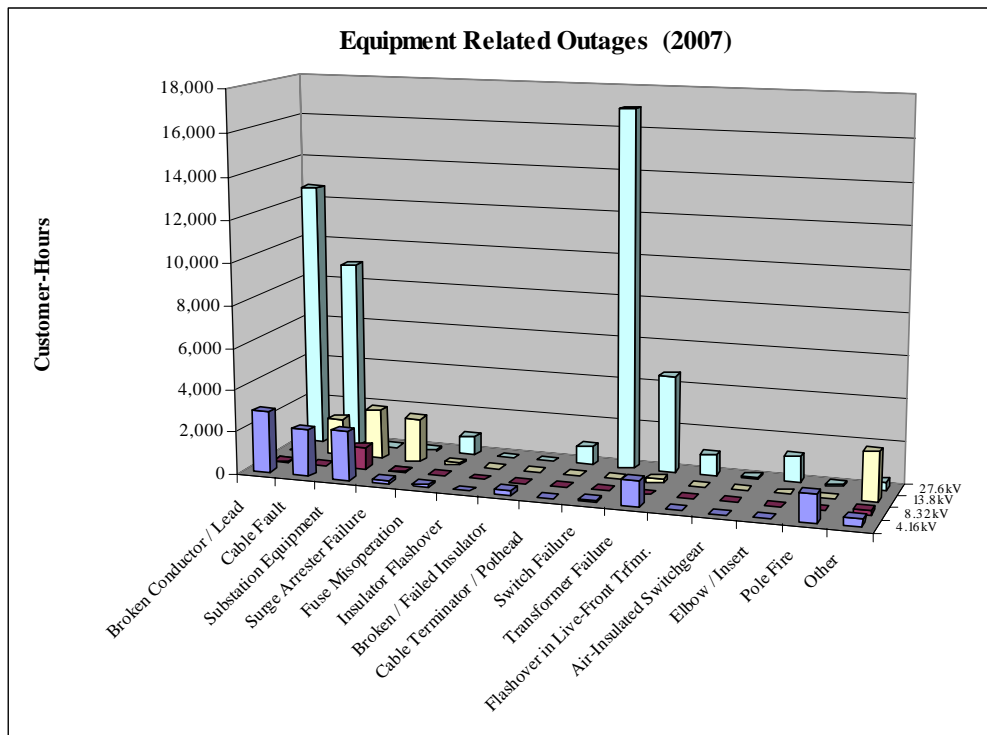
Figure 10, Customer Hours of Interruption by Voltage and Equipment Type (SAIDI)

Equipment-related outages caused by *adverse environment* and *defective equipment* can be further broken down by apparatus and voltage, as illustrated in Figure 10.

This analysis has proven helpful in identifying the type of equipment that consistently has poor reliability over the years, and also in separating low-probability, high-impact events that can skew the analysis results. However, despite certain trends being recognized (i.e. flashover risk in the air-insulated switchgear), failures still occur in those areas since projects generally need to be budgeted over several years. Over time, the trend drops off for certain equipment that has improved in performance and another problematic type of equipment with poor performance becomes the new focus.

Equipment-related outages contributed 30% of the total outage time in 2007.

Year 2007 experienced a high-impact event that again affected Wonderland TS⁷ and some Talbot TS feeders. A Firon in-line *switch failure* affected thousands of customers which in turn resulted in almost 17,000 customer hours of interruption. This event alone exceeded all other equipment-related totals in terms of duration as shown in Figure 10. A recommendation was listed in the 2008 capital budget to resolve the issue in accordance with the failure report received from the manufacturer (a copy is found in Appendix 8).

Broken conductors had a fairly high impact as well, with only one incident contributing to the majority of the outage time (over 12,000 customer hours of interruption). Not unexpectedly, *cable faults* continue to be a significant contributor to SAIDI every year; a total of 25 incidents occurred on the system (17 on polymeric cable), compared to 25 occurrences in 2006 and 15 in 2005. The trend in the number of cable faults is increasing despite the annual program of subdivision cable rebuilds. The SPOORE analysis⁸ has targeted areas where rehabilitation of the underground plant was most needed. Between the years 2000 and 2007, approximately 90 km of polymeric cable has been replaced for an estimated investment of 10.5 million dollars.
