**IN THE MATTER OF the *Ontario Energy Board Act, 1998*,
S.O. 1998, c. 15, (Schedule B);**

**AND IN THE MATTER OF an application by London
Hydro Inc. for an order approving just and reasonable
rates and other charges for electricity distribution to be
effective May 1, 2009.**

**London Hydro Inc. (“London Hydro”) Responses to
Ontario Energy Board Staff Interrogatories**

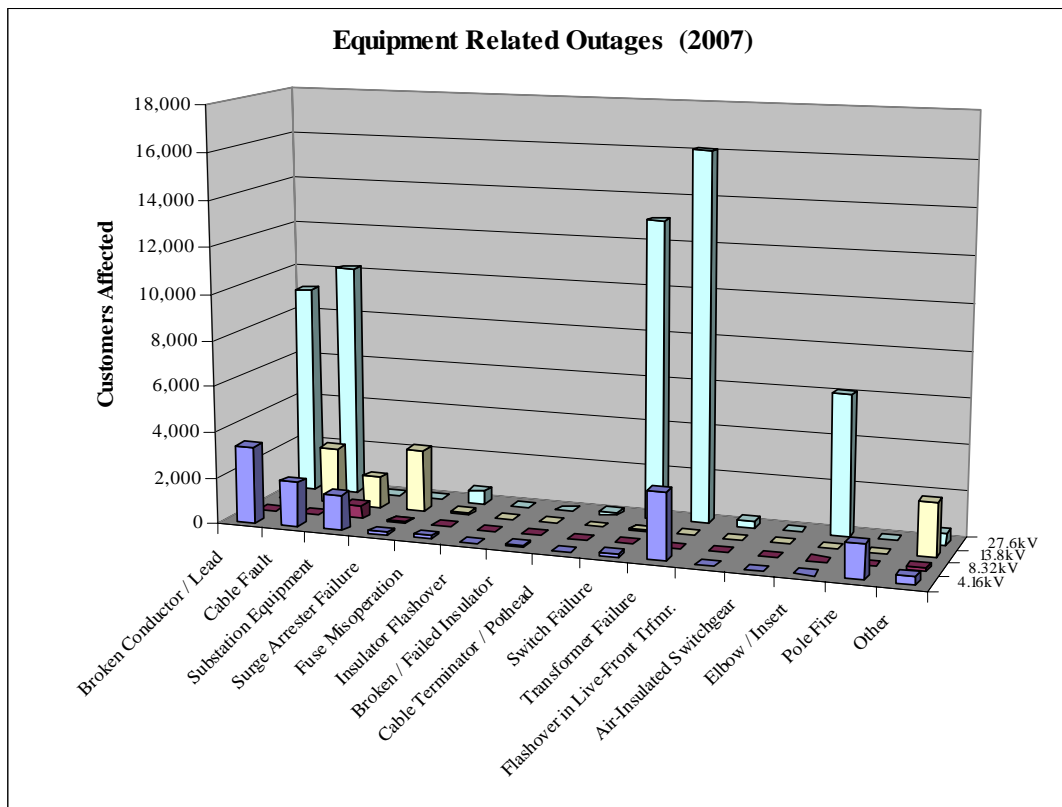
Figure 11, Customers Affected by Voltage and Equipment Type (SAIFI)

Equipment-related outages were responsible for 25% of SAIFI in 2007 compared to 40% in the previous year. Surprisingly, *defective transformers* was the sub-category with the largest contribution to the number of interruptions. Seven breaker operations were counted with outages caused by the failure of transformers, either due to a hold-off on a feeder, or mis-coordination between the transformer fuse and the station breaker. Breaker operations accounted for 88% of the interruptions in the sub-category. The isolated incident of the *Firon switch failure* had huge implications on SAIFI related to equipment outages as well, causing a power interruption for over 12,000 customers.

The third largest sub-cause was *cable faults*; numerous failures were experienced with 14 out of 25 resulting in breaker operations. Also, four incidents occurred due to failures of station egress cable (both polymeric and lead).

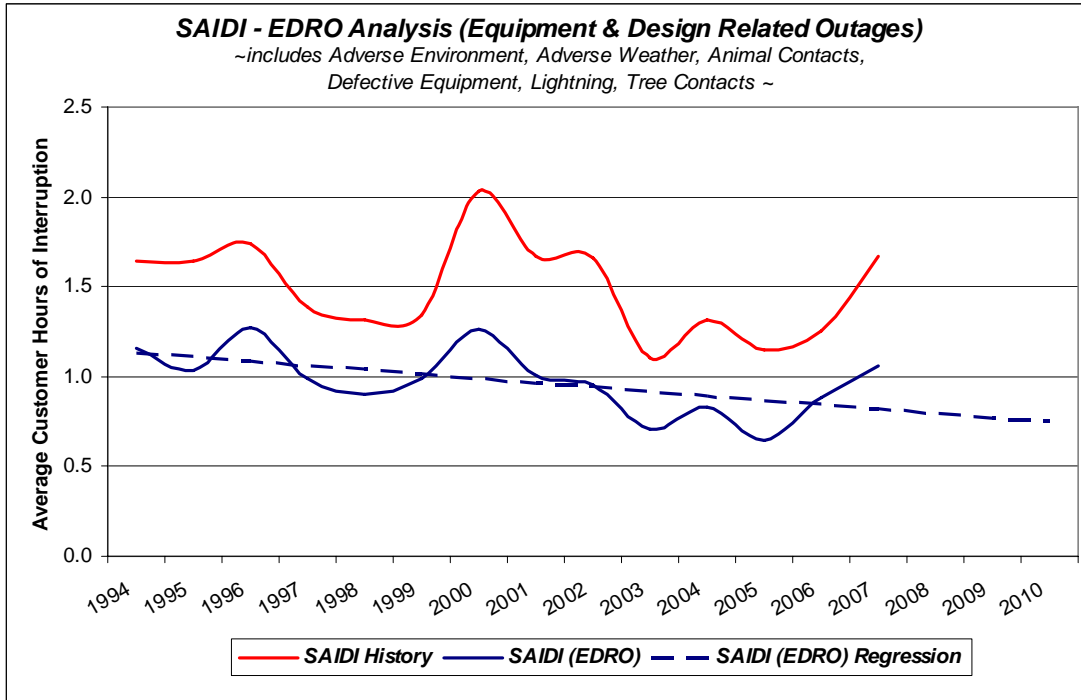
Figure 12, Regression Analysis for SAIDI using EDRO

Historic profiles using targeted data for the EDRO analysis are plotted in Figure 12 and Figure 13 together with the traditional graphs for both SAIDI and SAIFI¹⁰. It is immediately evident in both cases that yearly variations using EDRO are narrower than when using all eleven cause categories. This less volatile, quasi-steady profile derived from the EDRO analysis reflects the fact that improved service and reliability are directly related to targeted capital work investment.

This re-defined benchmarking approach has taken reliability analysis to a higher level; some causes that affect the overall system performance are purposely set aside in order to provide a more focused engineering analysis that can be used to support future capital project budget proposals. A new reliability measuring tool was derived: *Equipment and Design Related Outages* analysis (EDRO). The scope of EDRO analysis⁹ is to combine the outage elements (weather, animals, vegetation, humidity, and last but not least, component failures) that are most affected by system design. Thus, outages related to specific causes within the control of the utility can be examined constructively to improve the design of the system. Future investments can then be targeted to the areas best expected to improve long term reliability.

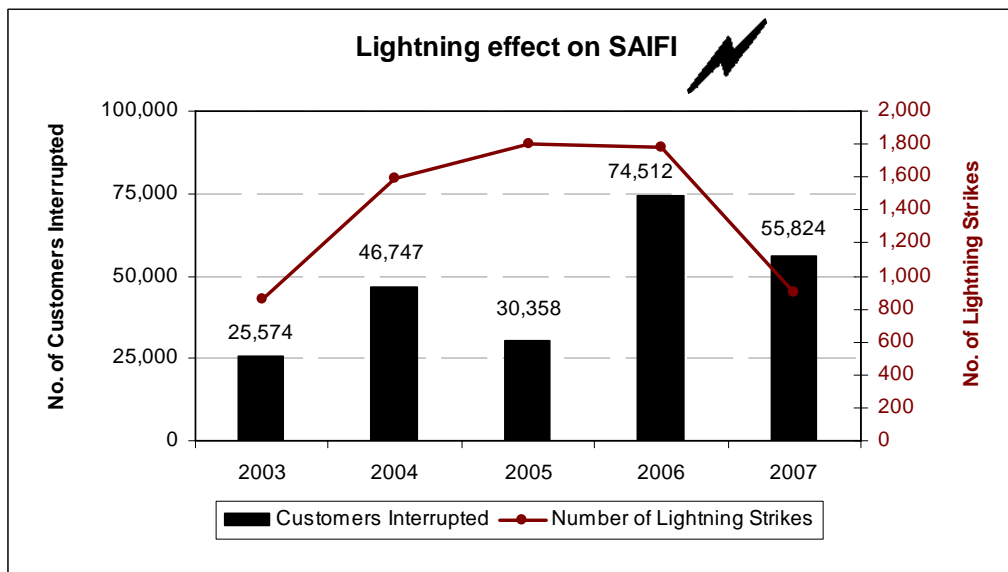
Figure 16, Correlation between Adjusted Lightning Strikes and Interrupted Customers

The correlation between interrupted customers within London’s territory and the new annual number of strikes will continue to be the measure for future comparison (see Figure 16).

During 2007, London Hydro experienced 74 lightning-related outages (compared to 115 in 2006). The number of lightning strikes has fallen significantly from the previous year.

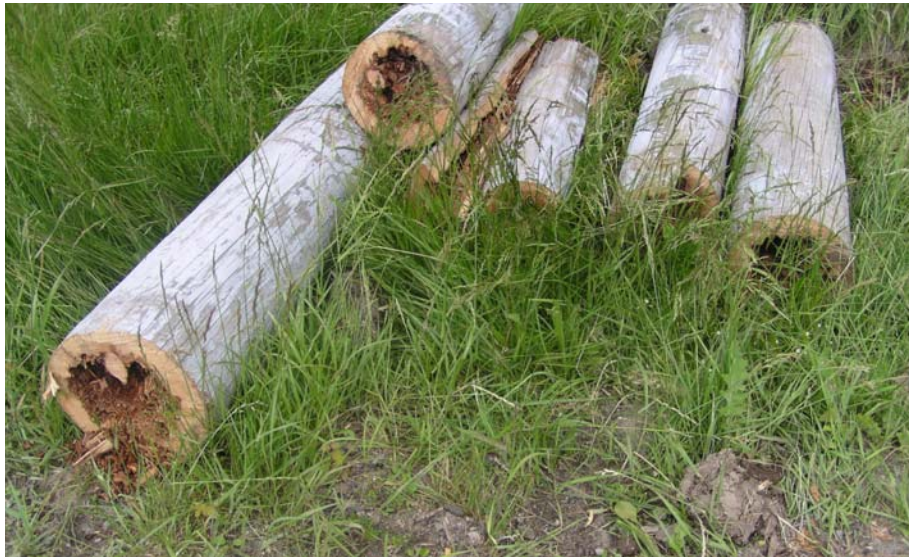
Figure 17, Pole decay in Grey Munsell Poles

London Hydro continues a yearly program to systematically test its wood poles. Using the test data, the appropriate poles are proposed for replacement in the capital budget in following years. Also, Grey Munsell poles continue to be eliminated from the system; the aesthetic grey coating makes them prone to rot prematurely, leading to failures.

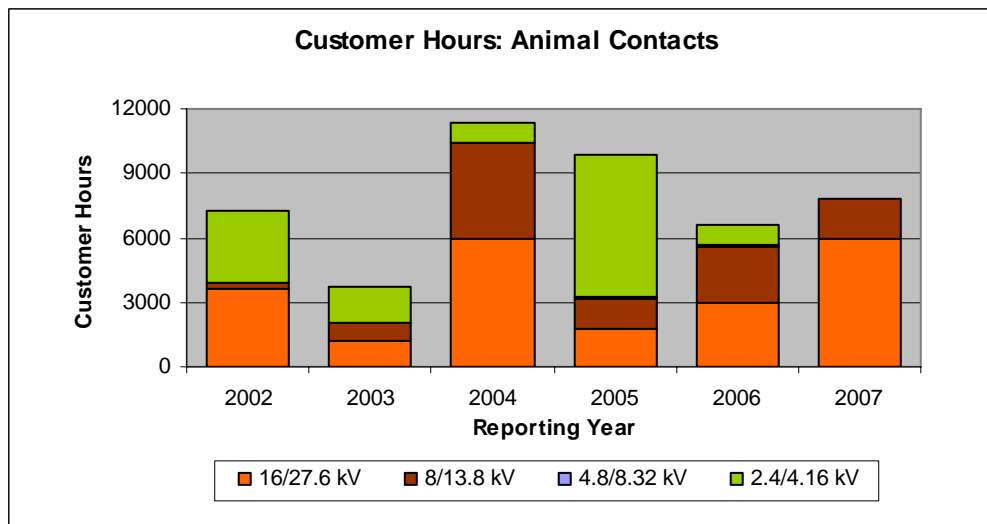
Figure 18, Animal-Caused Service Interruptions by Distribution Voltage Class

In 2005, one municipal substation alone (SUB-35) had three high-impact animal-related outages. Remedies to the exposure of the secondary live bus are being implemented in 2008. As the above chart indicates, the outage contribution on the 4 kV system continues to be minimal in recent years compared to the 27.6 kV and the 13.8 kV systems, where the interruptions account for many more hours. Year 2007 experienced a total of 105 animal contacts – higher than the five-year average. A special focus may be placed in the near future on animal protection if certain areas continue to develop a higher frequency of animal contacts.

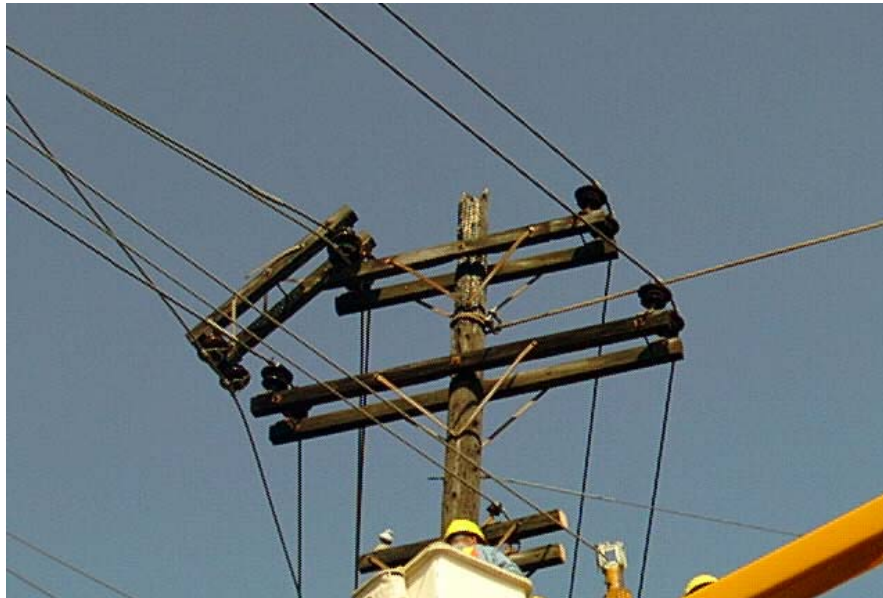
Figure 19 depicts an old construction style commonly referred to as “Christmas tree” construction because of its triangular shape. The damage normally occurs at the top of the pole where leakage can be present across insulators, initiating charring that can further set the pole on fire. All “Christmas tree” configurations have been identified and eliminated from the system. However, there remain other types of pole line construction (i.e., using pin-type insulators) that are also posing a risk of pole fires.

Figure 19, Pole Fire Damage

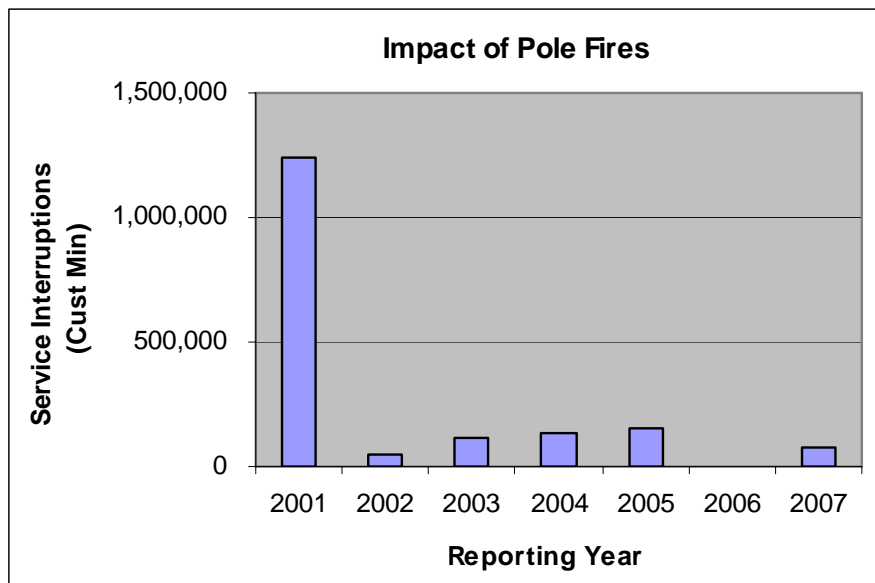
Figure 20 illustrates the improved performance with respect to pole fires on London Hydro’s distribution system since 2001.

Figure 20, Service Interruptions Due to Pole Fires

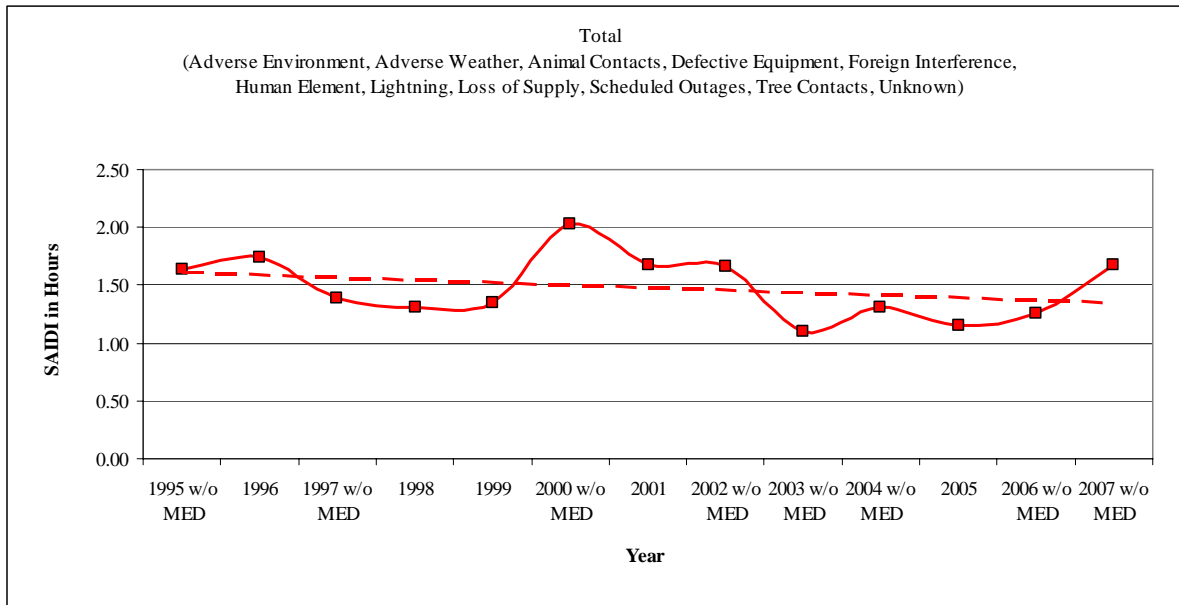
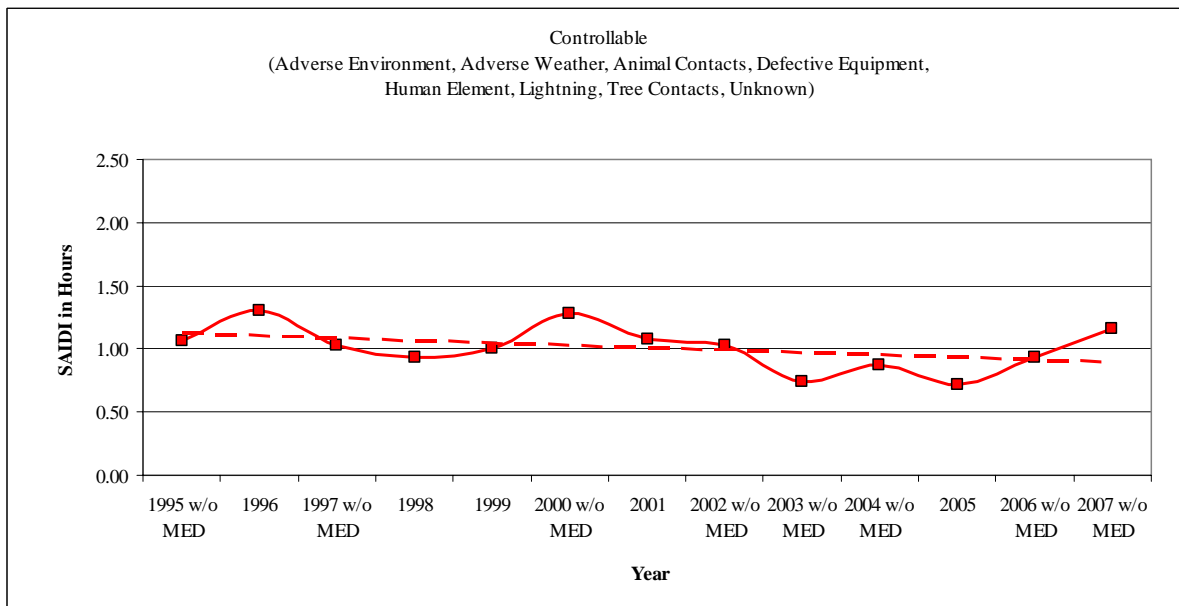
Appendix 5

SAIDI

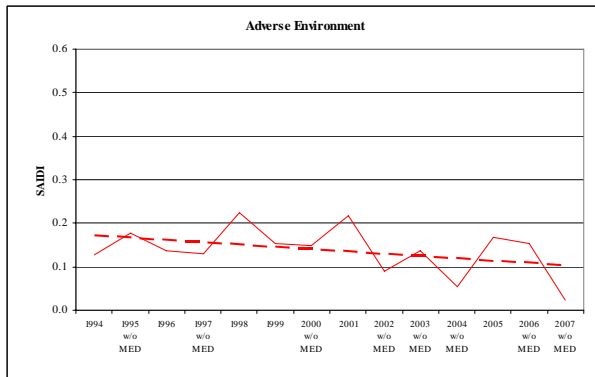
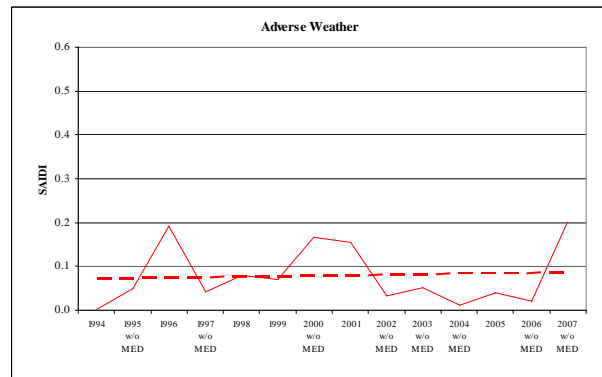
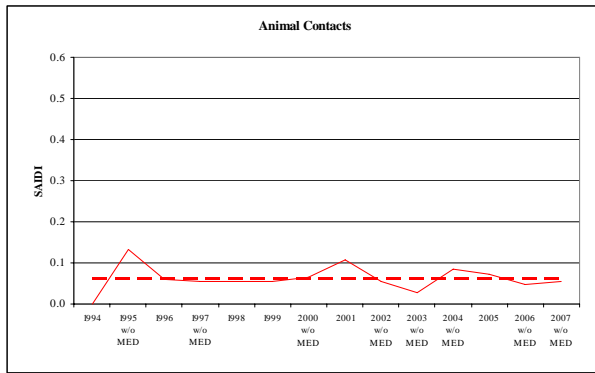
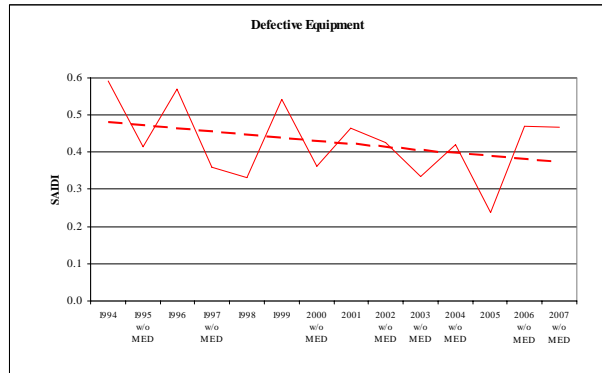
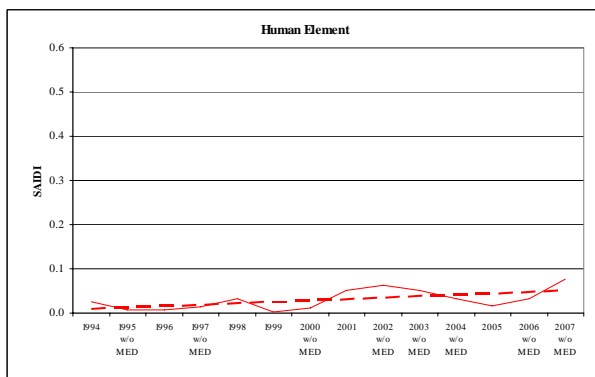
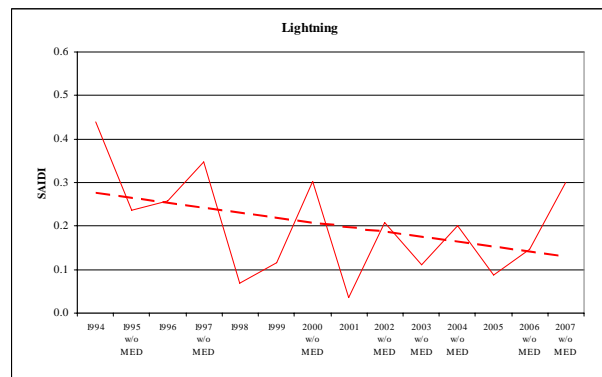
SAIDI (Controllable)

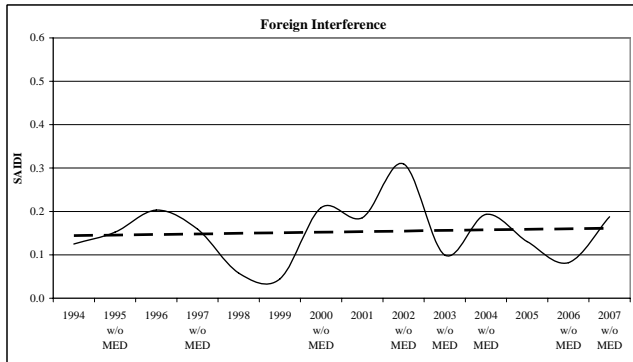
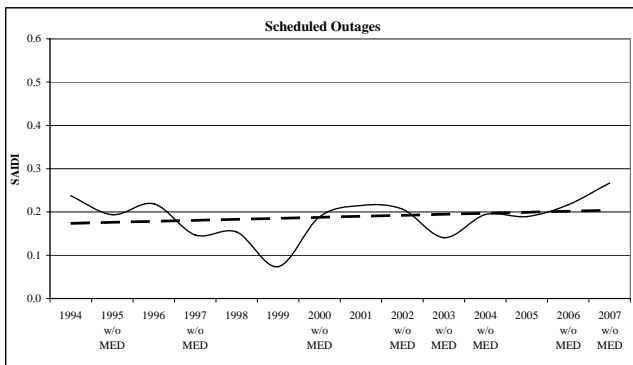
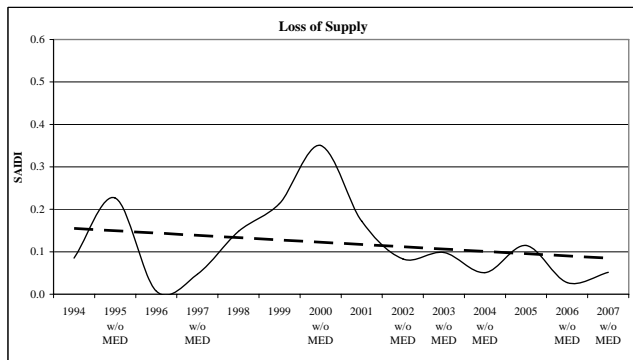
SAIDI (Uncontrollable)

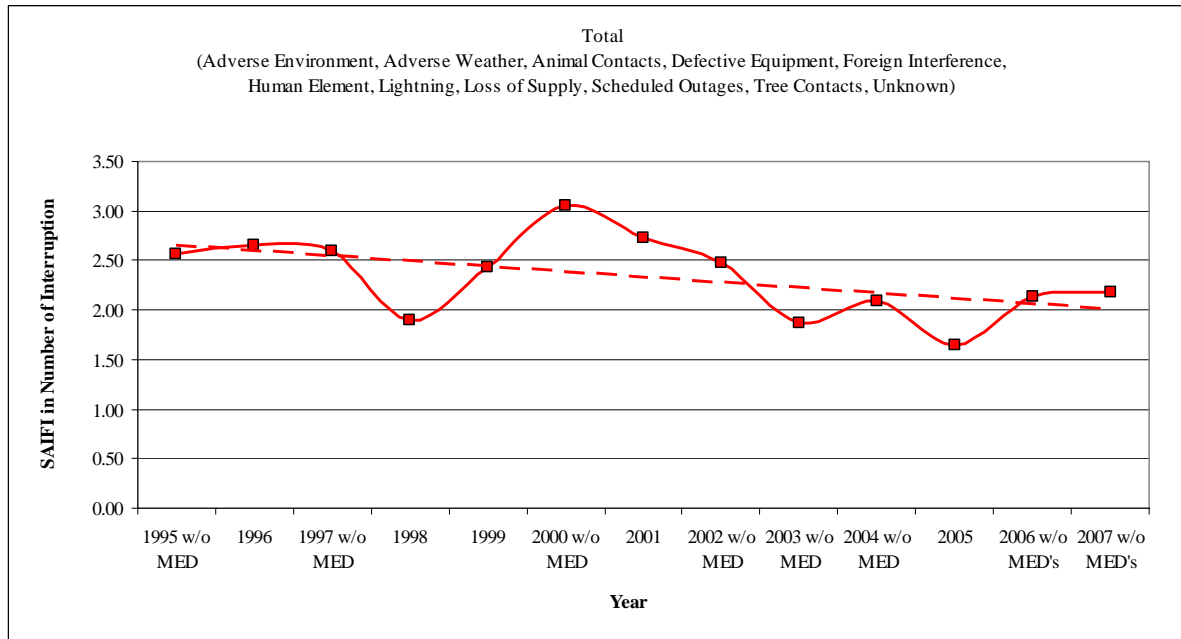
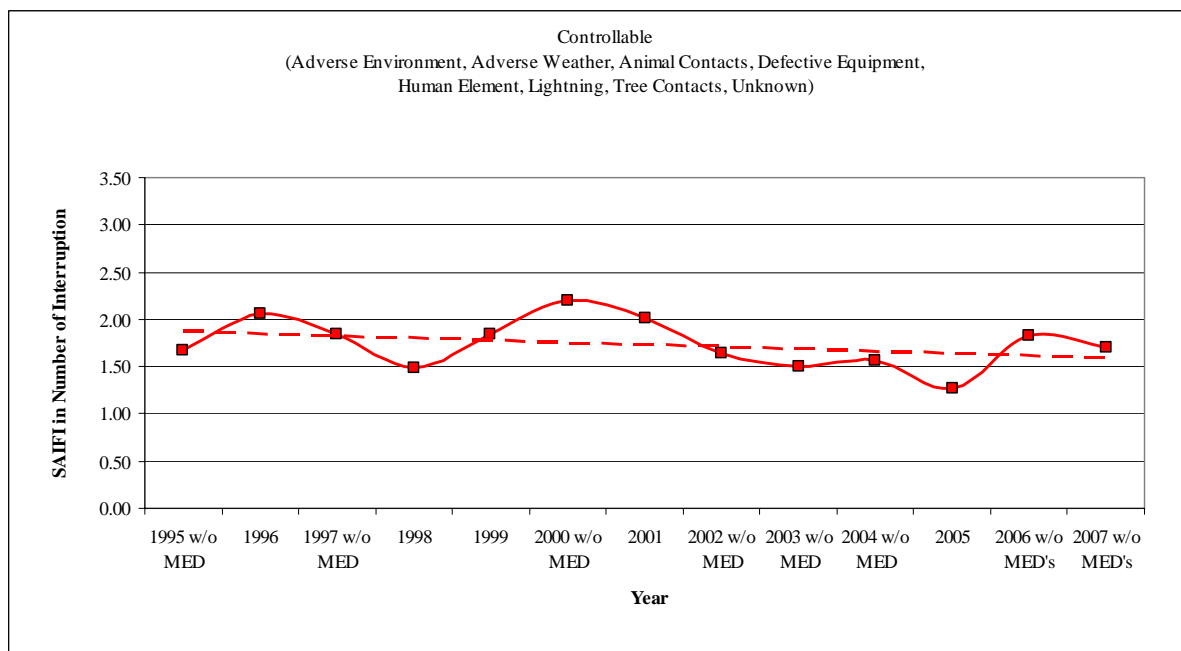
Appendix 6

SAIFI

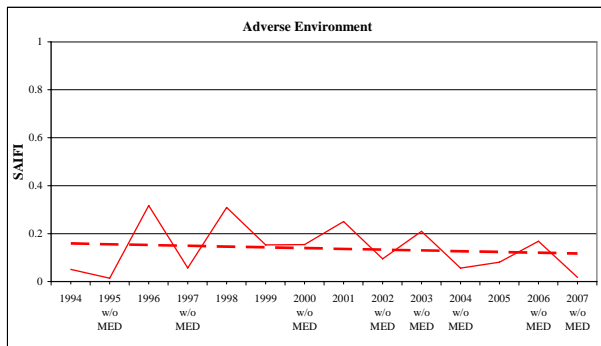
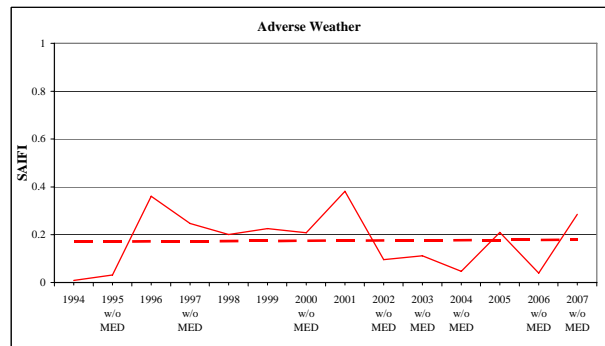
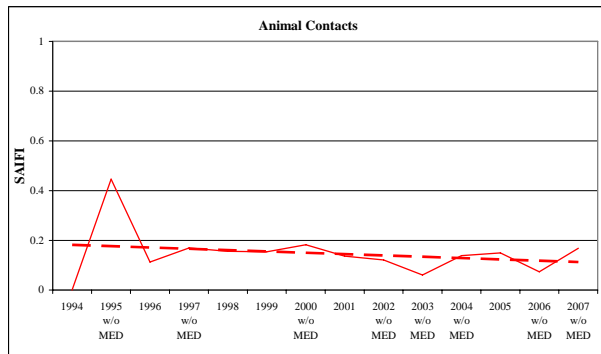
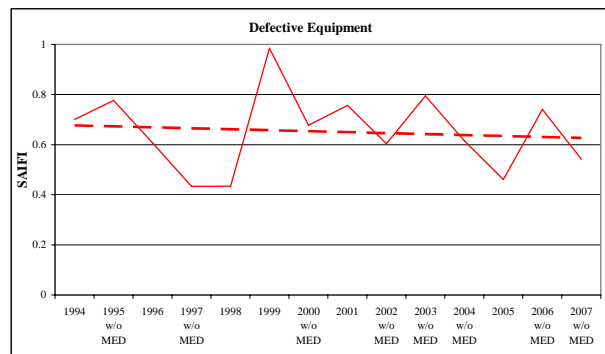
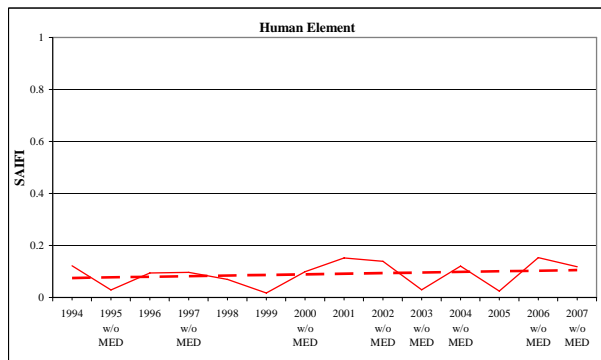
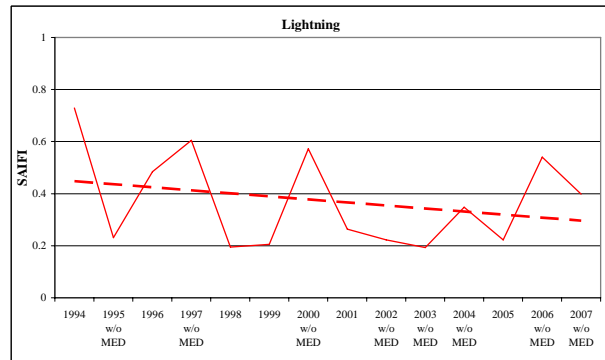
SAIFI (Controllable)

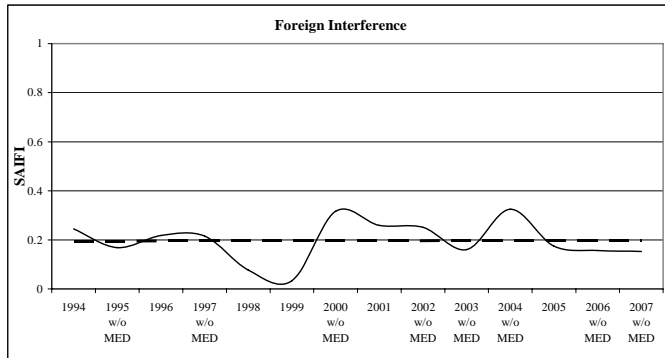
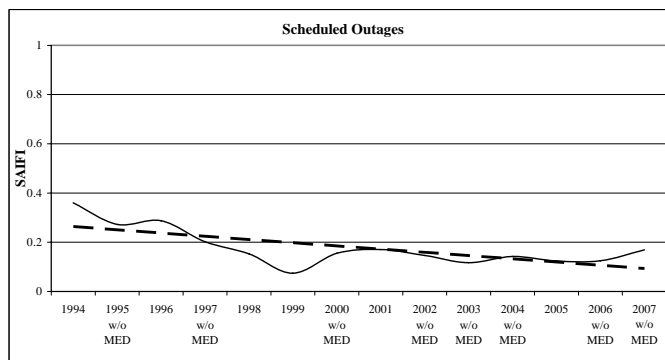
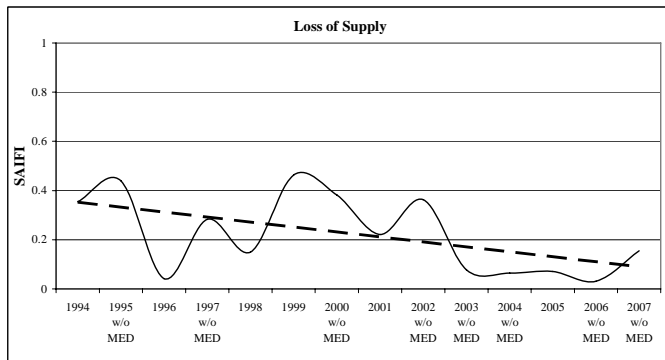
SAIFI (Uncontrollable)

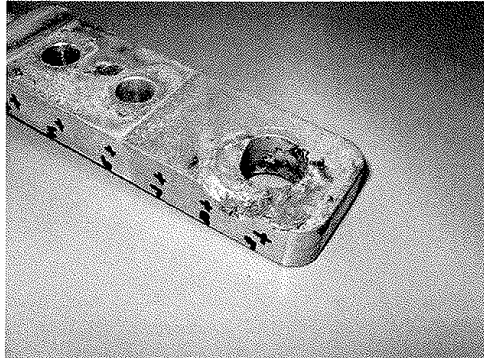
Photo #1: End fitting from switch.

Report received from Firon Industries after investigating the failure of a in-line switch.

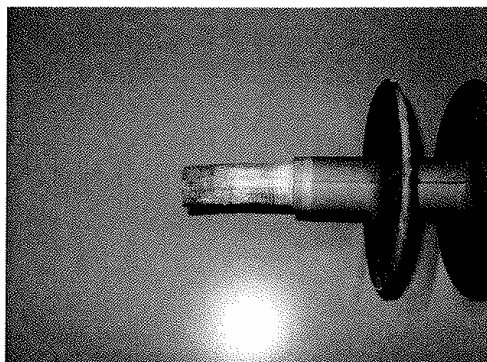
Photo #2: Discolouration of the fiberglass rod.

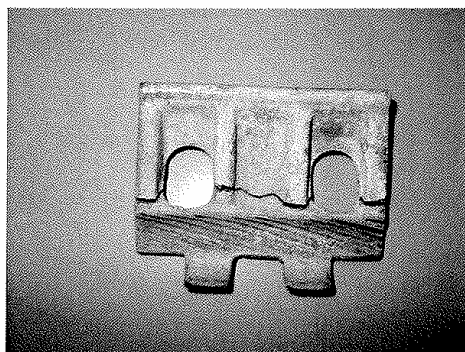
Photo #3: Crack in two-hole connector.
