Re: Halton Hills Hydro Inc. 2008 Electricity Distribution Rates Application  
Board File Number EB 2007-0696  
Second Round Interrogatory Responses to OEB Staff

### 3 Visual Survey

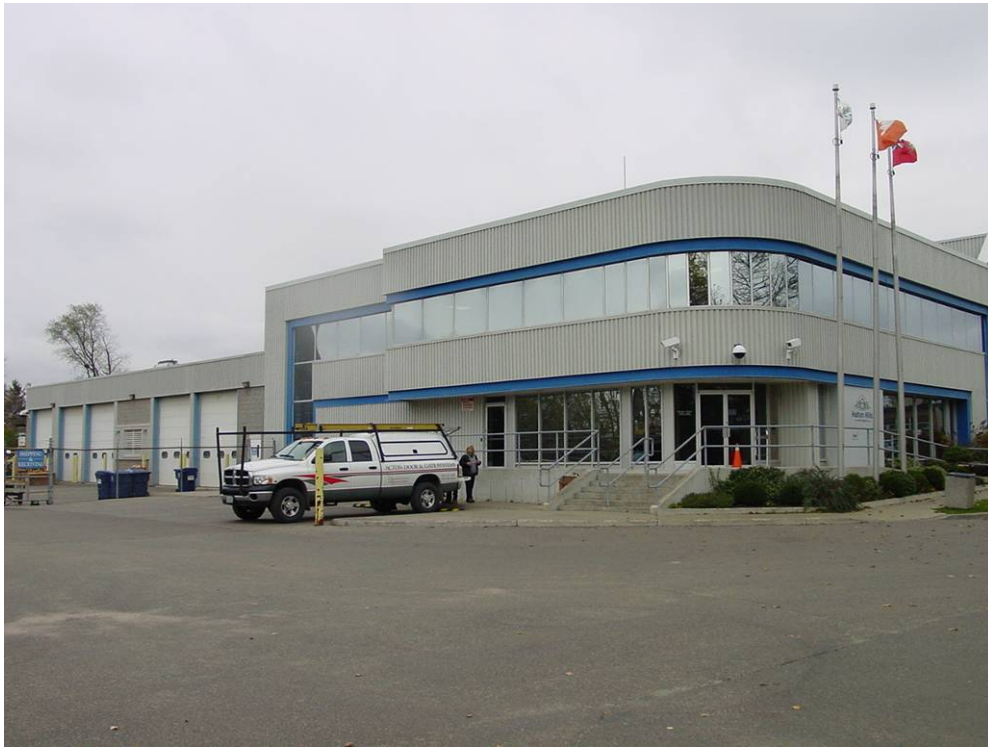
**Photograph 1:** Northwest elevation of the Halton Hills Hydro Building in Acton. The existing building is a multi storey steel frame and metal clad structure extensively renovated and rebuilt in 1989.

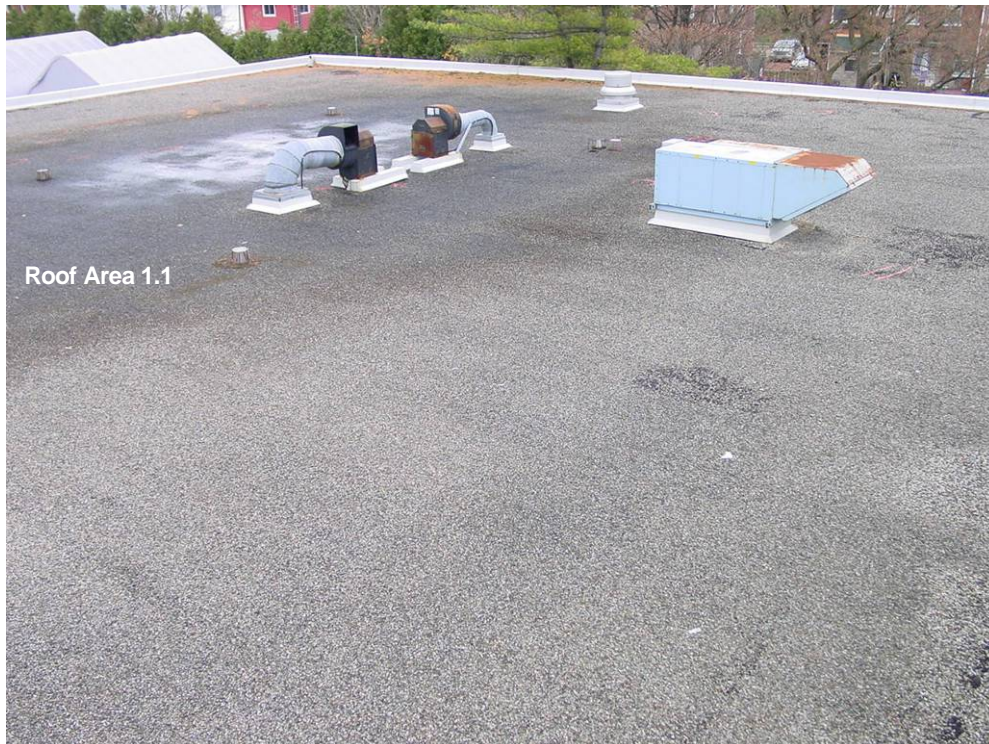
**Photograph 3:** Roof Area 1.1 – Overall view looking northeast at roof area 1.1 situated over the Garage in the east end of the facility. The existing roof consists of a built up bituminous membrane system installed in 1989.

This roof area (photographs 3 and 4) is situated over the Garage at the east end of the facility. The existing roof consists of a built up bituminous membrane system installed in 1989. Investigation revealed the following:

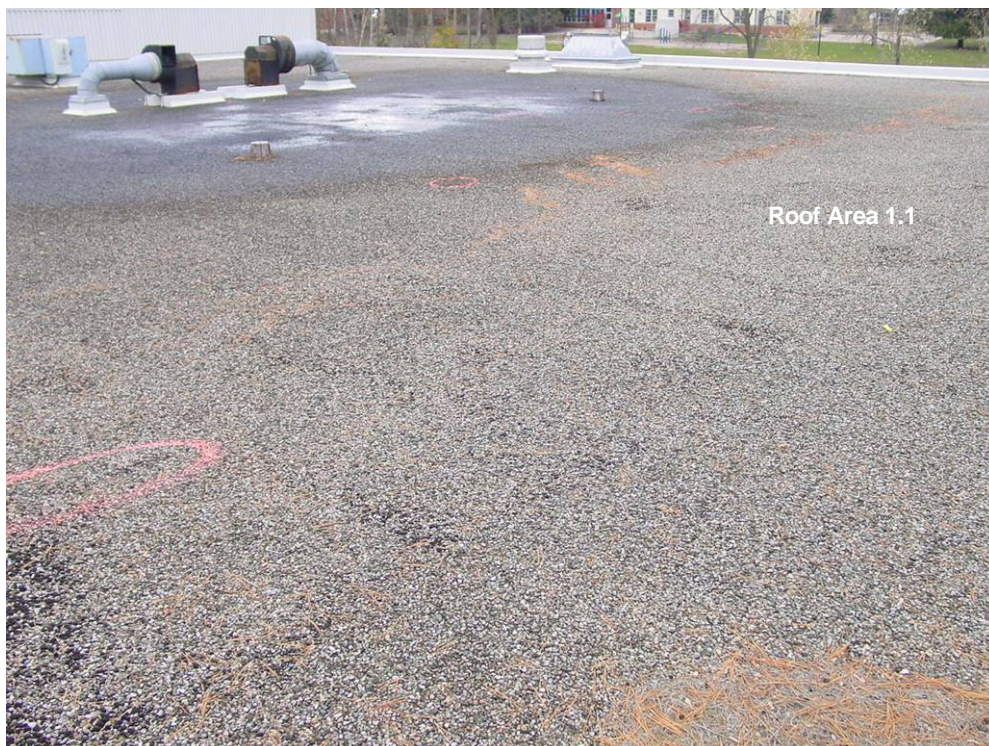
**Photograph 4:** Roof Area 1.1 – Overall view of roof area 1.1 looking northwest. Drainage patterns appear to be generally good due to a slightly sloping structural substrate.

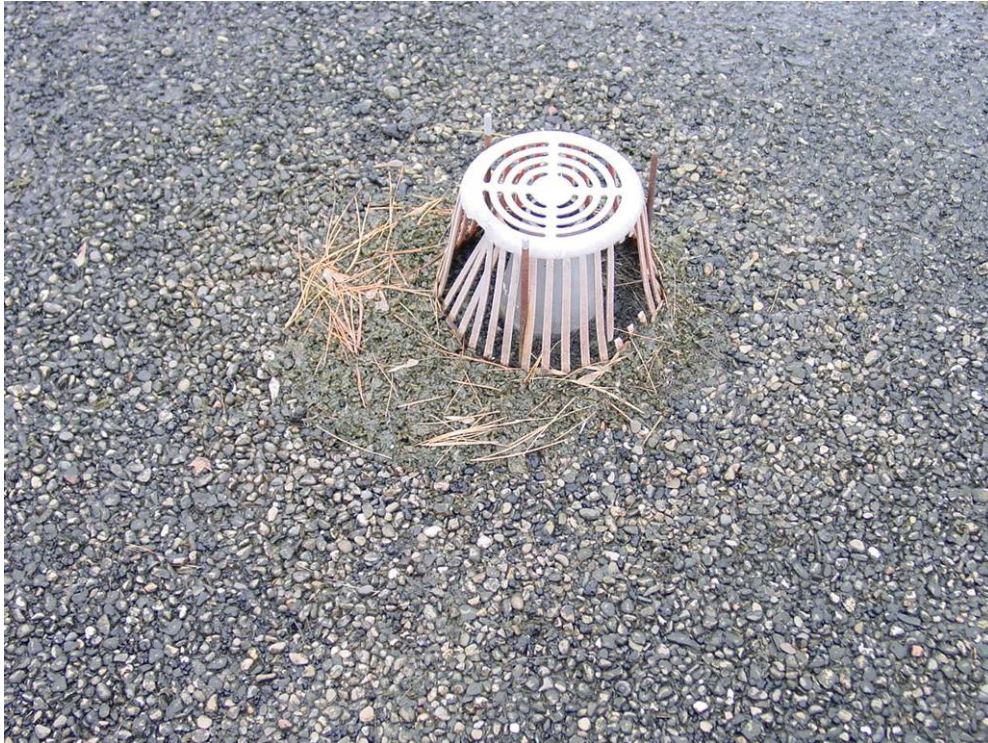
**Photograph 5:** Roof Area 1.1 – Localized ponding is evident along the central portion of the roof area primarily due to debris obstructing the roof drains.

3. Drainage patterns appear to be generally good due to a slightly sloping structural substrate. Localized ponding is evident along the central portion of the roof area primarily due to debris obstructing the roof drains (photograph 5).

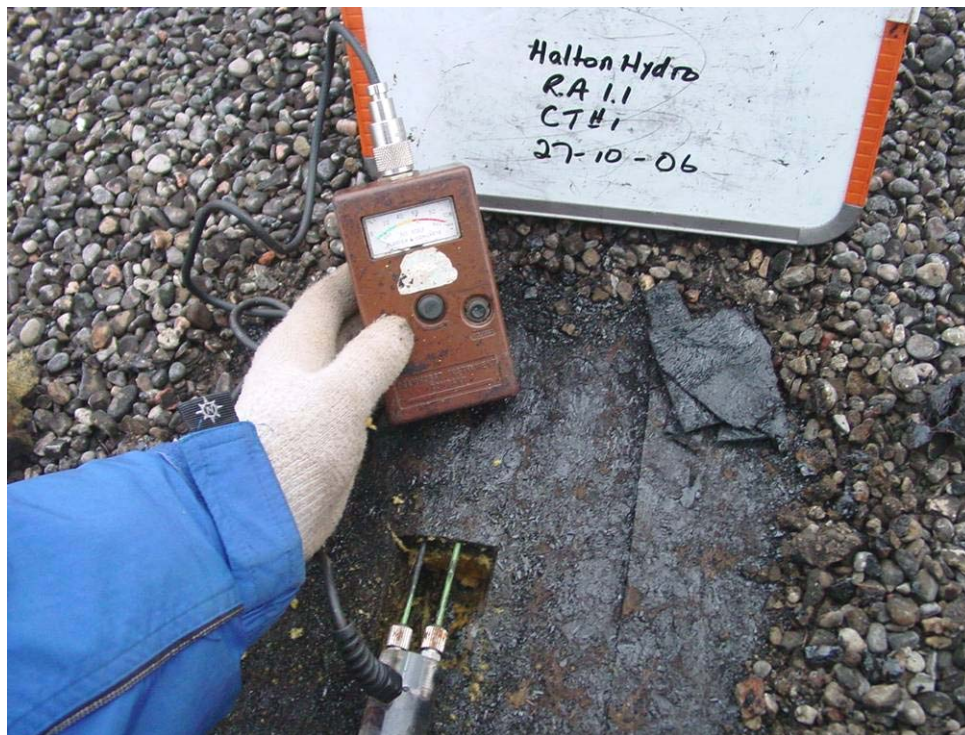
**Photograph 6:** Roof Area 1.1 – Core cuts revealed that the membrane is exhibiting top ply deterioration, increased brittleness and poor interply adhesion. These observations would suggest that the existing membrane is in poor condition with limited service life remaining. Probes taken at the core cut locations revealed no moisture present in the insulation layer or within the membrane interply.

1. The existing roof system on this area is assessed to be in weathered condition in the latter stages of its serviceable life cycle.
2. Core cuts revealed that the membrane is exhibiting top ply deterioration, increased brittleness and reduced interply adhesion. These observations would suggest that the existing membrane is in poor condition with limited service life remaining. Probes taken at the core cut locations revealed no moisture present in the insulation layer or within the membrane interply (photograph 6).

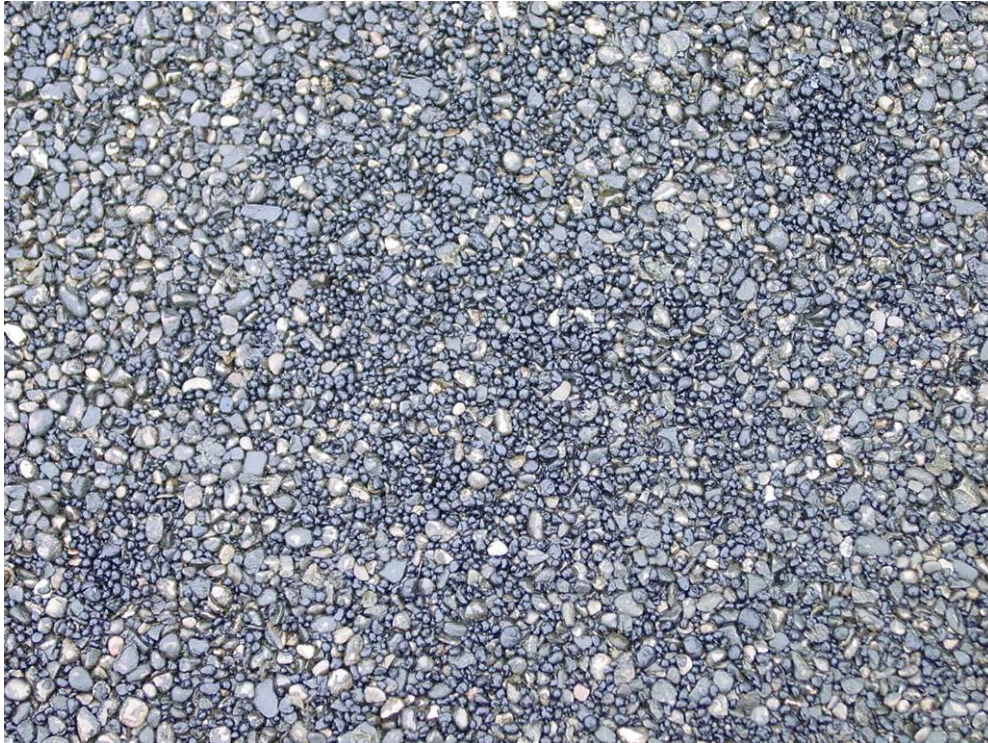
**Photograph 7:** Roof Area 1.1 – Generally heavy bitumen bleedthrough and blueberry accumulation was noted throughout the area. These anomalies are associated with weathering and aging of the roof system.

4. Generally heavy bitumen bleedthrough and blueberry accumulation was noted throughout the area (photograph 7). These anomalies are associated with weathering and aging of the roof system.

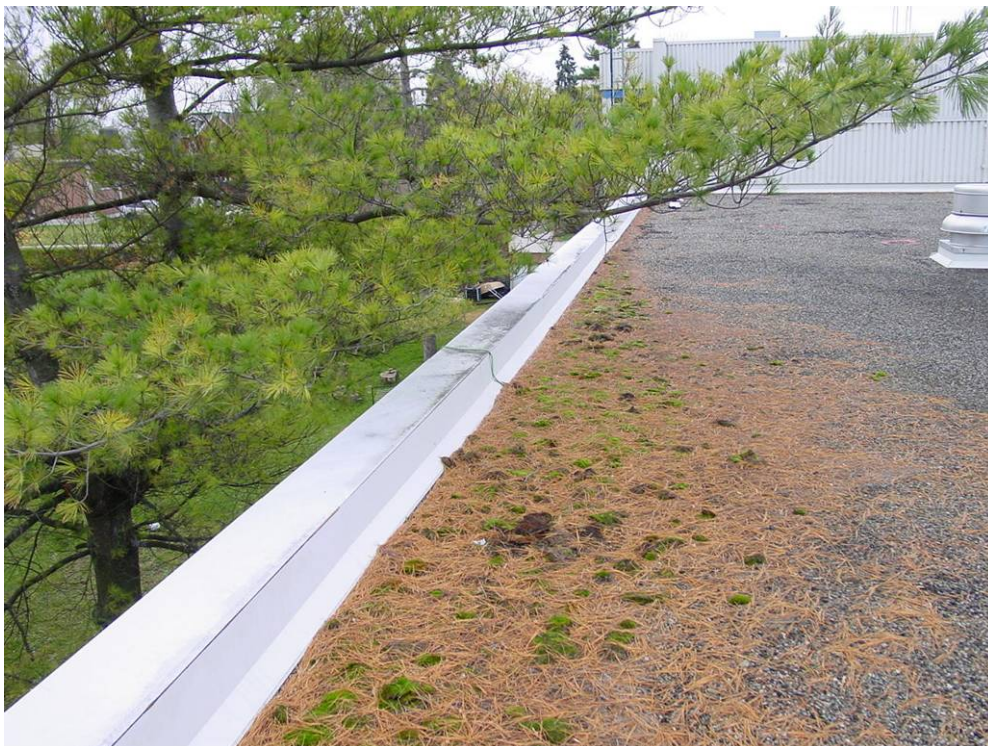
**Photograph 8:** Roof Area 1.1 - Heavy moss growth and organic debris exists along the south perimeter due to adjacent trees overhanging the roof. Moss is a form of vegetation that can grow on a roof surface. A roof surface with moss cover tends to deteriorate at an accelerated rate.

5. Heavy moss growth and organic debris exists along the south perimeter due to adjacent trees overhanging the roof (photograph 8). Moss is a form of vegetation that can grow on a roof surface. A roof surface that has organic felts with moss cover tends to rot and deteriorate at an accelerated rate.

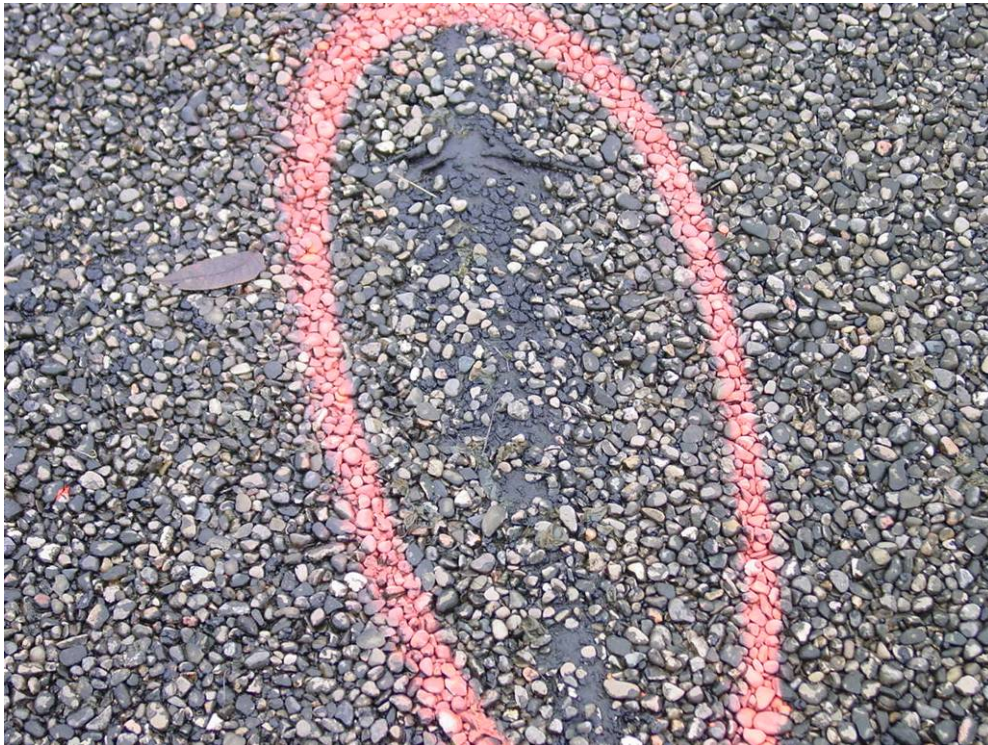
**Photograph 9:** Roof Area 1.1 – Heavy membrane blistering and ridging is evident in localized areas throughout the roof.

6. Heavy membrane blistering and ridging is evident in localized areas throughout the roof (photograph 9). Given the time of year this review was done (late fall during colder temperatures), it is suspected that blistering of the membrane would be more intense during warmer weather.

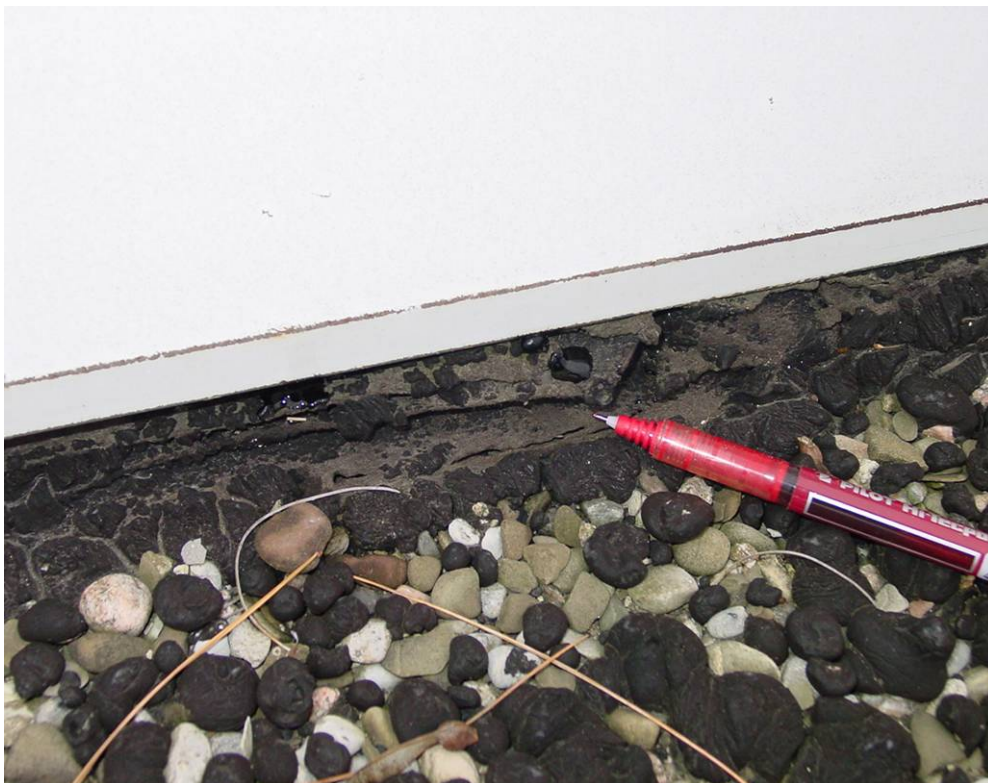
**Photograph 10:** Roof Area 1.1 - Existing membrane flashings at perimeter parapets are exhibiting developing deterioration, delamination and embrittlement.

7. Existing membrane flashings at perimeter parapets are exhibiting developing deterioration, delamination and embrittlement (photograph 10).
8. No membrane protection has been provided at the base of the access ladder along the west wall (photograph 11). The membrane at this area typically experiences additional stress and potential damage from foot traffic, impact loading and erosive forces. Walkway pads or concrete pavers are appropriate elements for such areas.

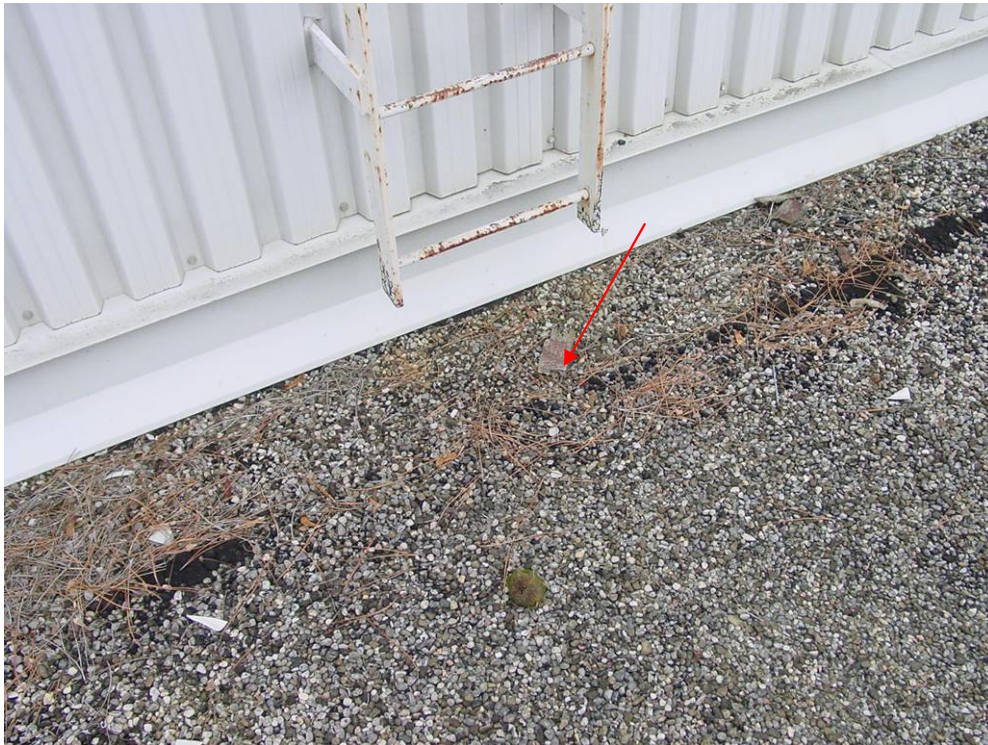
**Photograph 11:** Roof Area 1.1 – No membrane protection has been provided at the base of the access ladder along the west wall. The membrane at this area typically experiences additional stress and potential damage from foot traffic, impact loading and erosive forces. Walkway pads or concrete pavers are appropriate elements for such areas.

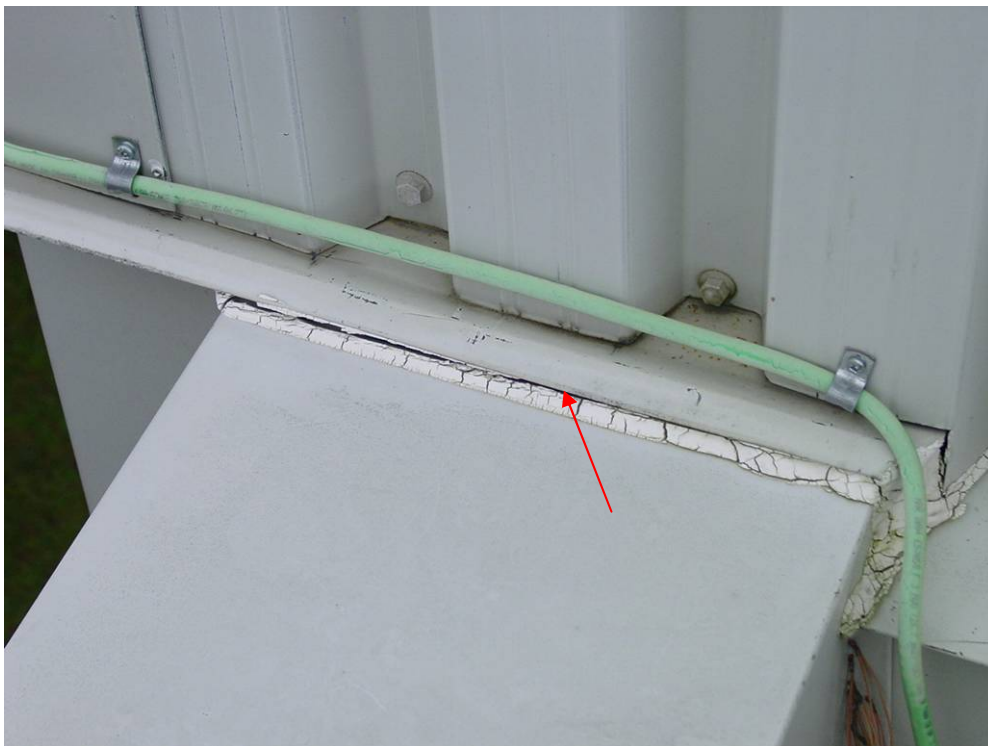
**Photograph 12:** Roof Area 1.1 - Sealant deterioration exists at metal flashing joints and transitions, adding to the potential for wind blown moisture to enter the building.

9. Sealant deterioration exists at metal flashing joints and transitions, adding to the potential for wind blown moisture to enter the building (photograph 12).

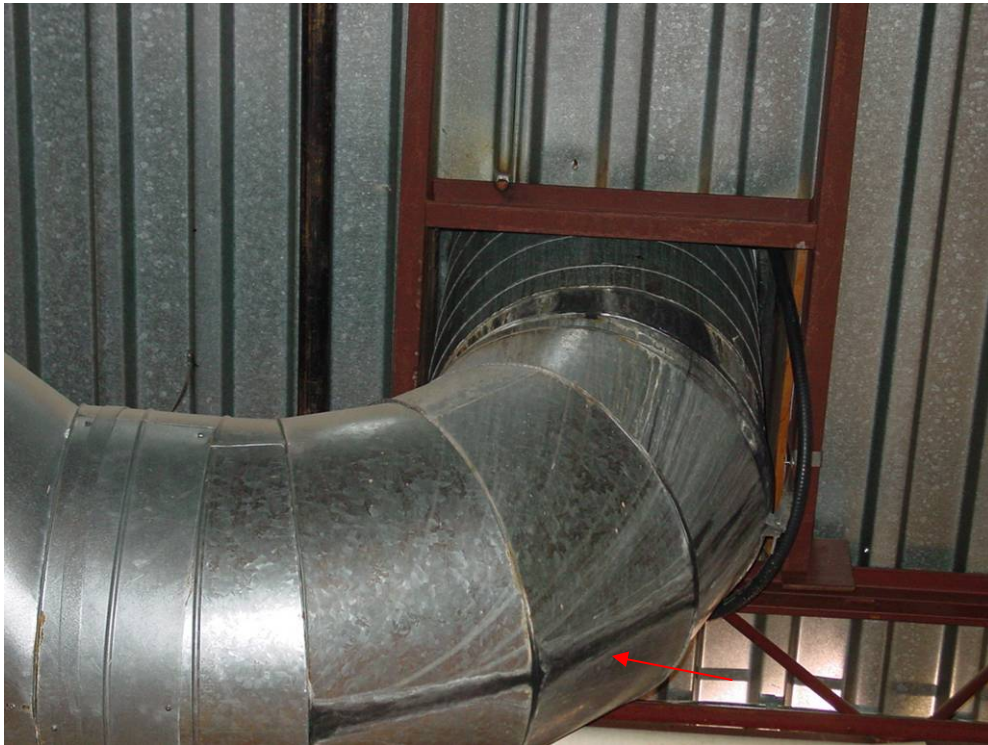
**Photograph 13:** Roof Area 1.1 – Ongoing leaks were reported below the north exhaust duct opening. Water stains are evident around spiral duct.

11. Investigation of the leaks around the truck exhaust duct penetrations (photograph 13) revealed that the source of water entry could be one of the following:
  - Existing flex connectors on ductwork are open to water entry (photograph 15),
  - Lack of proper rain collars around ductwork (photograph 16),
  - Lack of rain hoods over duct exhaust openings (photograph 17),
  - Failed sealant at duct penetrations,
  - Membrane flashing deterioration at sleeper supports and curbs (photograph 18).

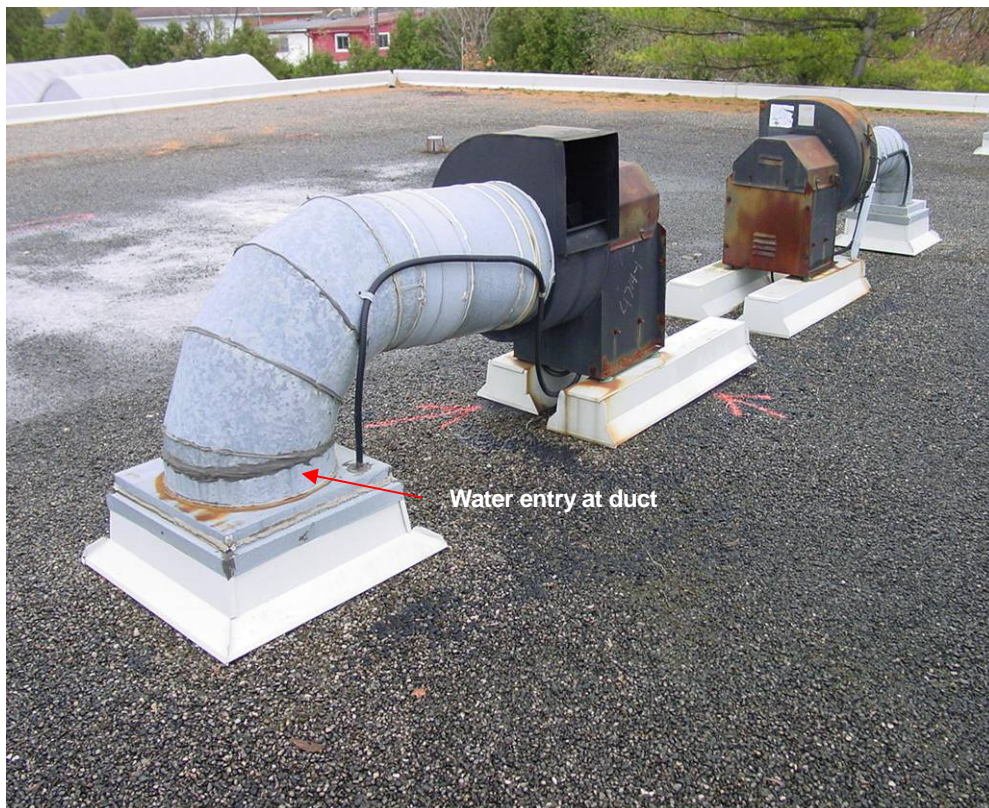
**Photograph 14:** Roof Area 1.1 – Photograph showing the duct penetrations (area of leaks) above the garage.

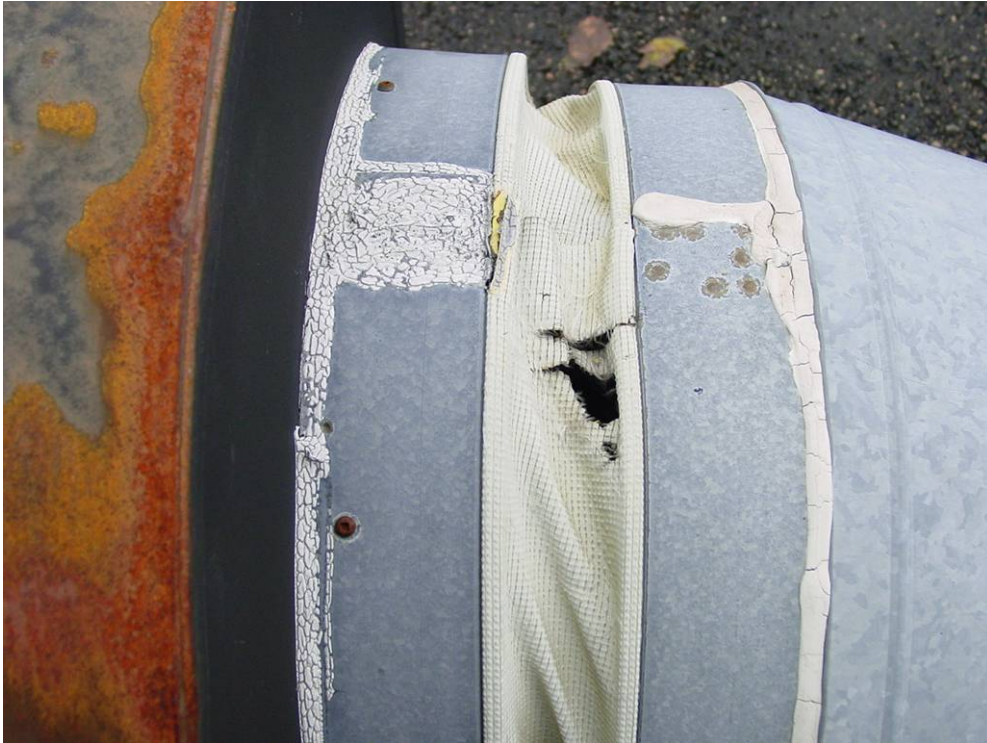
**Photograph 15:** Roof Area 1.1 – Water entry is likely at the deteriorated flexible duct connections.

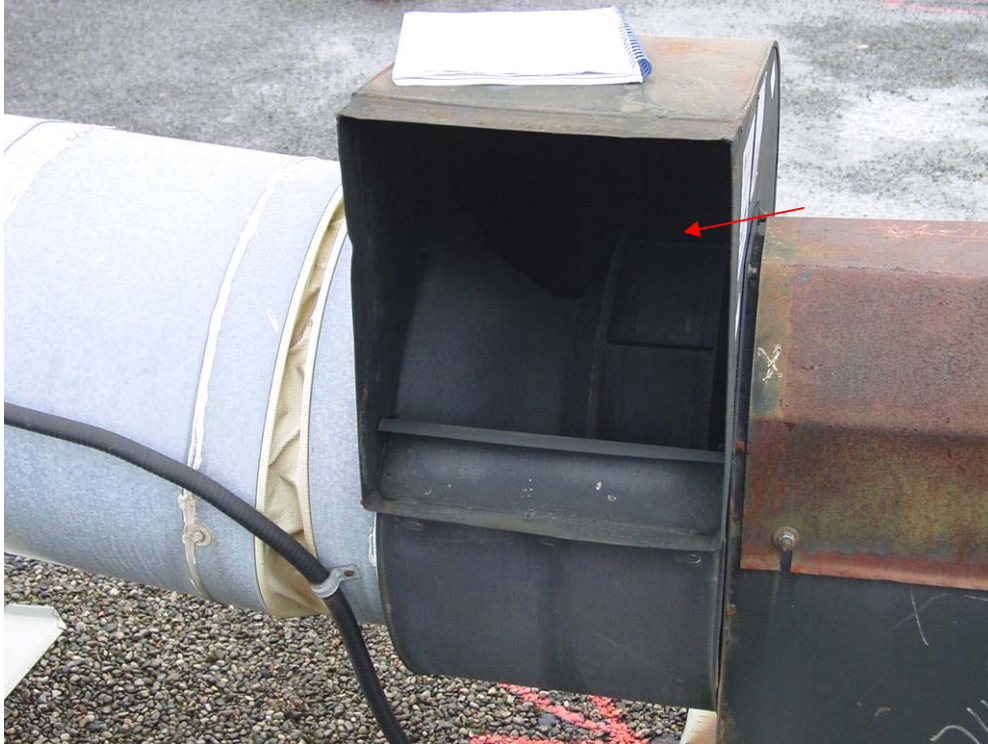
**Photograph 17:** Roof Area 1.1 – Existing exhaust openings lack protective rain hoods.

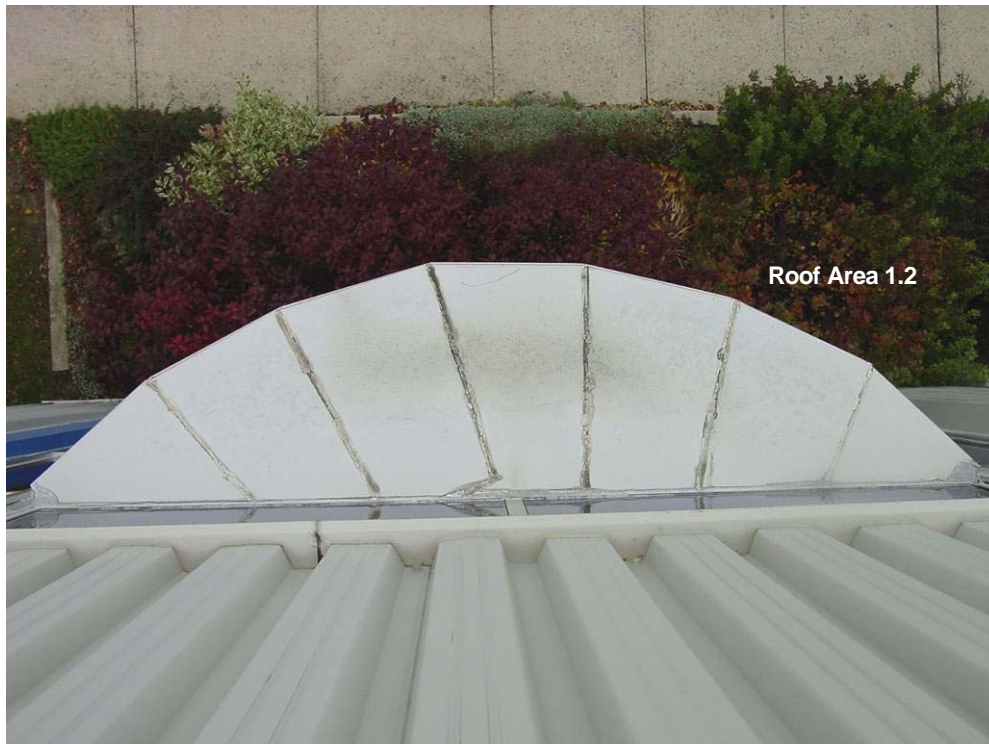
**Photograph 19:** Roof Area 1.2 - This small roof area is situated over the lunchroom bay window along the west perimeter of the building. The existing roof consists of prepainted metal panels, installed in 1989.

This small roof area (photograph 19) is situated over the lunchroom bay window along the west perimeter of the building. The existing roof consists of prepainted metal panels, installed in 1989. Investigation revealed the following:

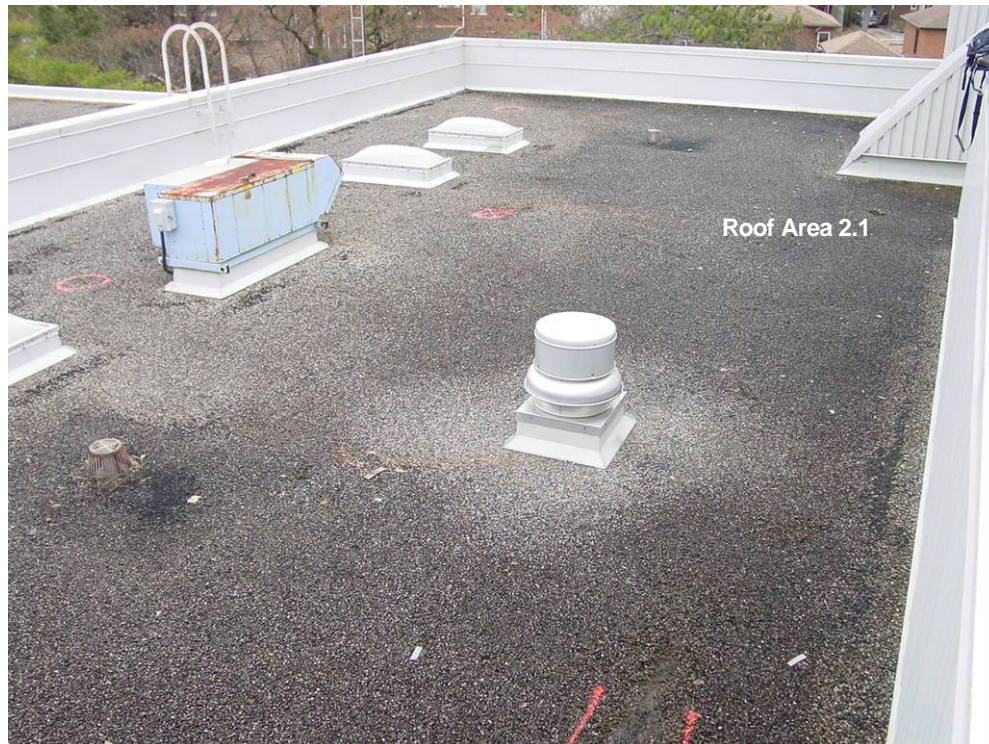
**Photograph 21:** Roof Area 2.1 - Overall view looking south at roof area 2.1 situated over the Engineering Department in the central portion of the building. The existing roof consists of a built up bituminous membrane system installed in 1989.

This roof area (photographs 21 and 22) is situated over the Engineering Department in the central portion of the building. The existing roof consists of a built up bituminous membrane system installed in 1989. Investigation revealed the following:

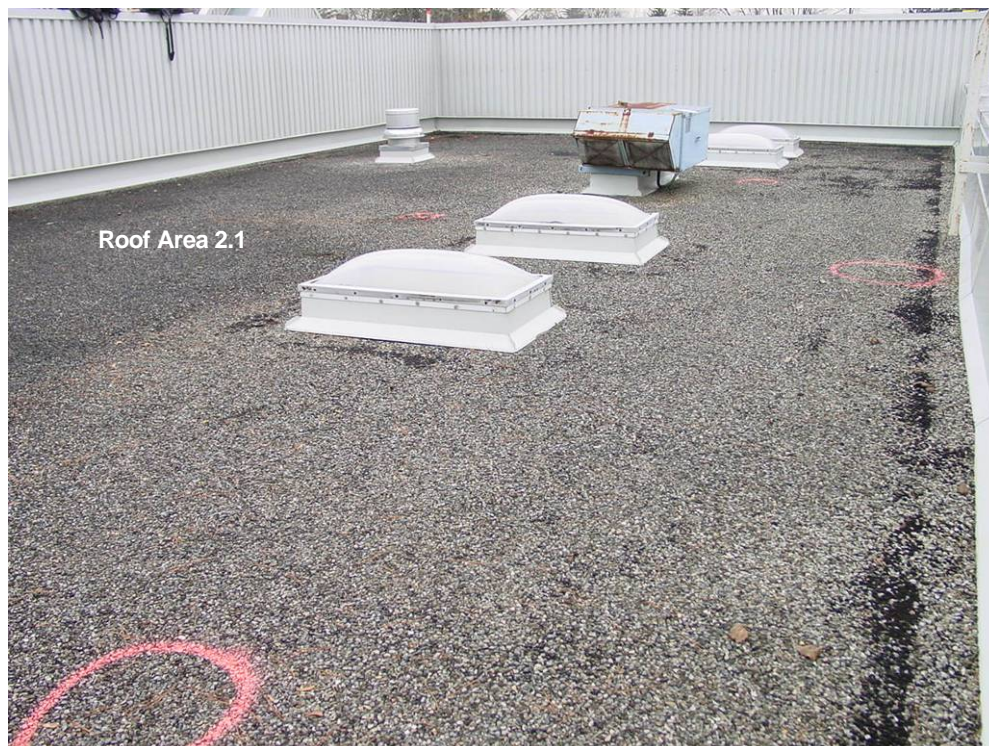
**Photograph 22:** Roof Area 2.1 – Overall view of roof area 2.1 looking north.

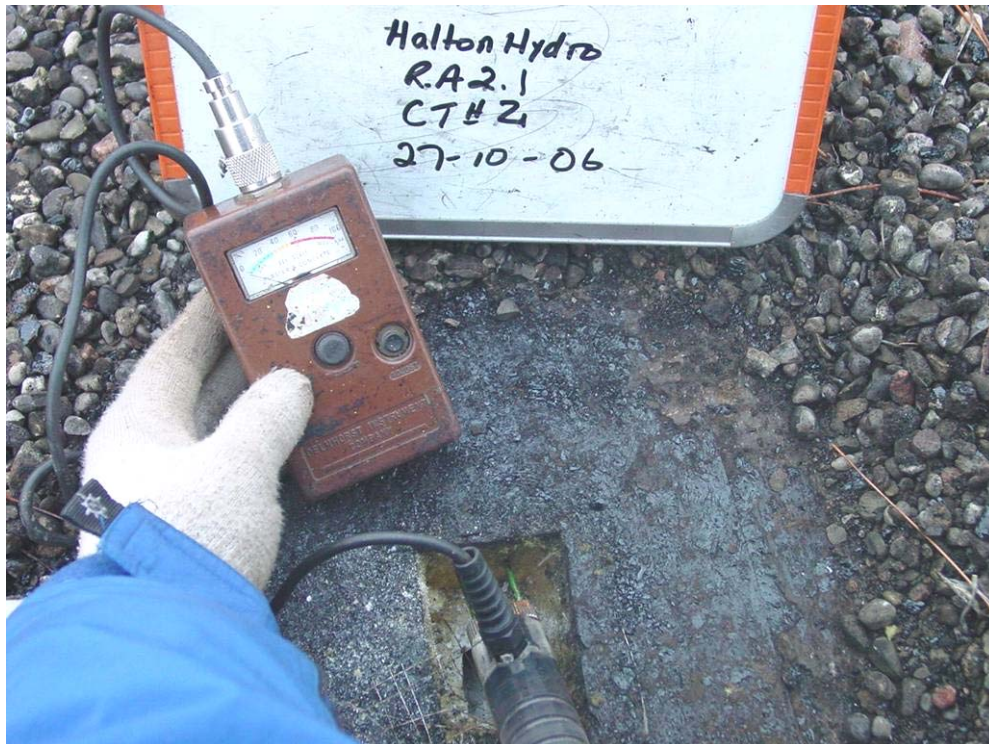
**Photograph 23:** Roof Area 2.1 – Probes taken at the core cut locations revealed no moisture present in the insulation layer or within the membrane interply.

1. The existing roof system on this area is assessed to be in weathered condition in the latter stages of its serviceable life cycle.
2. Core cuts revealed that the membrane is exhibiting top ply deterioration, increased brittleness and very poor interply adhesion (photograph 24). Probes taken at the core cut locations revealed no moisture present in the insulation layer or within the membrane interply (photograph 23).

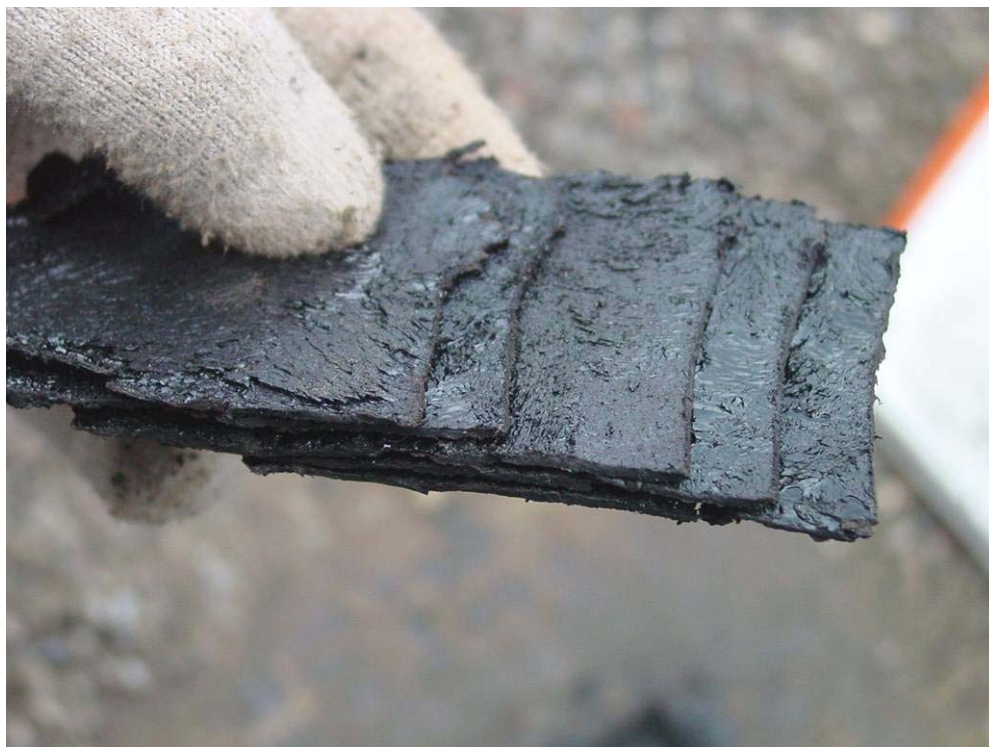
**Photograph 24:** Roof Area 2.1 – The membrane at the core cut on this area exhibits very poor interply adhesion. The individual membrane plies were very easily delaminated.

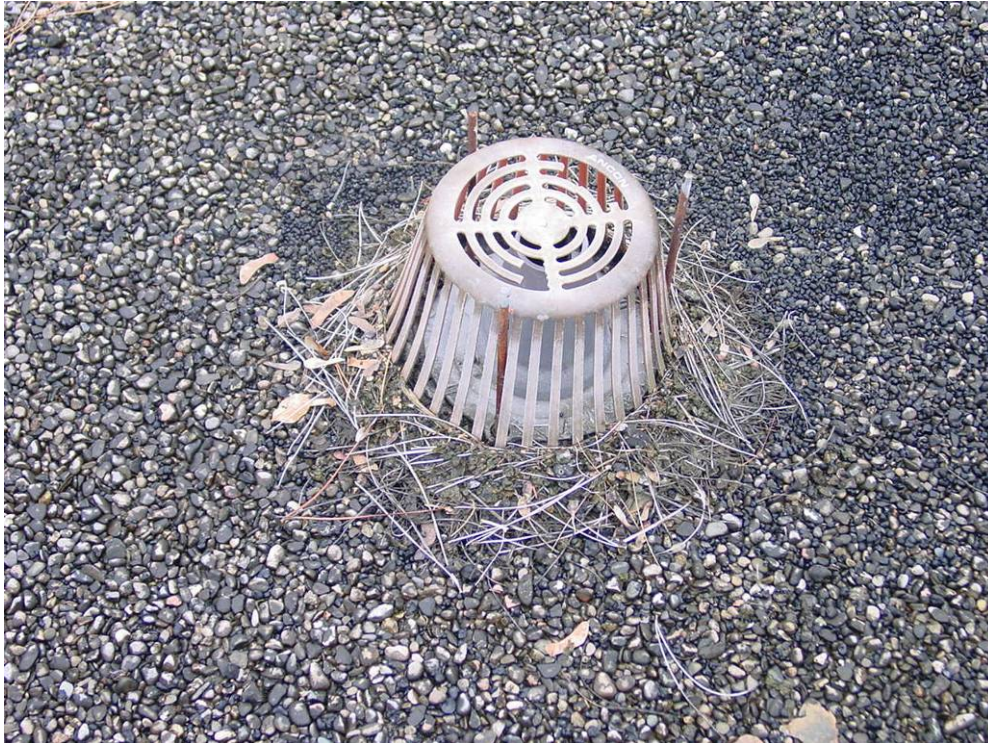
**Photograph 25:** Roof Area 2.1 – Drainage patterns appear to be generally good with evidence of ponding due to debris accumulation around drains.

3. Drainage patterns appear to be generally good with evidence of ponding due to debris accumulation around drains (photograph 25).
4. Generally heavy bitumen bleedthrough and blueberry accumulation was noted throughout the area. These anomalies are associated with weathering and aging of the roof system.

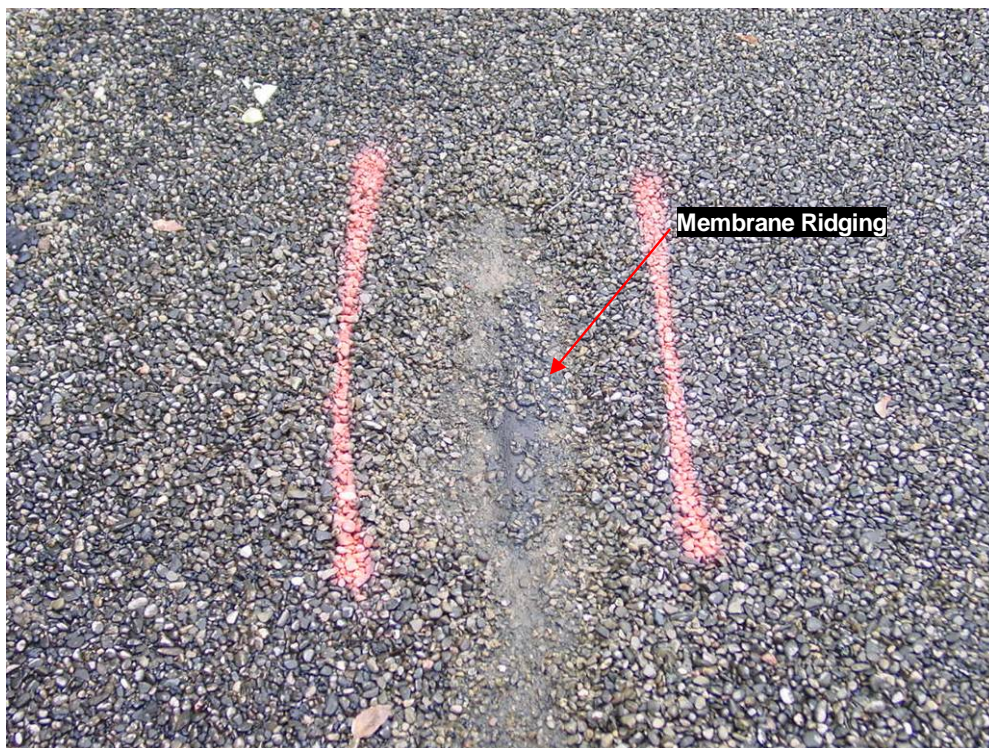
**Photograph 26:** Roof Area 2.1 – Localized membrane ridging and blistering was evident throughout the roof area.

5. Localized membrane ridging (photograph 26) and blistering was evident throughout the roof area. A broken blister was evident in the northwest corner and may be a source of leakage (photograph 27).

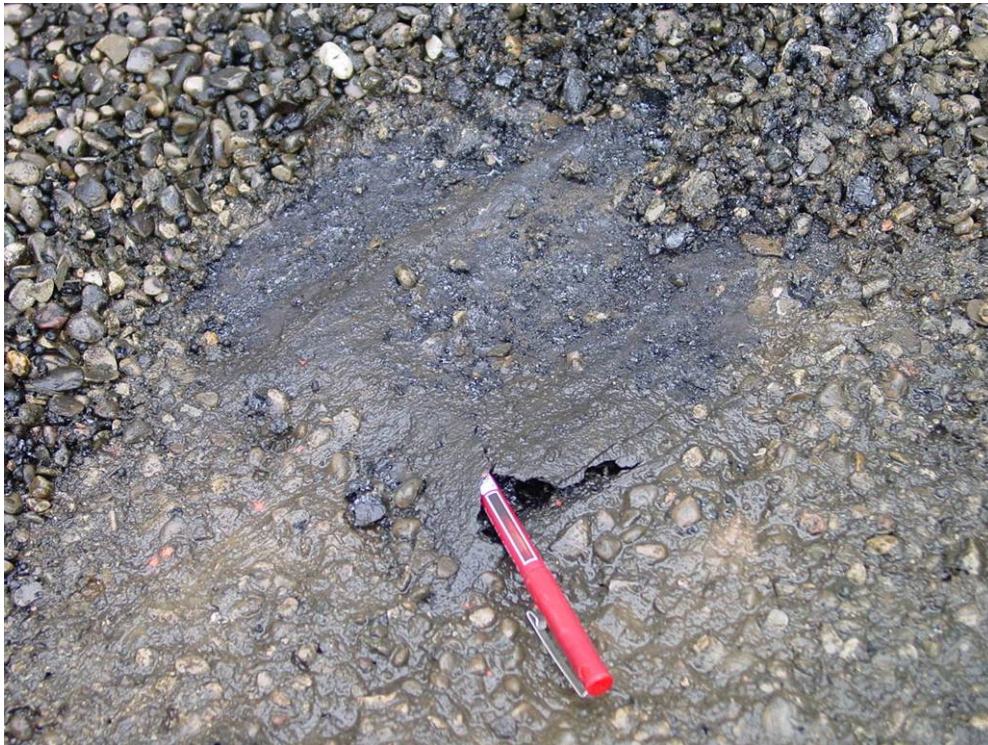
**Photograph 27:** Roof Area 2.1 – A broken blister was evident in the northwest corner and may be a source of leakage.

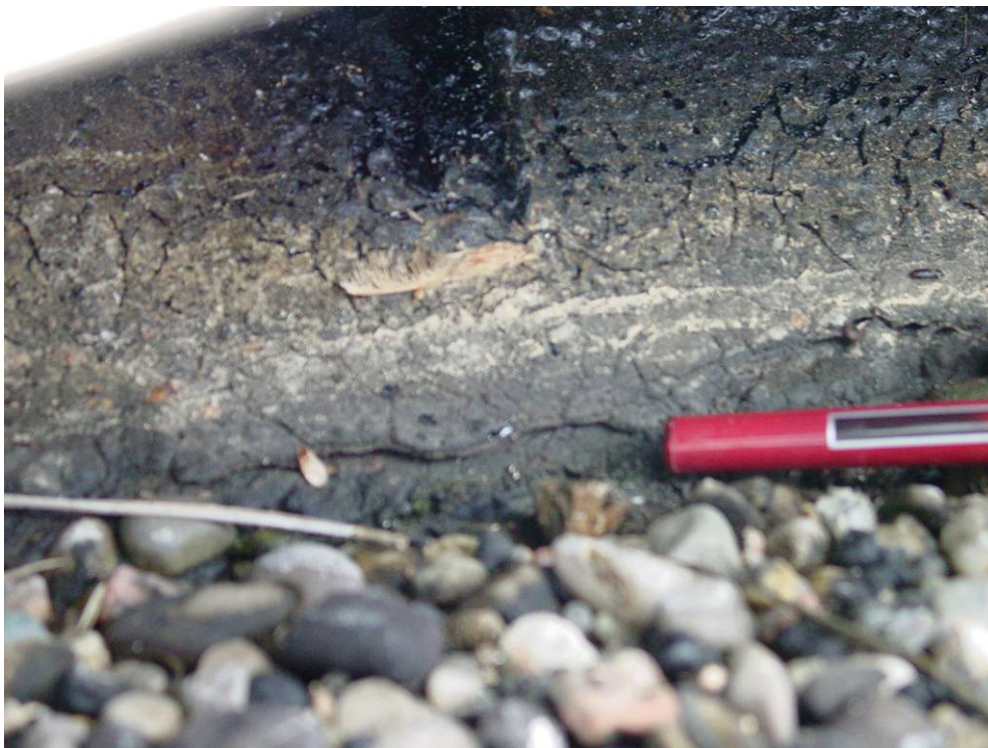
**Photograph 28:** Roof Area 2.1 – Existing membrane flashings at perimeter parapets and curb penetrations are exhibiting developing deterioration and exposure (photograph 15). Cracking of the membrane flashings along the base of the north wall is a potential source of the reported leaks over the north end of the Engineering Department.

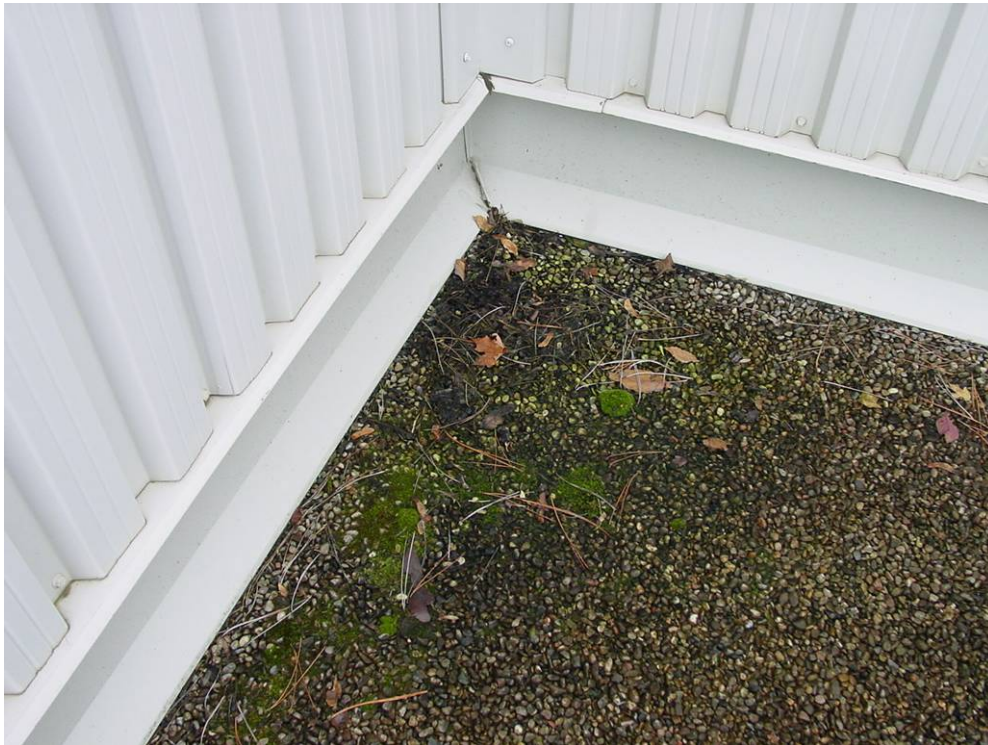
**Photograph 29:** Roof Area 2.1 – Localized moss growth and organic debris exists at corner transitions.

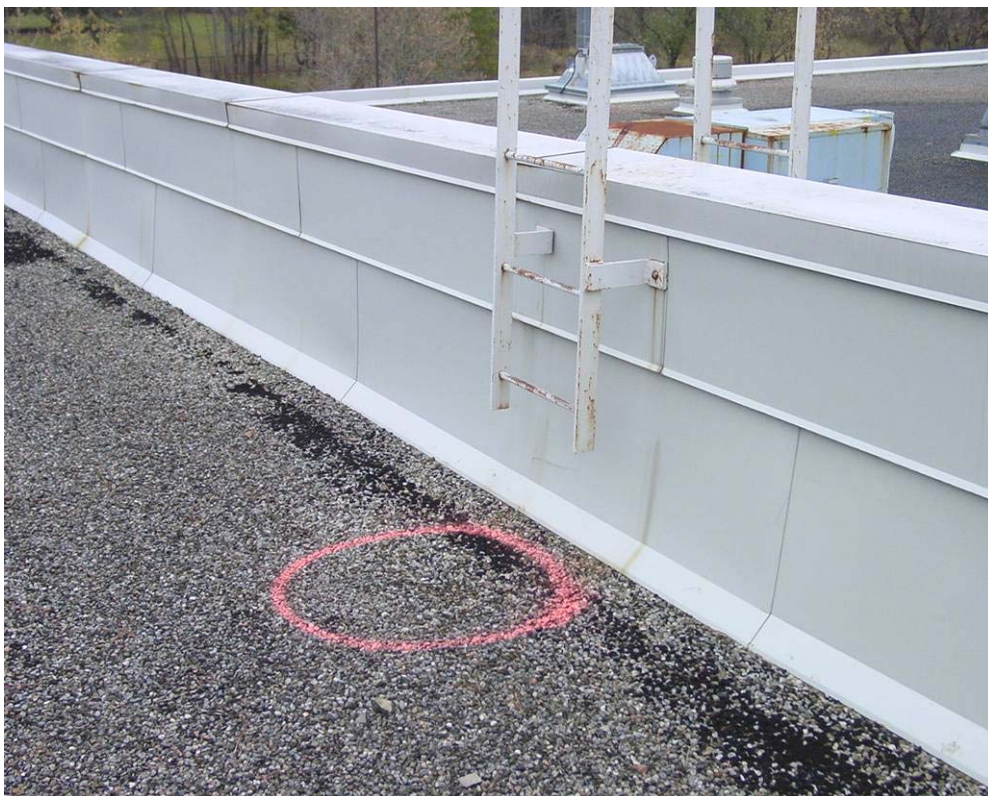
**Photograph 30:** Roof Area 2.1 – No membrane protection has been provided at the base of access ladders. Membrane blistering and delamination was evident at the base of the east roof ladder. Active roof leaks were reported below the ladder along the east parapet shown above.

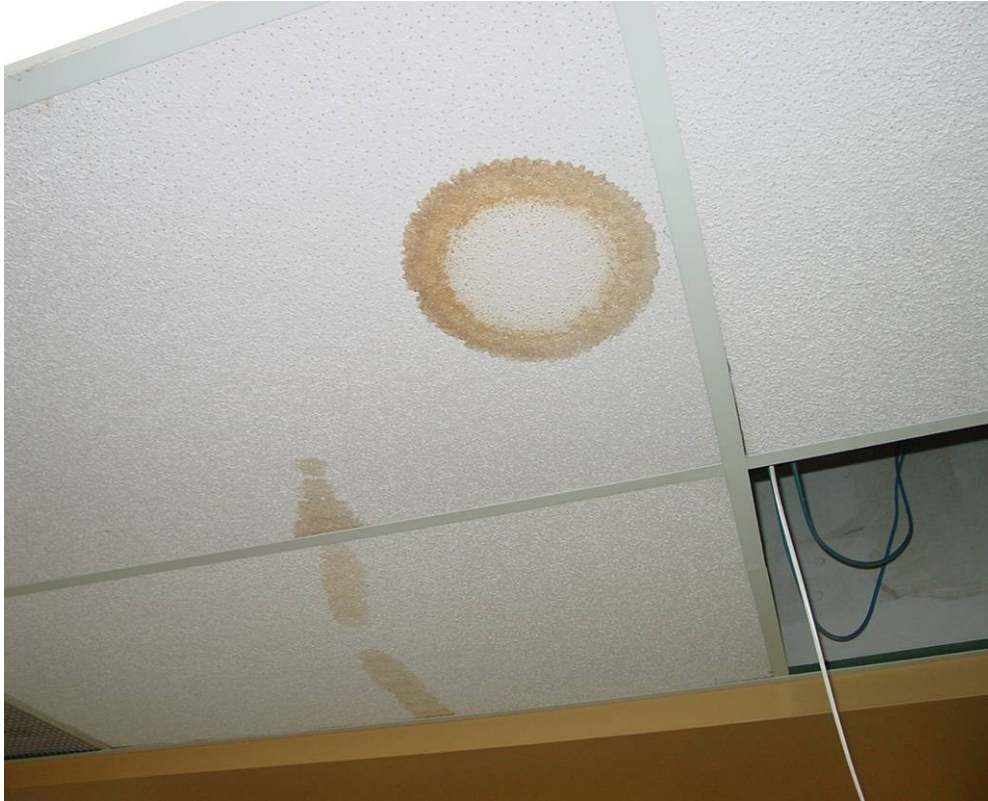
**Photograph 31:** Roof Area 2.1 – Water stained ceiling tile was noted over workstation in northeast corner.

**Photograph 32:** Roof Area 2.1 – Sealant deterioration exists at the metal flashing and cladding joints in the northwest corner. Reported leaks below this location (see photo 31 above) could be due to wind blown moisture entering through the failed sealant.
