Re: Halton Hills Hydro Inc. 2008 Electricity Distribution Rates Application  
Board File Number EB 2007-0696  
Second Round Interrogatory Responses to OEB Staff

### 3 Visual Survey

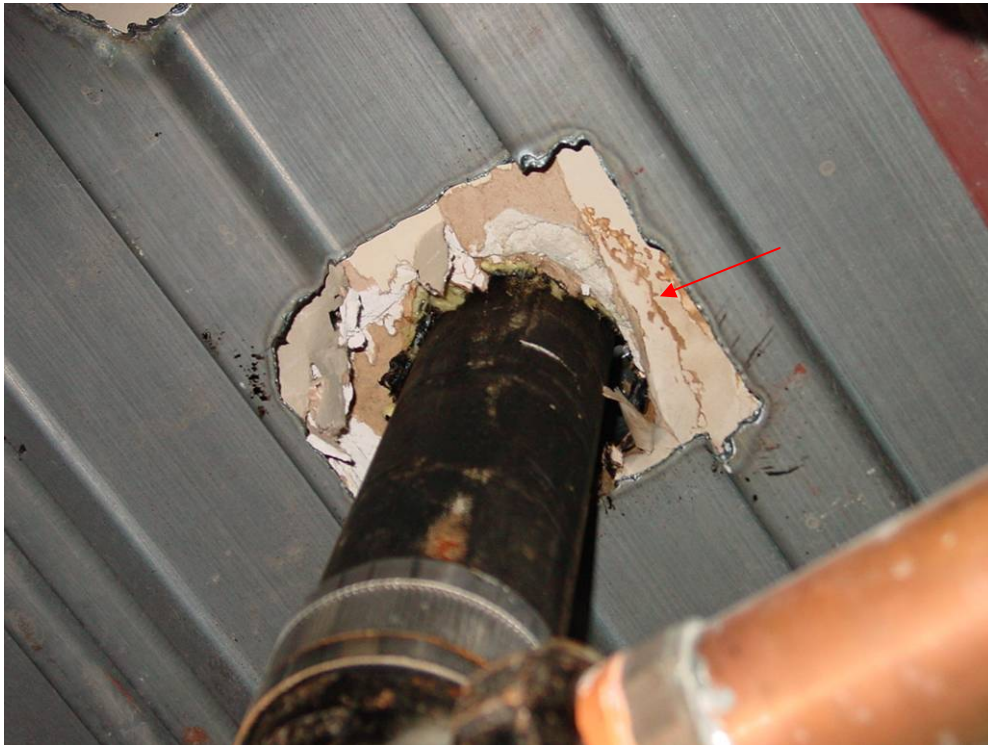
**Photograph 33:** Roof Area 2.1 – Water stained drywall was noted at a leak location above the corridor leading to the payroll department.

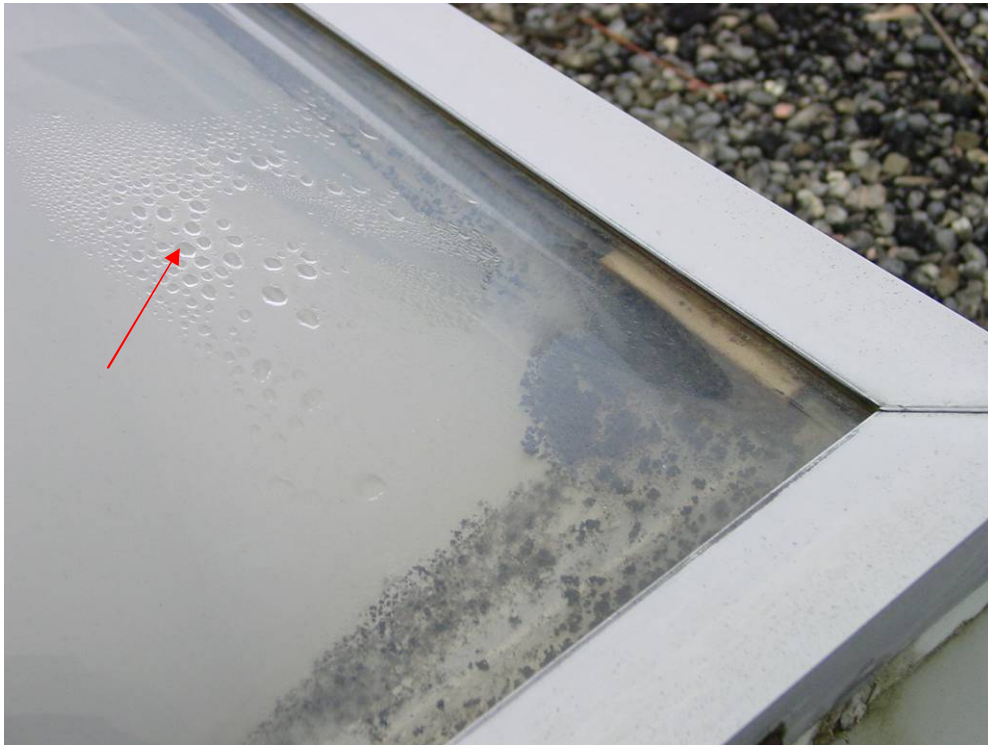
**Photograph 35:** Roof Area 2.1 – There is evidence of long-term moisture accumulation between the panes of the skylights and it is likely that the seal between the panes has failed. This condition may be contributing to the reported water entry into the space below.

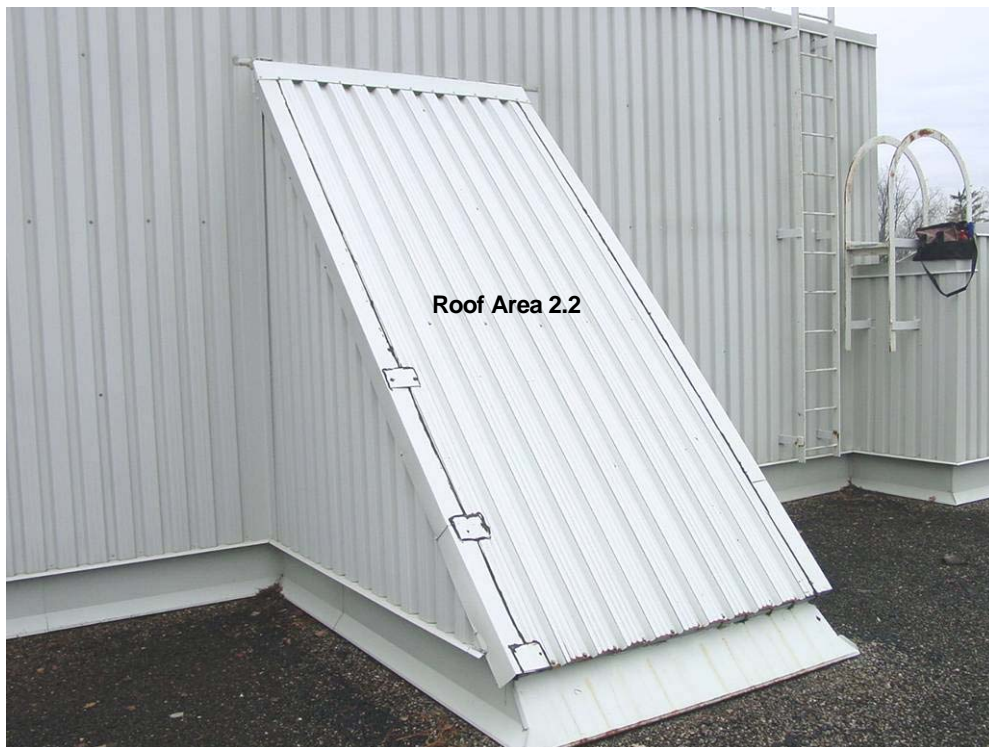
**Photograph 36:** Roof Area 2.2 – This small roof area is situated over the stairwell leading from the second floor level to the Engineering Department at the southeast portion of the building. The existing roof consists of prepainted metal panels installed in 1989.

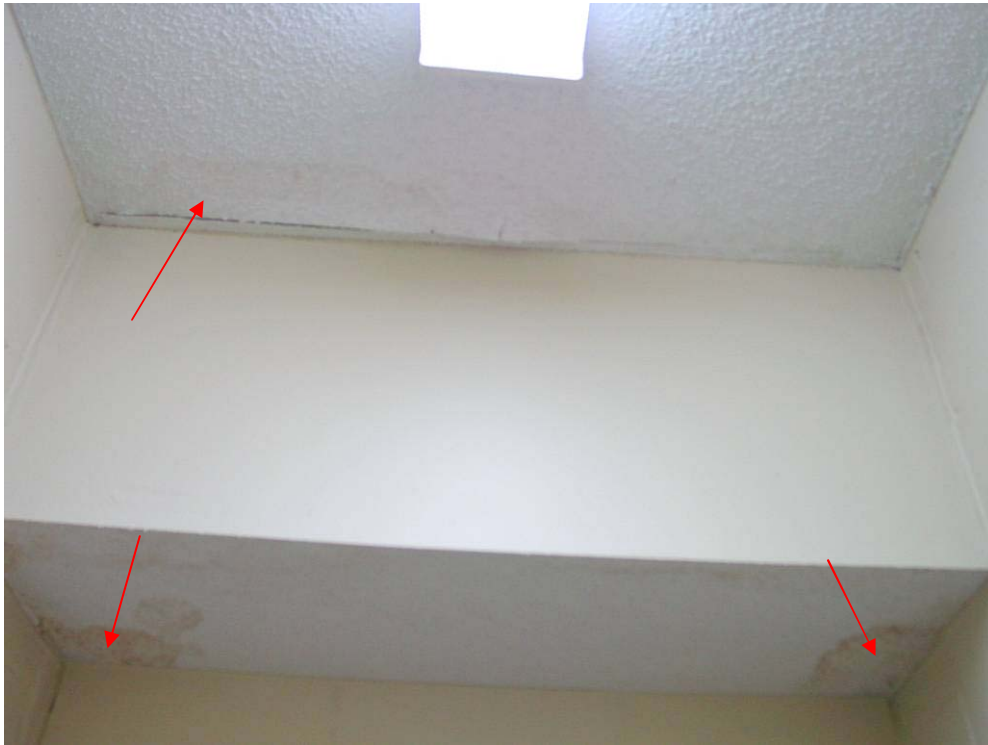
**Photograph 37:** Roof Area 2.2 – Interior view. Ongoing leaks were evident in the stairwell below this roof area particularly along the perimeter wall transitions.

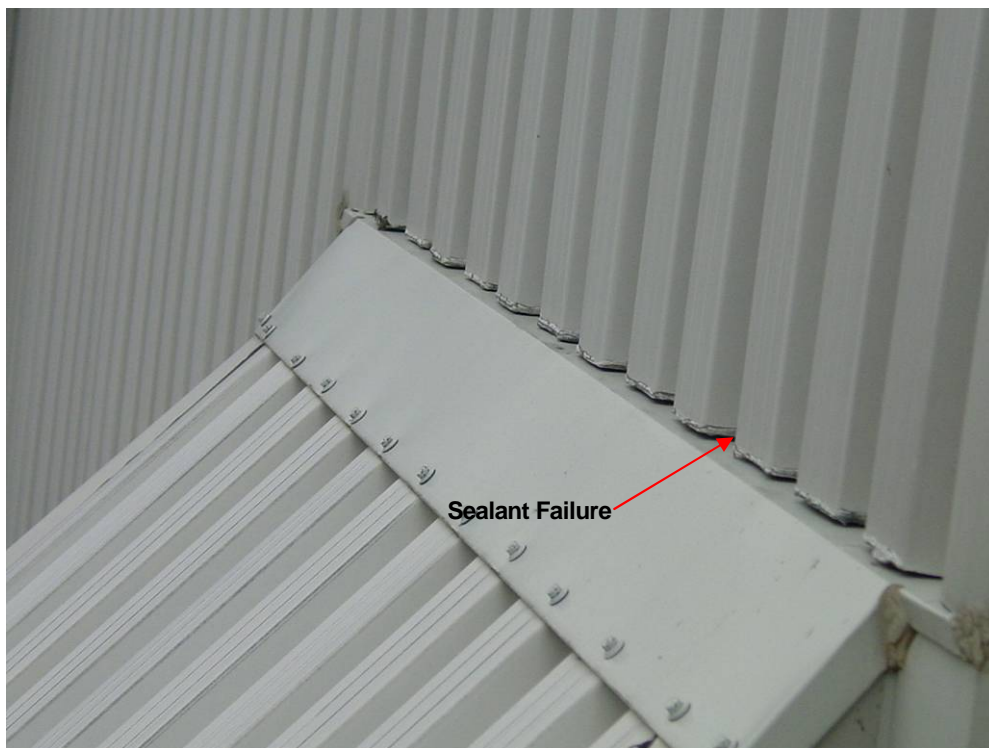
**Photograph 38:** Roof Area 2.2 – Investigation revealed that sealant failure along the upper west wall transition is a possible source of water entry. If inadequate membrane waterproofing was installed under the metal panels, then any water entering through failed sealant could more readily enter the building.

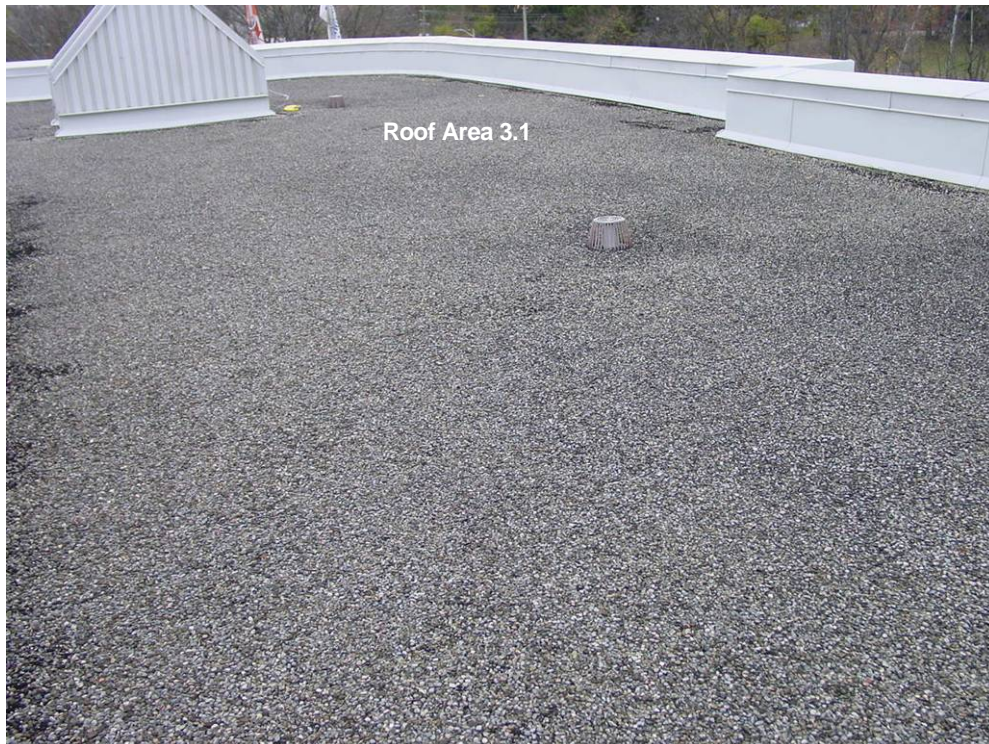
**Photograph 39:** Roof Area 3.1 – Overall view looking west. This roof area is situated over the Finance Department at the northwest portion of the facility. The existing roof consists of a built up bituminous membrane system installed in 1989.

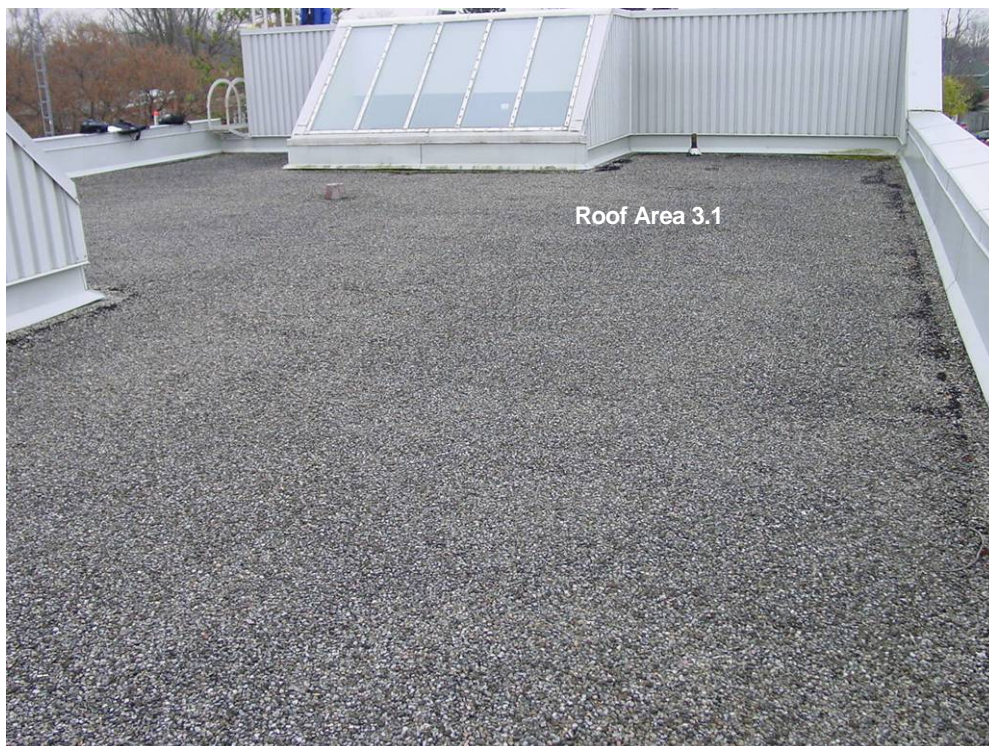
**Photograph 40:** Roof Area 3.1 – Overall view looking south.

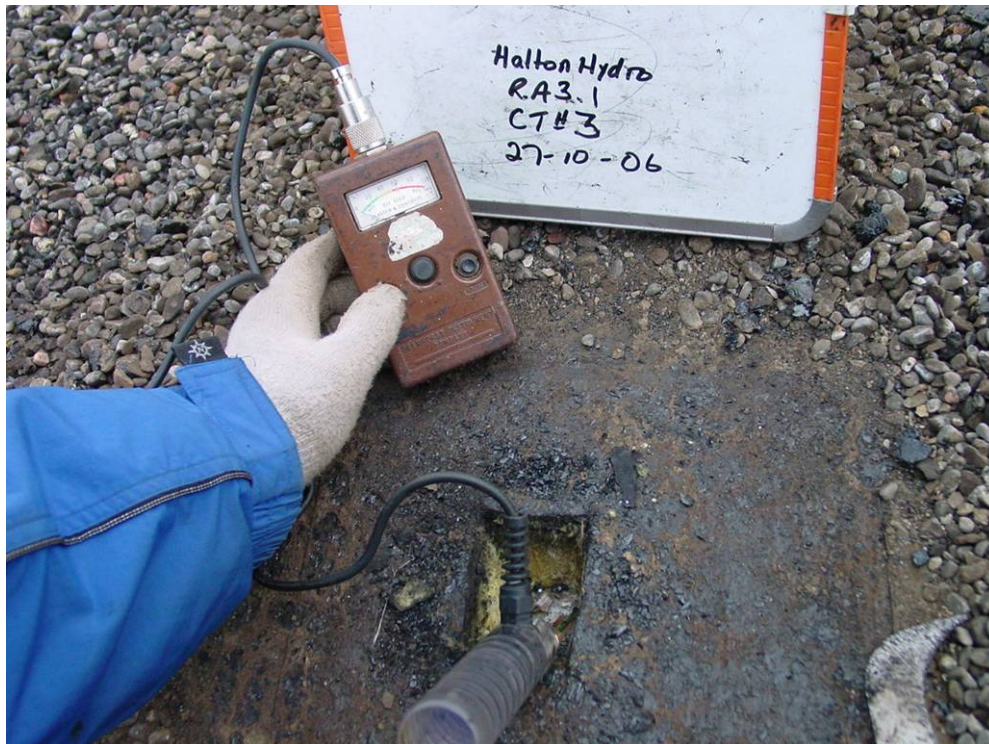
**Photograph 41:** Roof Area 3.1 – Core cuts revealed that the membrane is exhibiting top ply deterioration in addition to weak interply adhesion due to inadequate asphalt application quantities. Probes taken at the core cut locations revealed no moisture present in the insulation layer or within the membrane interply

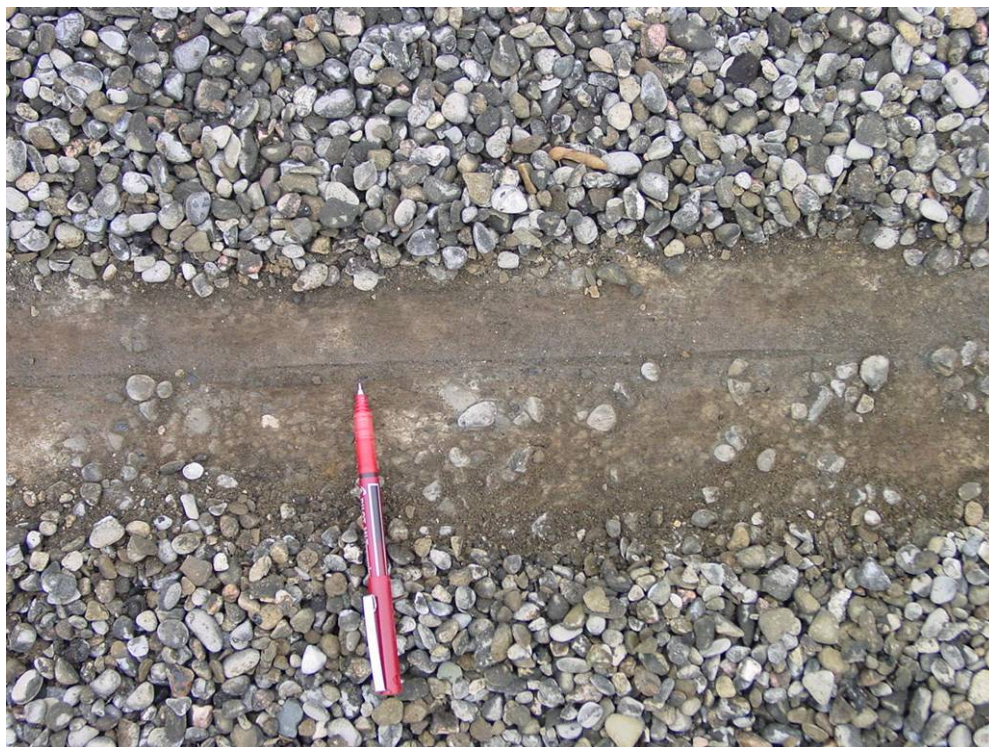
**Photograph 42:** Roof Area 3.1 – Photo showing evidence of poor floodcoat coverage and adhesion. This condition leads to premature wear and deterioration of the top membrane plies.

1. The existing roof system on this area is assessed to be in weathered condition in the latter stages of its serviceable life cycle.
2. Core cuts revealed that the membrane is exhibiting top ply deterioration due to a very thin asphalt floodcoat (photograph 42) in addition to weak interply adhesion. Probes taken at the core cut locations revealed no moisture present in the insulation layer or within the membrane interply (photograph 41).
3. Localized moss growth exists at corner transitions and along the base of the south skylight (photograph 43).
4. Localized membrane blistering is evident (photograph 44).
5. Existing membrane flashings at perimeter parapets are exhibiting exposure and developing deterioration, cracking and splitting. The membrane flashings along the

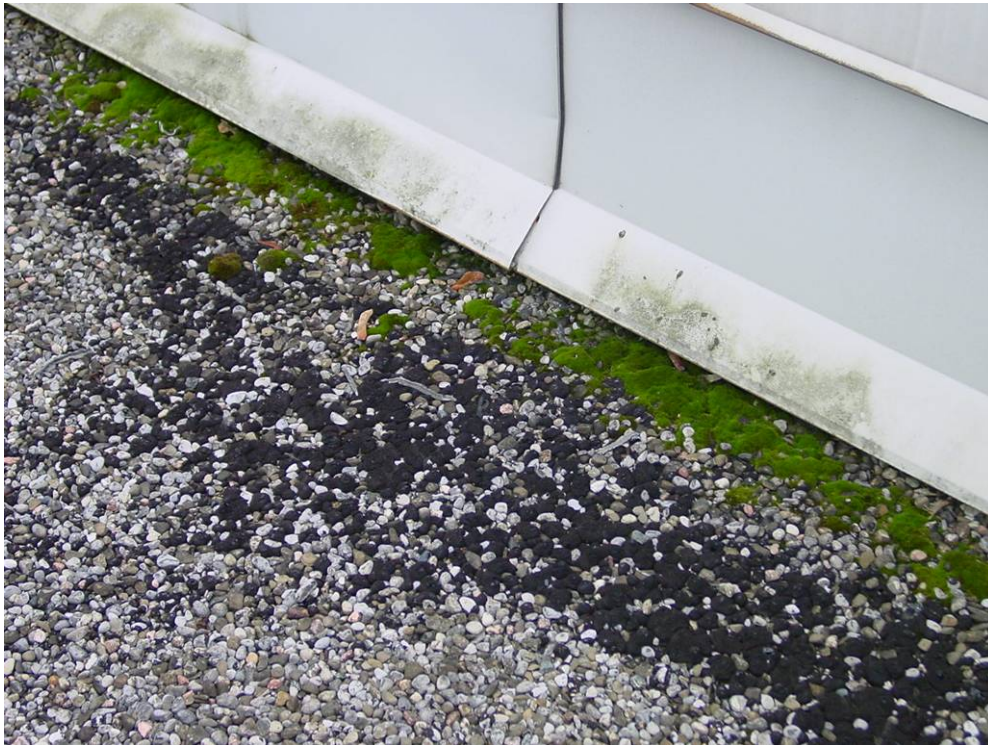
**Photograph 43:** Roof Area 3.1 - Localized moss growth exists at corner transitions and along the base of the south skylight.

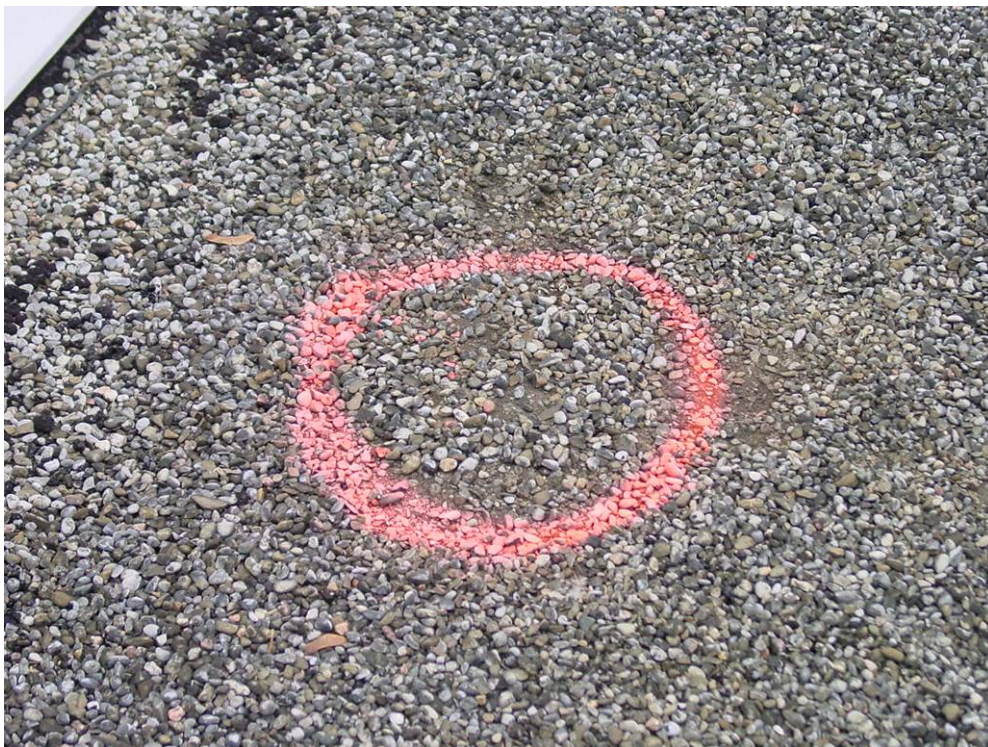
**Photograph 44:** Roof Area 3.1 – Localized membrane blistering is evident.

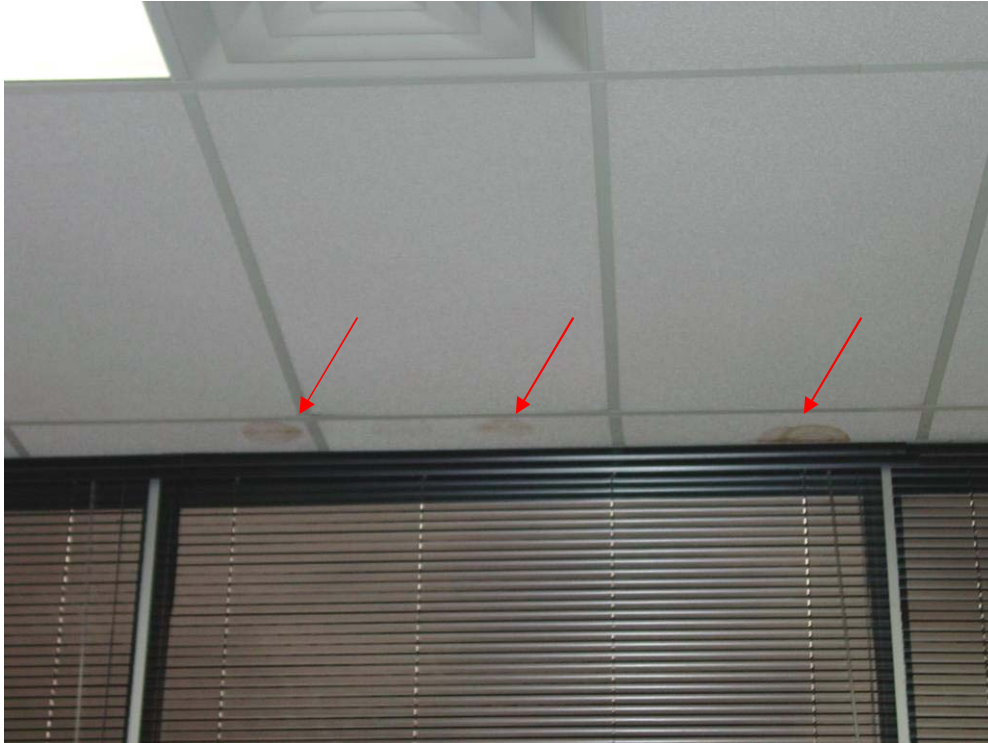
**Photograph 45:** Roof Area 3.1 – Water stained ceiling tile was observed along north wall of Manager of Engineering office.

north parapet are split, resulting in active leaks into the office below (photographs 45 and 47).

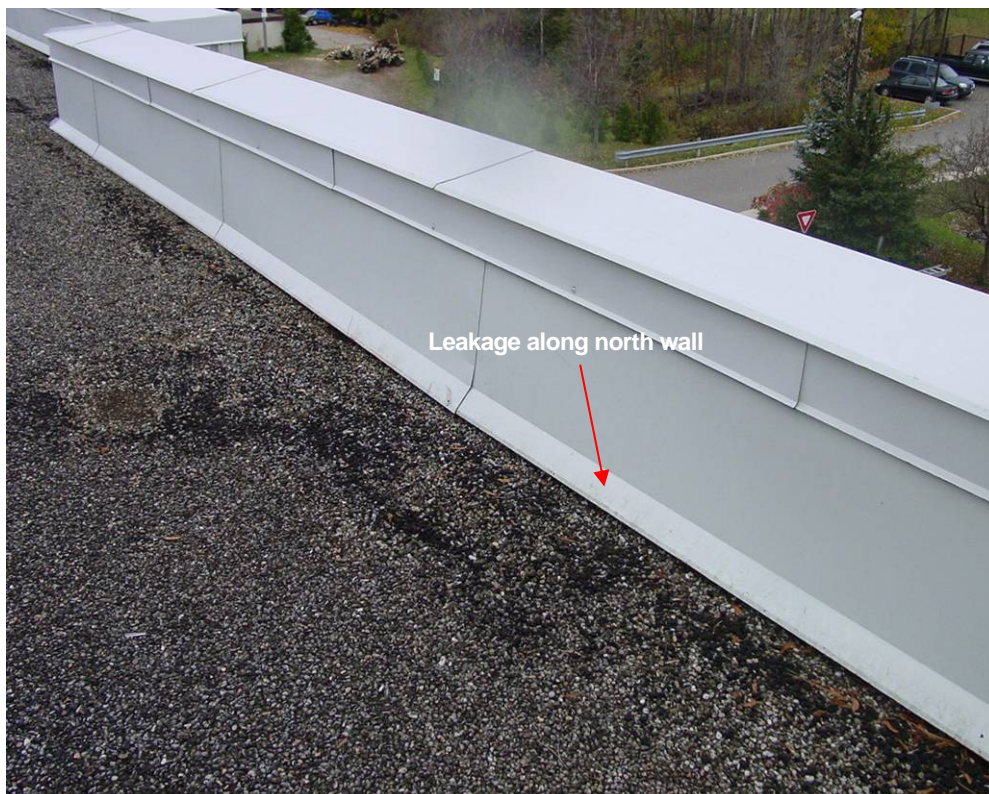
**Photograph 46:** Roof Area 3.1 – Photo of the north parapet in the vicinity of the leaks above Manager of Engineering office.

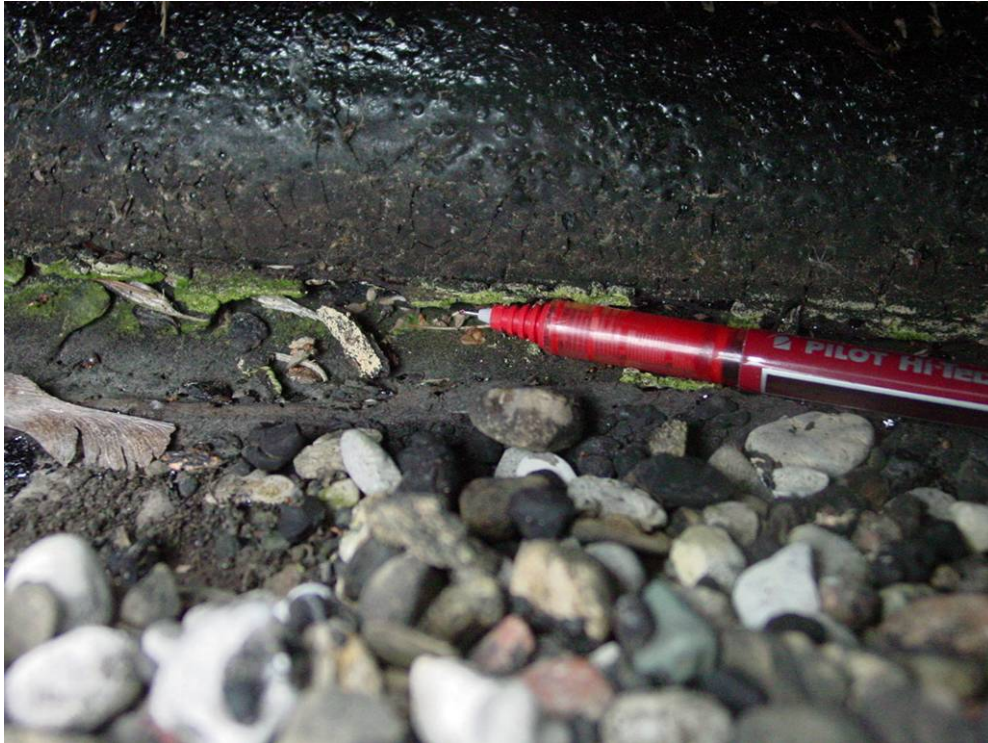
**Photograph 47:** Roof Area 3.1 North Wall – Investigation revealed splits in membrane flashing above the leak location.

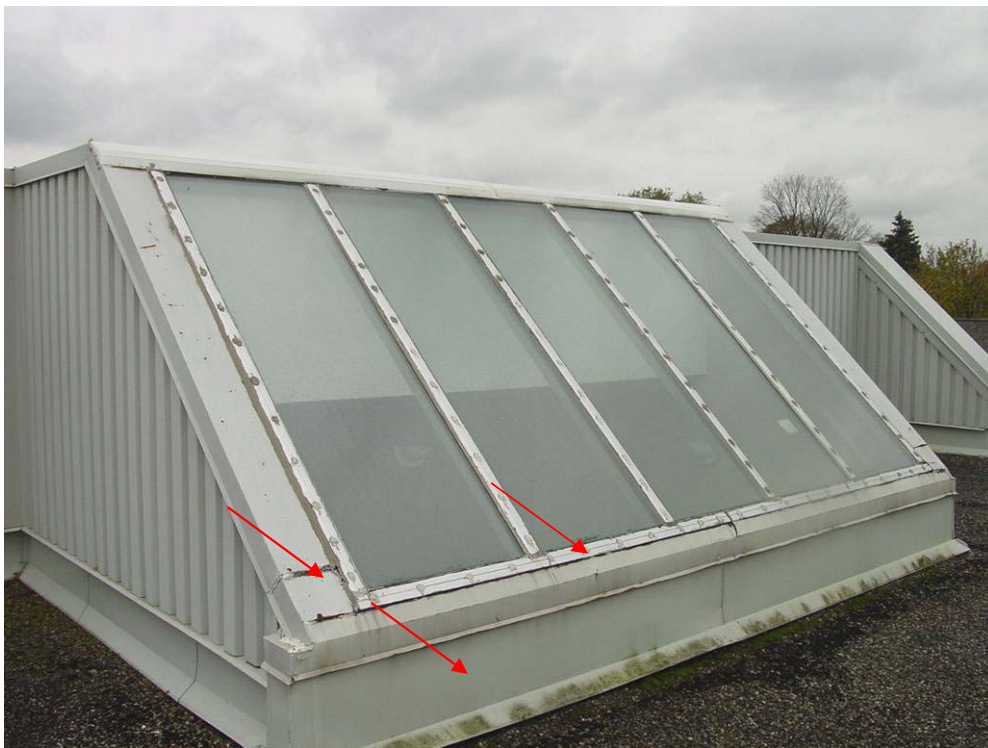
**Photograph 48:** Roof Area 3.1 – A history of leaking was reported along the base of the south skylight.

6. No membrane protection has been provided at the base of the access ladder in the southeast corner.
7. Existing skylights exhibit evidence of previous caulking repairs. A history of leaking was reported along the base of the south skylight (photograph 48). Visual review of this skylight indicated that sealant deterioration could be resulting in water entry (photograph 49). In addition, deterioration of the membrane flashings along the base of the skylight could be contributing to the water entry.

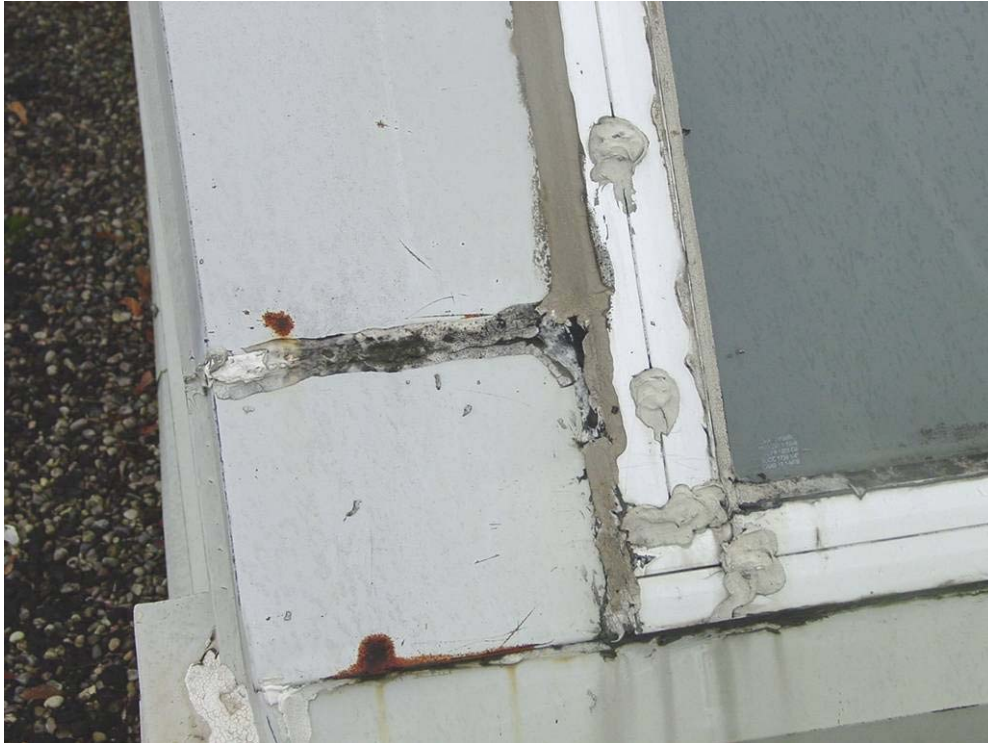
**Photograph 49:** Roof Area 3.1 - Visual review of this skylight indicated that sealant deterioration could be resulting in water entry. In addition, deterioration of the membrane flashings along the base of the skylight could be contributing to the water entry. Previous caulking repairs were evident throughout the skylight.

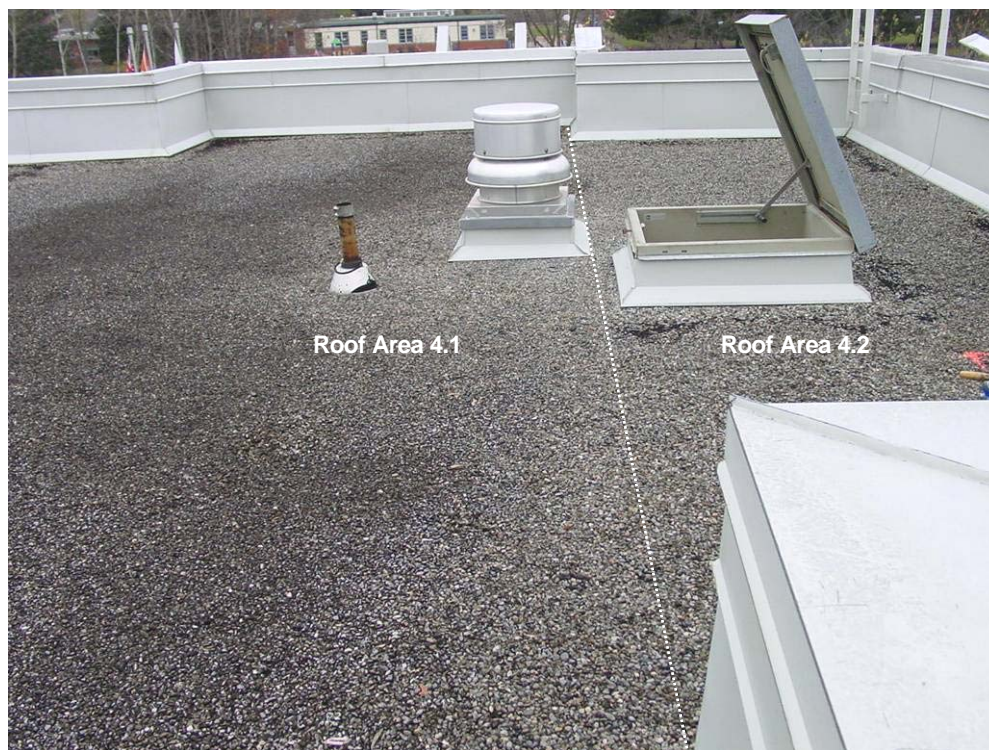
**Photograph 50:** Roof Areas 4.1 and 4.2 – These uppermost roof areas are situated over the southwest corner of the building and consist of built up bituminous membrane systems installed in 1989.

These uppermost roof areas (photograph 50) are situated over the southwest corner of the building and consist of built up bituminous membrane systems installed in 1989. Investigation revealed the following:

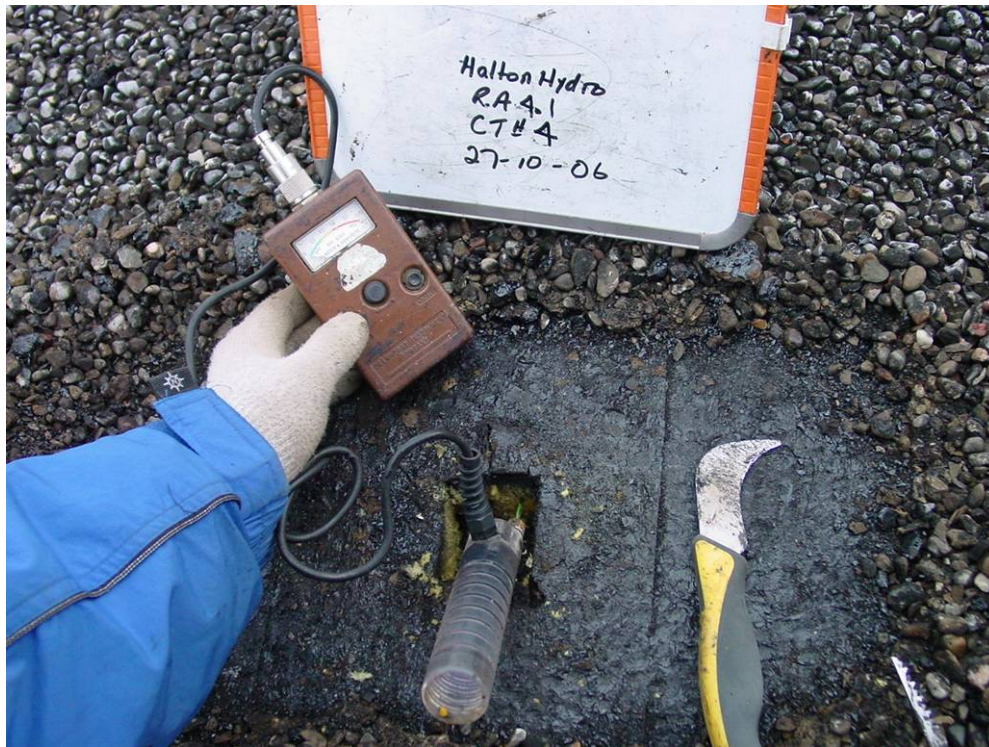
**Photograph 51:** Roof Area 4.1 - Probes taken at the core cut locations revealed no moisture present in the insulation layer or within the membrane interply.

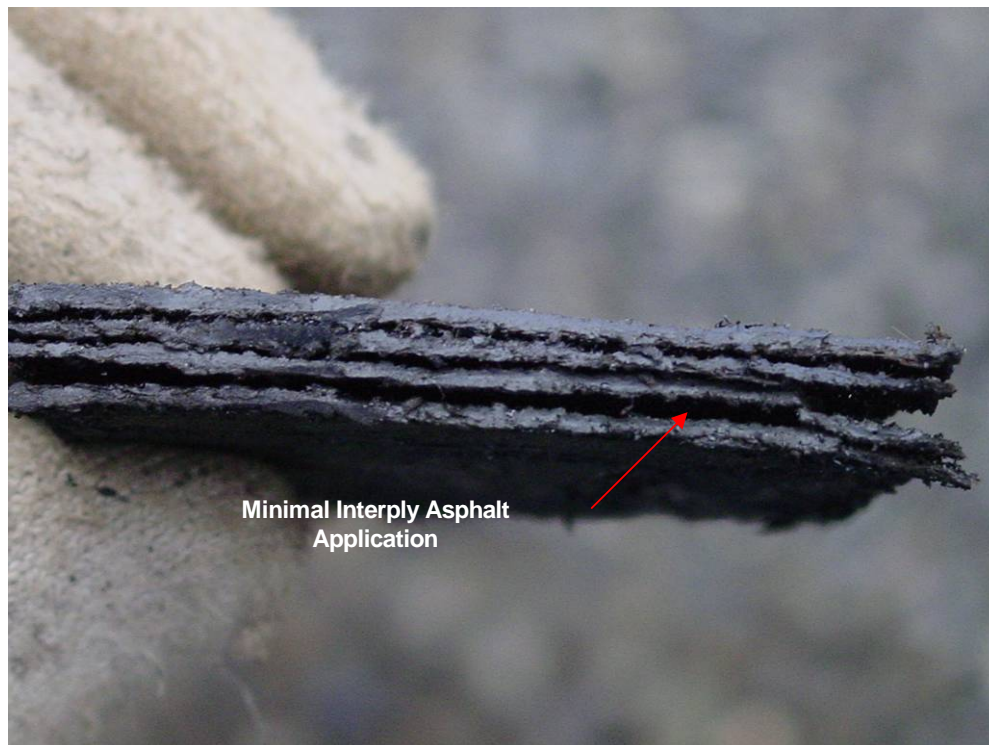
**Photograph 52:** Roof Area 4.1 – The existing membrane exhibits very poor interply adhesion.

1. The existing roof system on these areas is assessed to be in weathered condition in the latter stages of its serviceable life cycle.
2. Core cuts revealed that the membrane is exhibiting top ply deterioration, increased brittleness and very poor interply adhesion (photograph 52). Probes taken at the core cut locations revealed no moisture present in the insulation layer or within the membrane interply (photograph 51).
3. Localized membrane blistering and vegetation growth is evident (photograph 53).
4. Membrane exposure was identified along the transition between roof area 4.1 and 4.2 (photograph 54).
5. No membrane protection has been provided at the base of the access ladder or at the roof hatch.

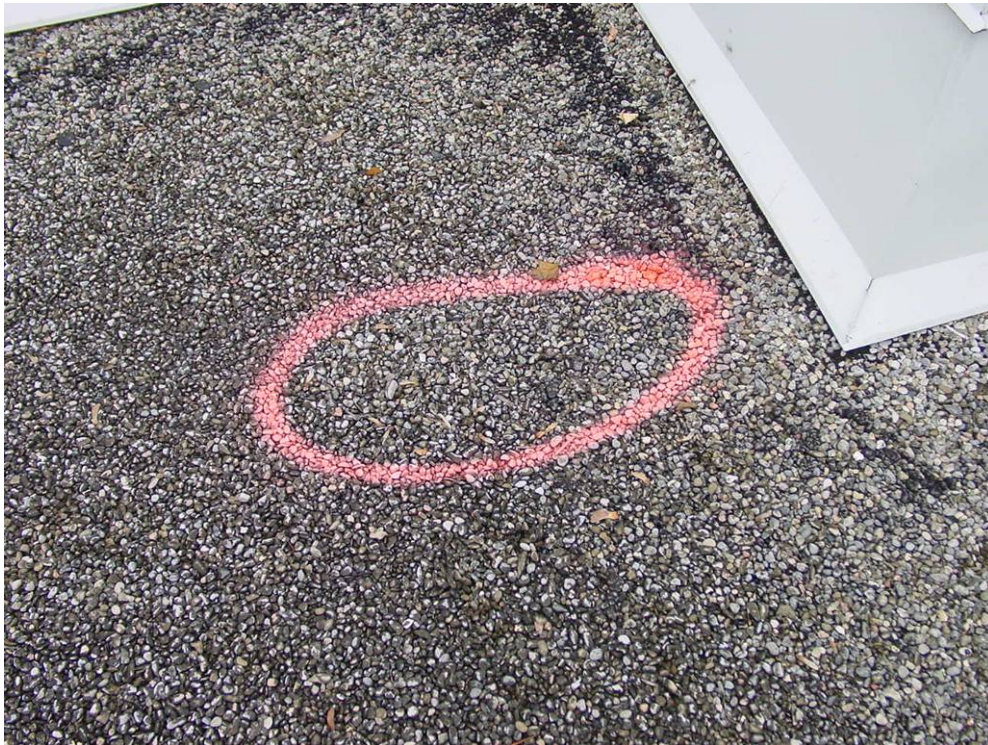
**Photograph 53:** Roof Area 4.1– Localized membrane blistering is evident.

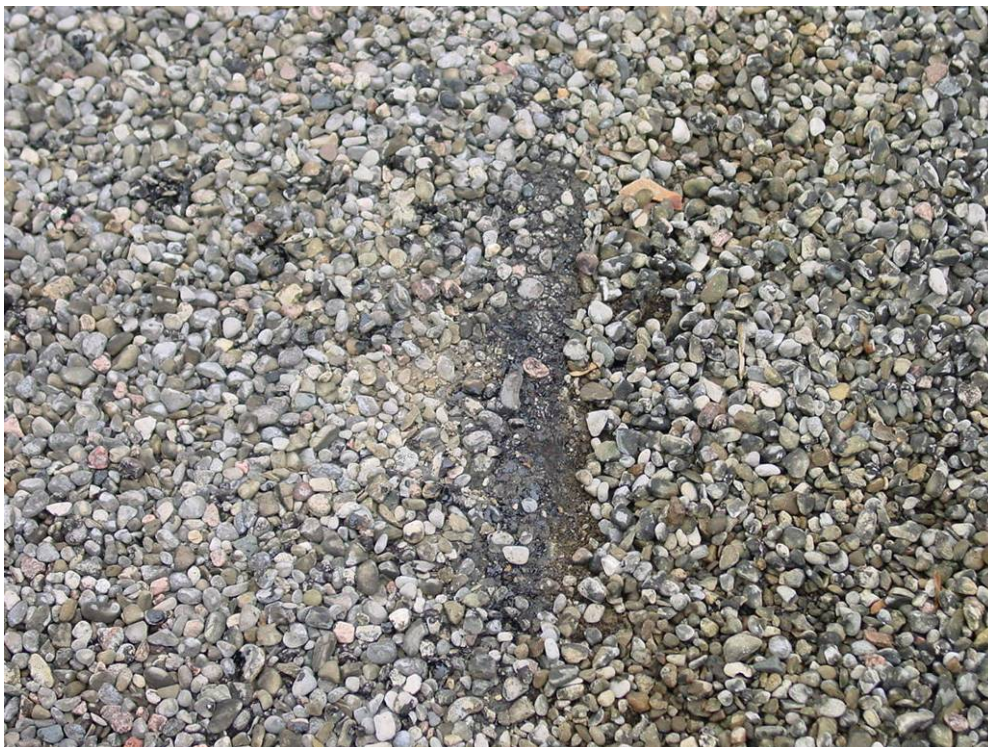
**Photograph 54:** Roof Area 4.1- Membrane exposure was identified along the transition between roof area 4.1 and 4.2.

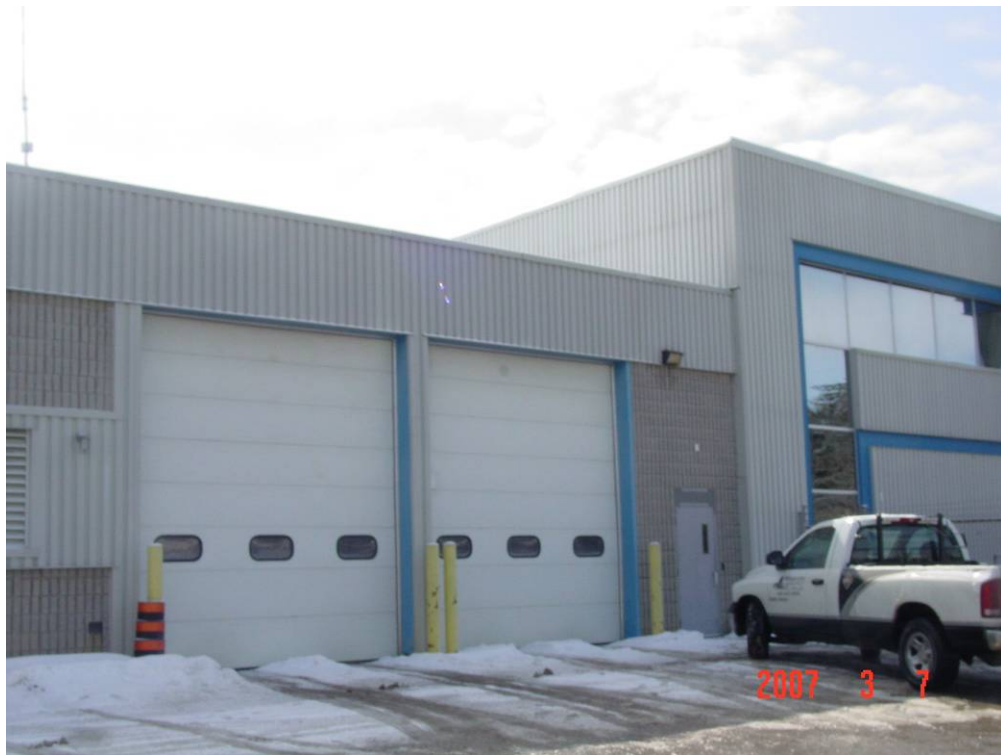
**Photograph 1:** Original warehouse portion of the building constructed with split-faced concrete block with siding accents to match newer addition.

Based on the drawings and site review, the warehouse/shop portion of the building is composed of split-faced architectural concrete block with siding accents to match the new addition constructed in 1988 (Photograph 1). The addition is a steel framed structure with prefinished steel siding supported on concrete footings with concrete block foundation walls (Photograph 2). At the interior of the building, metal studs/wood studs, fiberglass batt insulation, a polyethylene vapour barrier and gypsum board have been installed at the interior face of the plywood sheathing adjacent the exterior steel siding.

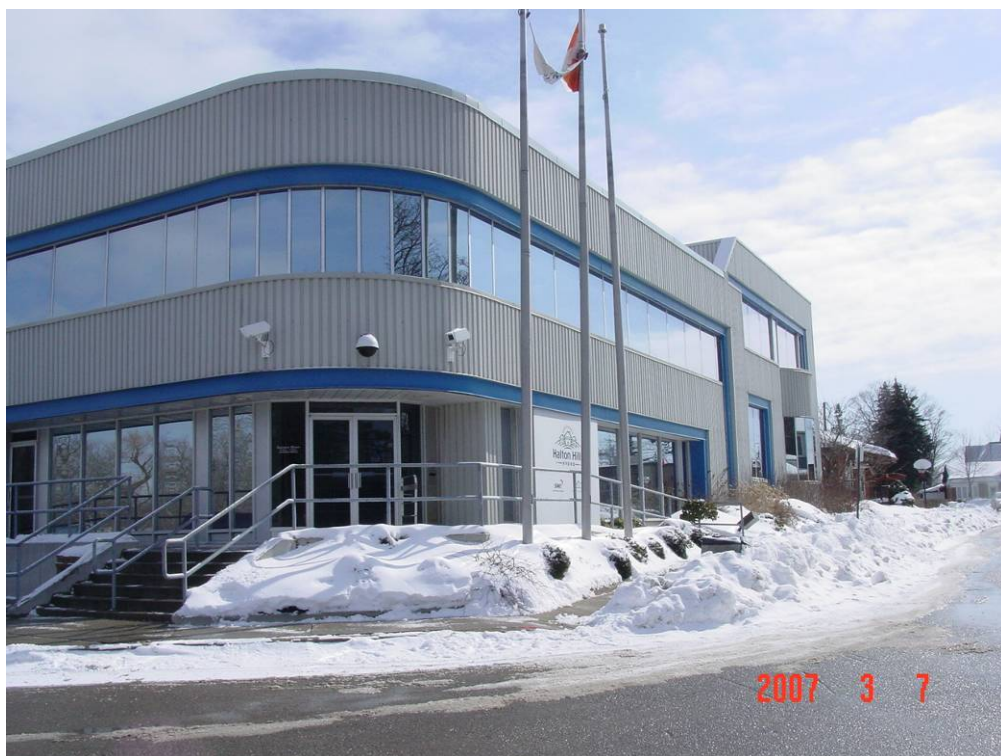
**Photograph 2:** The addition is a steel structure with prefinished steel siding supported on concrete footings with concrete block foundation walls.

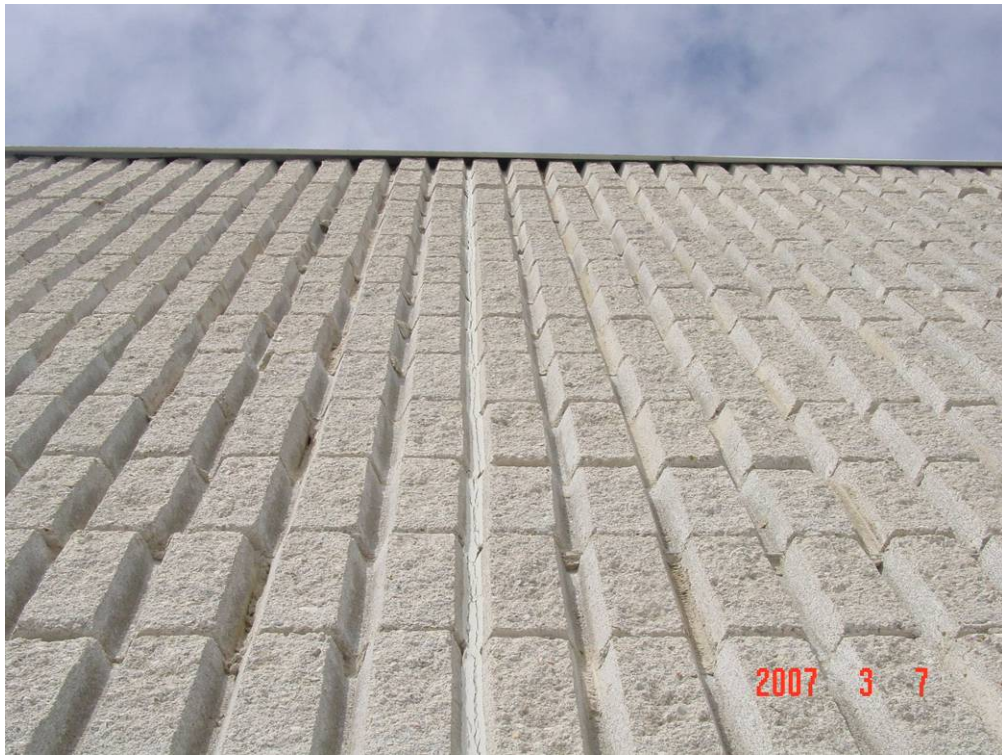
**Photograph 3:** In general, the exterior masonry walls are in good to fair condition with very minor deterioration observed.

In general, the exterior masonry walls are in good to fair condition with minor localized deterioration observed (Photograph 3). This was generally in the form of deteriorated mortar joints or poor masonry construction (Photograph 4). The split-face concrete blocks were not aligned correctly and various mortar joints were not completely filled with mortar (Photograph 5).

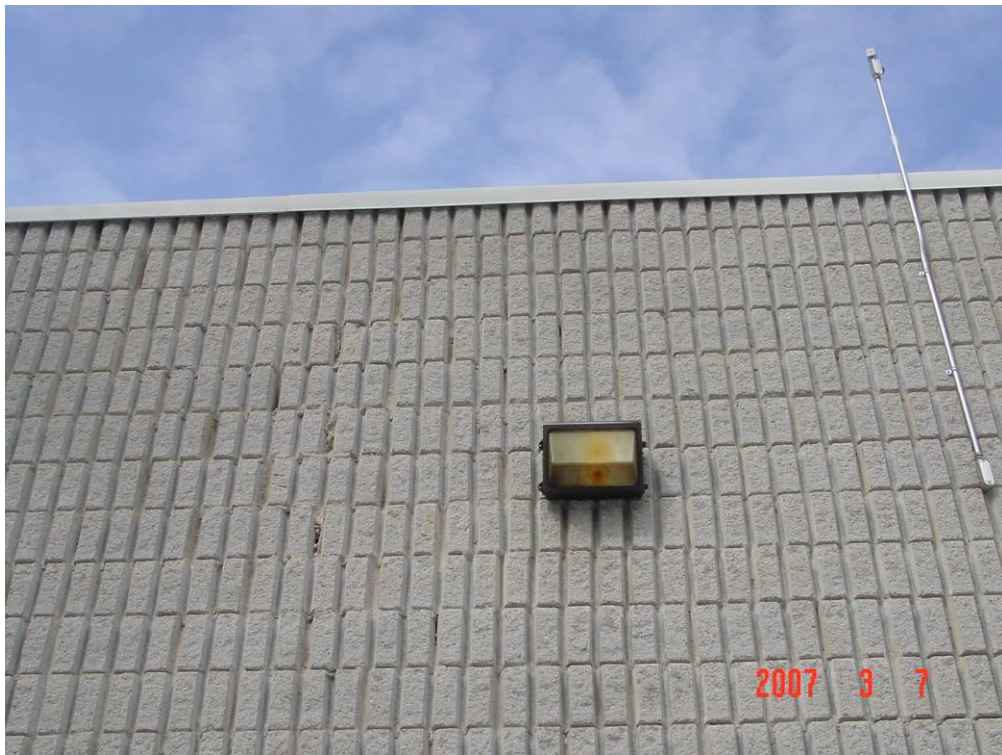
**Photograph 5:** The split-face concrete blocks were not aligned correctly and various mortar joints were not completely filled with mortar.

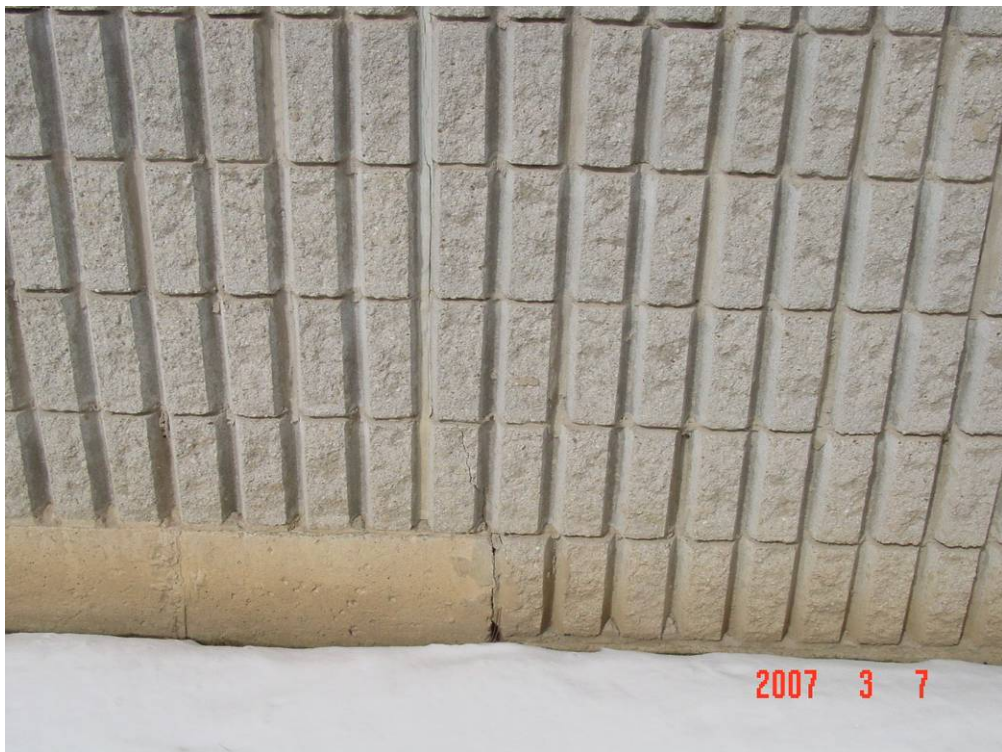
**Photograph 6:** Cracked concrete blocks were only visible at one (1) location, above a stepped foundation wall at the East elevation.

Cracked concrete blocks were only visible at one (1) location, above a stepped foundation wall at the east elevation (Photograph 6).

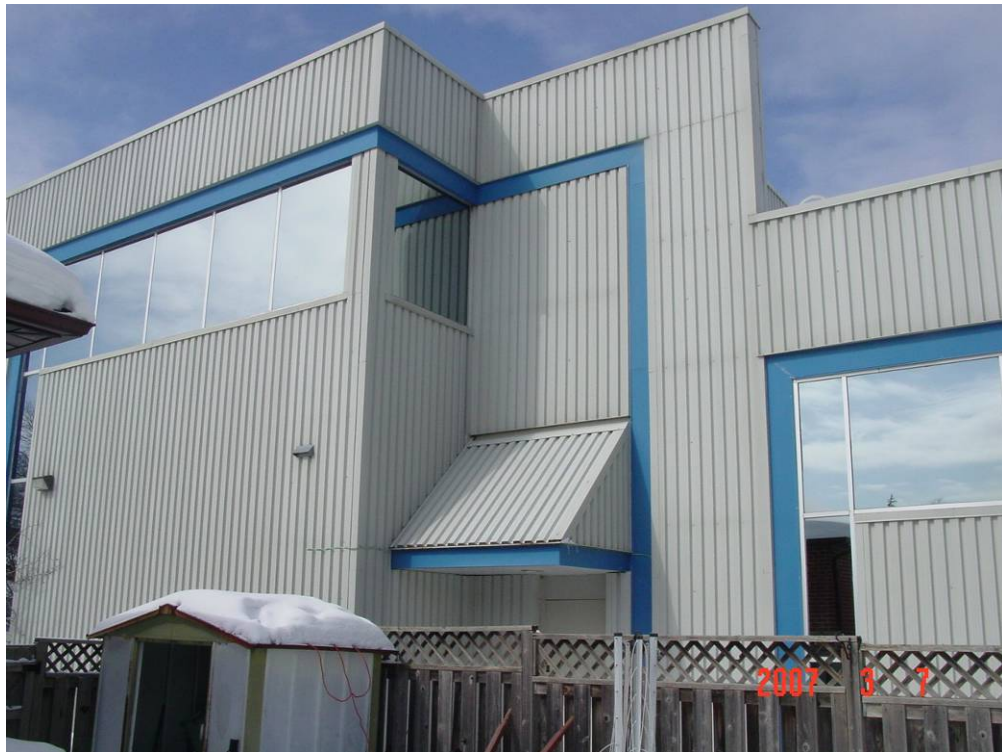
**Photograph 7:** The exterior prefinished steel siding was generally in good condition.

The prefinished metal cladding was generally in good condition, with no significant deterioration of the cladding observed (Photograph 7). Some chalking of the coating was typically observed.

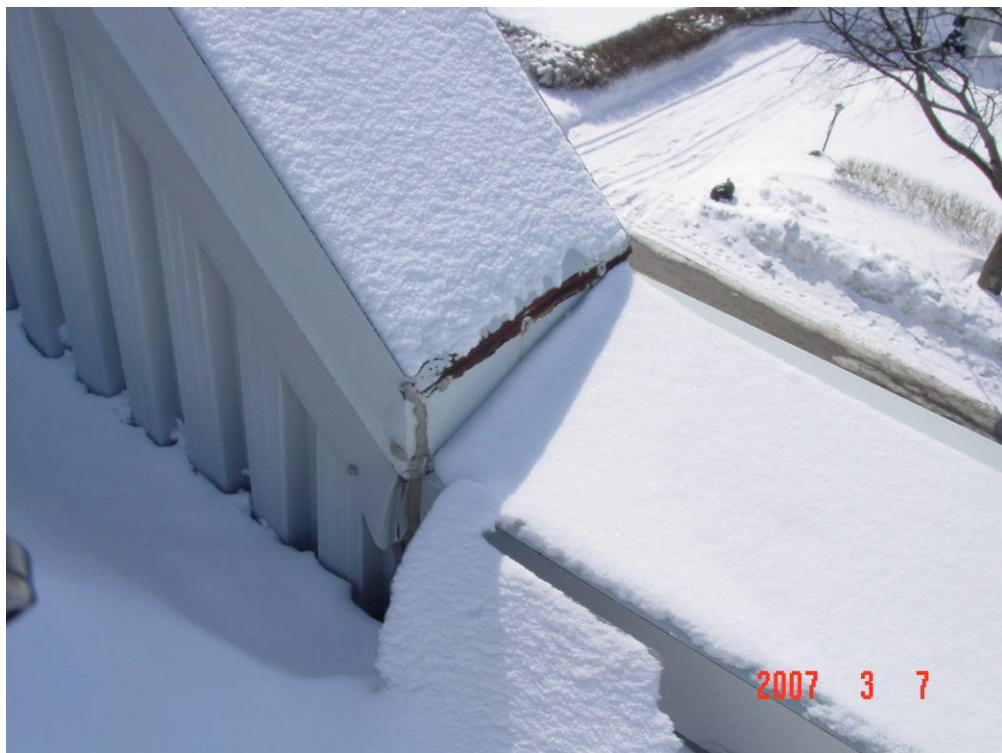
**Photograph 8:** The metal parapet cap flashings were in very good condition as well except at one (1) location, at the sloped parapet at the South elevation.

The metal parapet cap flashings were in very good condition as well except at one (1) location, at the sloped parapet at the south elevation (Photograph 8), where surface corrosion of the cladding was noted.
