Re: Halton Hills Hydro Inc. 2008 Electricity Distribution Rates Application  
Board File Number EB 2007-0696  
Second Round Interrogatory Responses to OEB Staff

### 3 Visual Survey

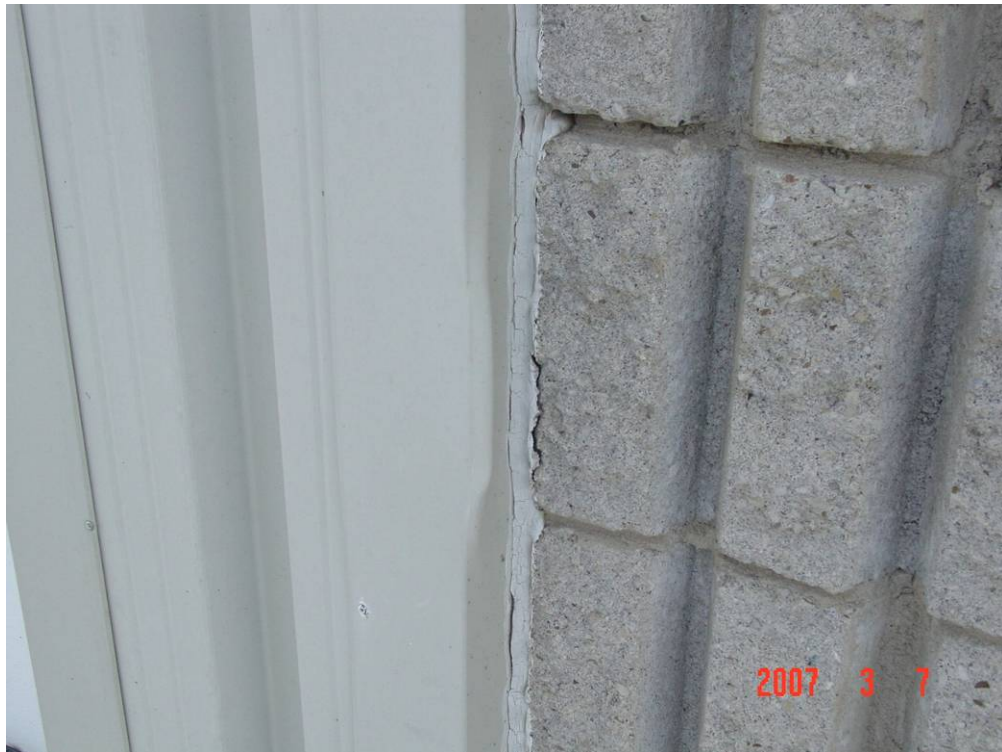
**Photograph 9:** All observed sealant joints at all elevations were in very poor condition, which included all sealant joints between the siding and the split-faced concrete block.

- .1 between the siding and the split-faced concrete block (Photograph 9),
- .2 the control joints at the full height of the concrete block walls (Photograph 10),
- .3 the window perimeter sealant joints (Photograph 11),
- .4 sealant at masonry penetrations (Photograph 12),
- .5 all metal-to-metal joints at the windows (Photograph 13), and
- .6 at all glass-to-metal sealant joints at the windows (Photograph 14).

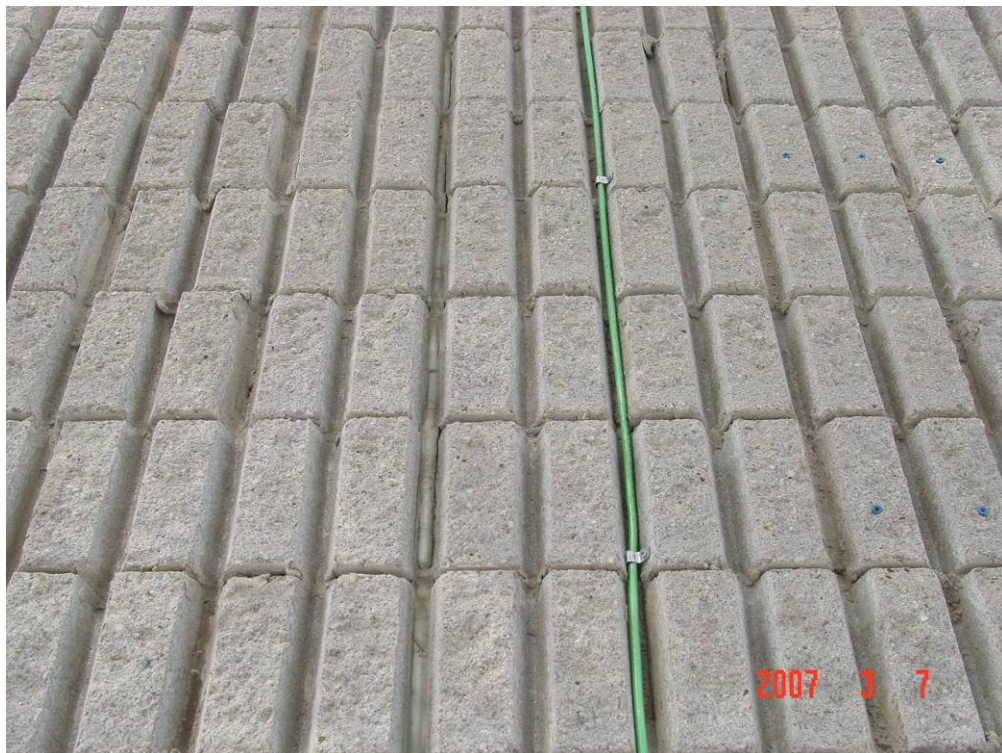
**Photograph 10:** Sealant deterioration at the control joints at the full height of the concrete block walls.

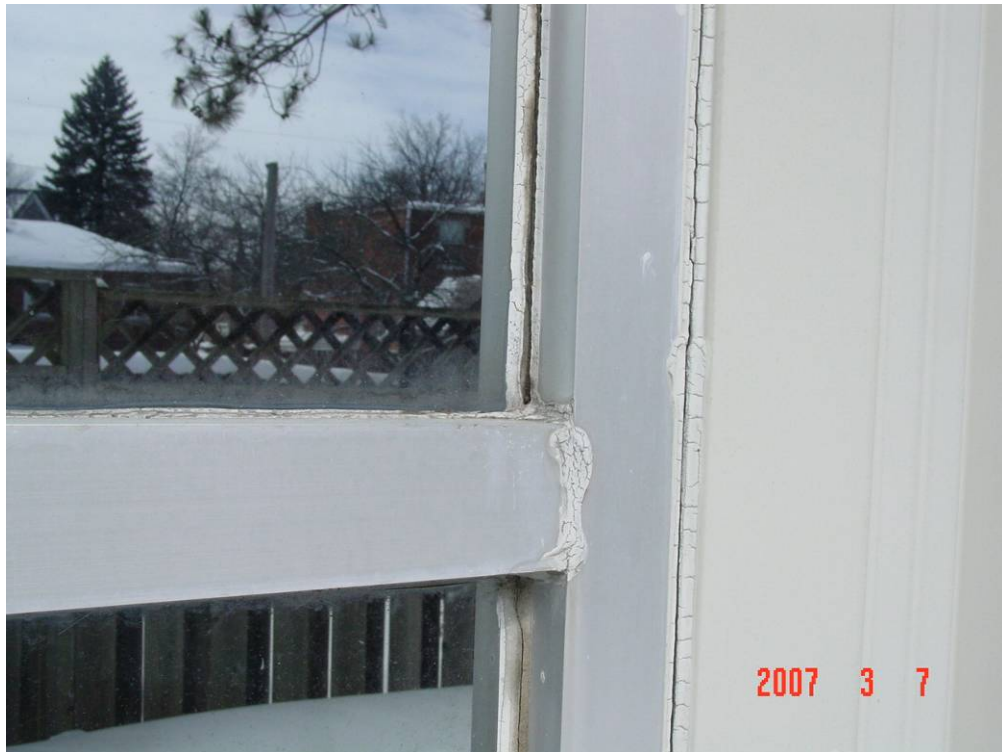
**Photograph 11:** Sealant deterioration at the window perimeters.

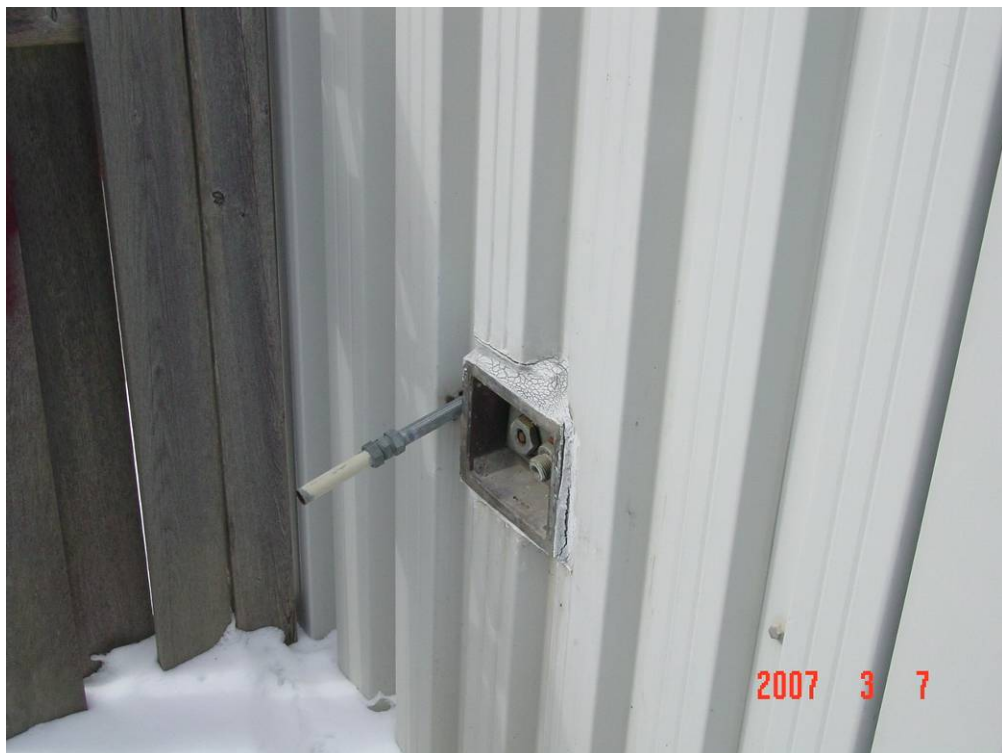
**Photograph 12:** Sealant deterioration at wall penetrations.

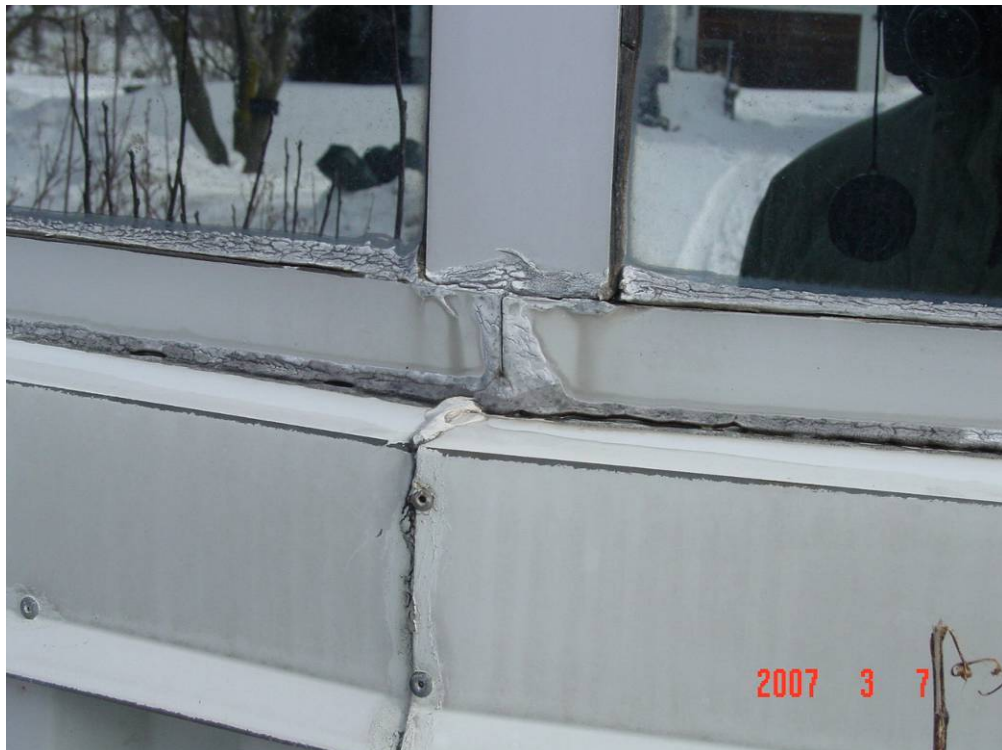
**Photograph 14:** Sealant deterioration at all glass-to-metal sealant joints.

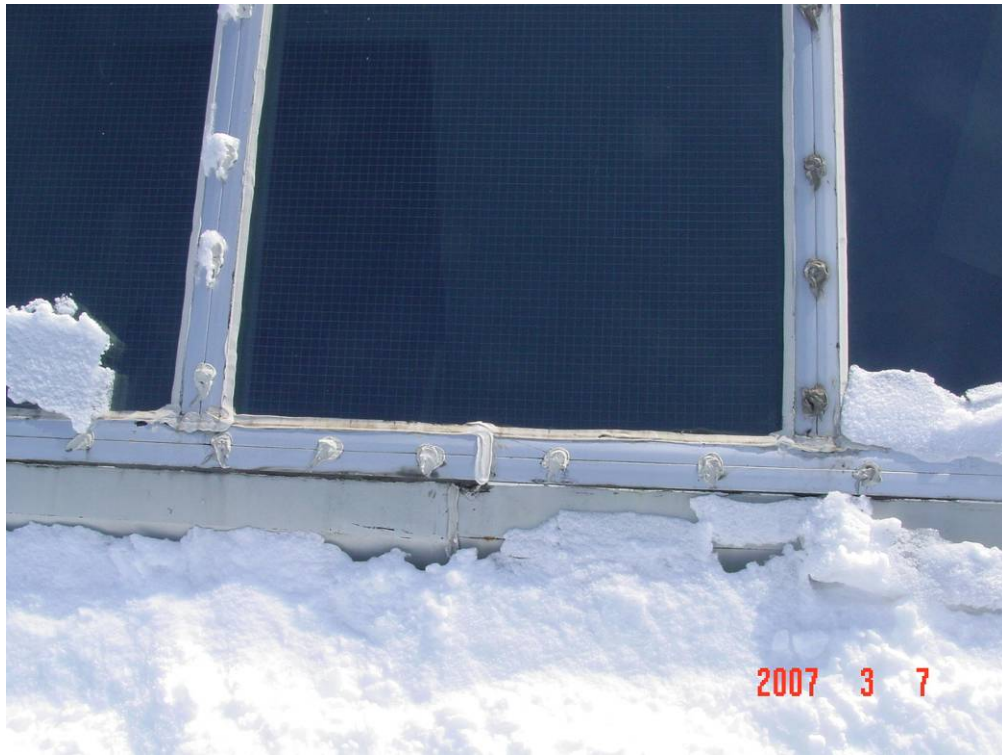
**Photograph 15:** Improper overbeading repairs to the sealant joints at the skylights.

Overbeading of the sealant joints at the skylights was evident at various locations (Photograph 15), most probably executed due to water leakage at the skylight locations. Failed sealants create an entry point for water penetration and air leakage into the building.

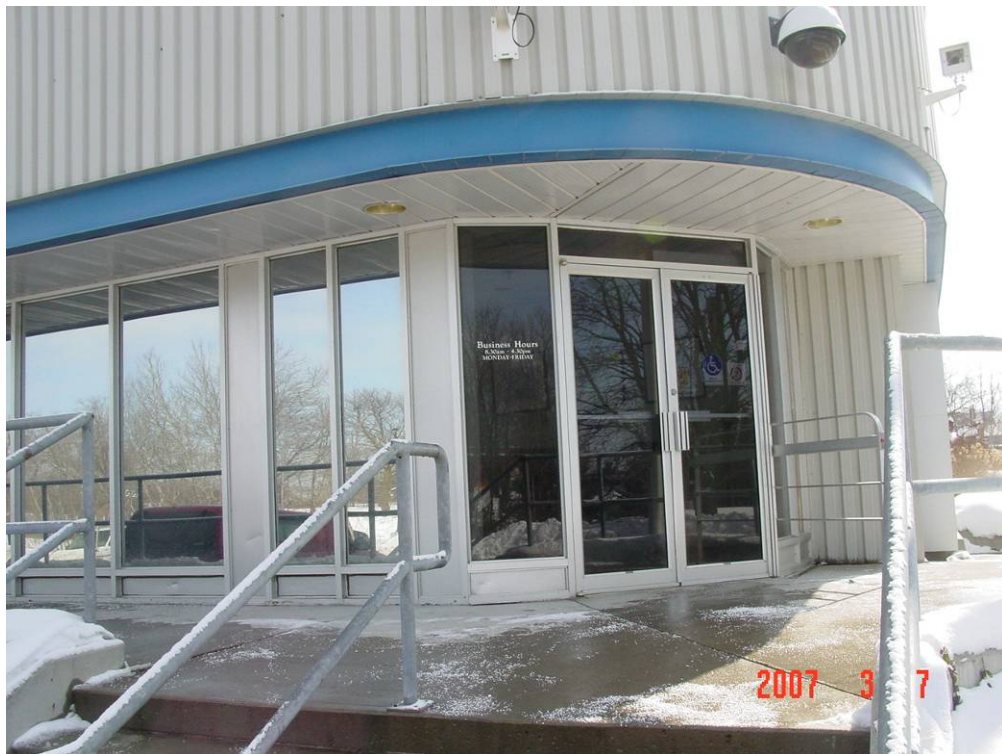
**Photograph 16:** The vestibule and lobby at the Southwest corner of the building have been reported to be very cold during the winter months.

The vestibule, lobby and 2<sup>nd</sup> floor offices at the southwest corner of the building (Photographs 16 and 17) have been reported to be very cold during the winter months.

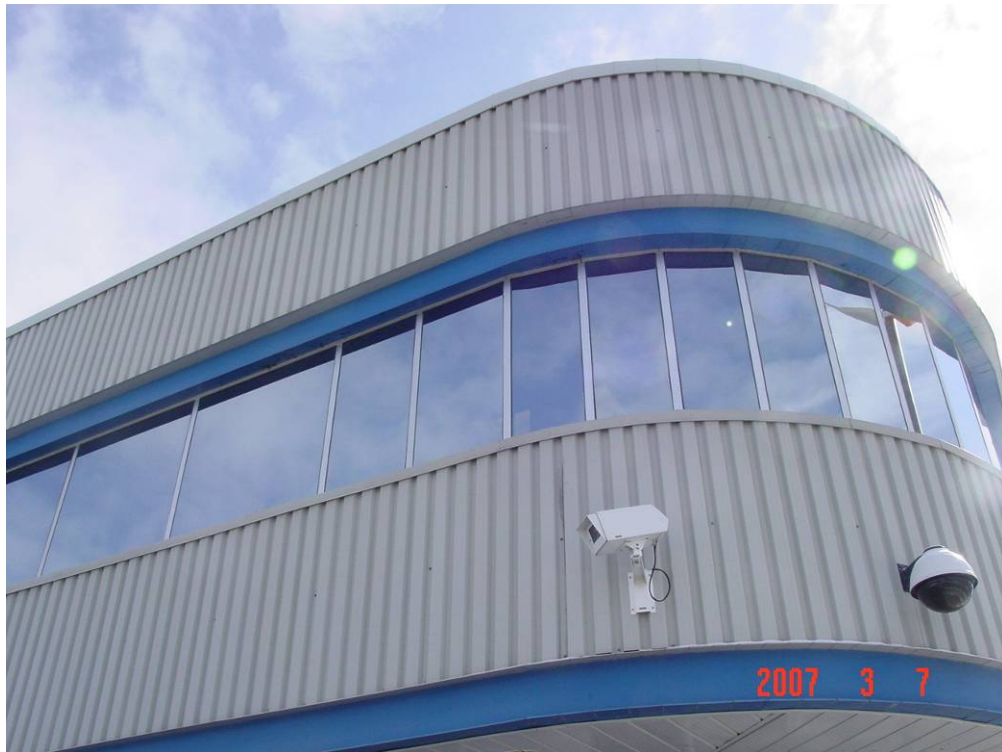
**Photograph 17:** The 2<sup>nd</sup> floor offices at the Southwest corner of the building have been reported to be very cold during the winter months.

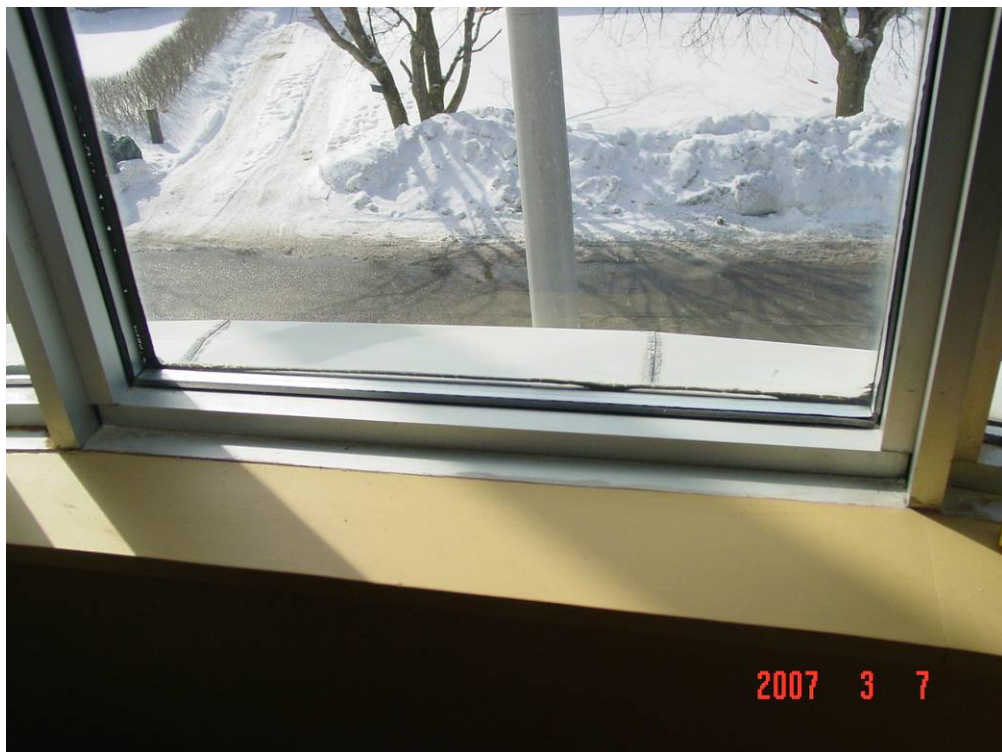
**Photograph 18:** Aluminum sills have been provided at the base of the 2<sup>nd</sup> floor windows. This was observed from the interior of the building.

- .2 Aluminum sills have been provided at the base of the 2<sup>nd</sup> floor windows. This was observed from the interior of the building (Photograph 18).

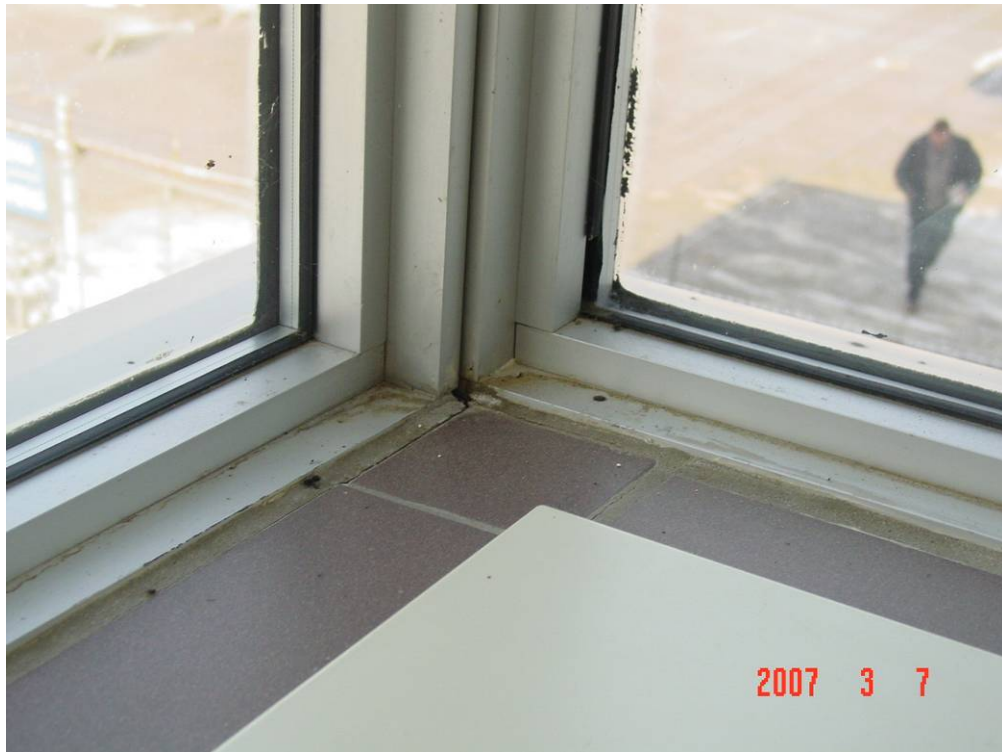
**Photograph 19:** Various installed glazing stops were undersized.

- .3 Various installed glazing stops were undersized, leaving large gaps between them. (Photograph 19).
- .4 Water leakage or condensation at various locations at the interior window sills/frames was evident (Photograph 20).

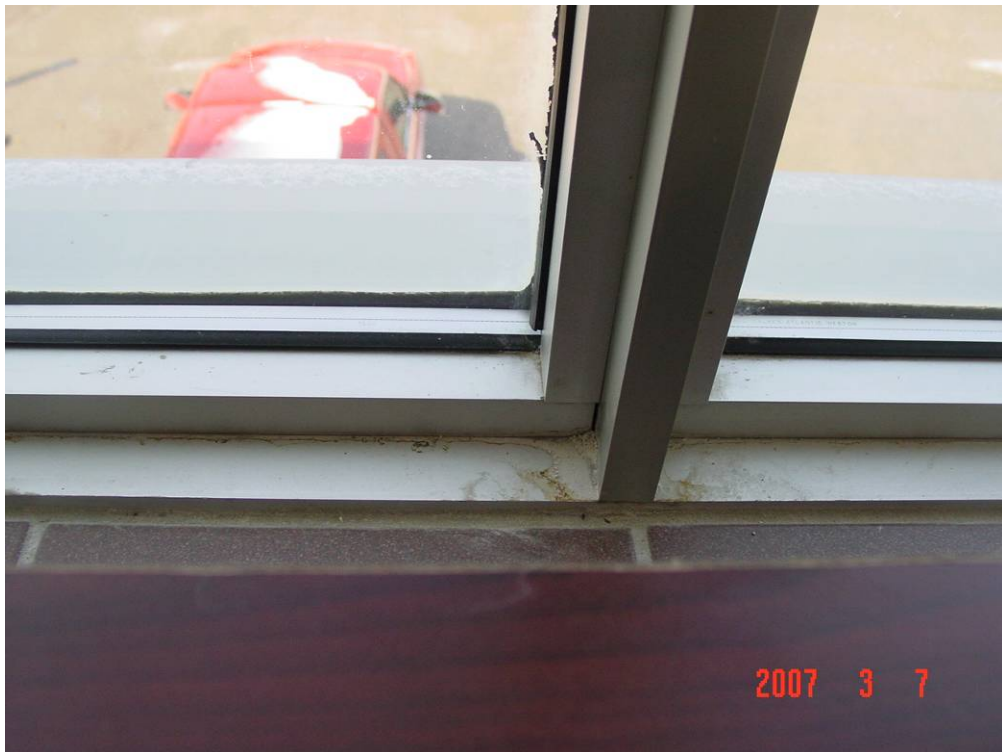
**Photograph 20:** Water leakage at various locations at the interior window sills/frames was evident.

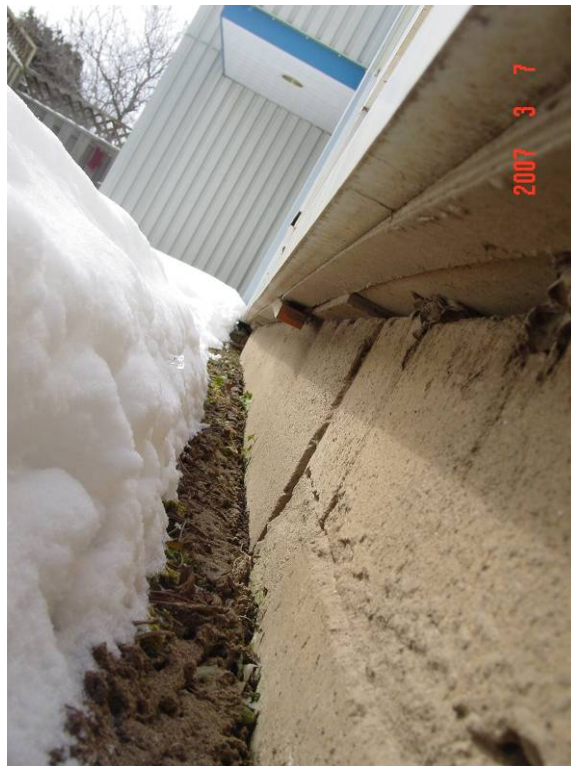
**Photograph 22:** At the East elevation, it was observed that no sill flashings were installed below the ground floor windows; there seemed to be plywood strips beneath, some of them being loose.

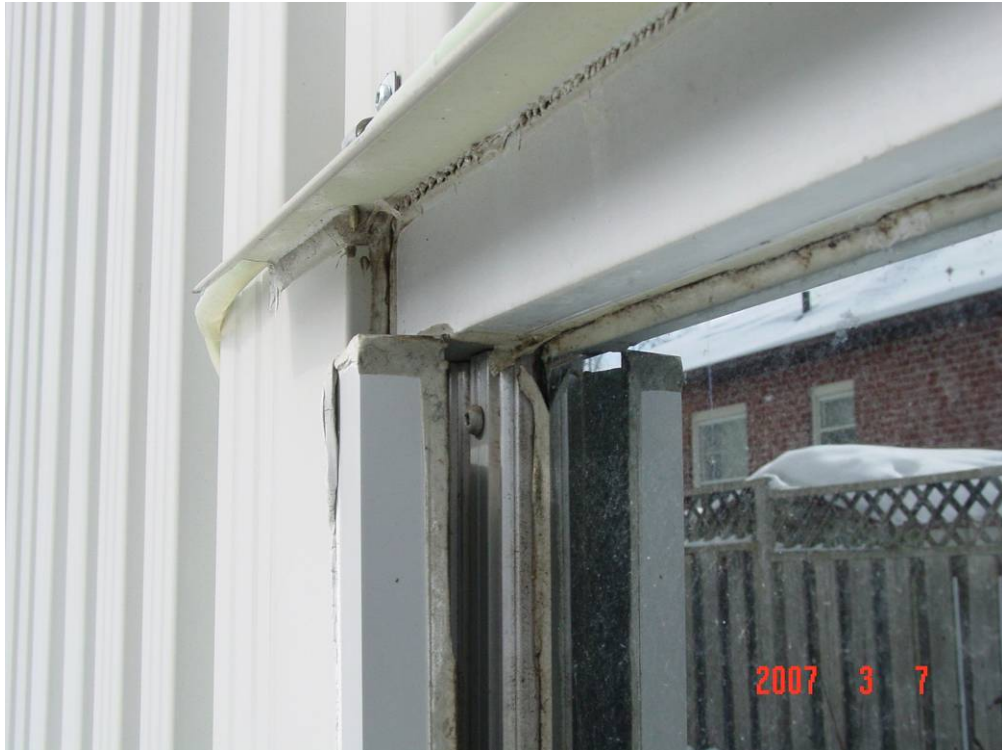
**Photograph 23:** Some glazing cover caps were noted to be loose.

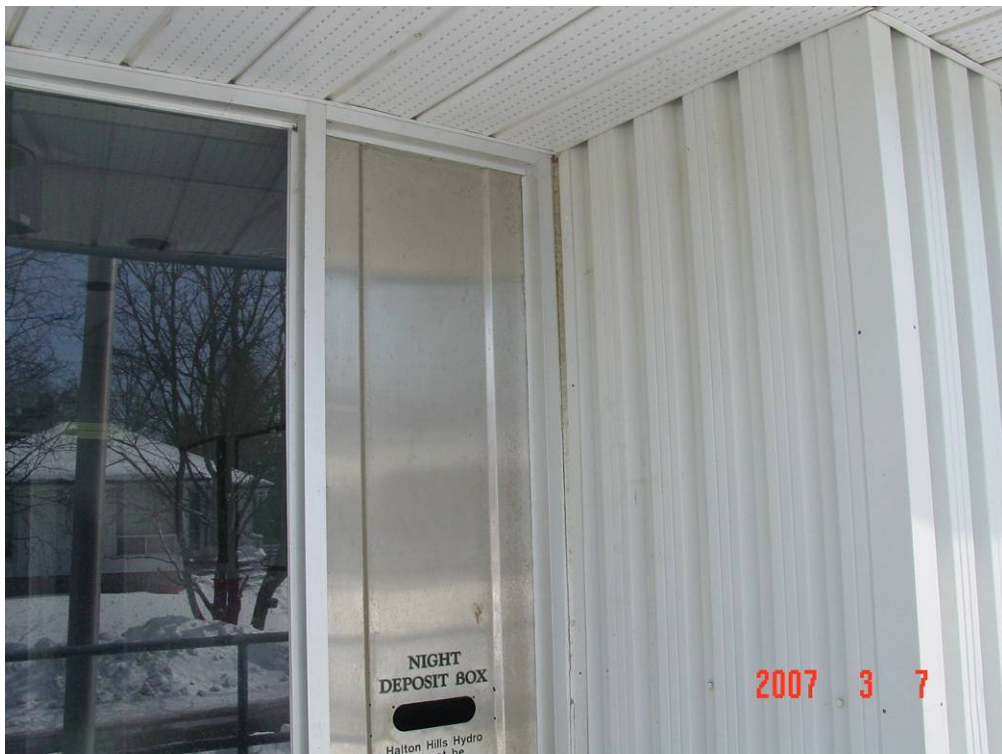
**Photograph 24:** Within the vestibule, Halton Hills Hydro has installed a 'Night Deposit Box', a steel panel en lieu of the window at this location. The steel panel is not insulated and there are obvious holes at the corners of the window frame

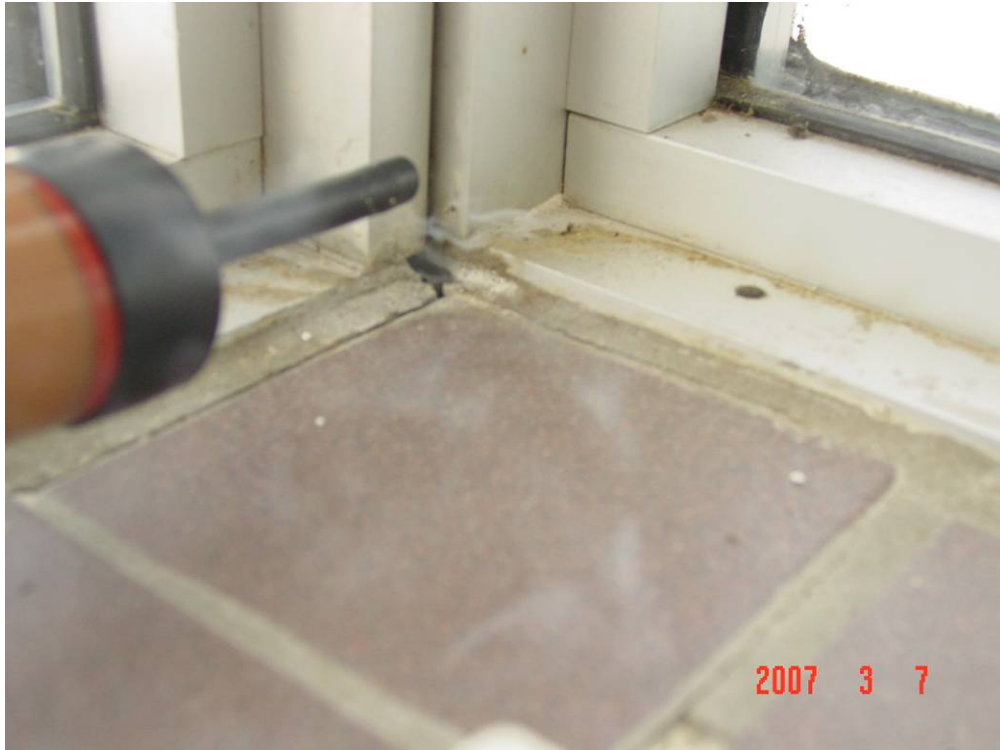
**Photograph 25:** Using a smoke pencil, it was observed at various locations at the window framing gaps and openings, that air leakage was evident.

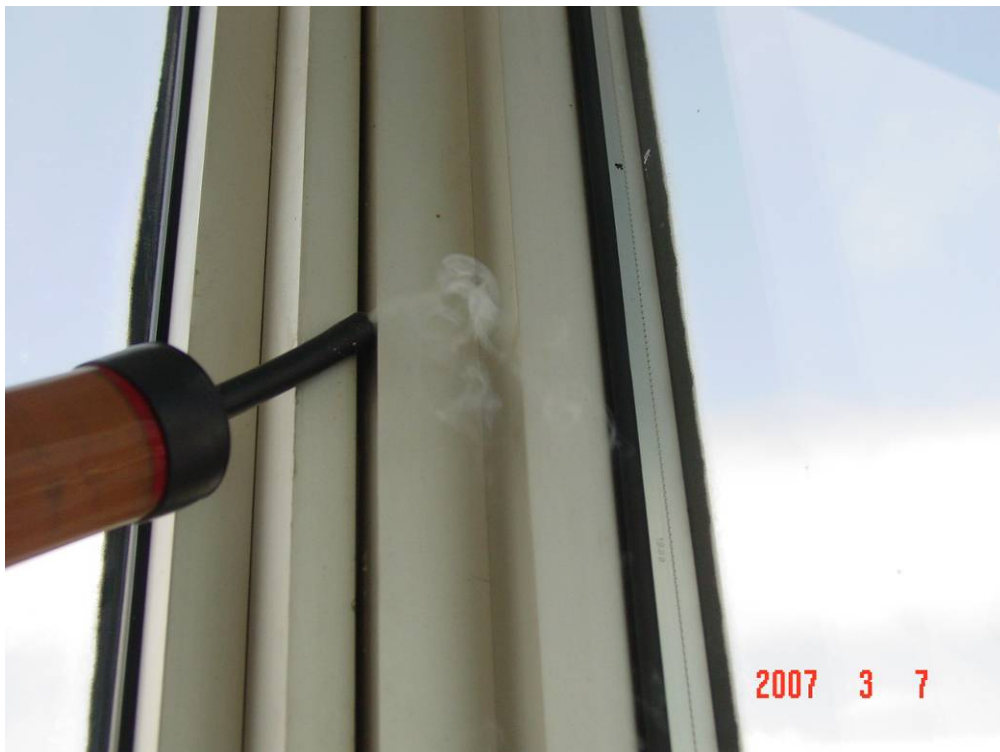
**Photograph 26:** The gaps or openings and the lack of sealant between the window framing components allows cold air to enter the building at these locations.

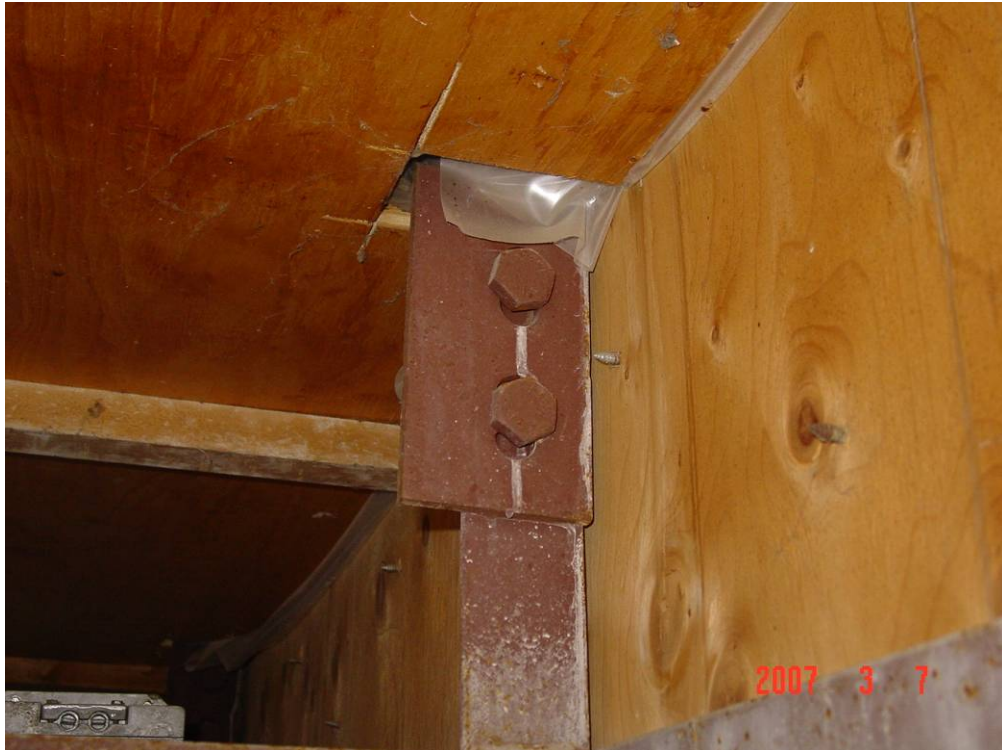
**Photograph 27:** At soffit locations where the plywood was cut out around the structural steel framing, it did not appear that the polyethylene air/vapour barrier was sealed.

- .1 At the exposed soffit area, below the second floor and outside the main entrance area, a soffit panel was removed to permit examination of the space. Based on the drawings and site observations, the soffit construction is as follows:
  - a) prefinished metal vented soffit,
  - b) 300 mm cavity (allowance for recessed pot lights),
  - c) 13 mm plywood sheathing,
  - d) batt insulation within steel C-channel framing,
  - e) polyethylene vapour retarder
  - f) cantilevered structural steel I-beams,
  - g) 2nd floor composite floor slab (concrete on steel deck).
- .2 Within the soffit space, the insulation and air/vapour barrier was generally hidden by the plywood sheathing. At locations where the plywood was cut out around the structural steel framing, it did not appear that the polyethylene air/vapour barrier was sealed (Photograph 27).

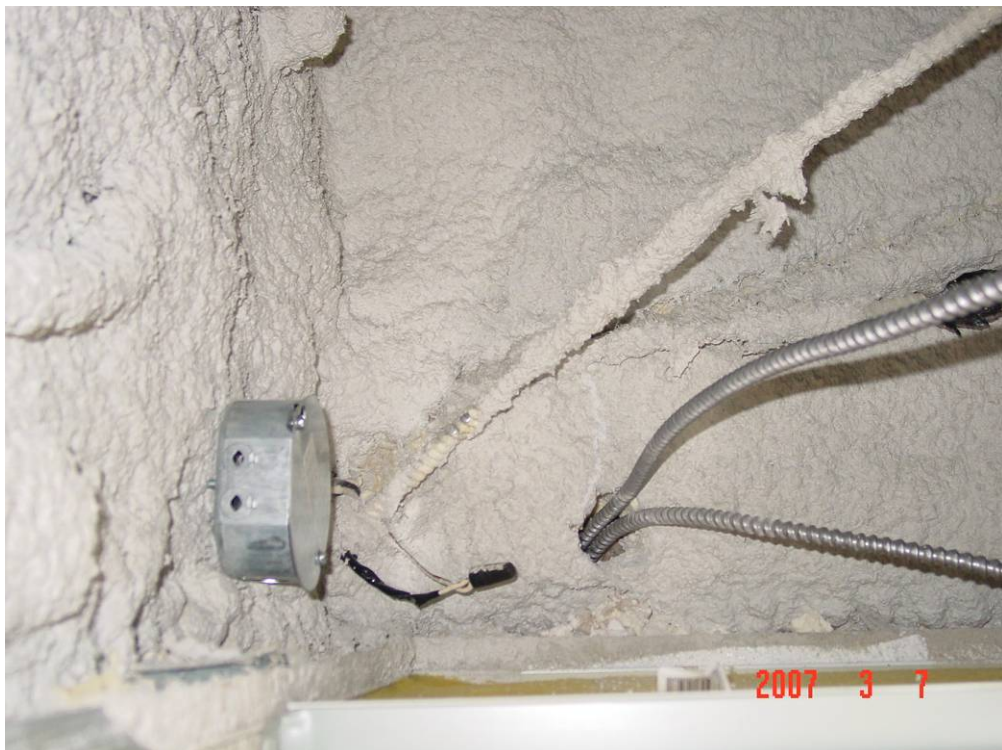
**Photograph 28:** At one location between the soffit and the main floor ceiling space, an opening in the polyurethane foam was noted at an electrical conduit.

- .3 At the ground floor area within the ceiling space, it appears that the vertical divider between the soffit space and the interior has been upgraded with the installation of spray applied polyurethane foam insulation covered with a cementitious thermal barrier. In one location, it was noted that electrical cable has been installed/modified and the opening in the foam was not sealed (Photograph 28). All areas of this exterior wall in the ceiling space were not accessible so it could not be determined if other discontinuities were present.
