Wellington North Power Inc.

Re: OEB File Number: EB-2013-0178
Wellington North Power Inc. – ED-2002-0511
2014 4th Generation Distribution Rate Application
Response to VECC Interrogatories

Enclosed are Wellington North Power Inc.'s responses to the Vulnerable Energy Consumers Coalition (VECC) Interrogatories relating to the LDC's Incentive Rate Mechanism Adjustment Application for 2014 Distribution rates (file number: EB-2013-0178).

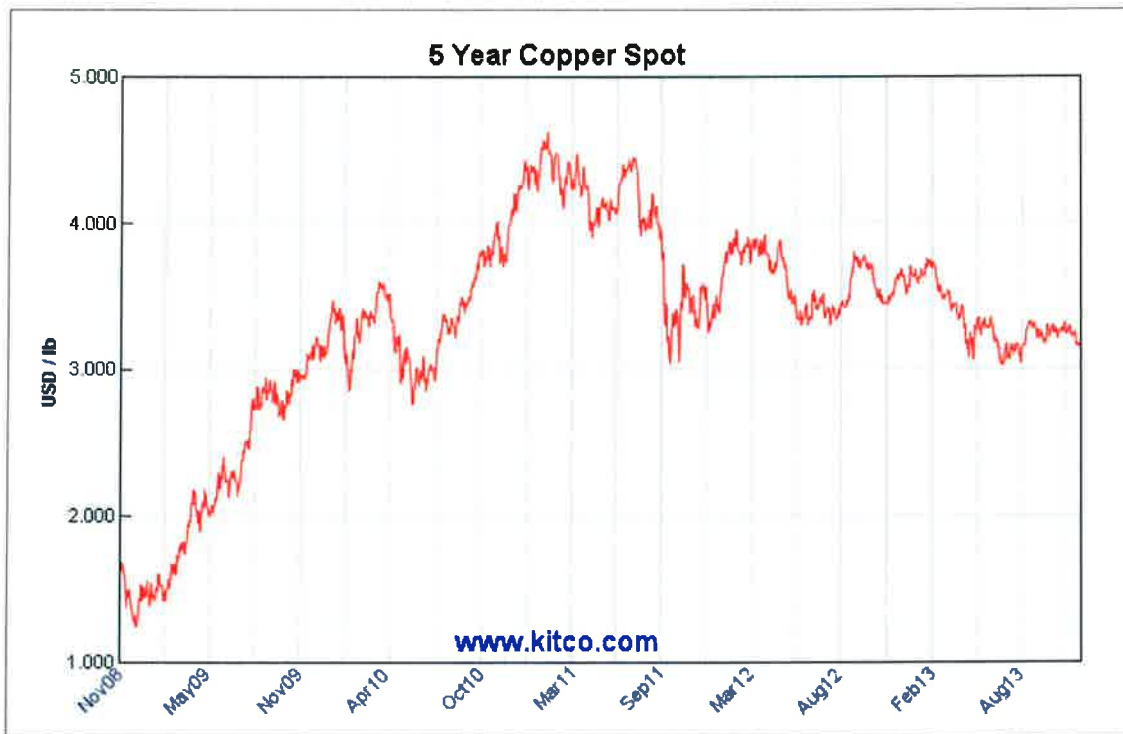
- b) The price of copper as a commodity has a significant impact on the project cost of substation projects as a result of need for copper's electrical properties in manufacturing electrical equipment including cable and transformers. The following chart, taken from the internet, shows the price of copper over the past five years.

As shown in the above chart, the price of copper reached a recent high over 4USD/lb in 2011, a recent low of under 2USD/lb in 2008 and currently (fall 2013) sits just over 3USD/lb. There is no doubt that the cost of copper impacts the project cost when rebuilding a substation. Within WNP's budget, approximately \$800,000 of proposed spend for MS2 substation relates to purchasing electrical equipment and/or cable. It can be assumed that the price of copper would have significant influence over the cost of this equipment; however, keeping in mind that electrical equipment and cable are highly engineered products that require advanced manufacturing processes to be created. This engineering design and advanced manufacturing would make the price of resulting electrical equipment and cable less elastic when compared to the price of copper. The decision to replace this substation has been made in consideration of reliability and good asset management practice.
