**Re: EB-2012-0459 - Enbridge Gas Distribution Inc. ("Enbridge")
2014 – 2018 Rate Application
Undertaking Responses**

UNDERTAKING J1.2

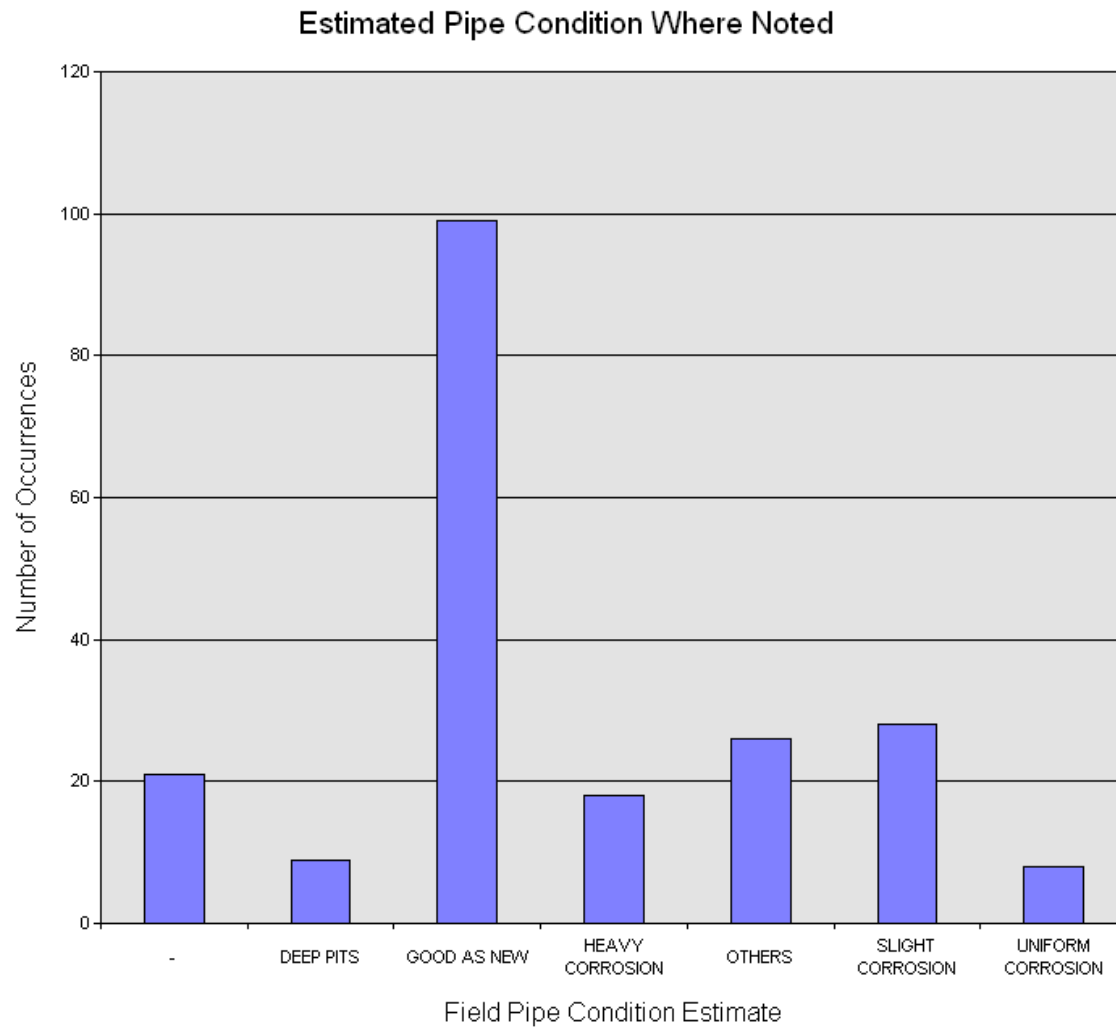
Figure 4.2.2.8: The estimated condition of the pipe where noted at the time of repair from the Leak Repair Pipe Condition facility attribute.

Figure 4.2.2.8 and Table 4.2.2.2 show the reported condition of the pipe at locations where below ground repairs were completed. This data can be correlated to the main leg in PMTS should an investigation be warranted. The data in Table 4.2.2.2 shows only those repairs where the network, low node and high node are available and have corrosion identified. i.e. those incidents recorded as having “slight corrosion”, “uniform corrosion”, “heavy corrosion” and “deep pits”. The label of the first column is “-”, an option in the Leak Repair Pipe Condition drop down menu in eField.

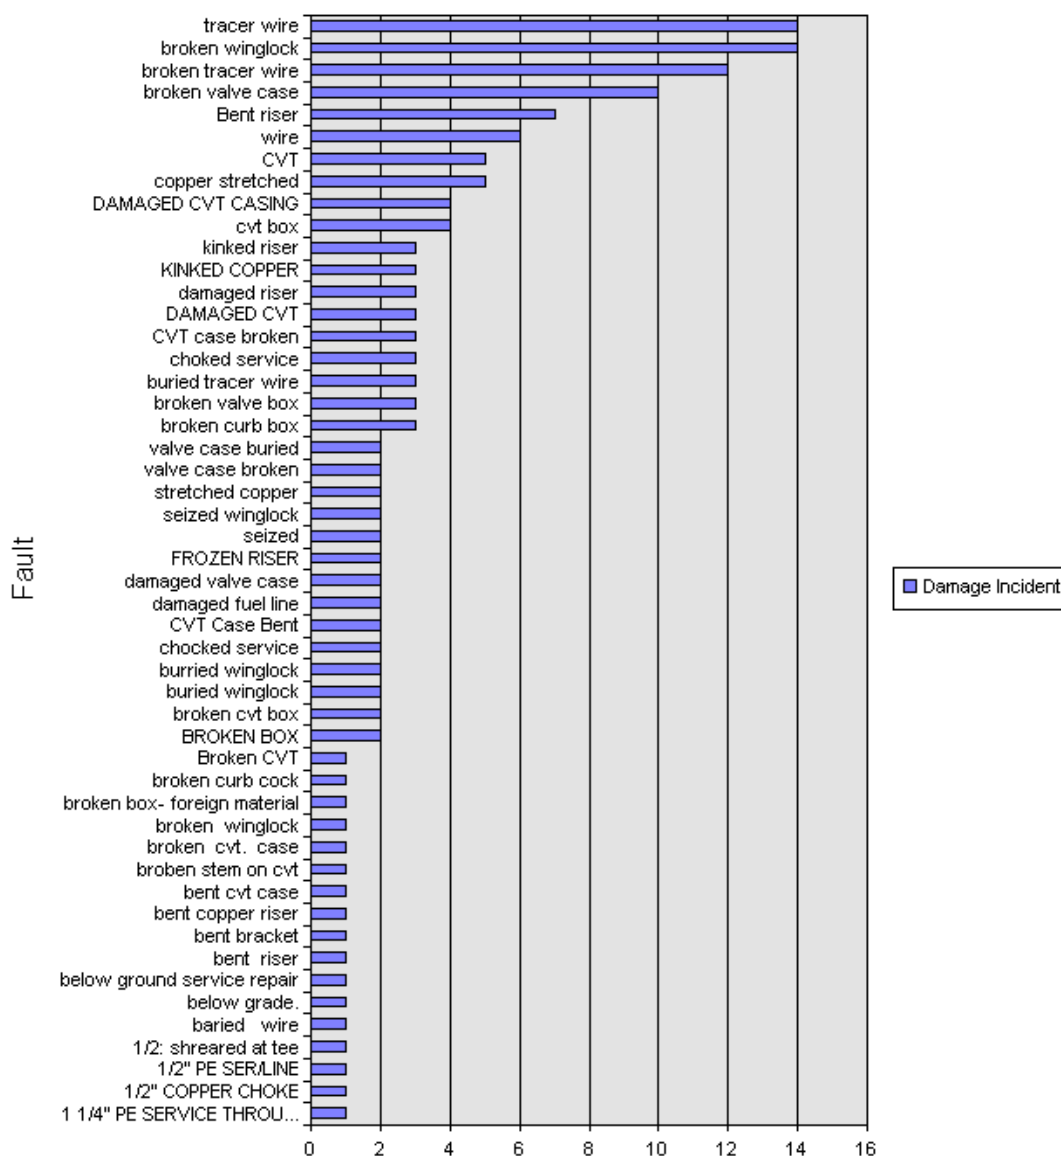
Figure 4.3.2: Top 50% of faults related to Damage Incidents on Services

Damage Incidents Related to Below Ground Service Repairs (Top 50%)

Figure 4.3.2 shows the top 50% of faults due to damage incidents. The data provided is limited to below ground service repairs. There are a small number of damage incidents associated to mains and valves but the data is insufficient to draw any conclusion of trends. This graph highlights the type of hazards that are being recorded in the field. The free form nature of the fault description limits the ability to count the number of individual fault types. As is seen from the graph.

31 of the 49 fault descriptions were used either once or twice. This highlights the difficulty of collecting data with free form comments.

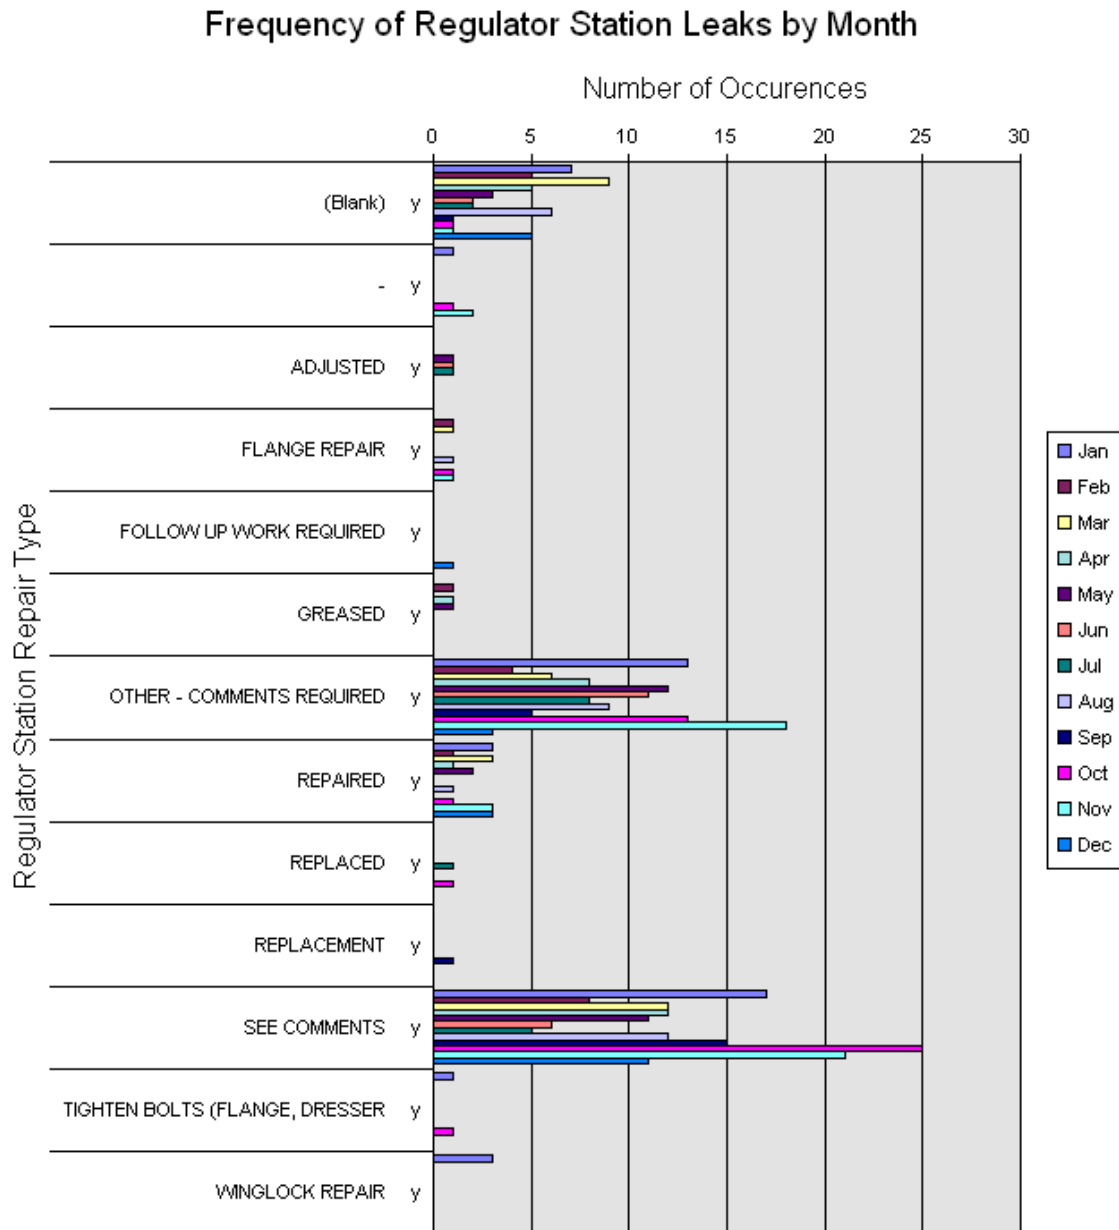
Figure 4.6.2: Regulator Station Estimated Number of Leaks

As a method of estimating, Integrity Management determined there are indications of Leaks among these comments and these can be seen in Figure 4.6.2. This is achieved by filtering the repair comments for the word "leak". The total is 244 for the period.

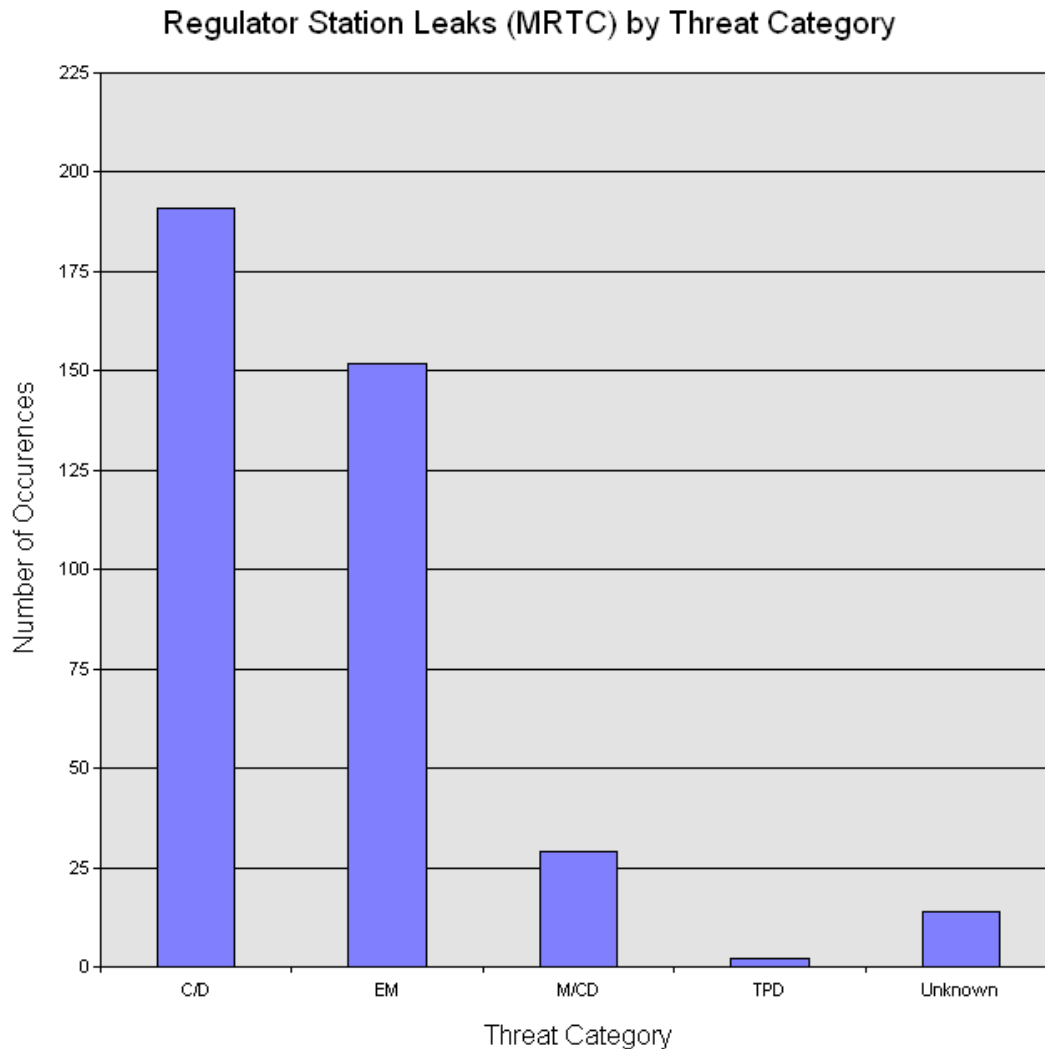
Figure 4.6.3: Regulator Station Estimated Leaks by Threat Category.

Each of the leaks was assigned to a threat category to attempt to establish any trends in failures. The data is formatted this way to be incorporated into the Summary of Threats in Section 5.0.
