# **Appendix A - Material Capital Projects**

# Appendix A – Material Capital Expenditure Projects

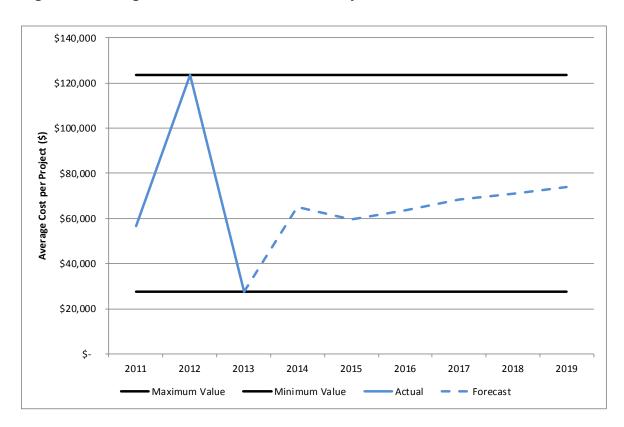
- Horizon Utilities' investment requirements for the 2015 Test Year are based upon the volume and scope of known road relocation projects. The 2016 to 2019 Test Year investment requirement is based on a forecast of 25 projects annually. 25 projects is the average annual number of road relocation projects based on the 2011 to 2013 actuals and the 2014 to 2015 forecasts. The average annual project cost used to determine the 2016 to 2019 Test Year investment requirements, relative to the maximum and minimum average annual project costs, is illustrated in Figure 1 below.

# Figure 1 - Average Annual Road Relocation Project Cost

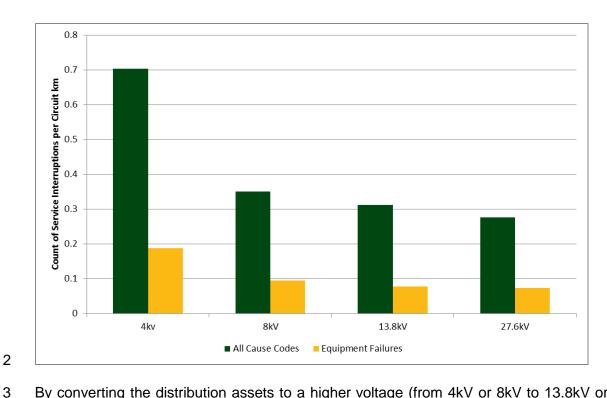
The assets at end of life can be illustrated through two key measurements: the volume of conductor having a Health Index of "very poor" or "poor"; and the rate of service interruptions experienced by customers served by the 4kV distribution system. The 4kV distribution system contains 82% (over 200km) of the total overhead conductor in Horizon Utilities' distribution system with a health index of poor or very poor. Customers serviced by 4kV distribution system experience a disproportionally high outage rate when compared to the other distribution systems. As illustrated in Figure 2 below, the 4kV distribution system experienced 225% and 254% more outages per circuit km than the 13.8kV and 27.6kV distribution systems respectively for outages caused by all cause codes over the four year period from 2010 to 2013. When considering only outages caused by equipment failures over this same period, the 4kV distribution system experienced 240% and 256% more outages per circuit km than the 13.8kV and 27.6kV distribution systems respectively.

# Figure 2 – Service Interruptions per Circuit km

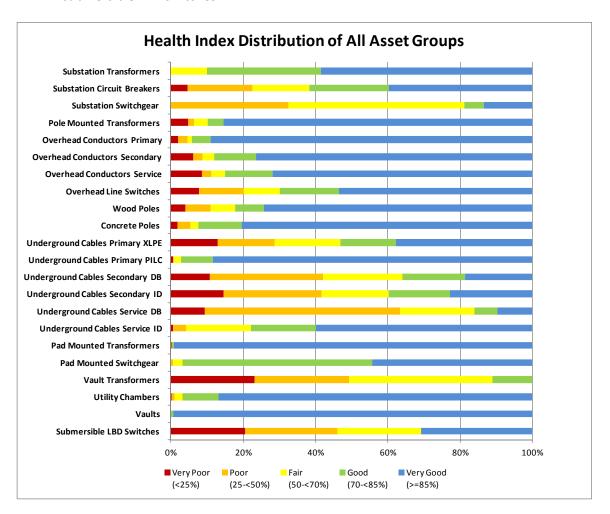
Figure 1 shows a graphical summary of the Health Index evaluation results. It is seen from the summary that based on their derived condition the assets with at least 20% of the units in "very poor" or "poor" condition are:

- substation circuit breakers
- substation switchgear
- overhead line switches
- underground XLPE primary, secondary and direct buried service cables
- vault transformers
- submersible LBD switches

Figure 1 Visual Summary of Health Index Results

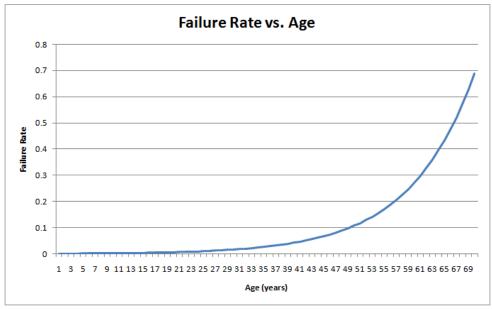
$$P_f(t) = 1 - e^{-(e^{\beta(t-\alpha)} - e^{\alpha\beta})/\beta} = 1 - e^{-(e^{0.093(t-74)} - e^{-6.882})/0.093}$$

The failure rate and probability of failure graphs are as shown:

Figure II-1 Failure Rate vs. Age

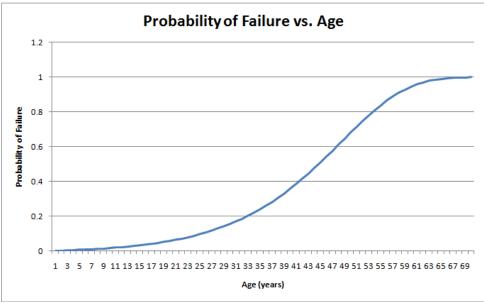
Figure II-2 Probability of Failure vs. Age

The probability of failure associated with a specific Health Index can be found using the Probability of Failure vs. Health Index (Figure II-4) and Probability of Failure vs. Age (Figure II-2). The probability of failure at a particular Health Index can be found from Figure II-4. The same probability of failure is located on Figure II-2, and the effective age is on the horizontal axis of Figure II-2. See example on the Figure II-5 below where a Health Index of 60% corresponds to an effective age of 35 years.

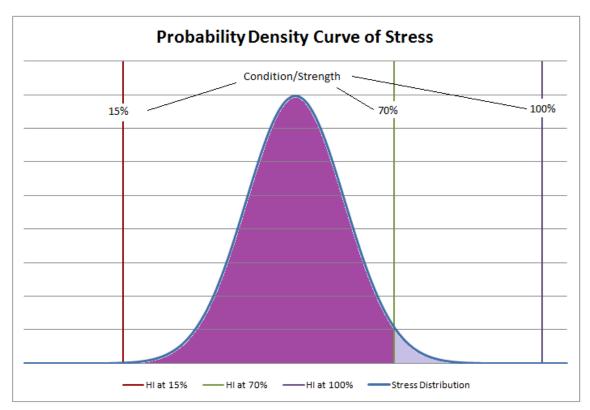
Failure of an asset occurs when the stress to which an asset is exposed exceeds its strength. Assuming that stress is not constant, and that stress is normally distributed, the probability of stress exceeding asset strength leads to the probability of failure. This is illustrated in the figure below. A vertical line represents condition or strength (Health Index) and the area under the curve to the right of the Health Index line represents the probability of failure.

Figure II-3 Stress Curve

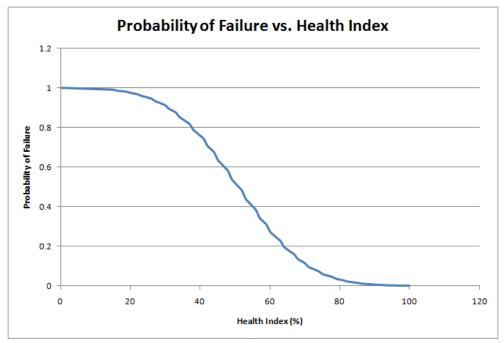
Two points of Health Index and probability of failure are needed to generate the probability of failure at other Health Index values. A Health Index of 100% represents an asset that is in brand new condition and a Health Index of 15% represents the asset's end of life. The 100% and 15% conditions are plotted on the stress curve by finding the points at which the areas under the stress curve are equal to  $P_{f\,100\%}$  (age at 100% Health Index) and  $P_{f\,15\%} = P_f$  (age at 15% Health Index). By moving the vertical line left from 100% to 15%, the probabilities of failure for other Health Indices can be found.

The probability of failure at a particular Health Index is found from plotting the Health Index on the X-axis and the area under the probability density curve to the right of the Health Index line on the Y-axis as shown on the graph of the figure below.

Figure II-4 Probability of Failure vs. Health Index

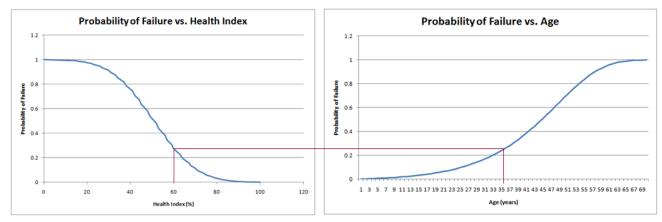
Figure II-5 Effective Age

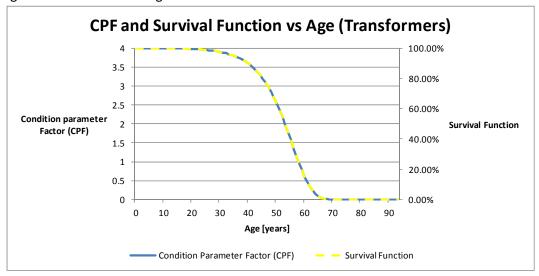
Assuming that at the ages of 45 and 60 years the probability of failures ( $P_f$ ) for this asset are 20% and 85% respectively results in the survival curve shown below. It follows that the CPF for Age is the survival curve normalized to the maximum CPF score of 4 (i.e. 4\*Survival Curve). The CPF vs. Age is also shown in the figure below.

Figure 1-1 Substation Transformers Age Condition Criteria

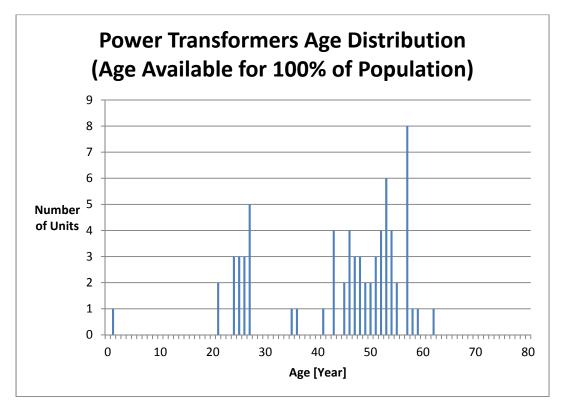
The age distribution is shown in the figure below. Age was available for 100% of the population. The average age was found to be 44 years.

Figure 1-2 Substation Transformers Age Distribution

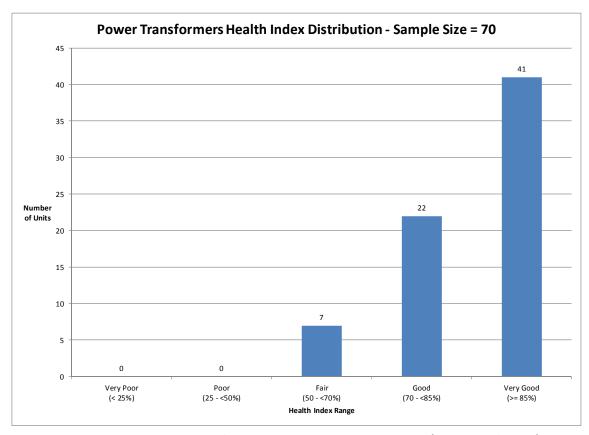
The average Health Index for this asset group is 86%. None of the units were found to be in poor condition.

The Health Index Distribution is shown in Figure 1-3 and Figure 1-4.

Figure 1-3 Substation Transformers Health Index Distribution (Number of Units)

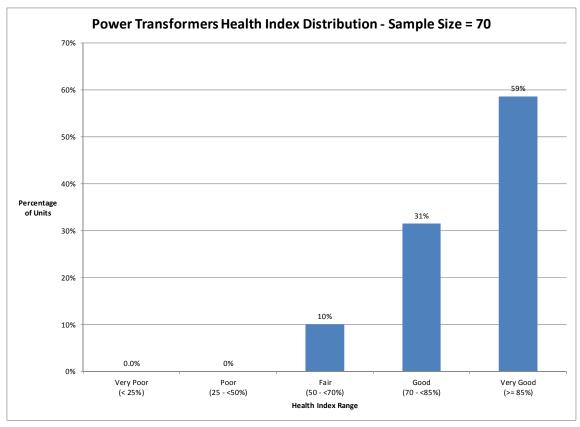
Figure 1-4 Substation Transformers Health Index Distribution (Percentage of Units) The detailed results, from lowest to highest Health Index are shown in section VII.

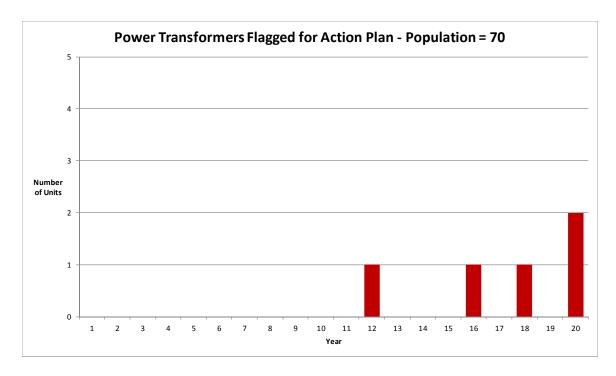
The following diagram shows the flagged for action plan in the next 20 years.

Figure 1-5 Substation Transformers Condition-Based Flagged-For-Action Plan

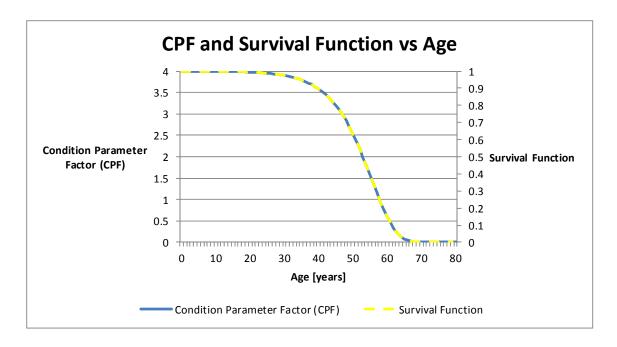
Assuming that at the ages of 45 and 60 years the probabilities of failure ( $P_f$ ) are 20% and 85% result in the survival curves shown below. It follows that the CPF for Age is the survival curve normalized to the maximum CPF score of 4 (i.e. 4\*Survival Curve). The CPF vs. Age is also shown in the figure below.

Figure 2-1 CPF and Survival Function vs. Age (Circuit Breakers)

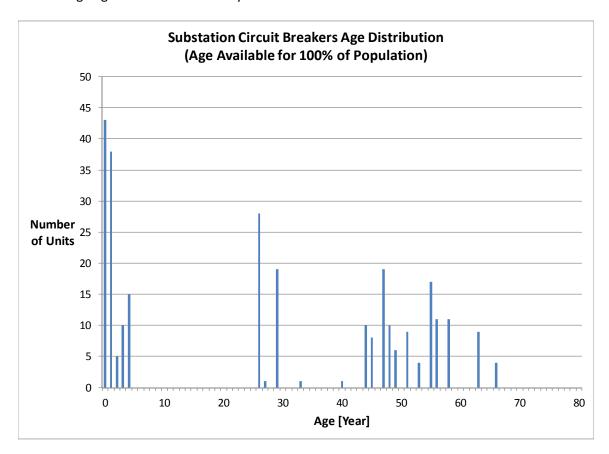
The age distribution is shown in the figure below. Age was available for 100% of the population. The average age was found to be 28 years.

Figure 2-2 Substation Circuit Breakers Age Distribution

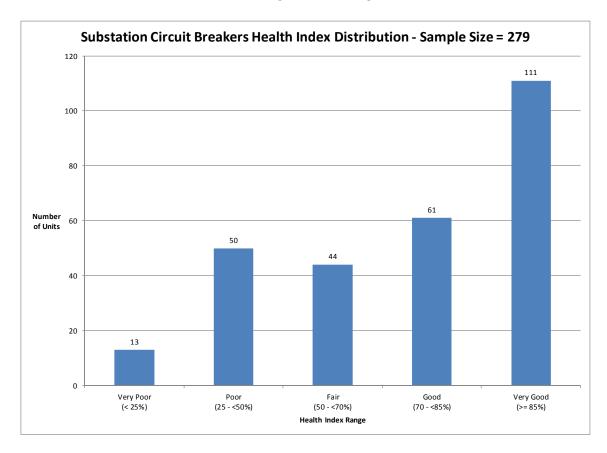
The average Health Index for this asset group is 77%. Approximately 23% of the units were found to be in poor or very poor condition.

Figure 2-3 Substation Circuit Breakers Health Index Distribution (Number of Units)

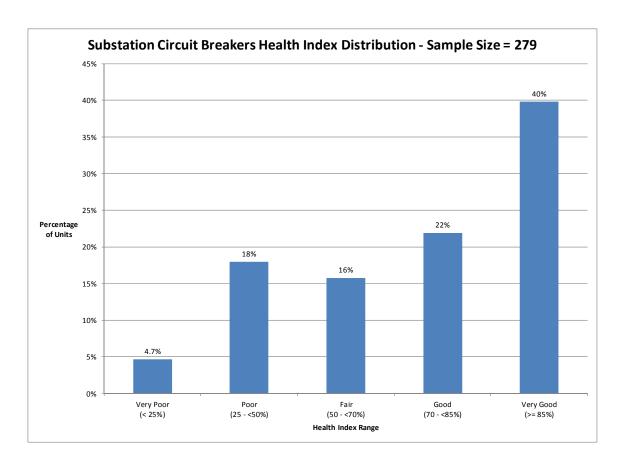
Figure 2-4 Substation Circuit Breakers Health Index Distribution (Percentage of Units)

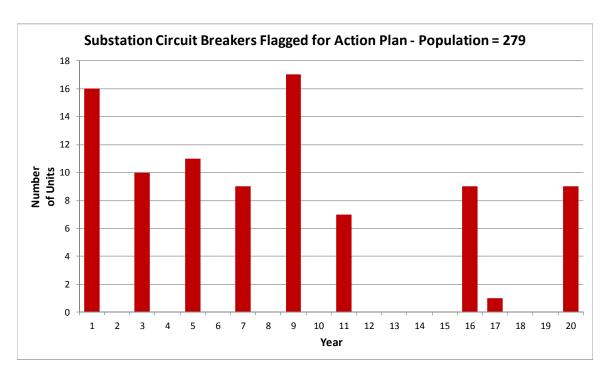
The condition-based Flagged-For-Action Plan for Substation Circuit Breakers is plotted in Figure 2-5.

Figure 2-5 Substation Circuit Breakers Condition-Based Flagged-For-Action Plan

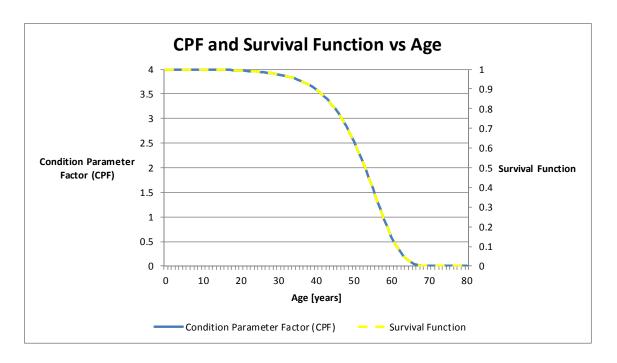
Assuming that at the ages of 45 and 60 years the probabilities of failure ( $P_f$ ) are 20% and 85% result in the survival curves shown below. It follows that the CPF for Age is the survival curve normalized to the maximum CPF score of 4 (i.e. 4\*Survival Curve). The CPF vs. Age is also shown in the figure below.

Figure 3-1 CPF and Survival Function vs. Age (Station Switchgear)

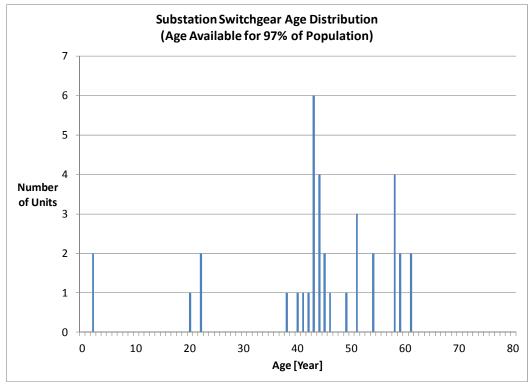
The age distribution is shown in the figure below. Age was available for 97% of the population. The average age was found to be 44 years.

Figure 3-2 Substation Switchgear Age Distribution

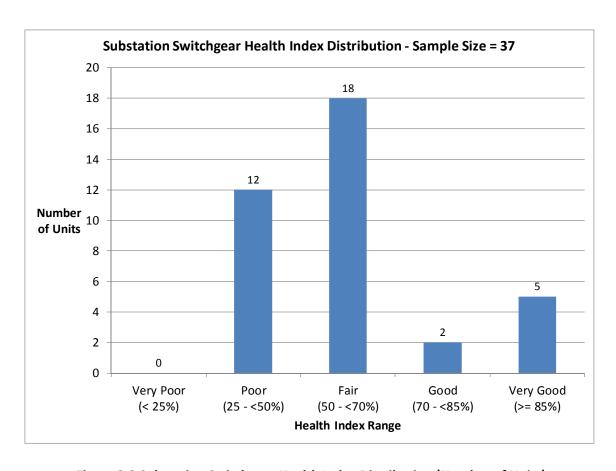
The average Health Index for this asset group is 59%. None of the units were in very poor condition. Approximately 32% of the units were found to be in poor condition.

The Health Index Distribution is shown in Figure 3-3 and Figure 3-4.

Figure 3-3 Substation Switchgear Health Index Distribution (Number of Units)

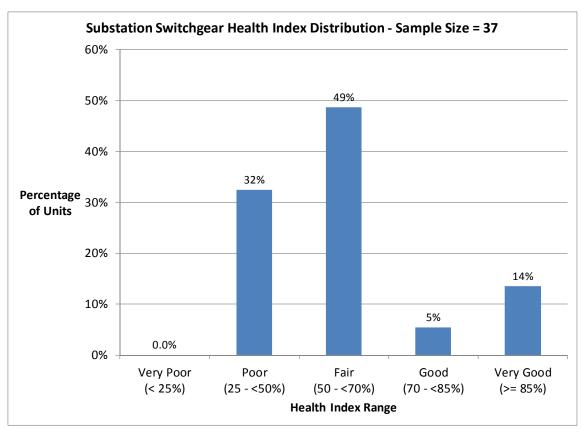
Figure 3-4 Substation Switchgear Health Index Distribution (Percentage of Units)

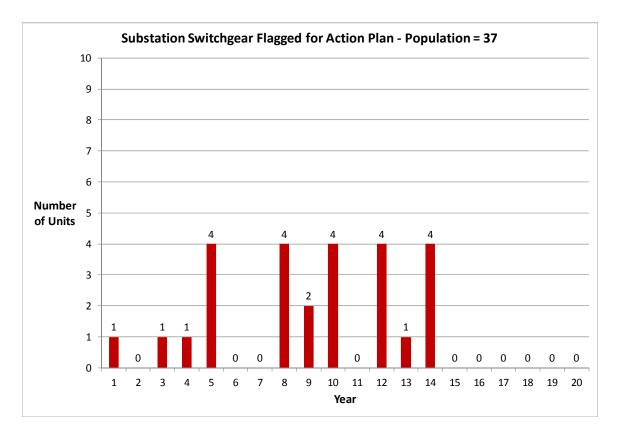
As it is assumed that Substation Switchgear is proactively replaced, the risk assessment and replacement procedure described in Section II.2.3 was applied for this asset class based on Health Index only, i.e. not including criticality assessment.

The Flagged-For-Action Plan is based on the years when the Health Index based probability of failure reaches 80% for asset units. In this case, the number refers to the bus-section assembly, which consists of multiple switch cells or cabinets. The following diagram shows such a flagged-for-action plan.

Figure 3-5 Substation Switchgear Condition-Based Flagged-For-Action Plan

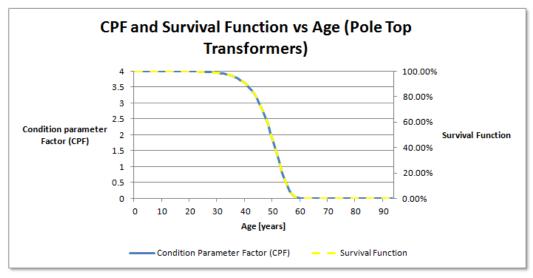
Assuming that at the ages of 40 and 55 years the probability of failure ( $P_f$ ) for this asset are 10% and 90% respectively results in the survival curve shown below. It follows that the CPF for Age is the survival curve normalized to the maximum CPF score of 4 (i.e. 4\*Survival Curve). The CPF vs. Age is also shown in the figure below:

Figure 4-1 Age Condition Criteria (Pole Top Transformers)

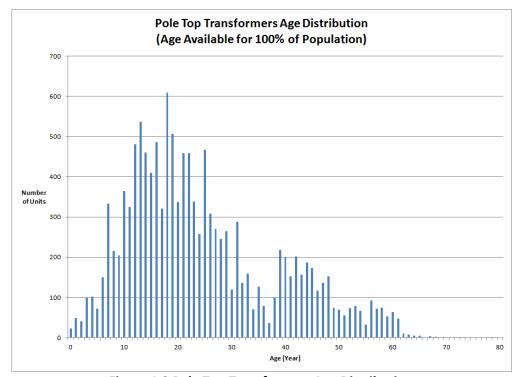
The age distribution is shown in the figure below. Age was available for 100% of the population. The average age was found to be 24 years.

Figure 4-2 Pole Top Transformers Age Distribution

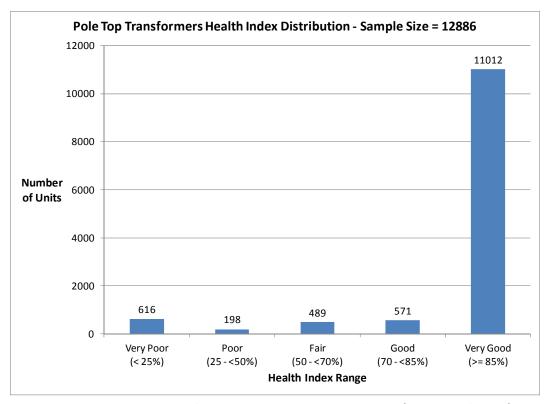
The average Health Index for this asset group is 91%. About 6% of the units were found to be in poor or very poor condition.

Figure 4-3 Pole Top Transformers Health Index Distribution (Number of Units)

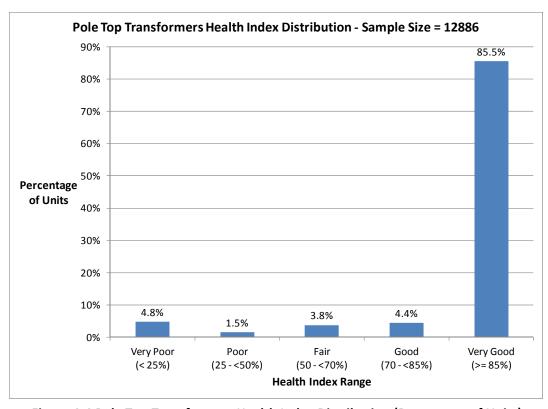
Figure 4-4 Pole Top Transformers Health Index Distribution (Percentage of Units)

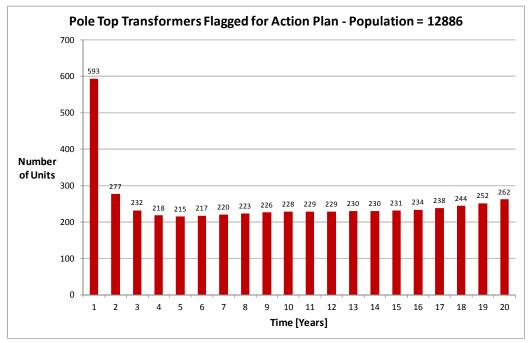
As it is assumed that Pole Top Transformers are reactively replaced, the Flagged-For-Action Plan is based on asset failure rate f (t), as described in Section II.2.2.

The Flagged-For-Action Plan is based on the number of expected failures in a given year.

Figure 4-5 Pole Top Transformers Condition-Based Flagged-For-Action Plan

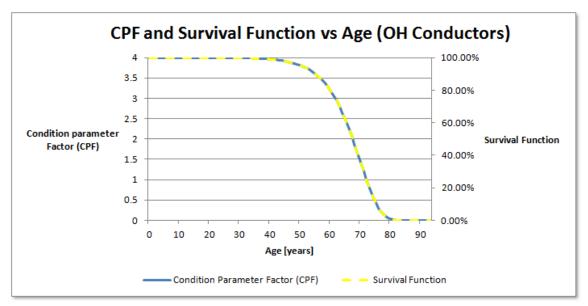
$S_f$  = survivor function  $P_f$  = probability of failure Assuming that for primary/secondary/service overhead conductors, at the ages of 60 and 77 years the probability of failure ( $P_f$ ) for this asset are 20% and 95% respectively results in the survival curve shown below. It follows that the CPF for Age is the survival curve normalized to the maximum CPF score of 4 (i.e. 4\*Survival Curve). The CPF vs. Age is also shown in the figure below:

Figure 5-1 Overhead Conductors Age Condition Criteria

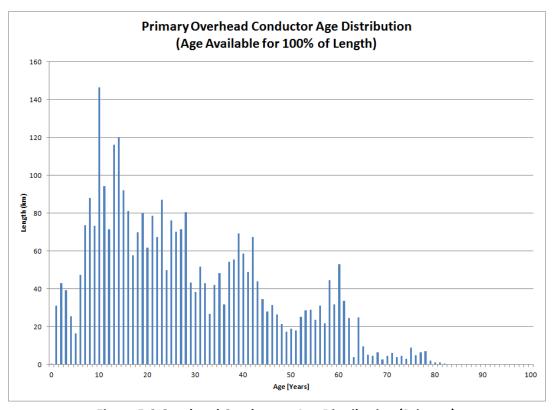
Figure 5-2 Overhead Conductors Age Distribution (Primary)

The age distribution is shown in the figures below. Age was available for 100% of the population. The average age was found to be 28, 38 and 40, for primary, secondary and service overhead conductors respectively.

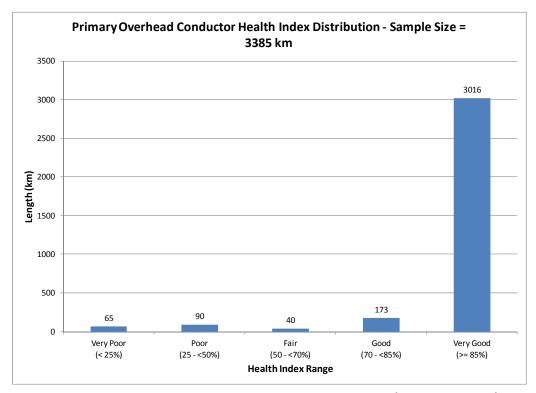
Figure 5-5 Overhead Conductors Health Index Distribution (Length, Primary)

There are 3385 km, 2196 km and 1897 km in-service Overhead Conductors at Horizon Utilities, for primary, secondary and service systems respectively. The condition assessment is mainly age-driven, together with de-rating based on #6 copper conductor type for primary conductors only.

The average Health Index for this asset group is 90%, 86% and 84% for primary, secondary and service systems respectively.

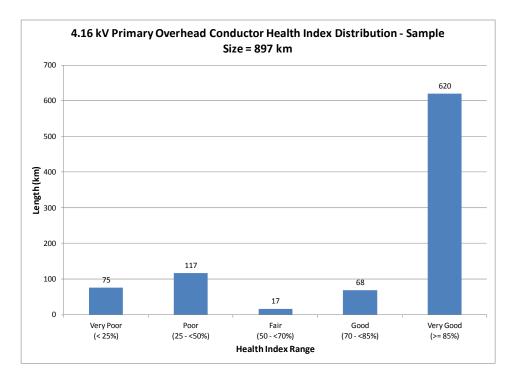
Figure 5-11 Overhead Conductors Health Index - Primary 4.16 kV

The following diagrams show the primary Overhead Conductors Health Index distribution by different voltage levels.

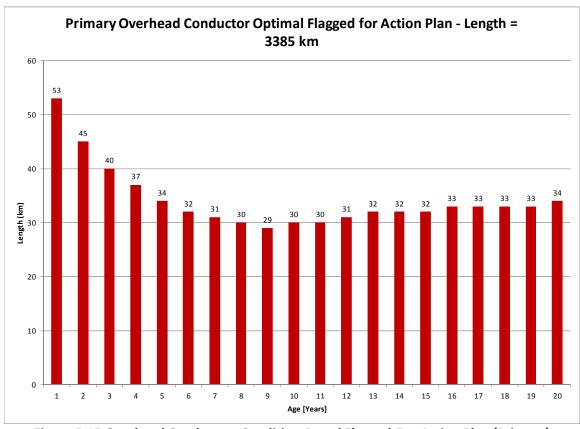
Figure 5-15 Overhead Conductors Condition-Based Flagged-For-Action Plan (Primary)

As it is assumed that Overhead Conductors are reactively replaced, the Flagged-For-Action Plan is based on asset failure rate f (t), as described in Section II.2.2.

The optimal Flagged-For-Action Plan is based on the number of expected failures in a given year.

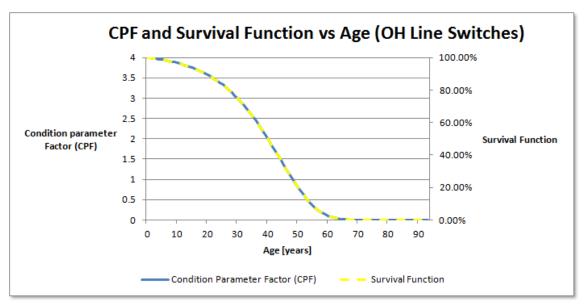
Figure 6-1 Overhead Line Switches Age Condition Criteria (Overhead Line Switches)

Assuming that at the ages of 40 and 50 years the probability of failure ( $P_f$ ) for this asset are 50% and 80% respectively results in the survival curve shown below. It follows that the CPF for Age is the survival curve normalized to the maximum CPF score of 4 (i.e. 4\*Survival Curve). The CPF vs. Age is also shown in the figure below:

| n | Sub-Condition Parameter | CPF Lookup<br>table | WCPF <sub>n</sub> | CPF <sub>n.max</sub> |
|---|---|---|---|---|
| 1 | Age | Figure 6-1 | 1 | 4 |

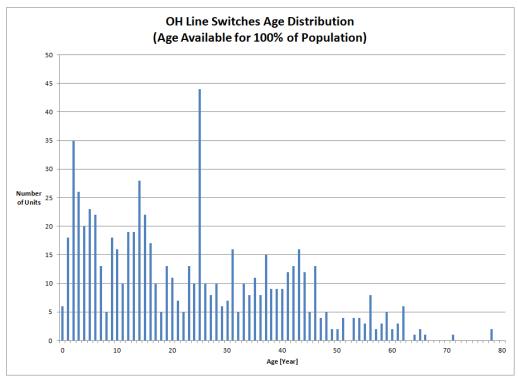
Figure 6-2 Overhead Line Switches Age Distribution

The age distribution is shown in the figure below. Age was available for 100% of the population. The average age was found to be 26 years.

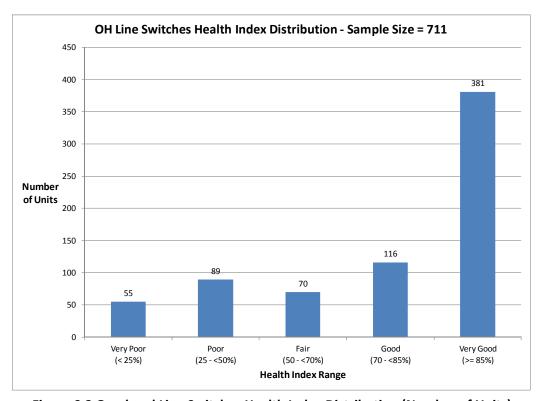
Figure 6-3 Overhead Line Switches Health Index Distribution (Number of Units)

There are 712 in-service Overhead Line Switches at Horizon Utilities. The condition assessment is age-driven.

The average Health Index for this asset group is 76%. Approximately 20% of the units were found to be in poor or very poor condition.

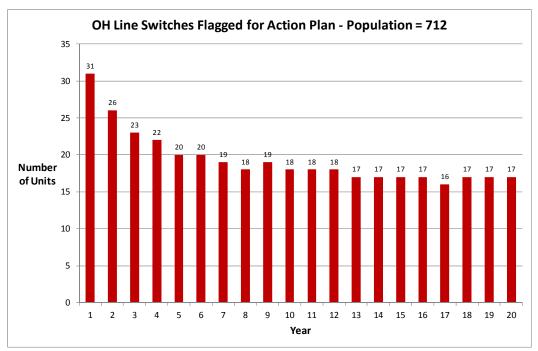
Figure 6-5 Overhead Line Switches Condition-Based Flagged-For-Action Plan

As it is assumed that Overhead Line Switches are reactively replaced, the Flagged-For-Action Plan is based on asset failure rate f (t), as described in Section II.2.2.

The Flagged-For-Action Plan is based on the number of expected failures in a given year.

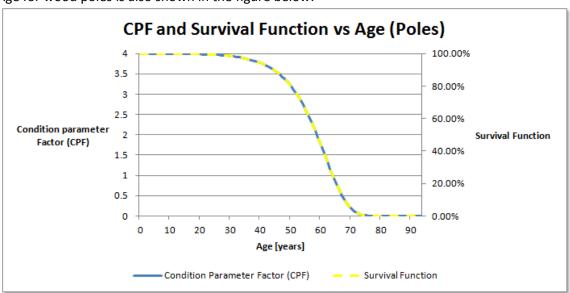
Figure 7-1 Wood Pole Age Condition Criteria (Wood Poles)

Assuming that at the ages of 50 and 65 years the probability of failures ( $P_f$ ) for this asset are 20% and 80% respectively results in the survival curve shown below. It follows that the CPF for Age is the survival curve normalized to the maximum CPF score of 4 (i.e. 4\*Survival Curve). The CPF vs. Age for wood poles is also shown in the figure below:

| n | Sub-Condition<br>Parameter | CPF Lookup table | WCPF <sub>n</sub> | CPF <sub>n.max</sub> |
|---|---|---|---|---|
| 1 | Age | Figure 7-1 | 2 | 4 |

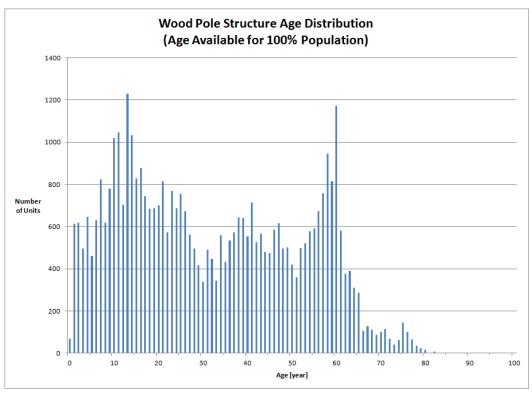
Figure 7-2 Wood Poles Age Distribution

The age distribution is shown in the figure below. Age was available for all the population. The average age was found to be 32 years.

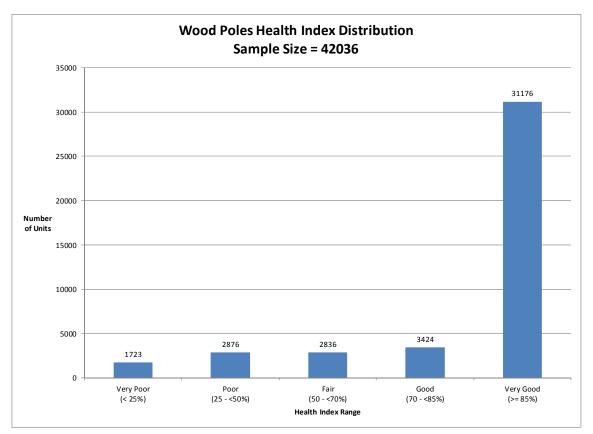
Figure 7-3 Wood Poles Health Index Distribution (Number of Units)

The average Health Index for this asset group is 86%. Approximately 11% of the units were found to be in poor or very poor condition.

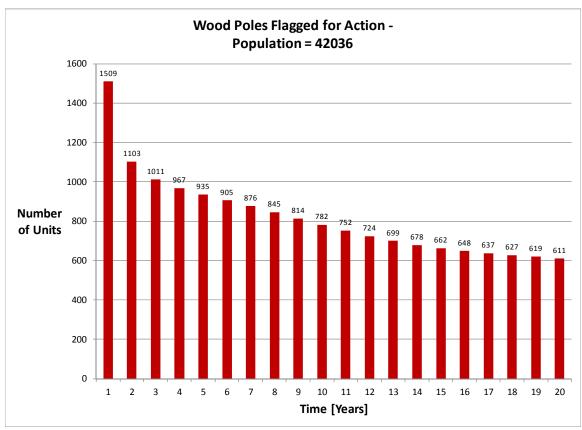
Figure 7-5 Wood Poles Condition-Based Flagged-For-Action Plan

As it is assumed that Wood Poles are reactively replaced, the Flagged-For-Action Plan is based on asset failure rate f (t), as described in Section II.2.2.

The Flagged-For-Action Plan is based on the number of expected failures in a given year.

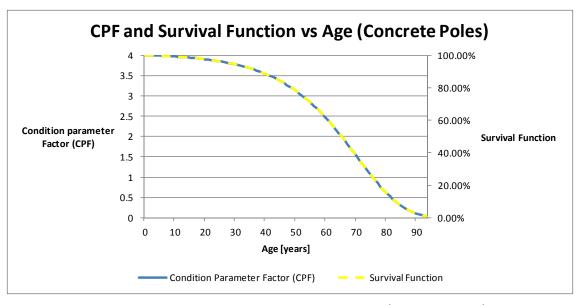
Figure 8-1 Concrete Pole Age Condition Criteria (Concrete Poles)

Assuming that at the ages of 65 and 80 years the probability of failures (Pf) for this asset are 50% and 85% respectively results in the survival curve shown below. It follows that the CPF for Age is the survival curve normalized to the maximum CPF score of 4 (i.e. 4\*Survival Curve). The CPF vs. Age for concrete poles is also shown in the figure below:

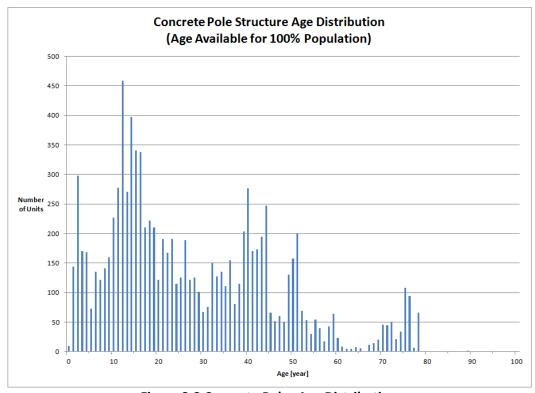
Figure 8-2 Concrete Poles Age Distribution

The age distribution is shown in the figure below. Age was available for all the population. The average age was found to be 27 years.

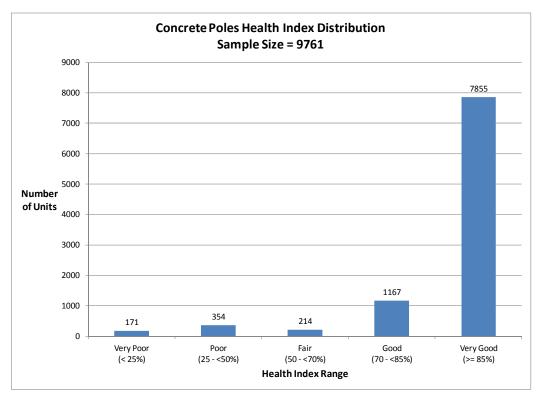
Figure 8-3 Concrete Poles Health Index Distribution (Number of Units)

The average Health Index for this asset group is 90%. Approximately 31% of the units were found to be in poor or very poor condition.

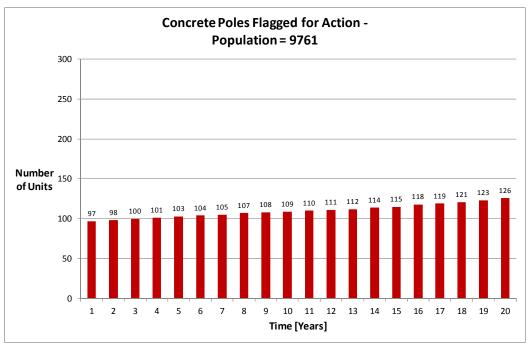
Figure 8-5 Concrete Poles Condition-Based Flagged-For-Action Plan

As it is assumed that Concrete Poles are proactively replaced, the Flagged-For-Action Plan is based on asset failure rate f (t), as described in Section II.2.2.

The Flagged-For-Action Plan is based on the number of expected failures in a given year.

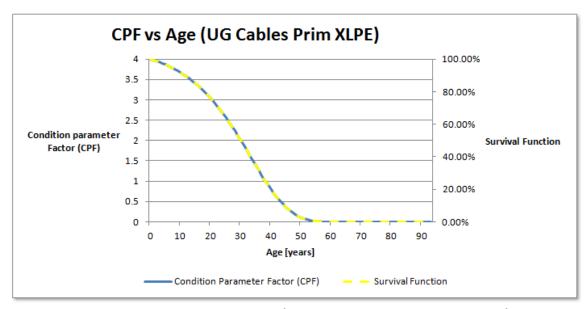
Figure 9-1 Age Condition Criteria (Underground Cables – Primary XLPE)

Assuming that at the ages of 30 and 40 years the probability of failures ( $P_f$ ) for this asset are 50% and 80% respectively results in the survival curve shown below. It follows that the CPF for Age is the survival curve normalized to the maximum CPF score of 4 (i.e. 4\*Survival Curve). The CPF vs. Age is also shown in the figure below:

| n | Sub-Condition<br>Parameter | CPF Lookup table | WCPF <sub>n</sub> | CPF <sub>n.max</sub> |
|---|---|---|---|---|
| 1 | Age | Figure 9-1 to Figure 9-3 | 1 | 4 |

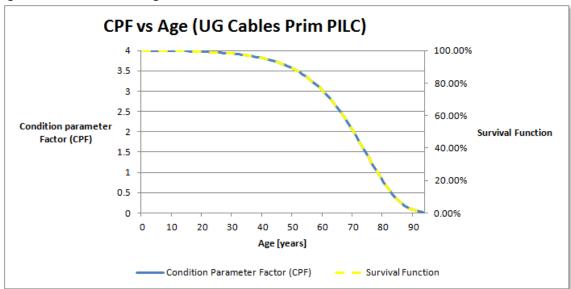
Figure 9-2 Age Condition Criteria (Underground Cables – Primary PILC)

Assuming that at the ages of 60 and 70 years the probability of failures ( $P_f$ ) for this asset are 25% and 50% respectively results in the survival curve shown below. It follows that the CPF for Age is the survival curve normalized to the maximum CPF score of 4 (i.e. 4\*Survival Curve). The CPF vs. Age is also shown in the figure below:

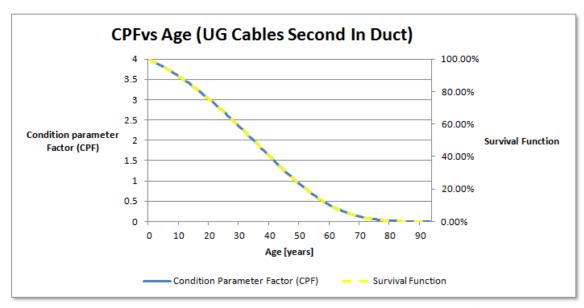
Figure 9-3 Age Condition Criteria (Underground Cables – Secondary/Service)

Assuming that at the ages of 40 and 60 years the probability of failures ( $P_f$ ) for this asset are 60% and 90% respectively results in the survival curve shown below. It follows that the CPF for Age is

the survival curve normalized to the maximum CPF score of 4 (i.e. 4\*Survival Curve). The CPF vs. Age is also shown in the figure below:

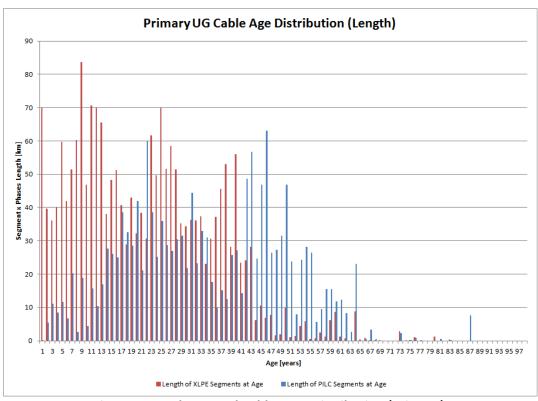
Figure 9-4 Underground Cables Age Distribution (Primary)

The age distribution is shown in the figures below. Age was available for 100% of the population. The average age was found to be 22 and 34 years, for primary underground XLPE and PILC cables respectively. For both secondary underground direct buried and in-duct cables, the average age was found to be 29 years. For service underground direct buried and in-duct cables, the average age was found to be 33 and 13 years respectively.

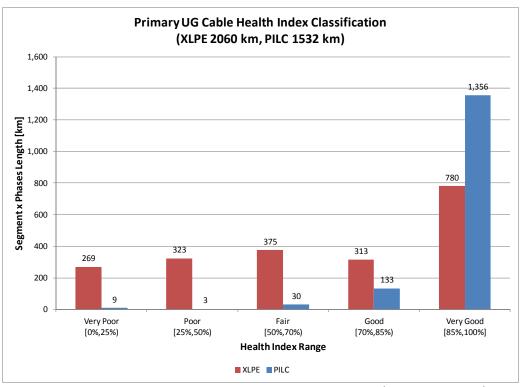
Figure 9-7 Underground Cables Health Index Distribution (Length, Primary)

There are 3592 km, 1290 km and 1035 km in-service Underground Cables at Horizon Utilities, for primary, secondary and service systems respectively. The condition assessment is mainly age-driven, together with some de-ratings based on locations and conductor types.

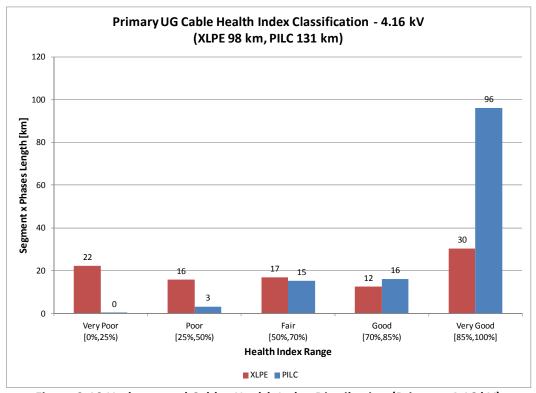
Figure 9-10 Underground Cables Health Index Distribution (Primary, 4.16 kV)

The following diagrams show the primary UG cables health index at different voltage level.

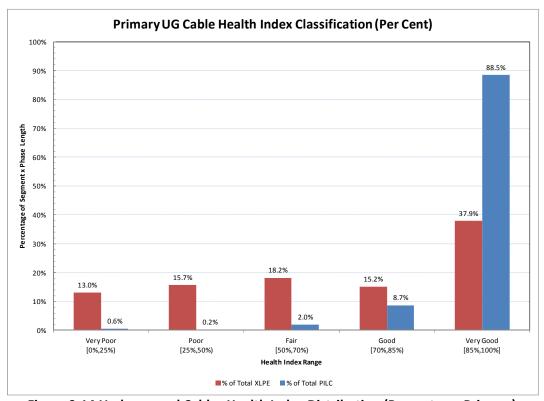
Figure 9-14 Underground Cables Health Index Distribution (Percentage, Primary)

The following diagrams show the percentage health index distribution.

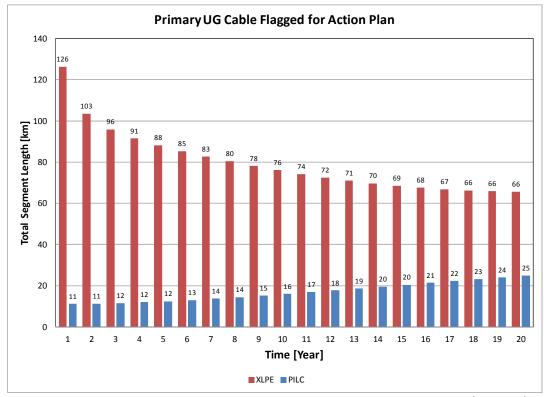
Figure 9-17 Underground Cables Condition-Based Flagged-For-Action Plan (Primary)

As it is assumed that primary Underground Cables are proactively replaced while secondary and service cable is primary replaced reactively. The Flagged-For-Action Plan is based on asset failure rate f (t), as described in Section II.2.2.

The optimal Flagged-For-Action Plan is based on the number of expected failures in a given year.

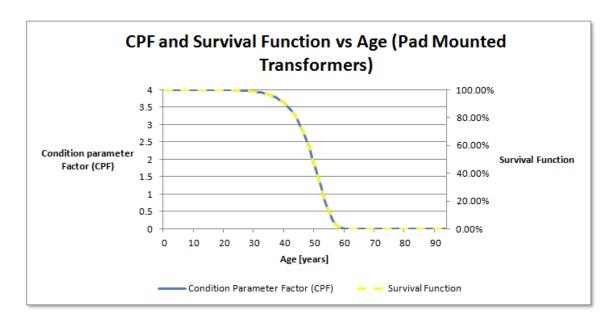
Figure 10-1 Age Condition Criteria (Pad-Mounted Transformers)

Assuming that at the ages of 40 and 55 years the probability of failure ( $P_f$ ) for this asset are 10% and 90% respectively results in the survival curve shown below. It follows that the CPF for Age is the survival curve normalized to the maximum CPF score of 4 (i.e. 4\*Survival Curve). The CPF vs. Age is also shown in the figure below:

| n | Sub-Condition<br>Parameter | CPF Lookup Table | WCPF <sub>n</sub> | CPF <sub>n.max</sub> |
|---|---|---|---|---|
| 2 | Age | Figure 10-1 | 2 | 4 |

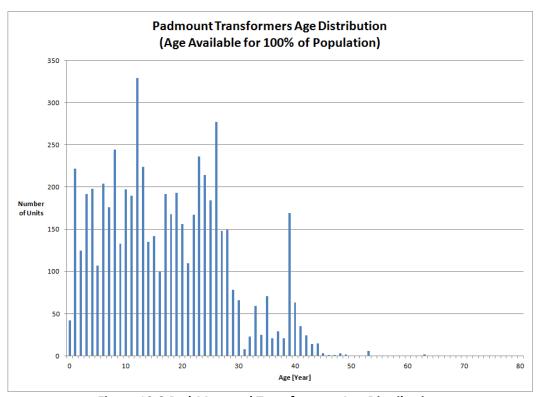
Figure 10-2 Pad-Mounted Transformers Age Distribution

The age distribution is shown in the figure below. Age was available for the entire population. The average age was found to be 17 years.

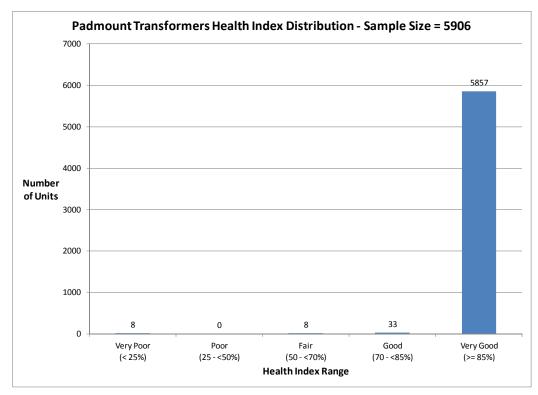
Figure 10-3 Pad-Mounted Transformers Health Index Distribution (Number of Units)

There are 5906 in-service Pad-Mounted Transformers at Horizon Utilities. The condition assessment is based on age, together with overloading condition calculated using hourly data obtained from Horizon Utilities Smart Meters.

The average Health Index for this asset group is 99%. Less than 1% of the units were found to be in poor or very poor condition.

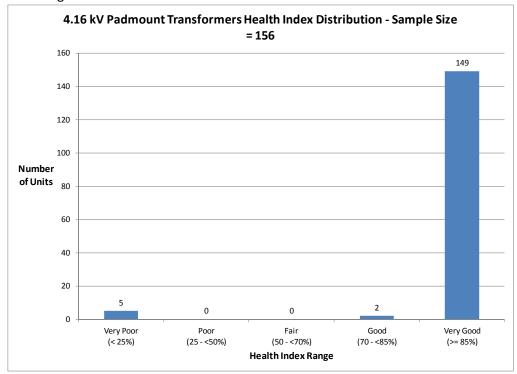
Figure 10-5 Pad-Mounted Transformers Health Index Distribution – 4.16 kV

The following diagrams show the Pad-Mounted Transformers Health Index distribution by different voltage levels.

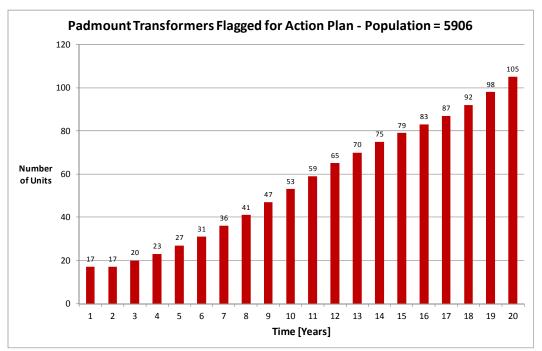
Figure 10-9 Pad-Mounted Transformers Condition-Based Flagged-For-Action Plan

As it is assumed that Pad-Mounted Transformers are reactively replaced, the Flagged-For-Action Plan is based on asset failure rate, f (t), as described in Section II.2.2.

The Flagged-For-Action Plan is based on the number of expected failures in a given year.

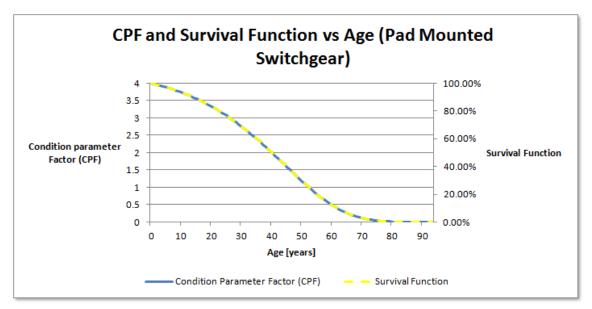
Figure 11-1 Age Criteria (Pad Mounted Switchgear)

$S_f$  = survivor function  $P_f$  = probability of failure Assuming that at the ages of 40 and 55 years the probability of failures ( $P_f$ ) for this asset are 50% and 80% respectively results in the survival curve shown below. It follows that the Score for Age is the survival curve normalized to the maximum Score of 4 (i.e. 4\*Survival Curve). The Score vs. Age is also shown in the figure below.

| n | Sub-Condition Parameter | WCPF <sub>n</sub> | Condition Criteria Table |
|---|---|---|---|
| 2 | Age | 2 | Figure 11-1 |

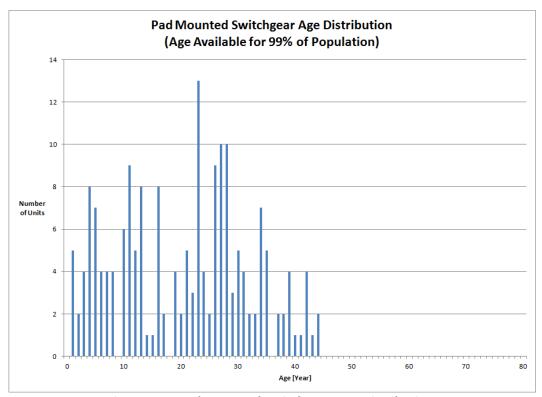
Figure 11-2 Pad Mounted Switchgear Age Distribution

The age distribution is shown in the figure below. Age was available for the entire population. The average age was found to be 23 years.

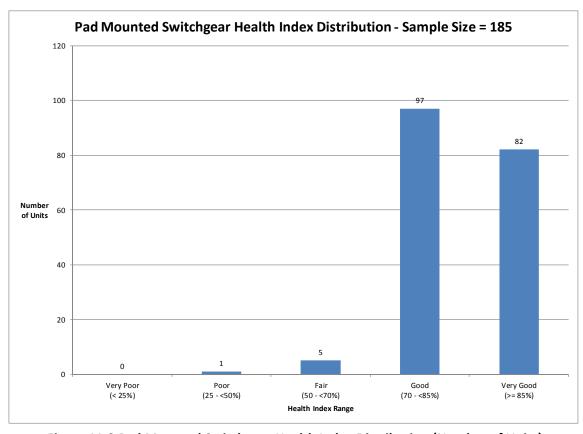
Figure 11-3 Pad Mounted Switchgear Health Index Distribution (Number of Units)

The average Health Index for this asset group is 77%. Approximately 4% of the units were found to be in poor condition.

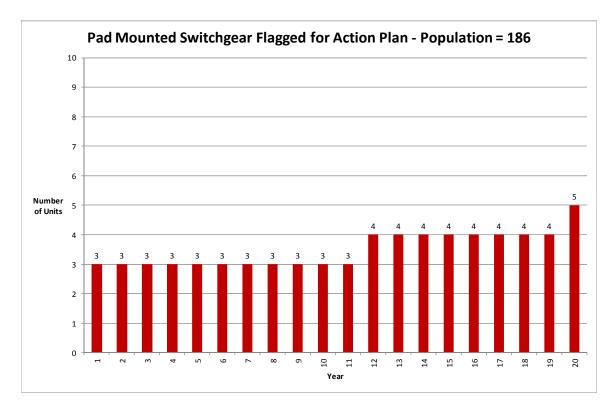
Figure 11-5 Pad Mounted Switchgear Optimal Condition-Based Flagged-For-Action Plan

As it is assumed that Pad Mounted Switchgear is reactively replaced, the risk assessment and replacement procedure described in Section II.2.2 was applied for this asset class.

The optimal Flagged-For-Action Plan is based on the number of expected failures in a given year.

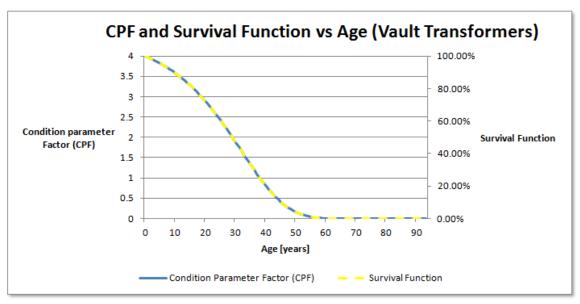
Figure 12-1 Age Condition Criteria (Vault Transformers)

Assuming that at the ages of 40 and 45 years the probability of failure ( $P_f$ ) for this asset are 80% and 90% respectively results in the survival curve shown below. It follows that the CPF for Age is the survival curve normalized to the maximum CPF score of 4 (i.e. 4\*Survival Curve). The CPF vs. Age is also shown in the figure below:

| n | Sub-Condition<br>Parameter | CPF Lookup Table | WCPF <sub>n</sub> | CPF <sub>n.max</sub> |
|---|---|---|---|---|
| 2 | Age | Figure 12-1 | 2 | 4 |

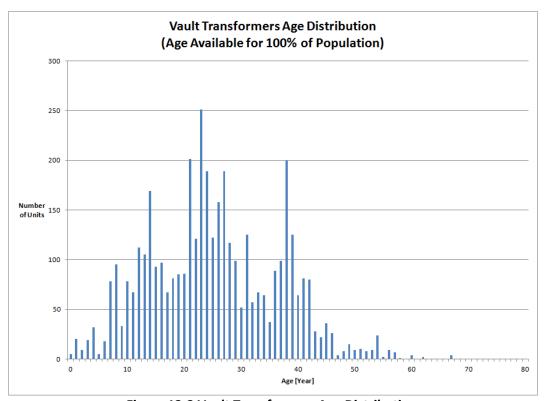
Figure 12-2 Vault Transformers Age Distribution

The age distribution is shown in the figure below. Age was available for 100% of the population. The average age was found to be 25 years.

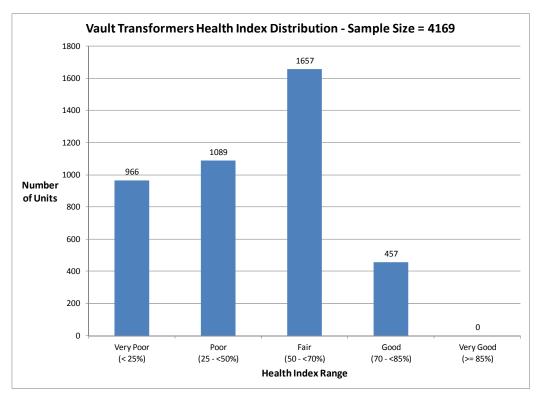
Figure 12-3 Vault Transformers Health Index Distribution (Number of Units)

The average Health Index for this asset group is 46%. Approximately 20% of the units were found to be in poor or very poor condition due mainly to the de-rating factor applied.

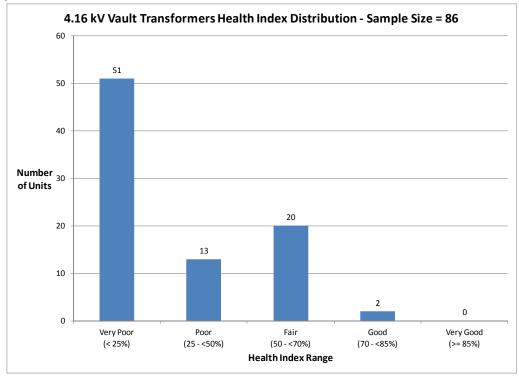
Figure 12-5 Vault Transformers Health Index Distribution – 4.16 kV

The following diagrams show the Vault Transformers Health Index distribution by different voltage levels.

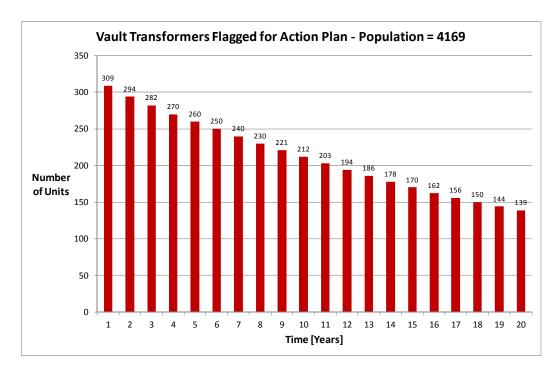
Figure 12-9 Vault Transformers Condition-Based Flagged-For-Action Plan

As it is assumed that Vault Transformers are reactively replaced, the Flagged-For-Action Plan is based on asset failure rate f (t), as described in Section II.2.2.

The Flagged-For-Action Plan is based on the number of expected failures in a given year.

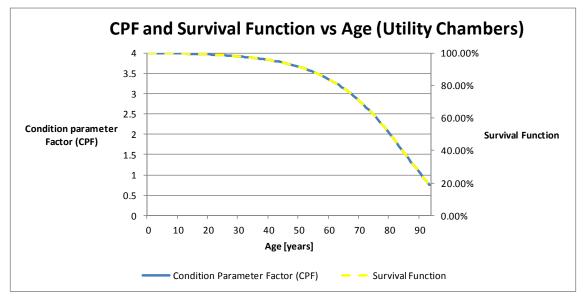
Figure 13-1 Age Condition Criteria (Utility Chambers)

Assuming that at the ages of 80 and 95 years the probability of failure ( $P_f$ ) for this asset are 50% and 85% respectively results in the survival curve shown below. It follows that the CPF for Age is the survival curve normalized to the maximum CPF score of 4 (i.e. 4\*Survival Curve). The CPF vs. Age is also shown in the figure below:

| n | Sub-Condition Parameter | CPF Lookup<br>Table | WCPF <sub>n</sub> | CPF <sub>n.max</sub> |
|---|---|---|---|---|
| 2 | Age | Figure 13-1 | 2 | 4 |

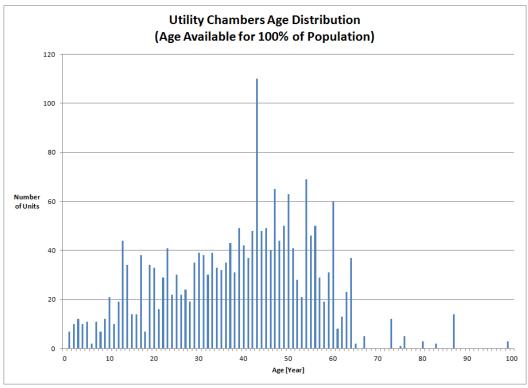
Figure 13-2 Utility Chambers Age Distribution

The age distribution is shown in the figure below. Age was available for 100% of the population. The average age was found to be 39 years.

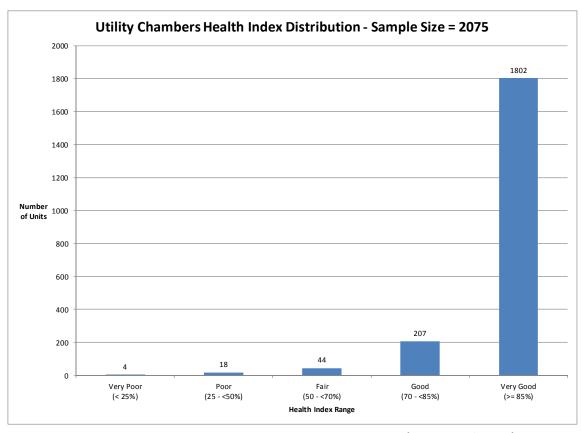
Figure 13-3 Utility Chambers Health Index Distribution (Number of Units)

The average Health Index for this asset group is 92%.

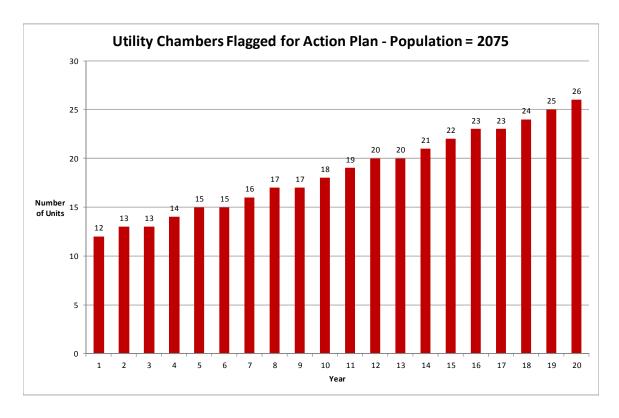
Figure 13-5 Utility Chambers Optimized Condition-Based Flagged-For-Action Plan

As it is assumed that Utility Chambers are reactively replaced, the Flagged-For-Action Plan is based on asset failure rate f (t), as described in Section II.2.2.

The Flagged-For-Action Plan is based on the number of expected failures in a given year.

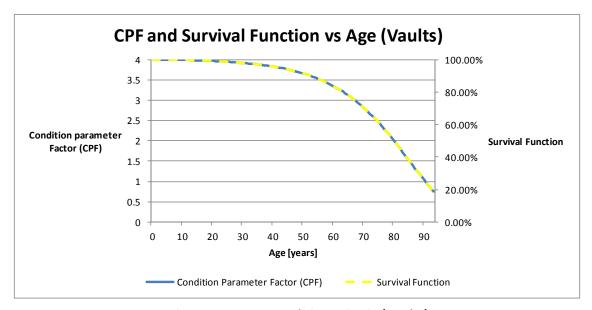
Figure 14-1 Age Condition Criteria (Vaults)

$S_f$  = survivor function  $P_f$  = probability of failure Assuming that at the ages of 80 and 95 years the probability of failure ( $P_f$ ) for this asset are 50% and 85% respectively results in the survival curve shown below. It follows that the CPF for Age is the survival curve normalized to the maximum CPF score of 4 (i.e. 4\*Survival Curve). The CPF vs. Age is also shown in the figure below:

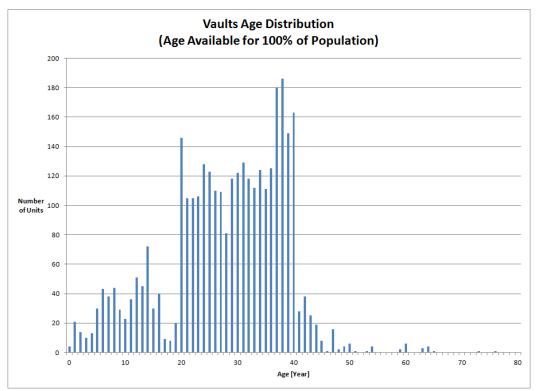
Figure 14-2 Vaults Age Distribution

The age distribution is shown in the figure below. Age was available for 100% of the population. The average age was found to be 28 years.
