# **Appendix A - Material Capital Projects**

# Appendix A – Material Capital Expenditure Projects

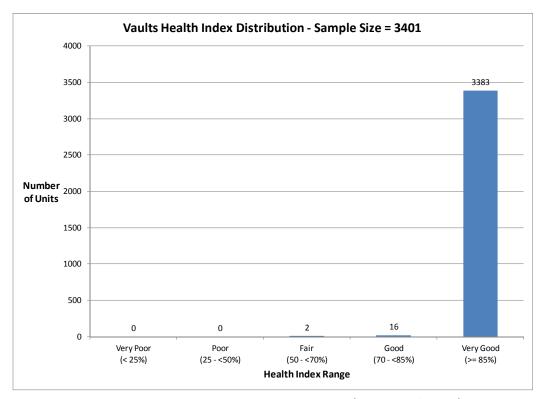
The average Health Index for this asset group is 97%. None of the units was found to be in poor or very poor condition.

The Health Index Results are as follows:

| Figure 11-5 Pad Mounted Switchgear Optimal Condition-Based Flagged-For-Action Plan | . 149 |
|---|---|
| Figure 14-3 Vaults Health Index Distribution (Number of Units) | . 172 |

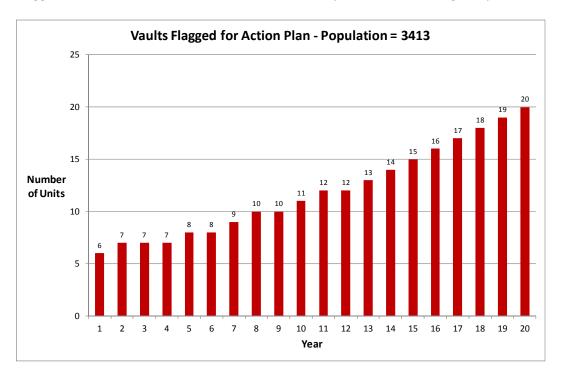
As it is assumed that Vaults are reactively replaced, the Flagged-For-Action Plan is based on asset failure rate f (t), as described in Section II.2.2.

The Flagged-For-Action Plan is based on the number of expected failures in a given year.

| Figure 11-5 Pad Mounted Switchgear Optimal Condition-Based Flagged-For-Action Plan | . 149 |
|---|---|
| Figure 14-5 Vaults Condition-Based Flagged-For-Action Plan | . 173 |

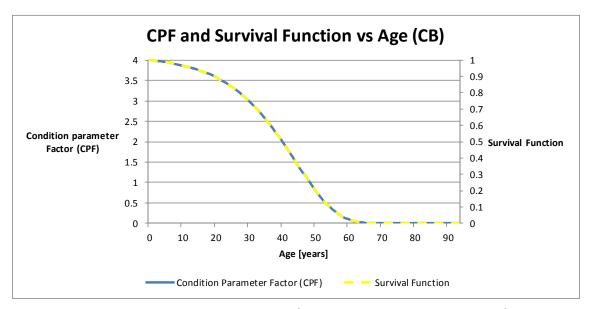
Assuming that at the ages of 40 and 50 years the probability of failure (P<sub>f</sub>) for this asset are 50% and 80% respectively results in the survival curve shown below. It follows that the CPF for Age is the survival curve normalized to the maximum CPF score of 4 (i.e. 4\*Survival Curve). The CPF vs. Age is also shown in the figure below:

| Figure 11-5 Pad Mounted Switchgear Optimal Condition-Based Flagged-For-Action Plan | . 149 |
|---|---|
| Figure 15-1 Age Condition Criteria (Submersible Load Break Switches) | . 176 |

| n | Sub-Condition Parameter | CPF Lookup<br>table | WCPF <sub>n</sub> | CPF <sub>n.max</sub> |
|---|---|---|---|---|
| 1 | Age | Figure 15-1 | 1 | 4 |

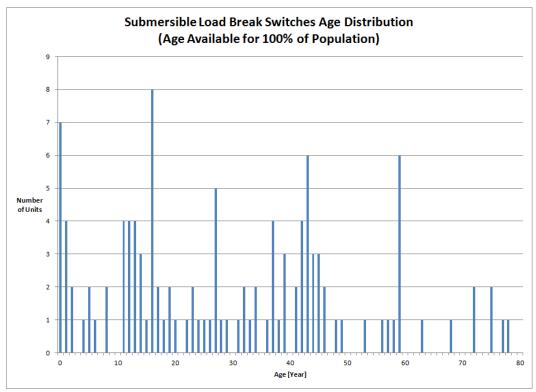
The age distribution is shown in the figures below. Age was available for 100% of the population. The average age was found to be 30 years.

| Figure 11-5 Pad Mounted Switchgear Optimal Condition-Based Flagged-For-Action Plan | . 149 |
|---|---|
| Figure 15-2 Submersible Load Break Switches Age Distribution | . 177 |

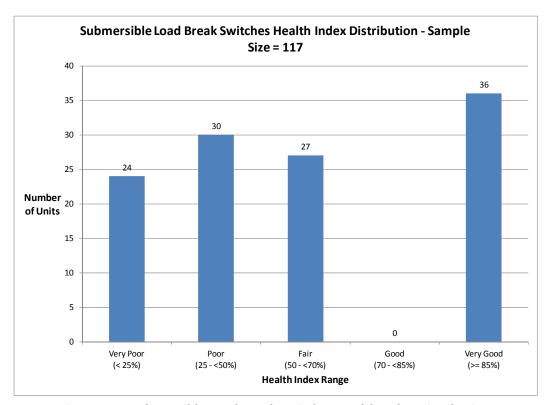
There are 117 in-service Submersible Load Break Switches at Horizon Utilities. The condition assessment is age-driven. The average Health Index for this asset group is 55%. Approximately 46% of the switches were found to be in poor or very poor condition.

| Figure 11-5 Pad Mounted Switchgear Optimal Condition-Based Flagged-For-Action Plan | . 149 |
|---|---|
| Figure 15-3 Submersible Load Break Switches Health Index Distribution | . 178 |

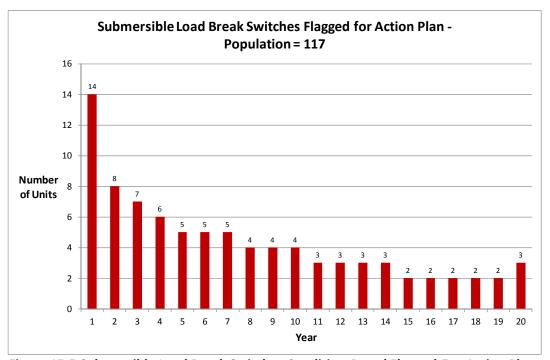
As it is assumed that Submersible Load Break Switches are reactively replaced, the Flagged-For-Action Plan is based on asset failure rate f (t), as described in Section II.2.2.

The Flagged-For-Action Plan is based on the number of expected failures in a given year.

| Figure 11-5 Pad Mounted Switchgear Optimal Condition-Based Flagged-For-Action Plan | . 149 |
|---|---|
| Figure 15-5 Submersible Load Break Switches Condition-Based Flagged-For-Action Plan | . 180 |

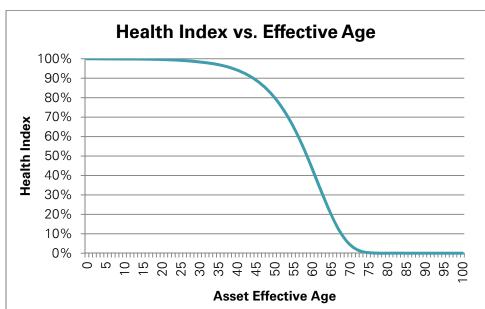
Figure 2: Determining Effective Age from Health Index

The formula used to calculate the health index for each asset class was unique depending on available asset condition data. The health index for each asset was calculated using weighted averages of known asset age and known asset condition parameters and their associated weighting factors. The health index was then used to determine the asset effective age as demonstrated in Figure 2 below using the appropriate survival curve determined jointly by Kinectrics and Horizon for that asset class.

This method takes into account known asset condition in order to modify the actual chronological age into an effective age prior to calculating the probability of failure. For example, an asset that is well maintained would have an effective age that is lower than its actual chronological age indicating a lower probability of failure. Conversely, an asset that is overloaded or that is situated in adverse conditions would be de-rated to have a higher effective age as compared to its chronological age leading to a higher probability of failure. This method of predicting asset failure is a more representative method for predicting probability of failure over using only the chronological age.

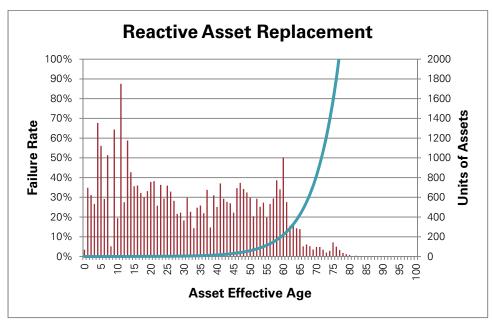
Figure 3: Flagged-for-Action Methodology used for Reactively Replaced Assets

Once the effective age distribution of an asset class is known, it is used to determine probable failure rates. For reactively replaced assets, the effective age distribution is mapped against the assigned failure rate curve for each asset class to determine the quantity of assets projected to fail over the next twenty years (see Figure 3 below).

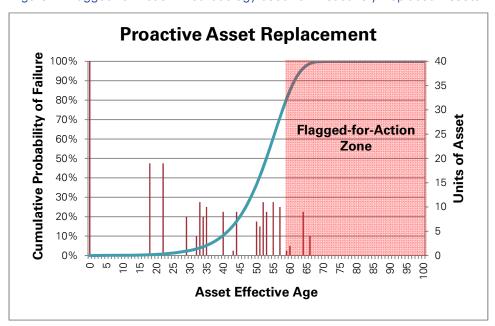
Figure 4: Flagged-for-Action Methodology used for Proactively Replaced Assets

For proactively replaced assets, the effective age is mapped against the cumulative probability of failure curve and assets with an effective age that returns a cumulative probability of failure of greater than or equal to 80% are flagged for replacement. Figure 4 represents the methodology used to flag proactively replaced assets.

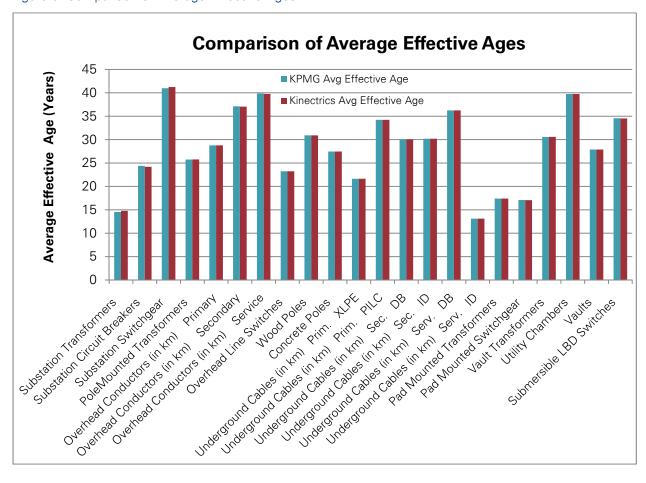
Figure 5: Comparison of Average Effective Ages

Health index calculations were recreated independently by KPMG using Kinectrics' published methodology found in their report (KPMG was not privy to Kinectrics' proprietary calculation models). The calculated health indices were then used to determine the effective ages. When the calculated health indices were compared to Kinectrics results, there were no significant differences identified and the calculated values were then used to determine the effective ages for each asset class. The results of the effective ages are summarized in Figure 5 below.

As evidenced by Figure 5, the average effective age distributions for the different asset classes are virtually identical for both Kinectrics calculations and KPMG's calculations. Minor differences were observed for the proactively replaced assets (Substation Transformers, Substation Circuit Breakers and Substation Switchgear) but as the subsequent Flagged-for-Action analysis shows, these minor differences did not result in material differences in the Flagged-for-Action plans for these asset classes.

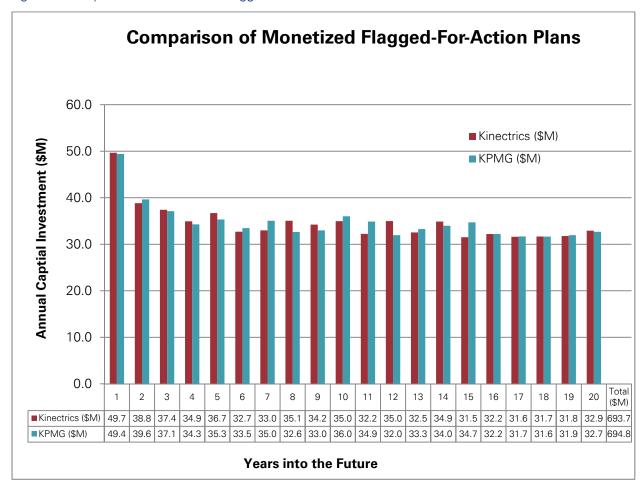
Figure 7: Comparison of Monetized Flagged-for-Action Plans

Flagged-for-Action unit plans were monetized using standard unit costs in order to effectively allow comparison of the business impact of the identified differences. The standard unit costs used were provided by Horizon for each asset class. The resultant estimated investment over twenty years for the respective plans is shown in Figure 7 below.

This monetized plan is meant to serve as a normalized comparison in dollar terms between the two respective Flagged-for-Action plans and it is not meant to be used as the definitive guide for Horizon's future capital investments. The two plans returned very similar total investment values over the twenty year span supporting the reasonableness of the calculations presented in the Kinectrics report. The total investment differs by only \$1.1 million over twenty years or 0.02% for the period. The estimated monetary differences for each asset class are summarized in Figure 8, below.

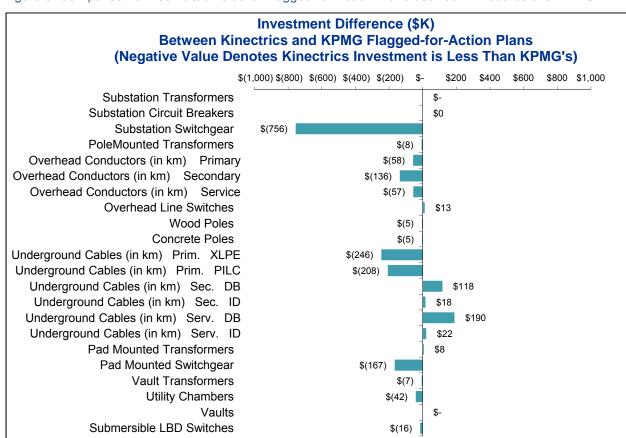
Figure 8: Comparison of Estimated Value of Flagged-for-Action Plans between Kinectrics and KPMG

When comparing Kinectrics and KPMG's results for the first five years of the monetized investment plan, the total investment portfolio difference found during this time period was \$1.8 million or 0.09% of the five year plan. This investment difference was found to be primarily caused by the Substation Switchgear asset class. Due to the relatively low number of Substation Switchgear assets involved, the different values returned by the respective lookup methods employed by Kinectrics and KPMG resulted in slight variations in the timing of the Flagged-for-Action profile (See Appendix 1 for details). This variation was deemed to be insignificant to the overall five year Flagged-for-Action plan.

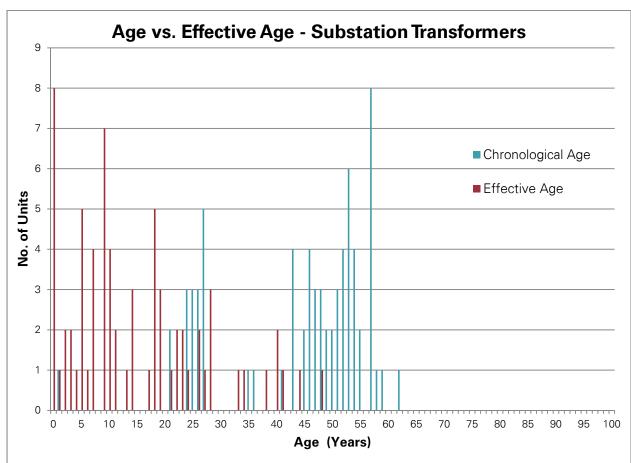
Figure 9: Example of Chronological Age versus Effective Age Comparison

In order to test whether the health indices and the associated effective ages of assets were reasonable, the calculated effective age was compared to the chronological age in terms of age distribution and overall average age for each of the asset classes. The age distribution comparison test was meant to reveal whether the incorporation of the asset condition parameters played a major role in altering the chronological age in a material way. Figure 9 below is an example of the comparison conducted for each asset class.

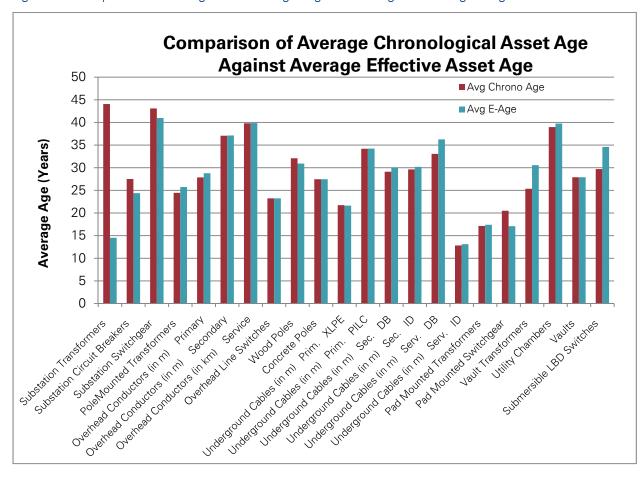
Figure 10: Comparison of Average Effective Ages against Average Chronological Ages

The conversion of chronological age to effective age as a result of having asset condition parameters applied did shift the age distribution significantly for some asset classes. The differences between the average effective ages and the average chronological ages can be seen in Figure 10 below. The most significant shift is in the Substation Transformer asset class as the average effective age is significantly below the average chronological age. This phenomenon, as explained by Horizon representatives is the result of having significant maintenance and testing programs in place for this relatively old asset class to ensure their performance and reliability as these assets are key core components of the distribution system.

This test revealed that the use of effective ages to calculate the Flagged-for-Action plans would generate different end results than plans generated from chronological ages. However, the Flagged-for-Action differences in all the asset classes with the exception of the Substation Transformers would be reasonably close between the two different age profiles. For the Substation Transformers, the Flagged-for-Action plan using the assets' effective ages would significantly understate the number of units to be Flagged-for-Action when compared with a plan generated by the use of chronological age alone. Using effective ages to determine the Flagged-for-Action plan was deemed to be more reflective of actual asset conditions than using just chronological age.

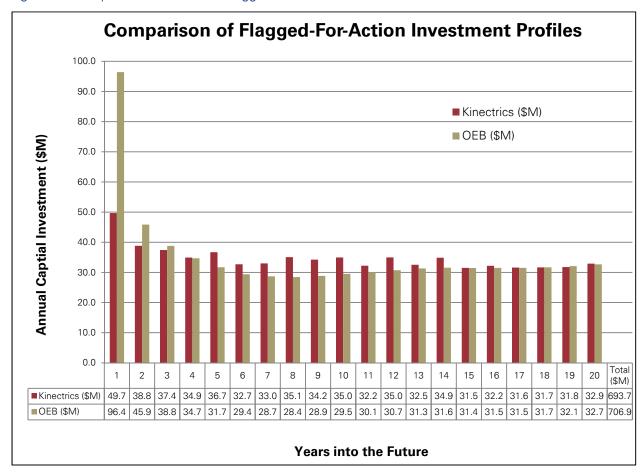
Figure 11: Comparison of Kinectrics Flagged-for-Action Plan versus Plan Generated from OEB Data

The final test to determine reasonability of the Kinectrics Flagged-for-Action plan was to compare the total plan against published and accepted industry standards for asset life expectancies. The standard life expectancies chosen for comparison were those published in the Asset Depreciation Study for the Ontario Energy Board (see Appendix 2). The published Typical Useful Life (TUL) and the Maximum Useful Life (MUL) were used to estimate the failure curve ( $f_t$ ) and the cumulative probability of failure ( $P_f$ ) for use in projecting asset replacements. Based on interpretation of the OEB report, the TUL was assigned 20%  $P_f$ , and the MUL was assigned 85%  $P_f$ . Failure curves were subsequently developed using the published TUL and MUL figures; the only exception was for the Submersible LBD Switches for which figures were not available in the OEB report. For this asset class, the UG Vault switch values for TUL and MUL were used as a proxy. Flagged-for-Action plans for each asset class were then calculated using the chronological age as the OEB useful lives data was developed for use with chronological asset age. The comparison of the normalized monetary results for the two different Flagged-for-Action plans is shown in Figure 11 below.

The total estimated investment for the two different plans over twenty years is within 2% of each other. The results calculated from the OEB life expectancies are heavily front-end loaded suggesting that model assesses Horizon's asset base as being closer to end of life than Kinectrics effective age model. This comparison substantiates the life curves used by Kinectrics in their models are reasonably close to industry accepted useful life data. The Kinectrics' life curves have longer average expected life-spans for some of the asset classes leading to fewer asset investments identified for the immediate short term. When compared to the OEB results, the Kinectrics Flagged-for-Action plan is not overstated and is reasonably within the industry accepted asset replacement or refurbishment practices for distribution utilities in Ontario.

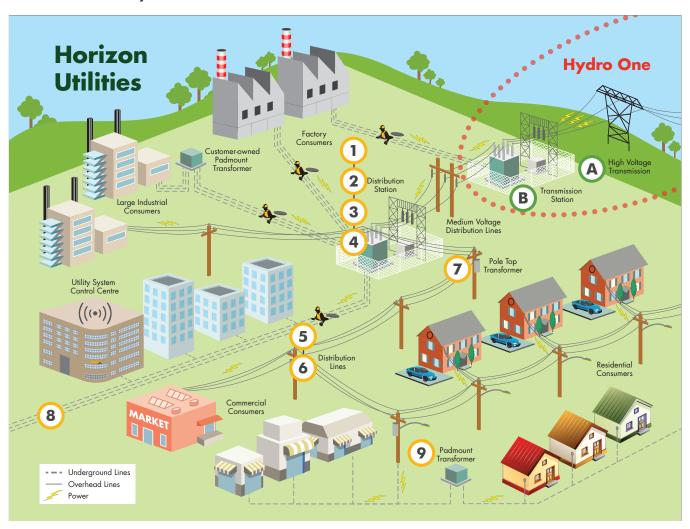
#### **Your Distribution System**

#### Horizon Utilities' Distribution System

#### **Distribution Stations**

- 1 Transformers devices that reduce the voltage of electricity to a lower level for use in the local distribution system.
- **Breakers** safety devices that interrupt a circuit if an unsafe amount of electricity passes through it (similar to a breaker panel in your home, except much larger).
- Switches devices that control the flow of electricity. They direct which supply of electricity is used and which circuits are energized.
- Feeder Circuits are the wires that exit the distribution station and deliver electricity to customers.

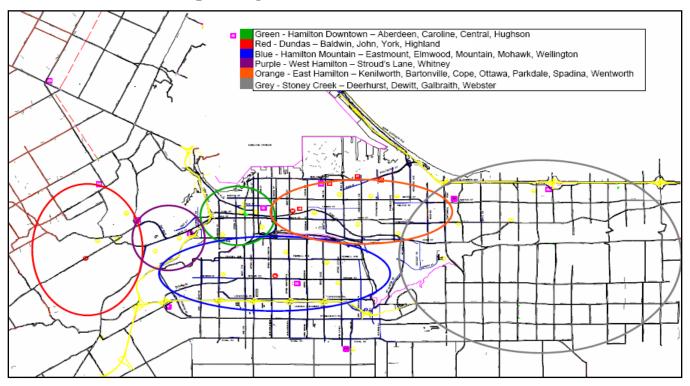
## **Hamilton Area Operating Clusters**

The following pages contain the 2009 and year-end 2013 GIS Maps showing the areas served by the 4.16 kV and 8.32 kV voltage levels in the Horizon Utilities Corporation service area.

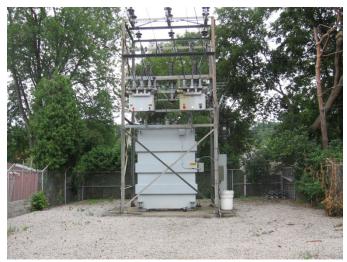
Address: 38 BALDWIN STREET, DUNDAS.

Facility: OUTDOOR S/S Year Built: UNKNOWN

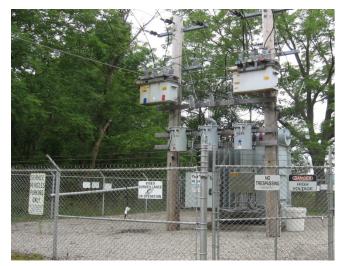
Address: 230 YORK RD, DUNDAS

Year Built: UNKNOWN Facility: OUTDOOR S/S
