**ONTARIO ENERGY BOARD**

**AND IN THE MATTER OF** an Application by Hydro One Networks  
Inc. for an Order or Orders approving or fixing just and reasonable rates  
and other service charges for the distribution of electricity as of January  
1, 2015.

**SCHOOL ENERGY COALITION CROSS-EXAMINATION COMPENDIUM  
(Panel 3)**

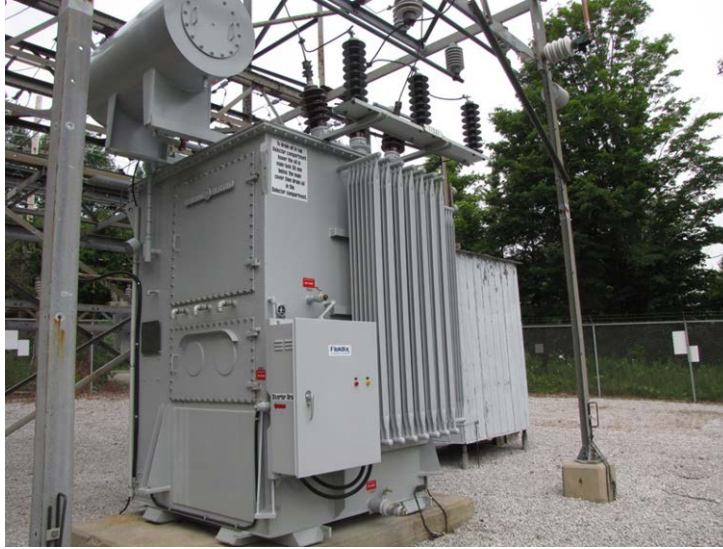
**Figure 1: Picture of a Station Transformer**

Distribution transformers convert a high level voltage (typically 115kV, 44kV, or 27.6kV) to a lower distribution voltage (typically 27.6, 25, 13.8, 12.47, 8.32 and 4.16 kV). Regulating transformers are also included in this asset group. The number of transformers by primary voltage is outlined in Table 1.

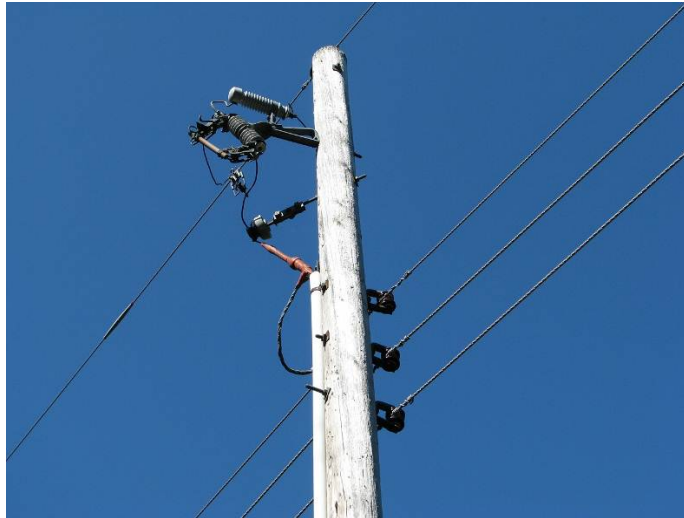
**Figure 11: Picture of a Wood Pole**

As shown in Table 6, Hydro One Distribution utilizes poles primarily made from wood, though concrete, steel and composite poles are used in specific situations.
