2007
Electric Service
Reliability Monitoring
Annual Report

Introduction

Pursuant to WAC 480-100-393 and WAC 480-100-398, Washington state investor-owned Electric companies must file a plan for monitoring and reporting electric service reliability information to the Commission annually.

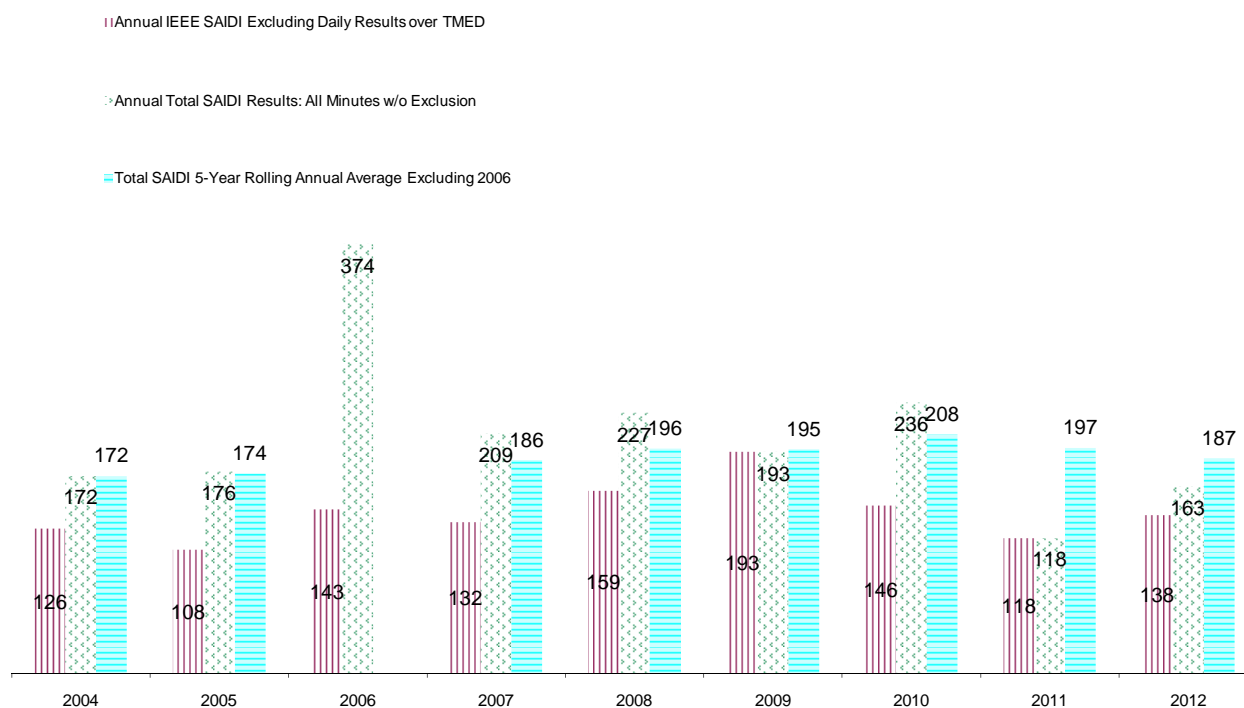
Chart 1: 2004-2012 AVA SAIDI Performance in Different Measurements by Year

Year	Calendar Year	Annual IEEE SAIDI Excluding Daily Results over T _{MED}	Annual Total SAIDI Results: All Minutes w/o Exclusion	Annual Total SAIDI Results Excluding 2006	Total SAIDI 5-Year Rolling Annual Average Excluding 2006	
1	2004	126	172	172	172	
2	2005	108	176	176	174	Baseline
3	2006	143	374			
4	2007	132	209	209	186	
5	2008	159	227	227	196	
6	2009	193	193	193	195	
7	2010	146	236	236	208	
8	2011	118	118	118	197	
9	2012	138	163	163	187	
		171				Target

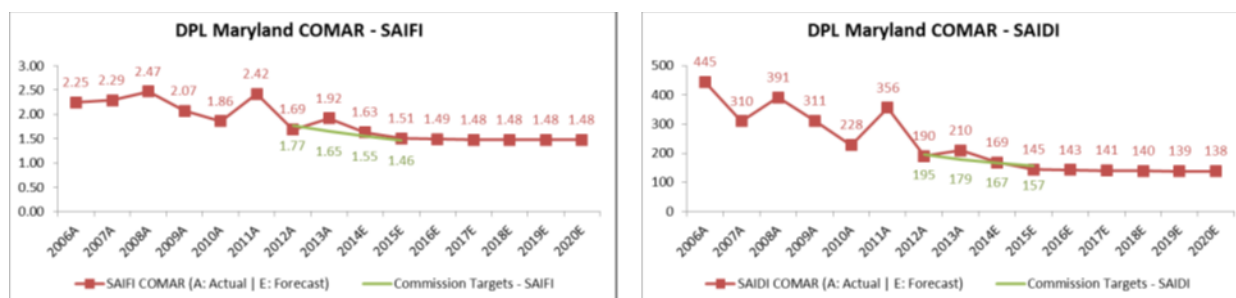
Figure 22: Delmarva SAIFI and SAIDI Projections without the CAP¹¹³

Prior to implementing the CAP, Delmarva predicted that the company would not meet the COMAR SAIFI standards for 2014 and 2015 and SAIDI standard for 2014.

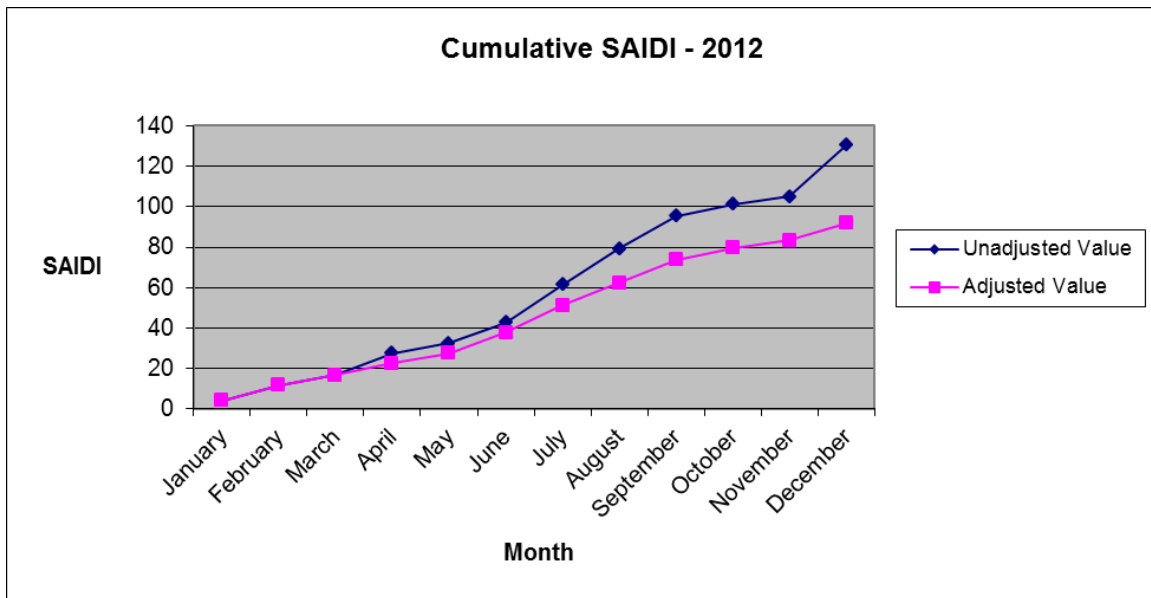
SAIDI:

Month	Unadjusted Value	Adjusted Value
January	4	4
February	12	12
March	17	17
April	28	23
May	33	28
June	43	38
July	61	51
August	79	62
September	95	74
October	101	79
November	105	83
December	130	92
