**Ontario Energy Board**

**AND IN THE MATTER OF** an application by PowerStream Inc. order approving just and reasonable rates and other charges for electricity distribution to be effective January 1, 2016.

**VULNERABLE ENERGY CONSUMERS COALITION  
("VECC")  
CROSS-EXAMINATION COMPENDIUM**

# 2013 ICE STORM REVIEW

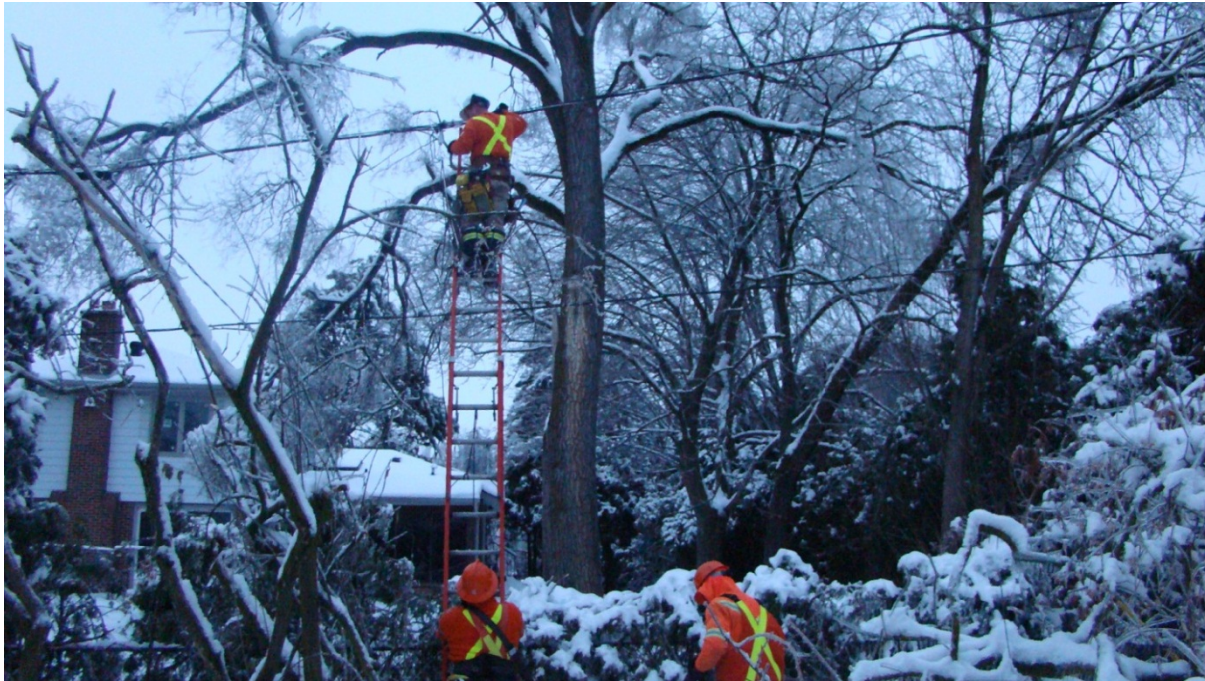
Lines crew clearing tree limbs and debris from a rear yard service during the ice storm restoration

Damage that occurred to the electrical distribution grid in these neighbourhoods was quite extensive, especially in the Thornhill area of Markham. Further, when Lines crews went to work in these areas, there were additional challenges such as gaining access through frozen gates and getting the necessary equipment and machinery in place to make repairs.

As a result, customers with rear yard service generally faced the longest restoration times, with some being out of power for up to a week.
