## **APPENDIX 2-4: HORIZON UTILITIES' DISTRIBUTION SYSTEM PLAN**

Horizon Utilities Corporation

# **Distribution System Plan**

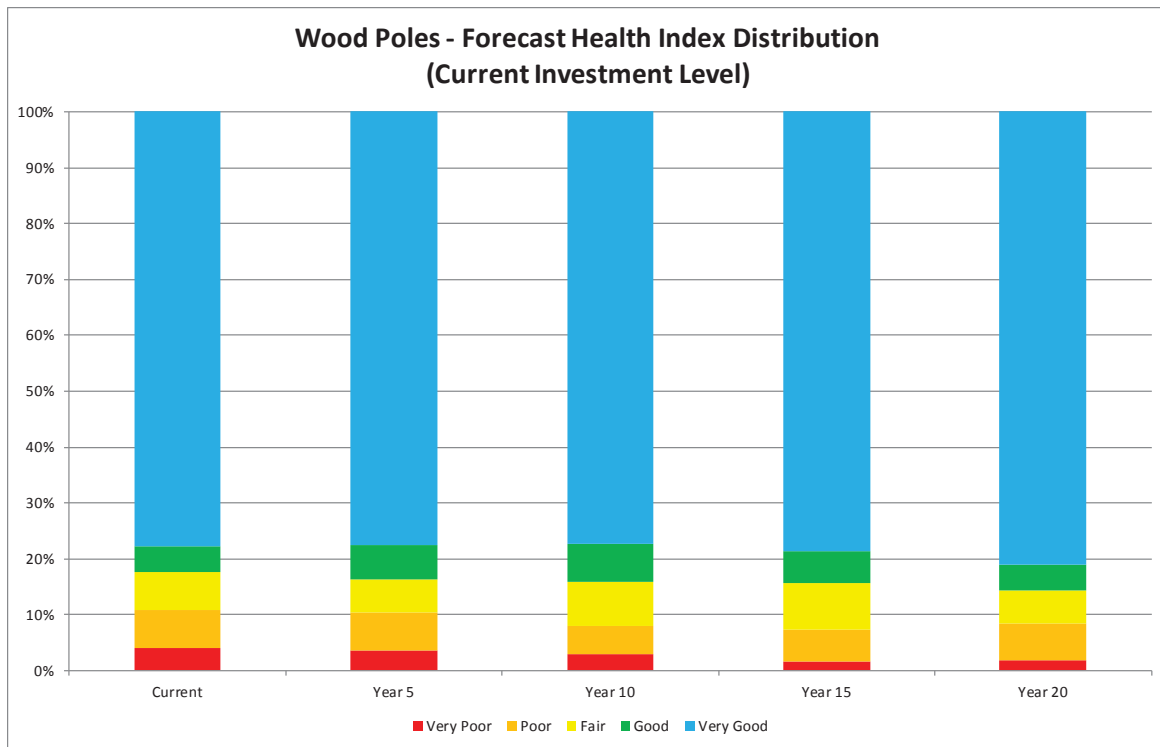
**Figure 5 - Wood Pole Health Index Distribution at the Current Investment Level**

By contrast, Figure 5 and Figure 6 above show that the forward risk for the overhead system will not increase dramatically in the future at the current investment level (using wood poles and overhead distribution transformers as a proxy).

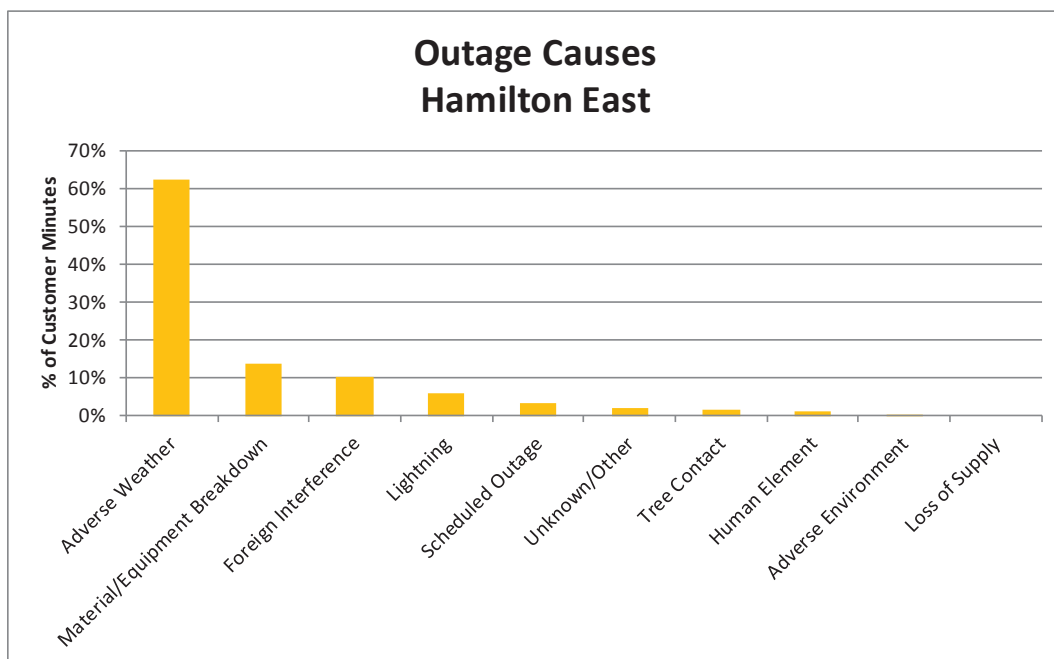
**Figure 29 - Hamilton East Operating Area – Cause of Outages**

Customers in the Hamilton East area have experienced an average annual SAIDI for the past three years of 2.16 hours. This is worse than Horizon Utilities' system average but, when the impact of the 2013 July windstorm and the 2013 December ice storms are excluded the performance, is better than both the Horizon Utilities system average and corporate system targets. Substation investments performed in 2011 through 2013 in the Hamilton East operating area have contributed to the higher level of reliability in this area. The health of the distribution system assets, combined with the recent investment in substation assets that were at the end of their useful life, have reduced the risk of outages in this area. As shown in Figure 29 below, outage in this area are primarily due to the adverse weather experienced in 2013.

Figure 28 and Figure 29 above illustrate the reliability history and outage causes experienced by customers in this area over the previous three years. Reliability has been relatively stable over the previous three years with the increase in 2011 attributable to an increase in service interruptions caused by lightning. The top three causes of outages are: foreign interference (animal contacts and vehicle accidents); lightning; and equipment failures, which is consistent with an old overhead distribution system such as exists in this area.

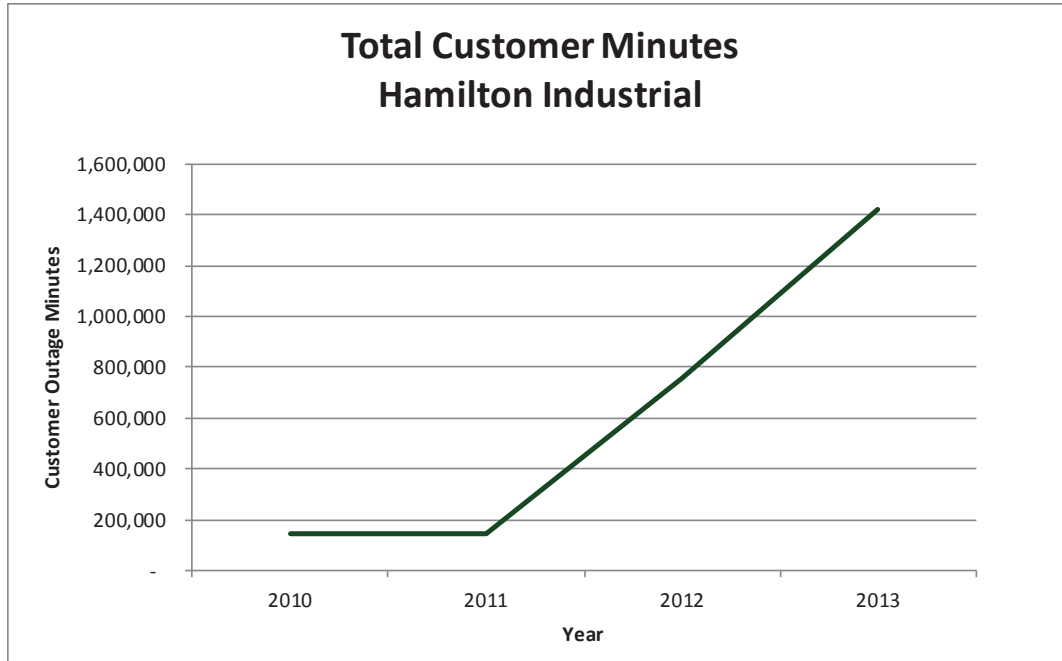
Figure 30 - Hamilton Waterfront Industrial Operating Area - Historical Reliability

1 1.57 hours. As illustrated in Figure 30 below, the reliability for this area deteriorated in 2012 and  
2 2013 relative to 2011 and 2010.

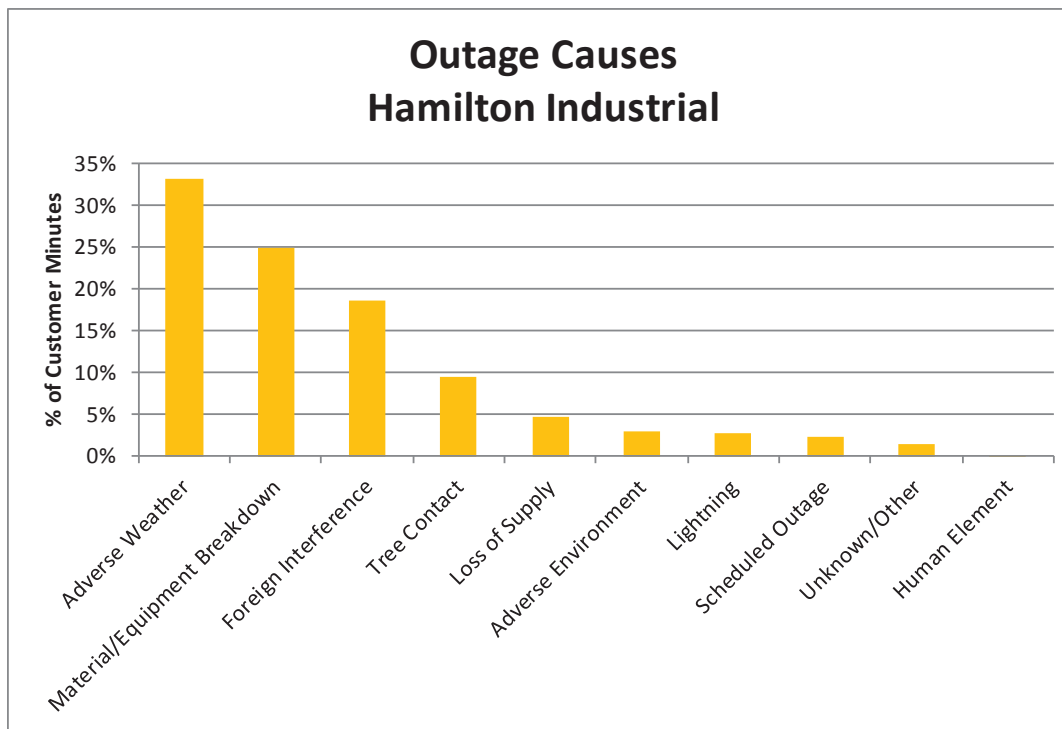
Figure 31 - Hamilton Waterfront Industrial Operating Area - Cause of Outages

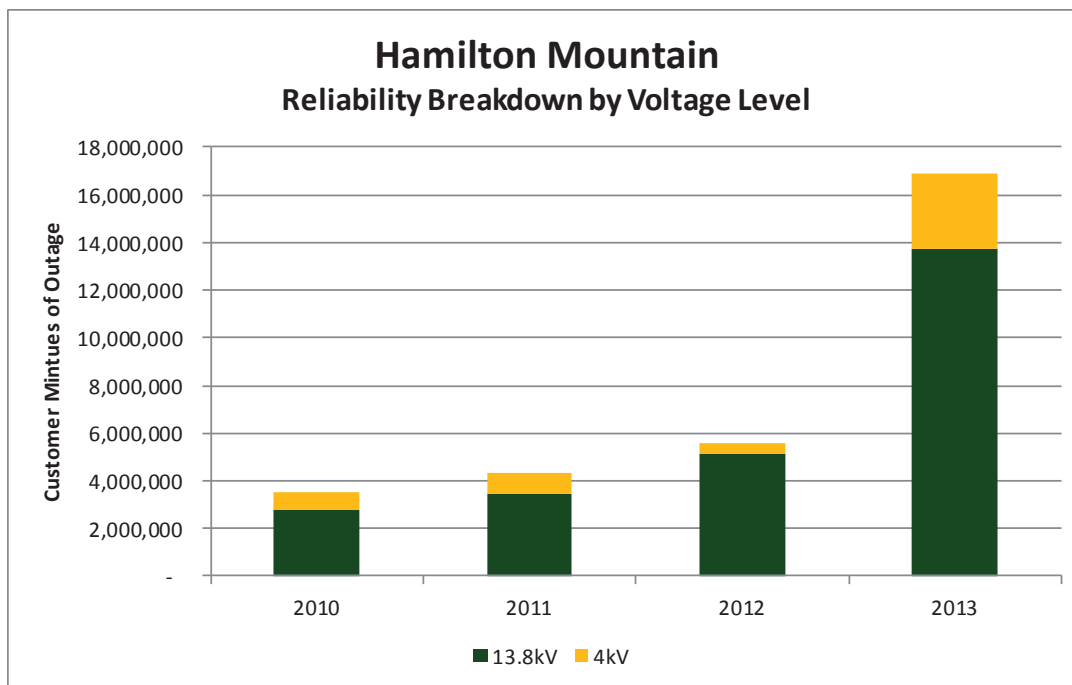
**Figure 32 - Hamilton Mountain - Reliability Breakdown by Voltage Level**

The 13.8kV underground system represented 83% of the total customer minutes of outage for the area resulting in a SAIDI of 2.90 hours. The SAIDI for the overhead system in comparison was 1.17 hours over the same period.

Customers in the Hamilton Mountain area have experienced an average annual SAIDI for the past three years of 2.31 hours. Reliability is trending negatively in this operating area with equipment failures dominating the cause of outages as illustrated in Figure 34 below. Reliability is materially different, however, between the 4.16kV overhead and 13.8kV underground system as illustrated in Figure 32 below.

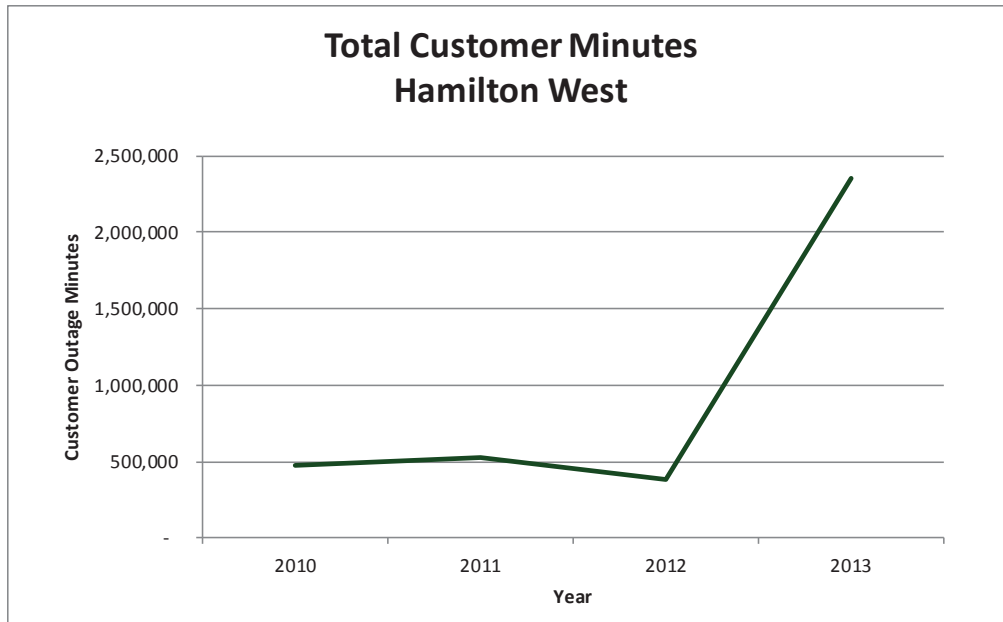
Figure 35 - Hamilton West Operating Area - Historical Reliability

Customers in the Hamilton West area have experienced an average annual SAIDI for the past three years of 1.26 hours. As illustrated in Figure 35 and Figure 36 below, the reliability is relatively stable (the 2013 increase is attributable to the July 2013 wind storm). Tree contact and foreign interference (animal contacts) are the largest cause of outages in this area when the impact of the July 2013 wind storm is excluded.

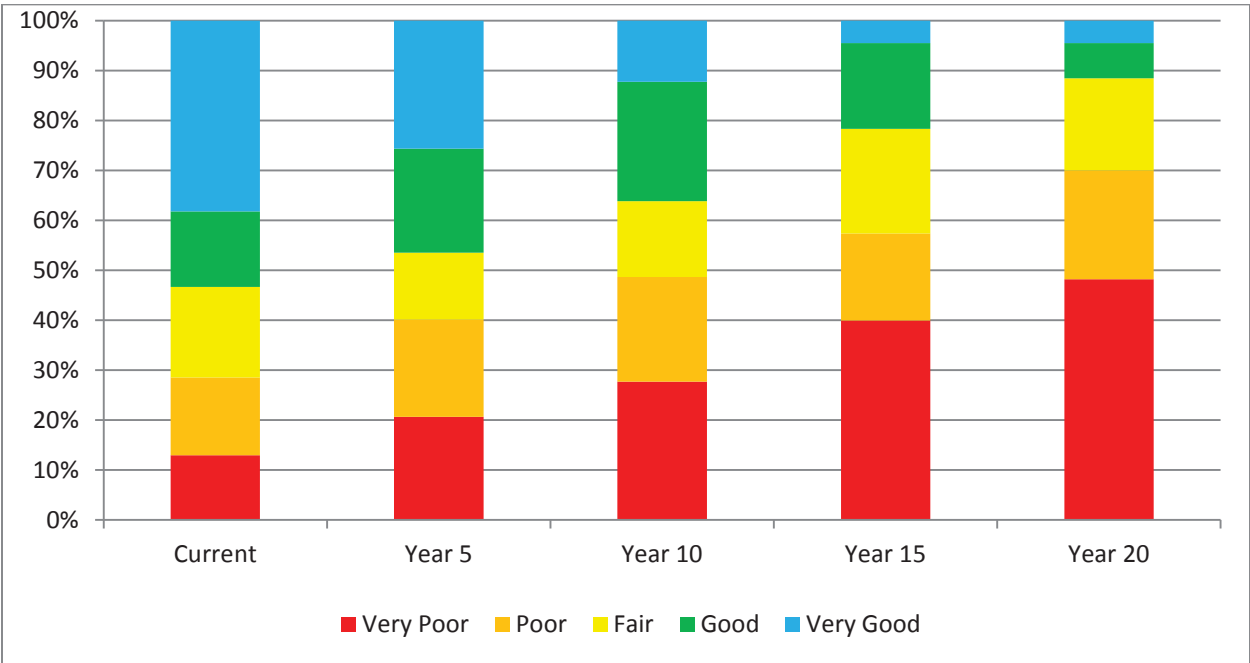
10  
11 Figure 80 - Forecasted XLPE Health Index at Current Investment Levels

6 The forecast of the future Health Index of this asset group at 2013 investment levels is  
7 illustrated in Figure 80 below. The percentage of XLPE primary cable having a Health Index of  
8 either "poor" or "very poor" would increase from the current value of 30% to 70% or 1,400km by  
9 2034, if investment is held at the current 2013 level.

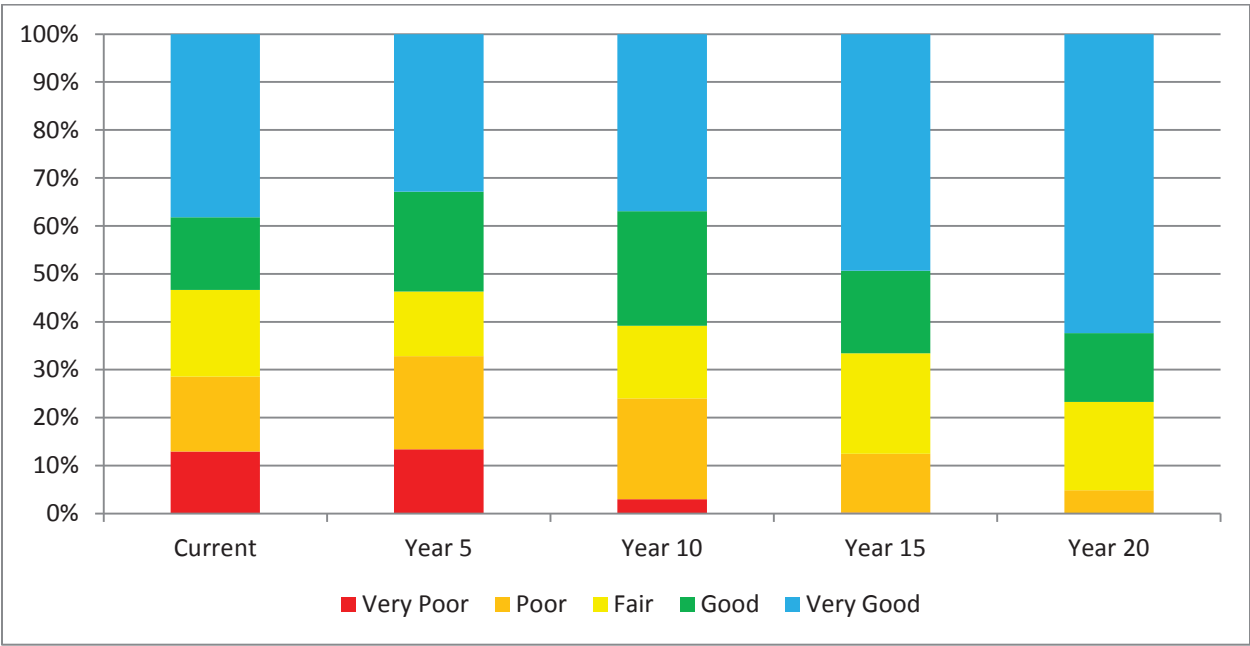
Figure 81 - Forecasted XLPE Health Index at Proposed Investment Levels

The current backlog volume of XLPE primary cable requiring renewal cannot be addressed in a single year and requires a multiple year investment strategy. The optimal level of renewal for XLPE cable, based on a 40-year useful life replacement cycle, is 50km/year. Horizon Utilities' proposed investment for the 2015 to 2019 Test Years is \$36,014,000, which provides for the replacement of 180km of cable over the 2015 to 2019 Test Years. This represents a managed, gradual increase in investment in order to balance rate payer concerns and practical operational limitations. This proposed investment is below the minimum investment required to maintain the current Health Index in 2015 to 2019, as identified in Figure 81 below. The backlog of XLPE cable with a "very poor" or "poor" Health Index continues to grow until 2019. It will take Horizon Utilities until 2017 to reach the optimal level of renewal, due to long lead times required to address planning and municipal consent processes and customer stakeholdering.

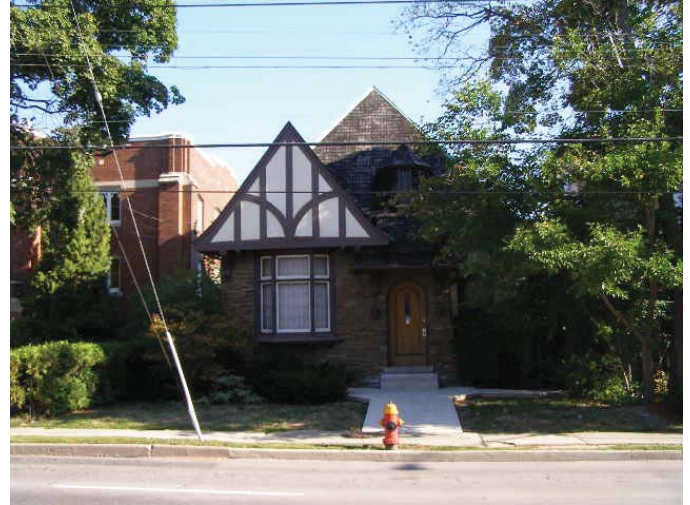
Facility: INDOOR S/S

Year Built: 1969

Equipment Type	Health Index	Weighting - Indoor
1) Transformer	90%	25%
2) Breaker	39%	20%
3) Reclosers	0	0%
4) Switch Gear	46%	20%
5) P&C	35%	20%
6) Station Service	45%	5%
7) Site & Civil	44%	10%
8) Bus, Switches & Structures	0%	0%
<b>Station Health Index</b>	<b>53%</b>	<b>100%</b>

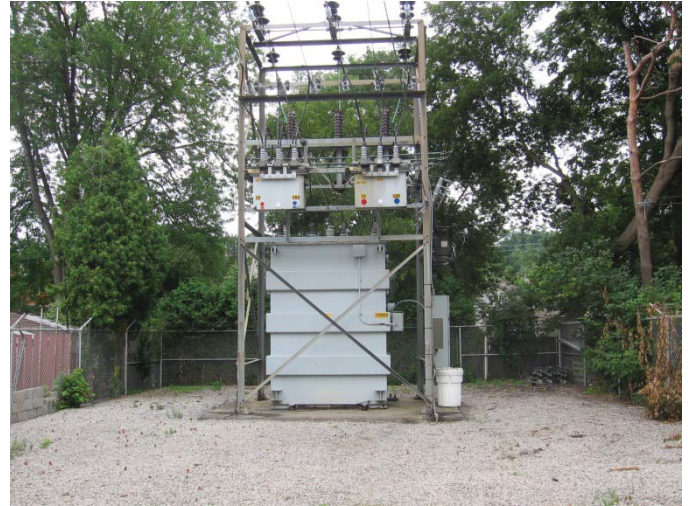
Address: 38 BALDWIN STREET, DUNDAS.  
 Facility: OUTDOOR S/S  
 Year Built: UNKNOWN

Equipment Type	Health Index	Weighting - Outdoor
1) Transformer	93%	30%
2) Breaker	0%	0%
3) Reclosers	96%	15%
4) Switch Gear	0%	0%
5) P&C	67%	15%
6) Station Service	40%	5%
7) Site & Civil	83%	10%
8) Bus, Switches & Structures	83%	25%
<b>Station Health Index</b>	<b>84%</b>	<b>100%</b>

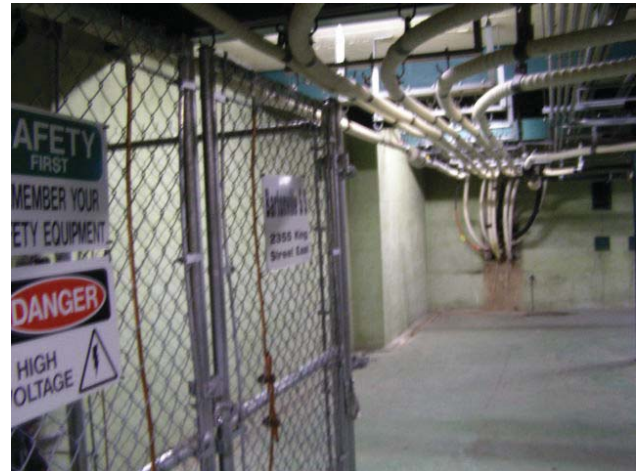
Year Built: 1952

Facility: INDOOR S/S

Equipment Type	Health Index	Weighting - Indoor
1) Transformer	86%	25%
2) Breaker	100%	20%
3) Reclosers	0%	0%
4) Switch Gear	52%	20%
5) P&C	90%	20%
6) Station Service	10%	5%
7) Site & Civil	66%	10%
8) Bus, Switches & Structures	0%	0%
<b>Station Health Index</b>	<b>77%</b>	<b>100%</b>

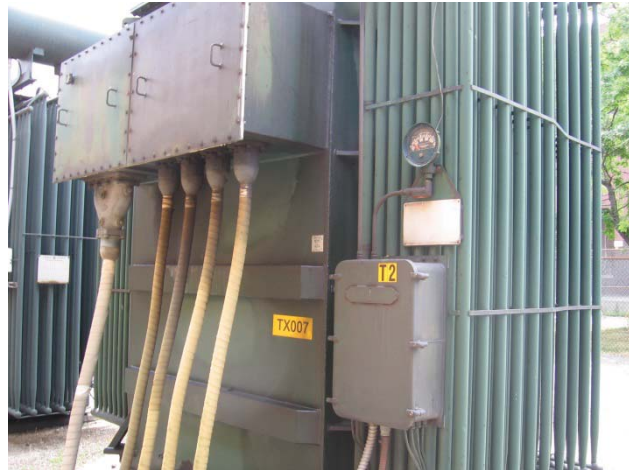
Year Built: 1955

Facility: INDOOR S/S

Equipment Type	Health Index	Weighting - Indoor
1) Transformer	86%	25%
2) Breaker	51%	20%
3) Reclosers	0%	0%
4) Switch Gear	51%	20%
5) P&C	55%	20%
6) Station Service	25%	5%
7) Site & Civil	64%	10%
8) Bus, Switches & Structures	0%	0%
<b>Station Health Index</b>	<b>61%</b>	<b>100%</b>

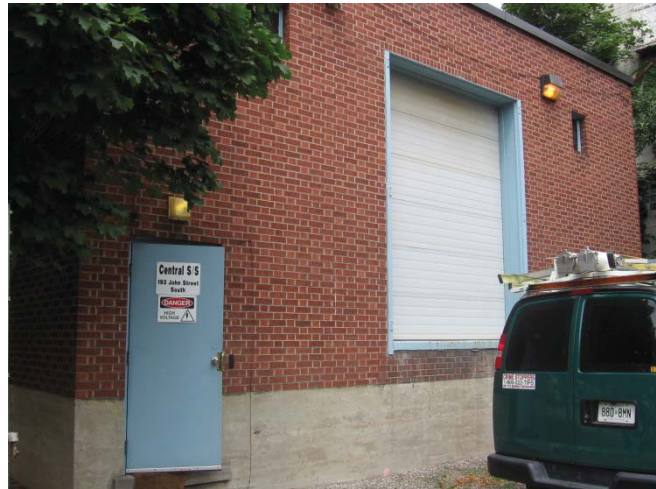
Year Built: 1950

Facility: INDOOR S/S

Equipment Type	Health Index	Weighting - Indoor
1) Transformer	90%	25%
2) Breaker	46%	20%
3) Reclosers	0	0%
4) Switch Gear	58%	20%
5) P&C	30%	20%
6) Station Service	20%	5%
7) Site & Civil	62%	10%
8) Bus, Switches & Structures	0%	0%
<b>Station Health Index</b>	<b>56%</b>	<b>100%</b>

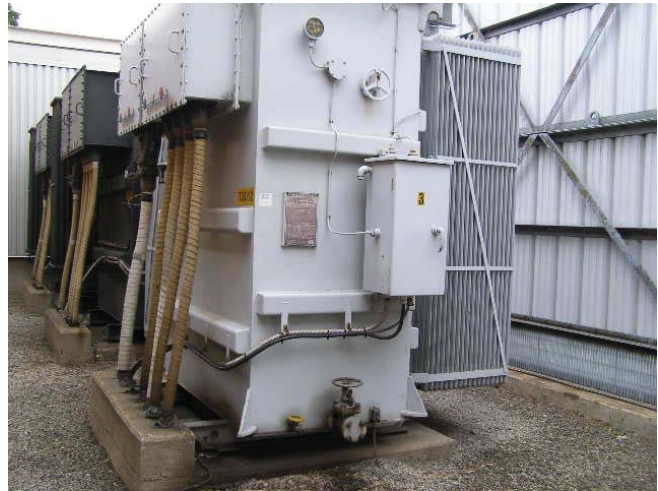
Year Built: 1965

Facility: INDOOR S/S

Equipment Type	Health Index	Weighting - Indoor
1) Transformer	88%	25%
2) Breaker	100%	20%
3) Reclosers	0%	0%
4) Switch Gear	71%	20%
5) P&C	90%	20%
6) Station Service	40%	5%
7) Site & Civil	82%	10%
8) Bus, Switches & Structures	0%	0%
<b>Station Health Index</b>	<b>84%</b>	<b>100%</b>

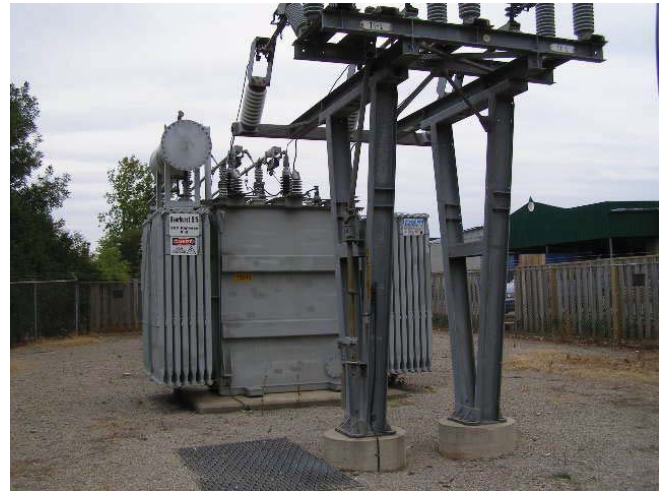
Year Built: UNKNOWN

Facility: OUTDOOR S/S

Equipment Type	Health Index	Weighting - Outdoor
1) Transformer	97%	30%
2) Breaker	0%	0%
3) Reclosers	100%	15%
4) Switch Gear	0%	0%
5) P&C	0%	15%
6) Station Service	60%	5%
7) Site & Civil	69%	10%
8) Bus, Switches & Structures	100%	25%
<b>Station Health Index</b>	<b>79%</b>	<b>100%</b>

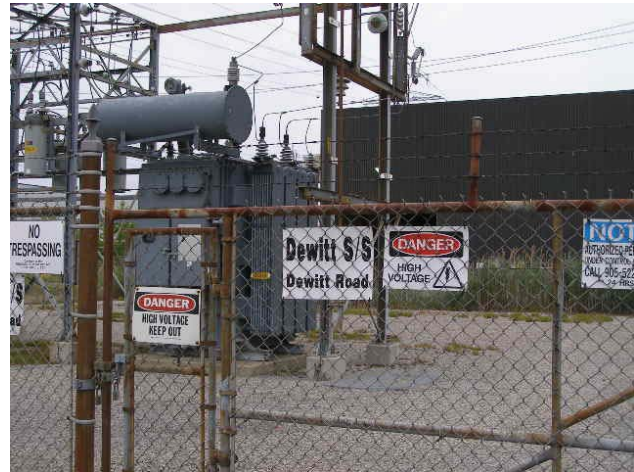
Year Built: UNKNOWN

Facility: OUTDOOR S/S

Equipment Type	Health Index	Weighting - Outdoor
1) Transformer	82%	30%
2) Breaker	0%	0%
3) Reclosers	100%	15%
4) Switch Gear	0%	0%
5) P&C	0%	15%
6) Station Service	55%	5%
7) Site & Civil	65%	10%
8) Bus, Switches & Structures	100%	25%
<b>Station Health Index</b>	<b>74%</b>	<b>100%</b>

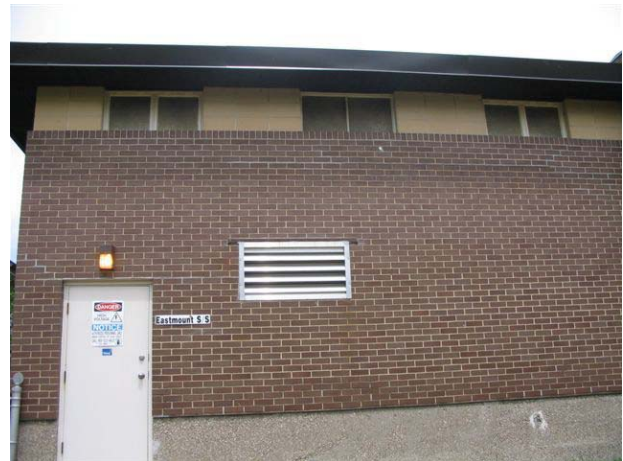
Year Built: 1959

Facility: INDOOR S/S

Equipment Type	Health Index	Weighting - Indoor
1) Transformer	90%	25%
2) Breaker	45%	20%
3) Reclosers	0%	0%
4) Switch Gear	69%	20%
5) P&C	45%	20%
6) Station Service	10%	5%
7) Site & Civil	78%	10%
8) Bus, Switches & Structures	0	0%
<b>Station Health Index</b>	<b>63%</b>	<b>100%</b>

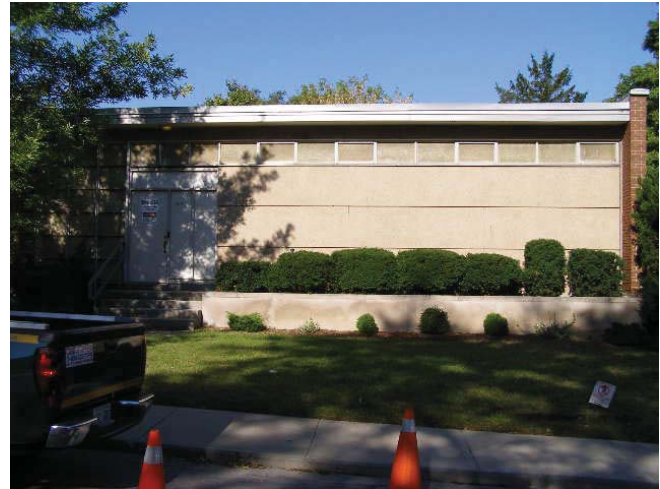
Year Built: 1958

Facility: INDOOR S/S

Equipment Type	Health Index	Weighting - Indoor
1) Transformer	93%	25%
2) Breaker	73%	20%
3) Reclosers	0%	0%
4) Switch Gear	55%	20%
5) P&C	35%	20%
6) Station Service	15%	5%
7) Site & Civil	82%	10%
8) Bus, Switches & Structures	0%	0%
<b>Station Health Index</b>	<b>65%</b>	<b>100%</b>

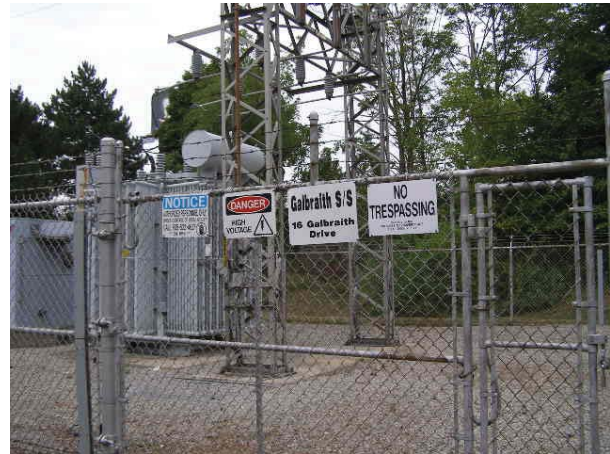
Year Built: 1959

Facility: OUTDOOR S/S

Equipment Type	Health Index	Weighting - Outdoor
1) Transformer	95%	30%
2) Breaker	0%	0%
3) Reclosers	100%	15%
4) Switch Gear	93%	10%
5) P&C	100%	15%
6) Station Service	45%	5%
7) Site & Civil	56%	10%
8) Bus, Switches & Structures	100%	15%
<b>Station Health Index</b>	<b>91%</b>	<b>100%</b>

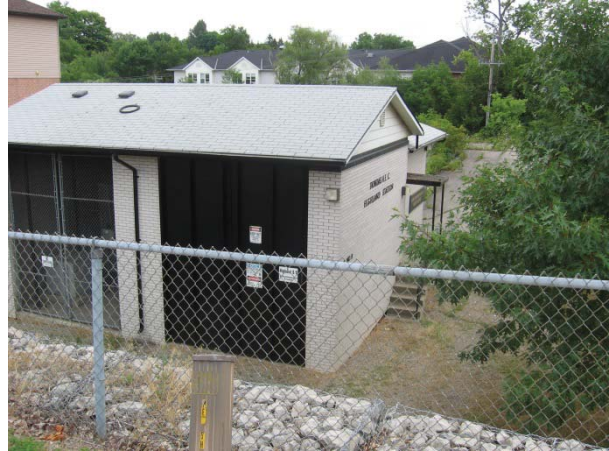
Year Built: 1977

Facility: INDOOR S/S

Equipment Type	Health Index	Weighting - Indoor
1) Transformer	95%	25%
2) Breaker	33%	20%
3) Reclosers	0%	0%
4) Switch Gear	36%	20%
5) P&C	25%	20%
6) Station Service	50%	5%
7) Site & Civil	72%	10%
8) Bus, Switches & Structures	0%	0%
<b>Station Health Index</b>	<b>52%</b>	<b>100%</b>

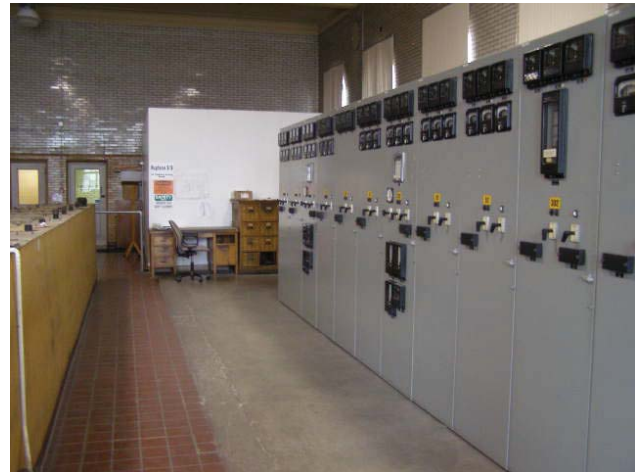
Year Built: 1926

Facility: INDOOR S/S

Equipment Type	Health Index	Weighting - Indoor
1) Transformer	95%	25%
2) Breaker	79%	20%
3) Reclosers	0%	0%
4) Switch Gear	81%	20%
5) P&C	60%	20%
6) Station Service	40%	5%
7) Site & Civil	55%	10%
8) Bus, Switches & Structures	0%	0%
<b>Station Health Index</b>	<b>75%</b>	<b>100%</b>

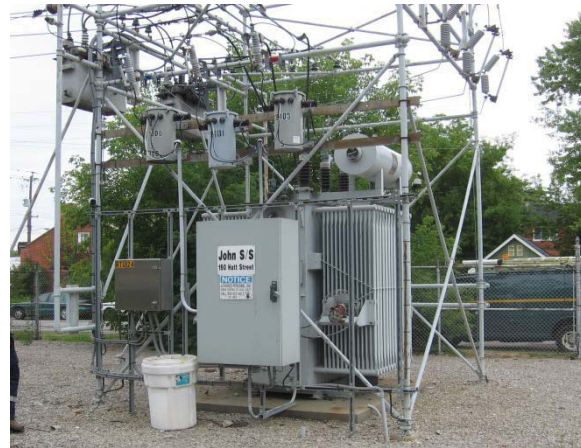
Year Built: 1985

Facility: OUTDOOR S/S

Equipment Type	Health Index	Weighting - Outdoor
1) Transformer	80%	30%
2) Breaker	0%	0%
3) Reclosers	100%	15%
4) Switch Gear	0%	0%
5) P&C	67%	15%
6) Station Service	50%	5%
7) Site & Civil	95%	10%
8) Bus, Switches & Structures	86%	25%
<b>Station Health Index</b>	<b>83%</b>	<b>100%</b>

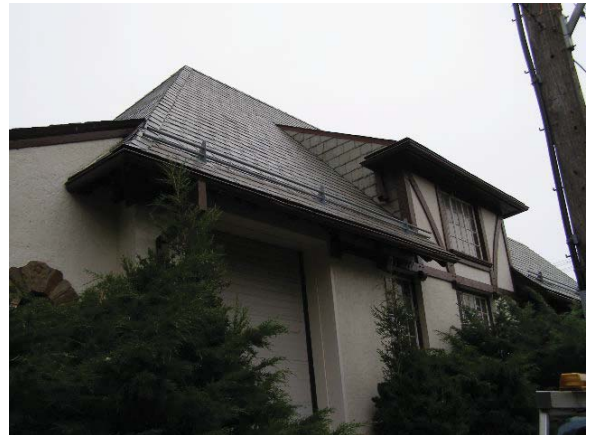
Year Built: 1960

Facility: INDOOR S/S

Equipment Type	Health Index	Weighting - Indoor
1) Transformer	91%	25%
2) Breaker	100%	20%
3) Reclosers	0%	0%
4) Switch Gear	50%	20%
5) P&C	90%	20%
6) Station Service	25%	5%
7) Site & Civil	61%	10%
8) Bus, Switches & Structures	0%	0%
<b>Station Health Index</b>	<b>78%</b>	<b>100%</b>

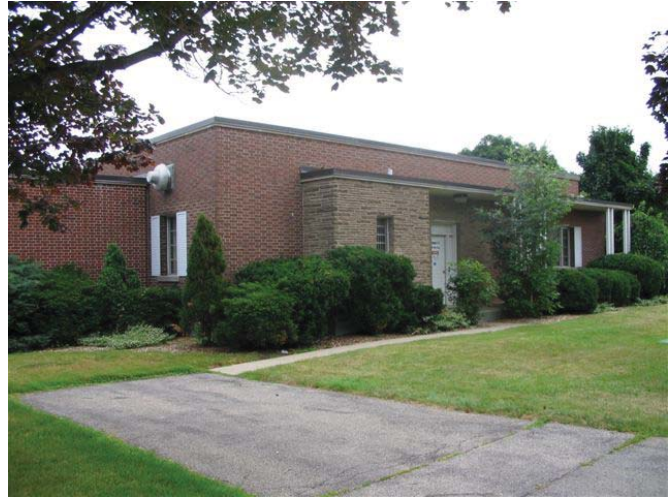
Year Built: 1953

Facility: INDOOR S/S

Equipment Type	Health Index	Weighting - Indoor
1) Transformer	85%	25%
2) Breaker	100%	20%
3) Reclosers	0	0%
4) Switch Gear	59%	20%
5) P&C	90%	20%
6) Station Service	25%	5%
7) Site & Civil	68%	10%
8) Bus, Switches & Structures	0%	0%
<b>Station Health Index</b>	<b>79%</b>	<b>100%</b>

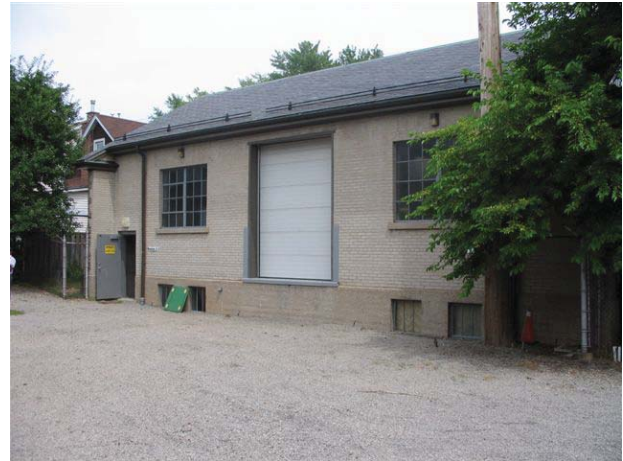
Year Built: 1965

Facility: INDOOR S/S

Equipment Type	Health Index	Weighting - Indoor
1) Transformer	91%	25%
2) Breaker	100%	20%
3) Reclosers	0	0%
4) Switch Gear	57%	20%
5) P&C	90%	20%
6) Station Service	25%	5%
7) Site & Civil	53%	10%
8) Bus, Switches & Structures	0%	0%
<b>Station Health Index</b>	<b>79%</b>	<b>100%</b>

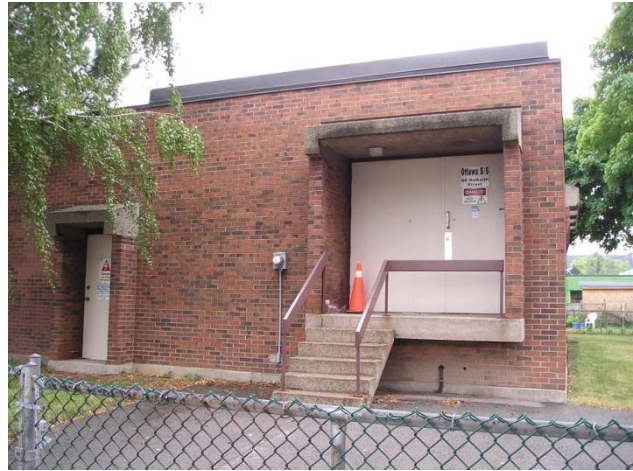
Year Built: 1967

Facility: INDOOR S/S

Equipment Type	Health Index	Weighting - Indoor
1) Transformer	89%	25%
2) Breaker	100%	20%
3) Reclosers	0%	0%
4) Switch Gear	76%	20%
5) P&C	90%	20%
6) Station Service	25%	5%
7) Site & Civil	86%	10%
8) Bus, Switches & Structures	0%	0%
<b>Station Health Index</b>	<b>85%</b>	<b>100%</b>

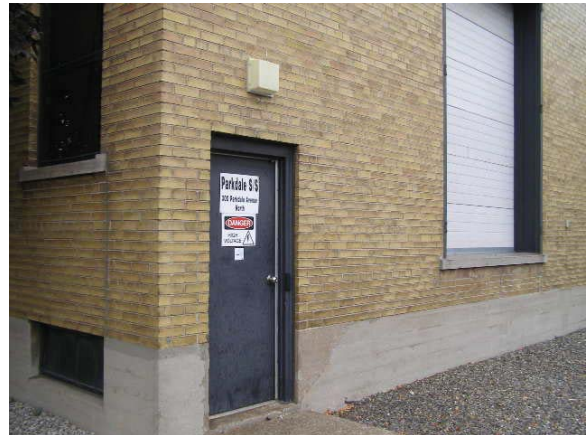
Year Built: 1924

Facility: INDOOR S/S

Equipment Type	Health Index	Weighting - Indoor
1) Transformer	100%	25%
2) Breaker	100%	20%
3) Reclosers	0%	0%
4) Switch Gear	100%	20%
5) P&C	90%	20%
6) Station Service	25%	5%
7) Site & Civil	66%	10%
8) Bus, Switches & Structures	0%	0%
<b>Station Health Index</b>	<b>91%</b>	<b>100%</b>

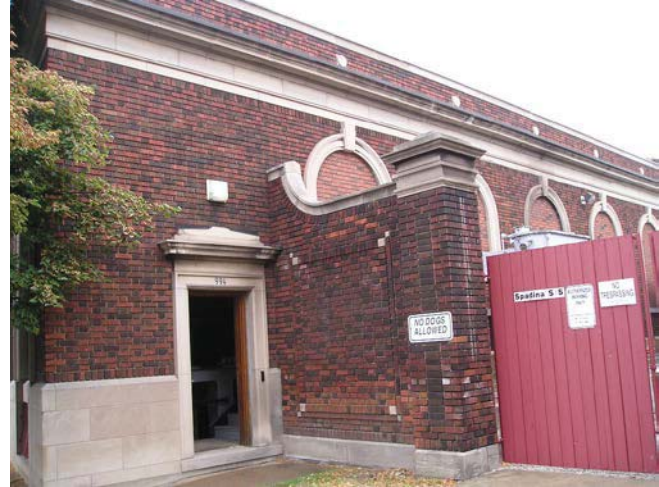
Year Built: 1930

Facility: INDOOR S/S

Equipment Type	Health Index	Weighting - Indoor
1) Transformer	88%	25%
2) Breaker	68%	20%
3) Reclosers	0%	0%
4) Switch Gear	79%	20%
5) P&C	90%	20%
6) Station Service	20%	5%
7) Site & Civil	68%	10%
8) Bus, Switches & Structures	0%	0%
<b>Station Health Index</b>	<b>77%</b>	<b>100%</b>

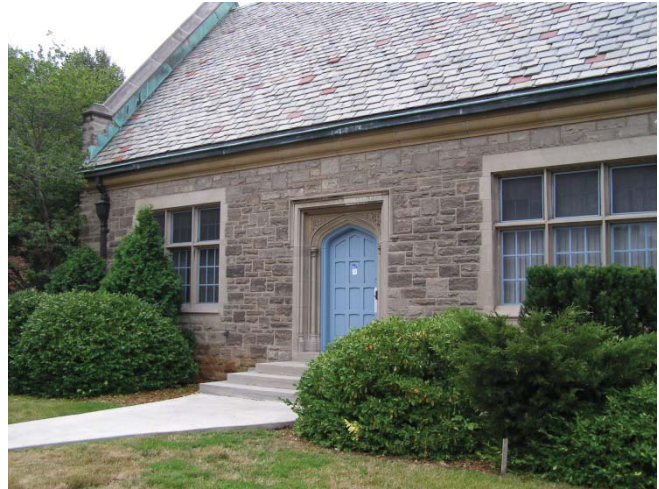
Year Built: 1938

Facility: INDOOR S/S

Equipment Type	Health Index	Weighting - Indoor
1) Transformer	85%	25%
2) Breaker	70%	20%
3) Reclosers	0%	0%
4) Switch Gear	37%	20%
5) P&C	55%	20%
6) Station Service	25%	5%
7) Site & Civil	71%	10%
8) Bus, Switches & Structures	0%	0%
<b>Station Health Index</b>	<b>62%</b>	<b>100%</b>

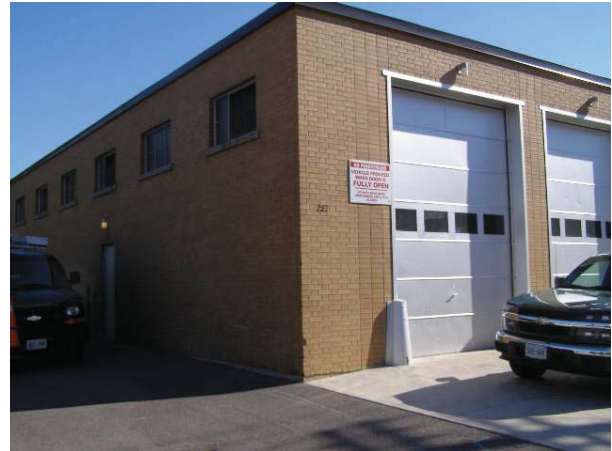
Year Built: 1960

Facility: INDOOR S/S

Equipment Type	Health Index	Weighting - Indoor
1) Transformer	85%	25%
2) Breaker	100%	20%
3) Reclosers	0%	0%
4) Switch Gear	59%	20%
5) P&C	90%	20%
6) Station Service	25%	5%
7) Site & Civil	83%	10%
8) Bus, Switches & Structures	0%	0%
<b>Station Health Index</b>	<b>81%</b>	<b>100%</b>

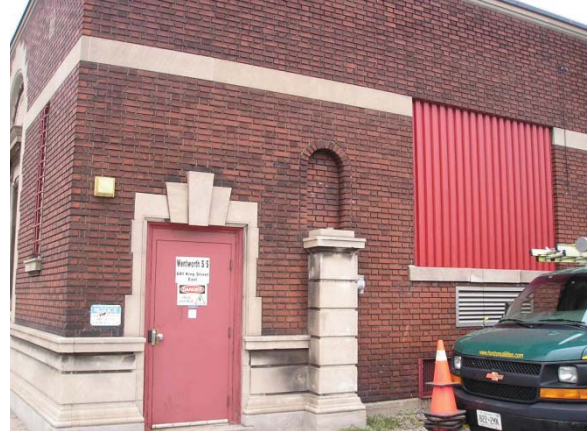
Year Built: 1930

Facility: INDOOR S/S

Equipment Type	Health Index	Weighting - Indoor
1) Transformer	90%	25%
2) Breaker	82%	20%
3) Reclosers	0%	0%
4) Switch Gear	73%	20%
5) P&C	90%	20%
6) Station Service	25%	5%
7) Site & Civil	64%	10%
8) Bus, Switches & Structures	0%	0%
<b>Station Health Index</b>	<b>79%</b>	<b>100%</b>

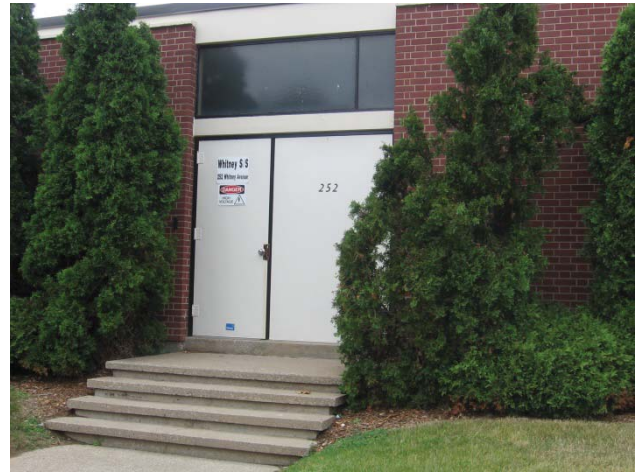
Year Built: 1963

Facility: INDOOR S/S

Equipment Type	Health Index	Weighting - Indoor
1) Transformer	92%	25%
2) Breaker	65%	20%
3) Reclosers	0%	0%
4) Switch Gear	43%	20%
5) P&C	45%	20%
6) Station Service	30%	5%
7) Site & Civil	83%	10%
8) Bus, Switches & Structures	0%	0%
<b>Station Health Index</b>	<b>63%</b>	<b>100%</b>

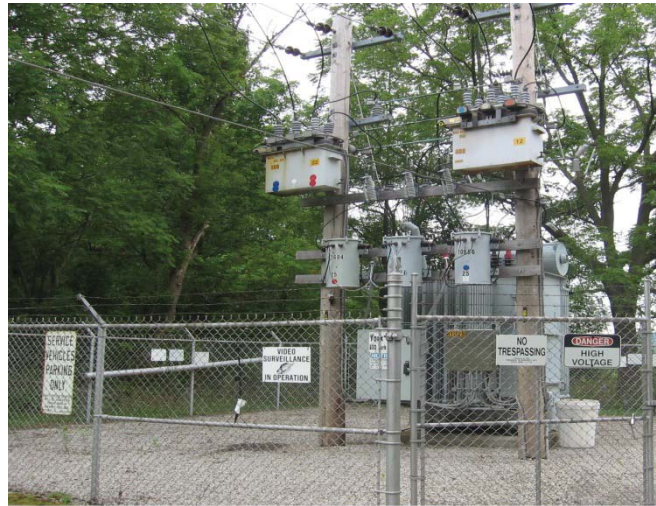
Year Built: UNKNOWN

Facility: OUTDOOR S/S

Equipment Type	Health Index	Weighting - Outdoor
1) Transformer	88%	30%
2) Breaker	0%	0%
3) Reclosers	100%	15%
4) Switch Gear	0%	0%
5) P&C	90%	15%
6) Station Service	40%	5%
7) Site & Civil	73%	10%
8) Bus, Switches & Structures	83%	25%
<b>Station Health Index</b>	<b>85%</b>	<b>100%</b>

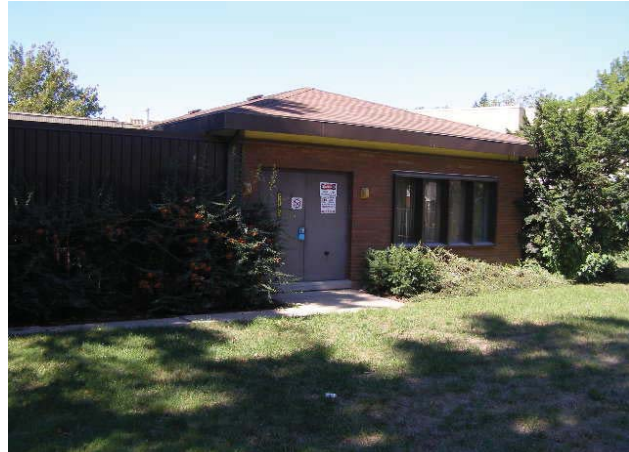
Year Built: 1965

Facility: INDOOR S/S

Equipment Type	Health Index	Weighting - Indoor
1) Transformer	82%	25%
2) Breaker	52%	20%
3) Reclosers	0%	0%
4) Switch Gear	57%	20%
5) P&C	35%	20%
6) Station Service	63%	5%
7) Site & Civil	59%	10%
8) Bus, Switches & Structures	0%	0%
<b>Station Health Index</b>	<b>58%</b>	<b>100%</b>

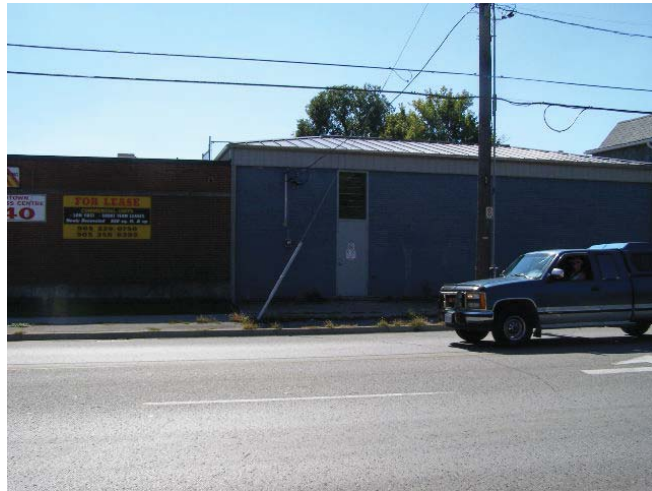
Year Built: 1959

Facility: INDOOR S/S

Equipment Type	Health Index	Weighting - Indoor
1) Transformer	70%	25%
2) Breaker	52%	20%
3) Reclosers	0%	0%
4) Switch Gear	61%	20%
5) P&C	50%	20%
6) Station Service	38%	5%
7) Site & Civil	53%	10%
8) Bus, Switches & Structures	0%	0%
<b>Station Health Index</b>	<b>57%</b>	<b>100%</b>

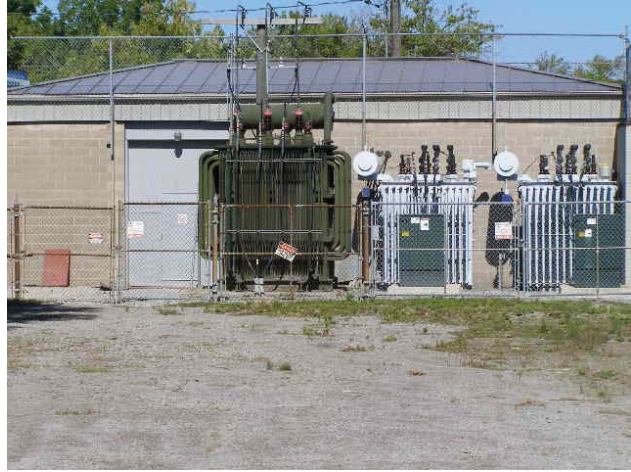
Year Built:

Facility: INDOOR S/S

Equipment Type	Health Index	Weighting - Indoor
1) Transformer	85%	25%
2) Breaker	60%	20%
3) Reclosers	0%	0%
4) Switch Gear	55%	20%
5) P&C	40%	20%
6) Station Service	38%	5%
7) Site & Civil	45%	10%
8) Bus, Switches & Structures	0%	0%
<b>Station Health Index</b>	<b>59%</b>	<b>100%</b>

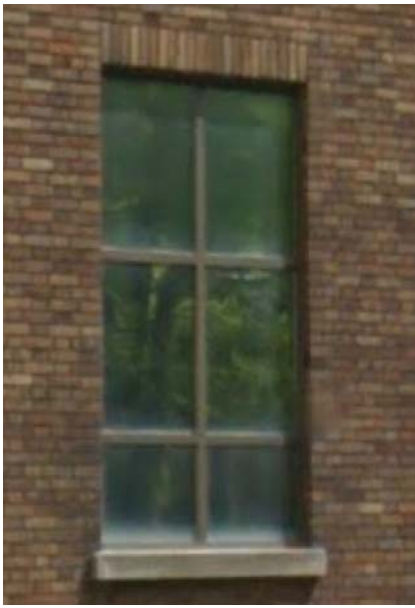
Window 1 - Composite window consisting of 6 fixed vision lites		
LOCATION	- First Floor, West Side, South-facing, adjacent to men's washroom.

TYPE	- Composite aluminum windows consisting of 6 vision lites.	
OVERALL SIZE	- 1562 mm wide by 2616 mm high.	
CONDITION	- Decent condition.	
FRAMING	- Extruded aluminum frame.	
GLAZING	- Laid-in, dual pane, glazed from the interior.	
PERIMETER CAULKING	- There were no cracks in perimeter caulking .

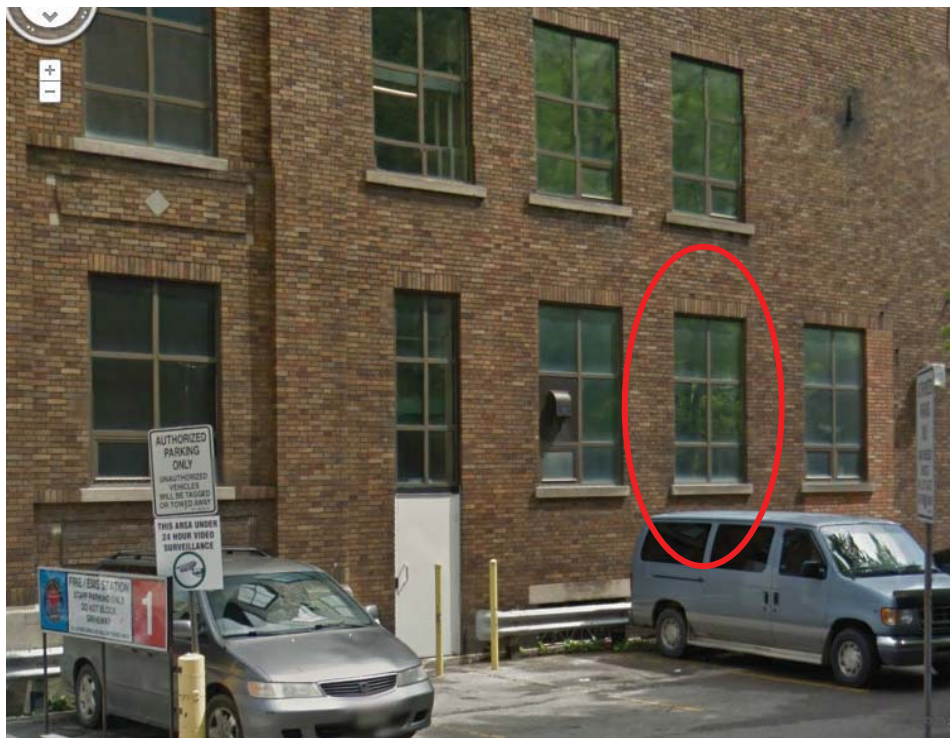
Photo 1. Exterior view of Window 1 (circled in red)

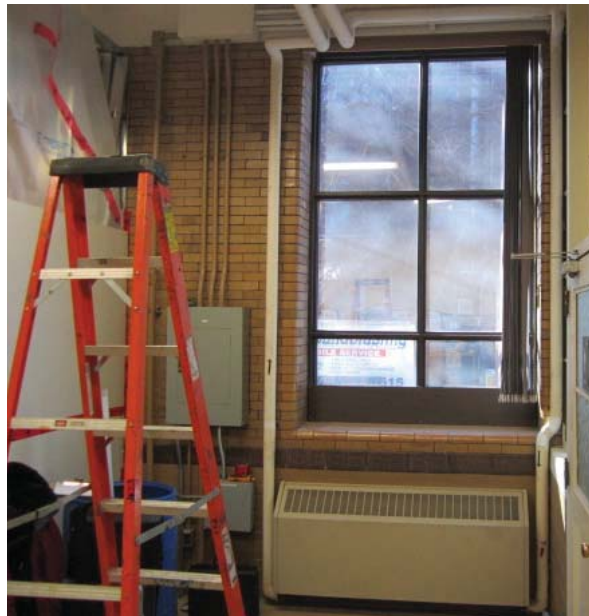
Photo 2. Interior view of Window 1

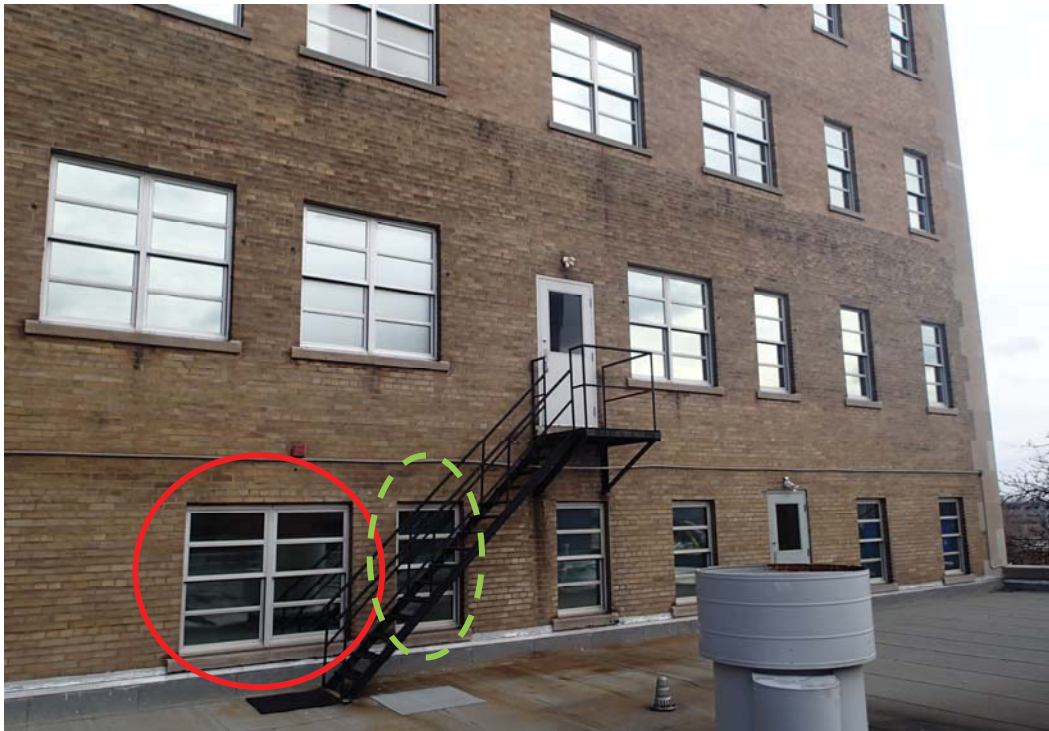
**Photo 3. Exterior view of Window 2 (circled in red) and Window 3 (circled in dashed green)**

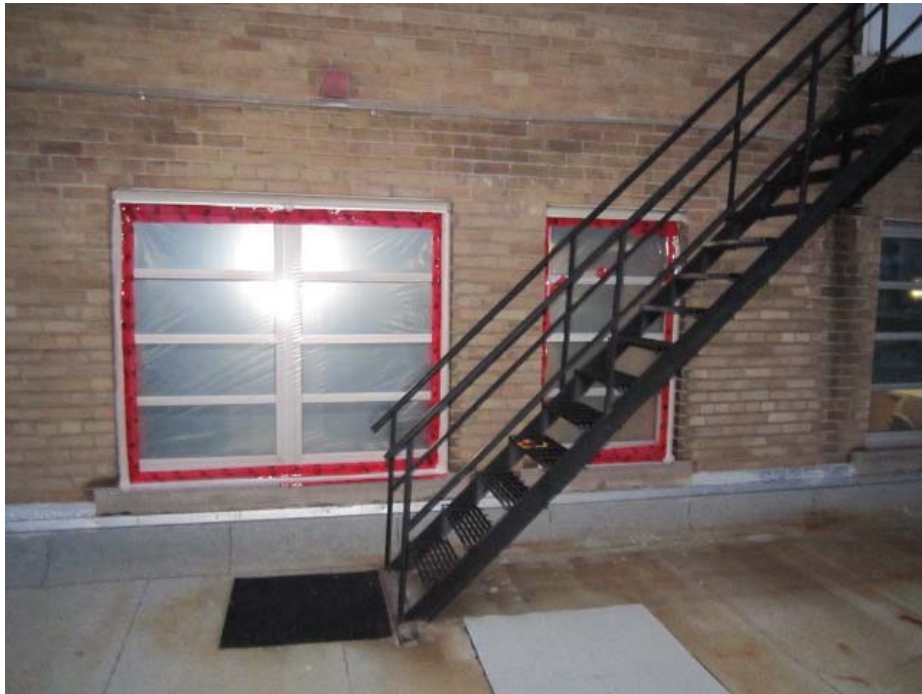
**Photo 5. Exterior view of Window 2 and Window 3 bagged on the exterior (bagged in order to calculate extraneous leakage)**

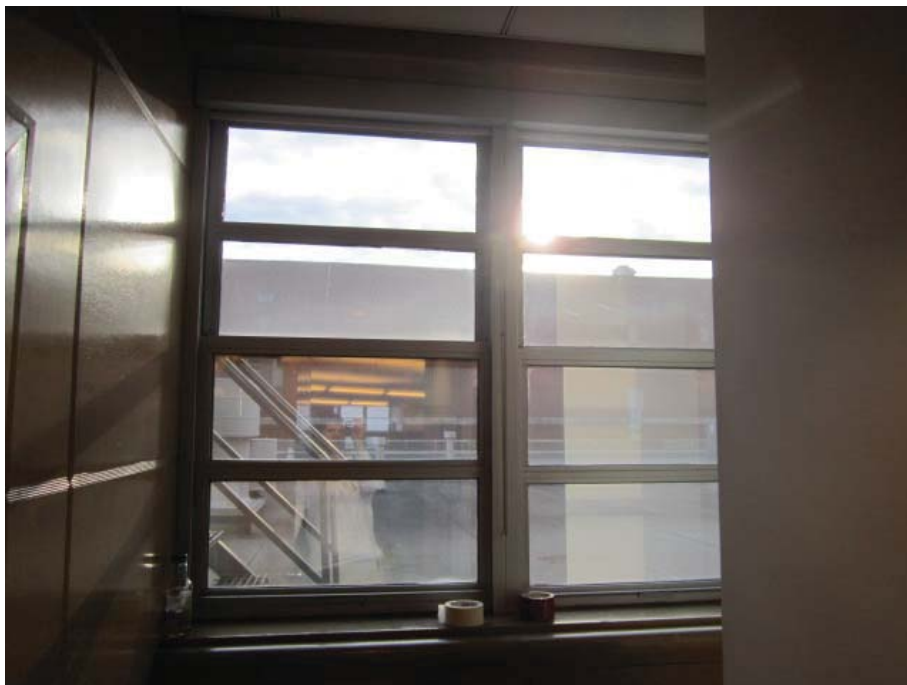
**Photo 6. Interior view of Window 3**
