## **APPENDIX 2-4: HORIZON UTILITIES' DISTRIBUTION SYSTEM PLAN**

Horizon Utilities Corporation

# **Distribution System Plan**

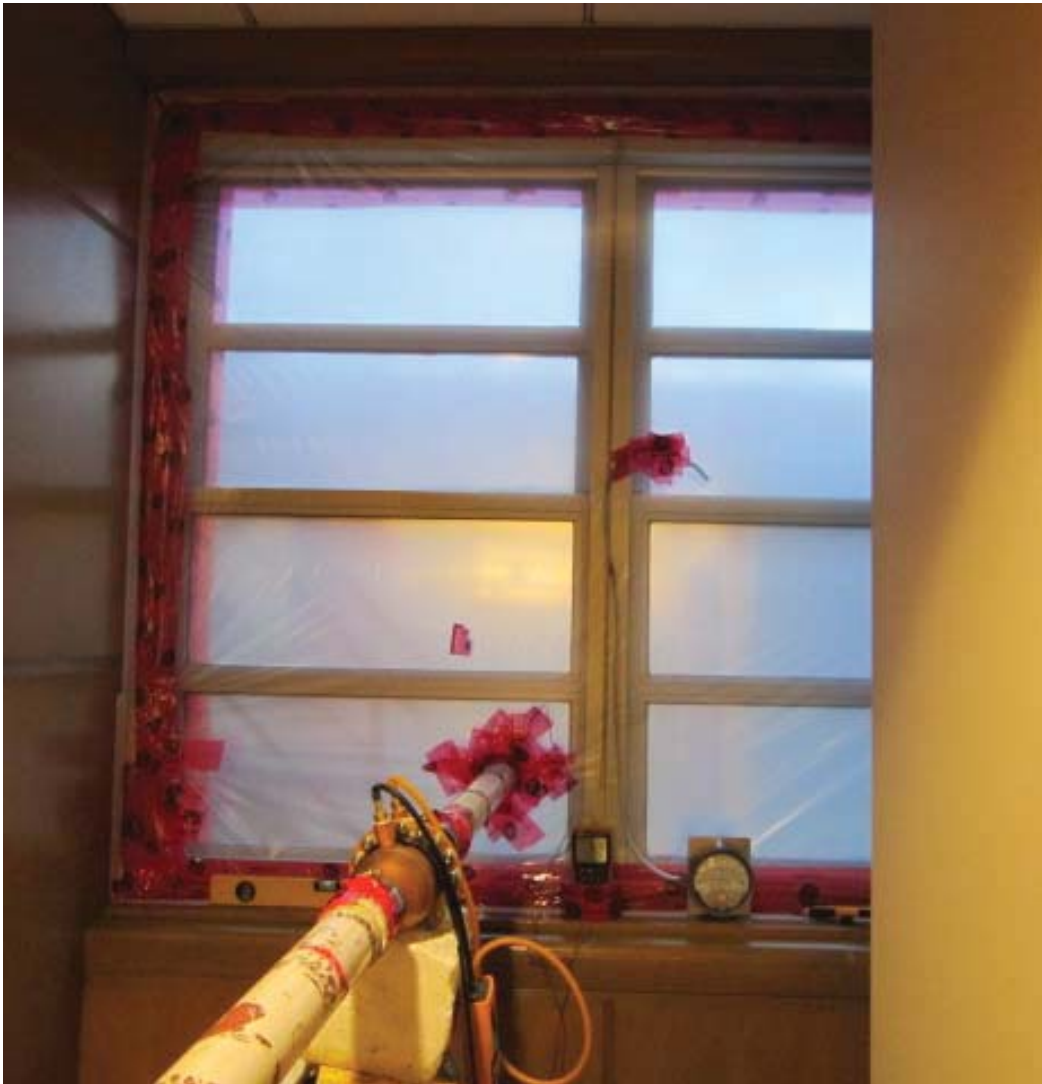
**Photo 7. Interior view of Window 3 being tested for air leakage**

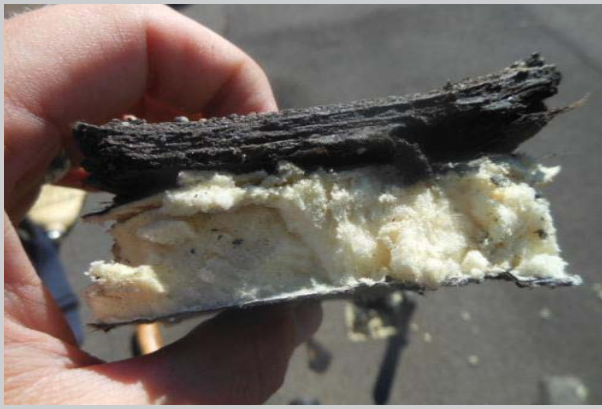
View of core cut reveals 2" polyisocyanurate, 1/8" separation sheet and 2 plies of modified membrane

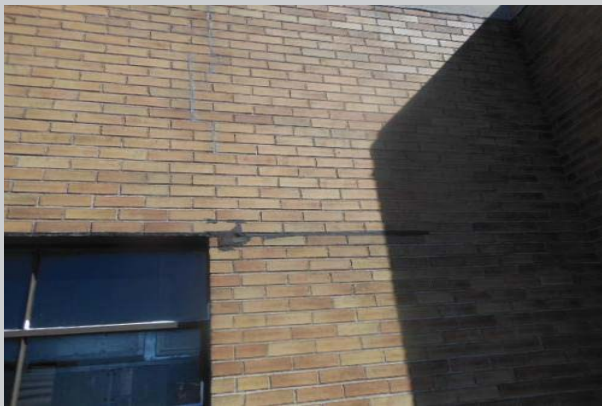
View of brick wall which has been repaired temporarily in the past.

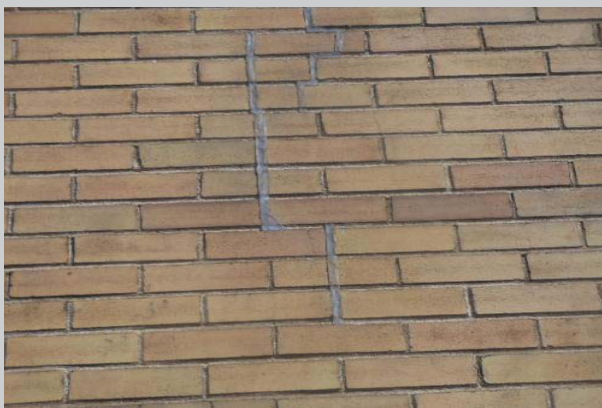
More brick work attempted repairs.

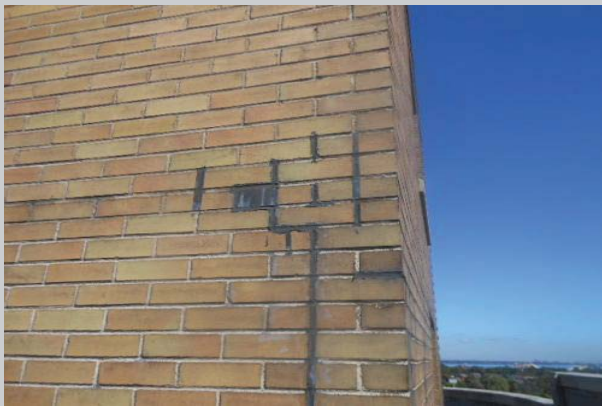
These walls are in very poor shape and should be protected better with new cladding, stucco or a coating.

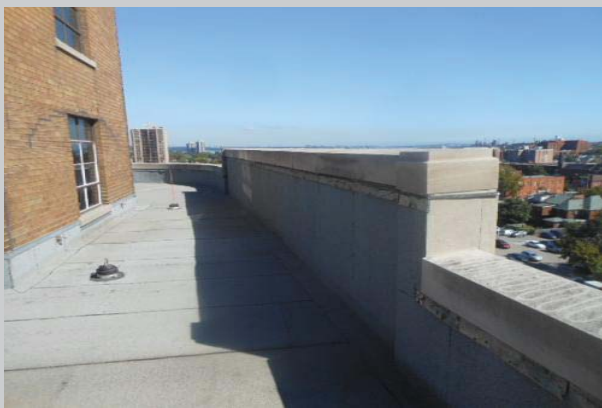
View of the east side of section 4 where an exaggerated cricket/saddle was installed to help with the drainage.

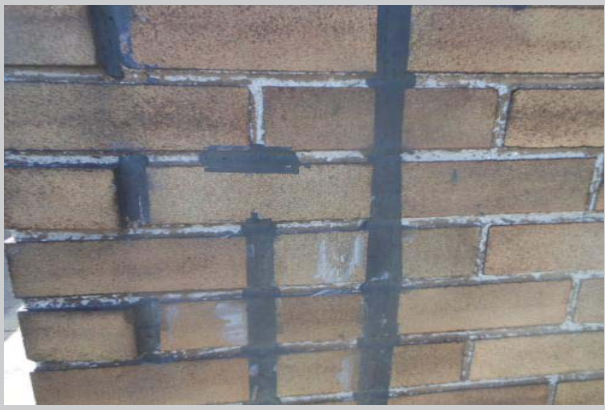
More signs of mortar repairs in the brickwork.

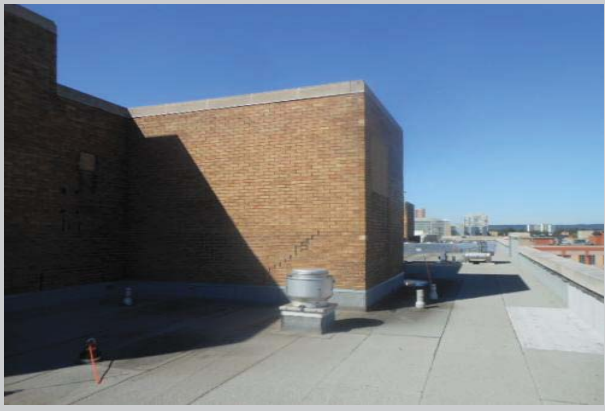
View of the northside of section 4 where a small area was already replaced recently (note lighter grey patch along the perimeter)

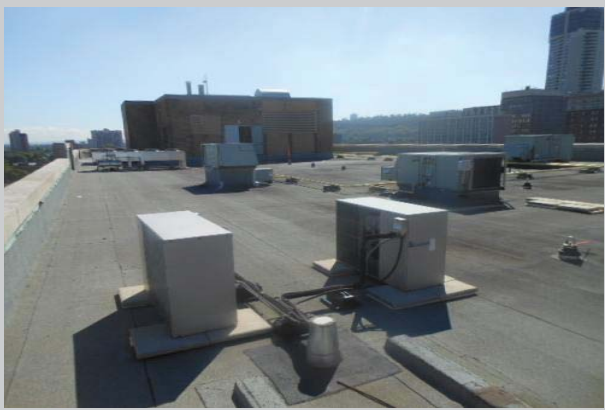
The redundant sleepers should be removed. This is the view from the west side of section 4 facing the east.

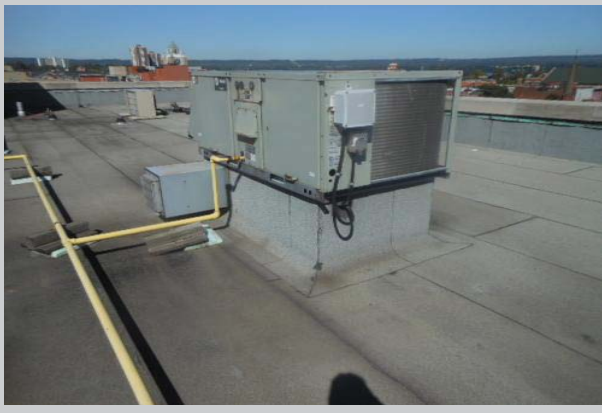
Signs of ponding water to the left of the HVAC unit, towards the middle of the roof section.

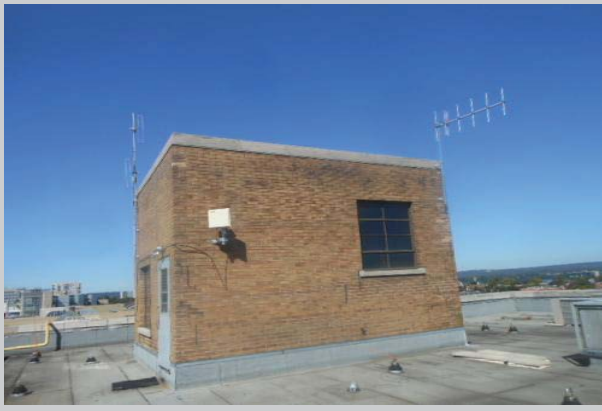
View of penthouse brick work that needs to be better protected as leaks are coming through these walls.

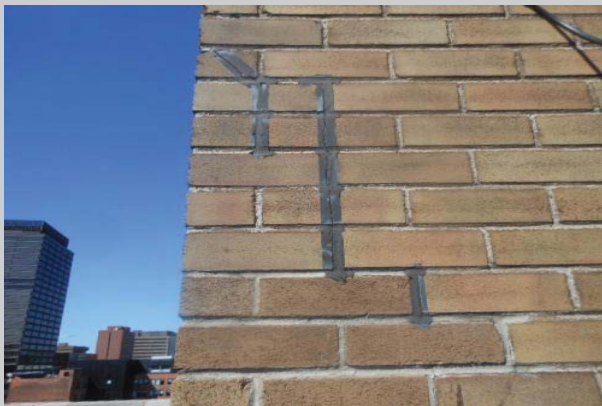
signs of previous attempts to repair the deteriorated mortar in the brick work.

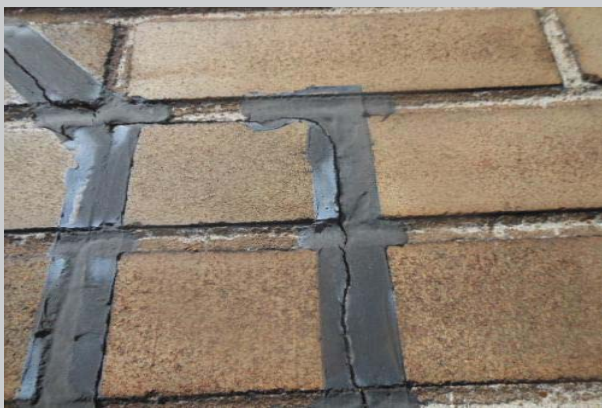
Closer view of current cracks in the brick found in a variety of areas below roof sections 1, 2 and 3.

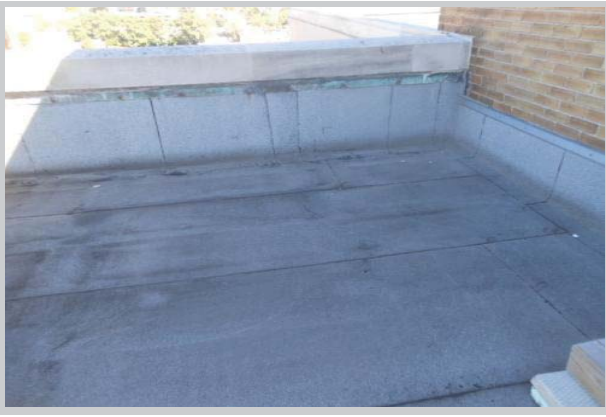
View of badly deteriorated membrane located on the north side of section 3

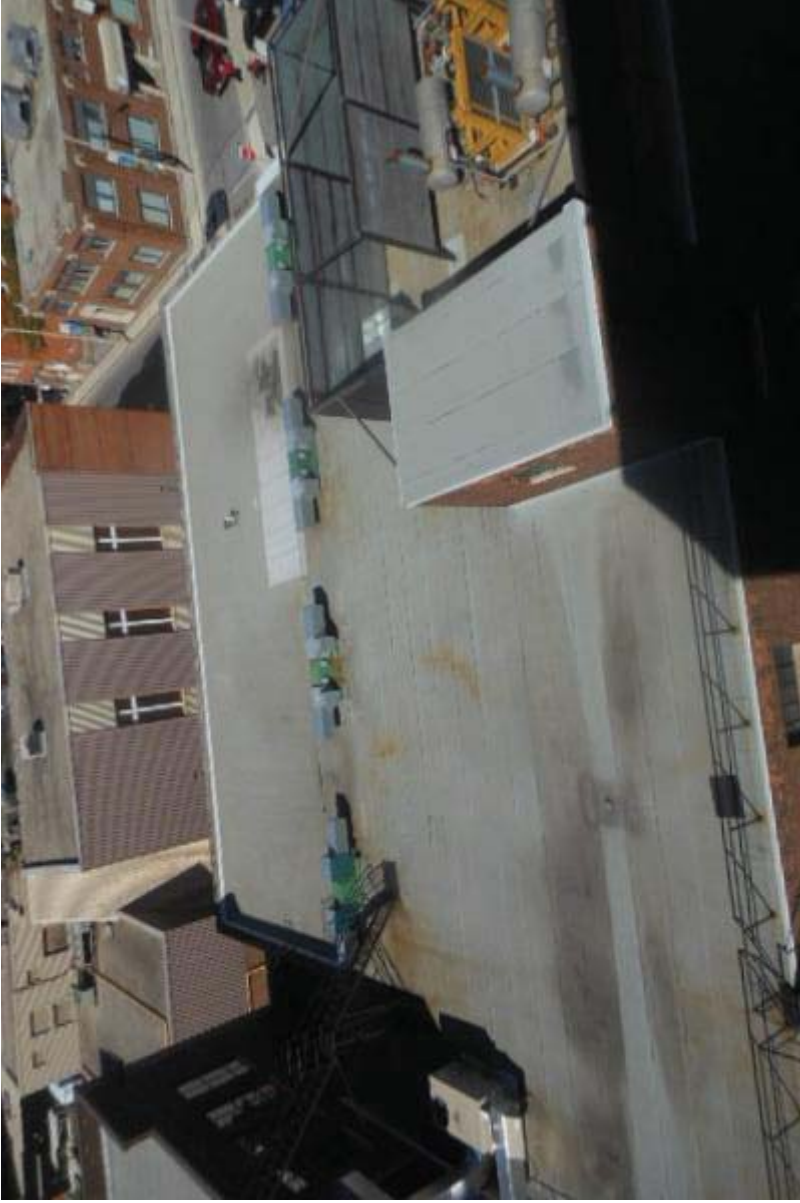
Roof Areas 5, 6, 7, 8, 9 and 10 make up the original Hughson Substation.  
The building is extremely old and has been designated as Historic Building.

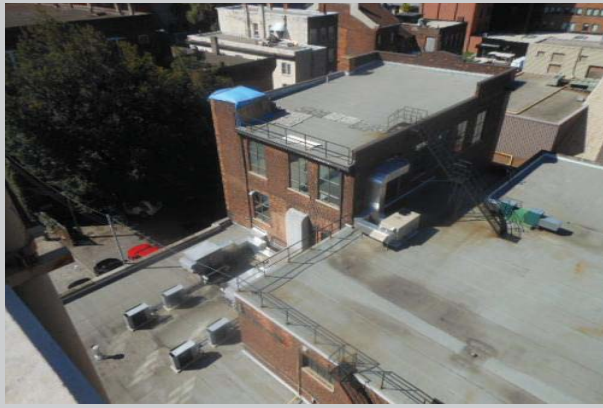
View of section 5, 6 and 8

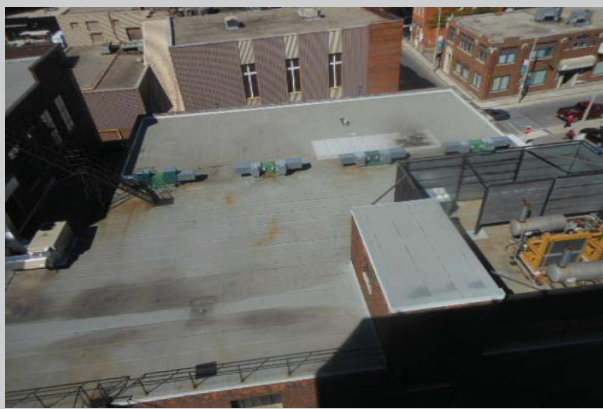
View of section 9, 8 and 7 (starting from the top and moving down, left to right)

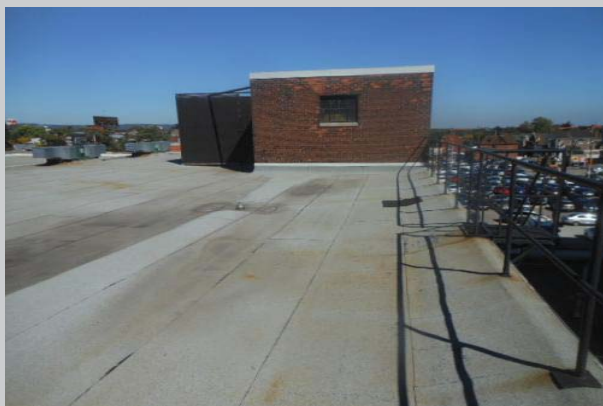
View of section 8 and the poorly installed railing that do not have proper pitch pans (seen on the right). Note the deteriorated membrane in the middle of the roof.

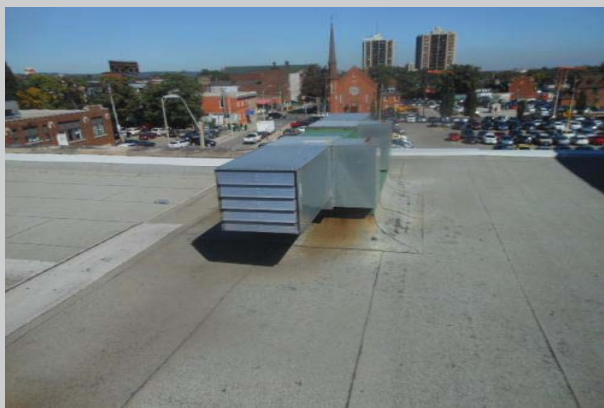
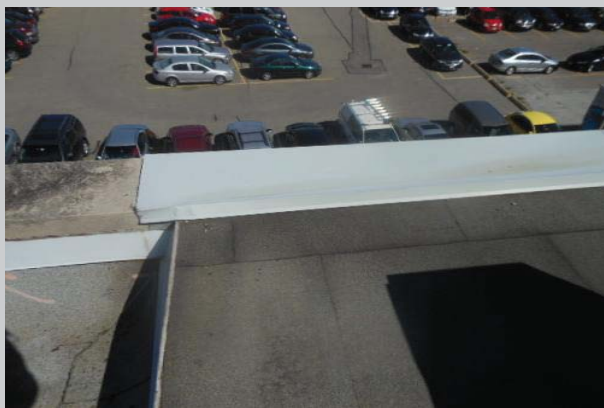
The membrane is in poor shape as seen here on section 8 where it ties into section 9 on the north side.

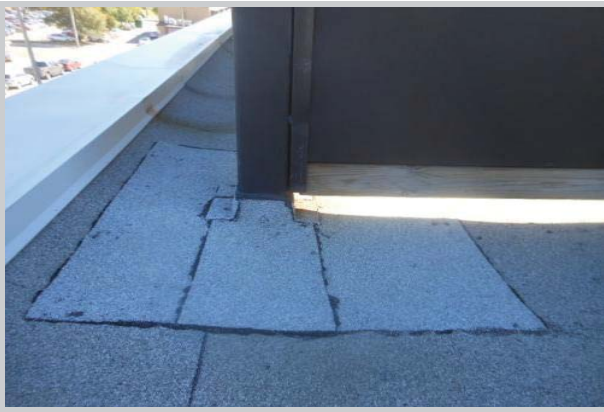
Recently installed new modified membrane where it was leaking at the base of the post.

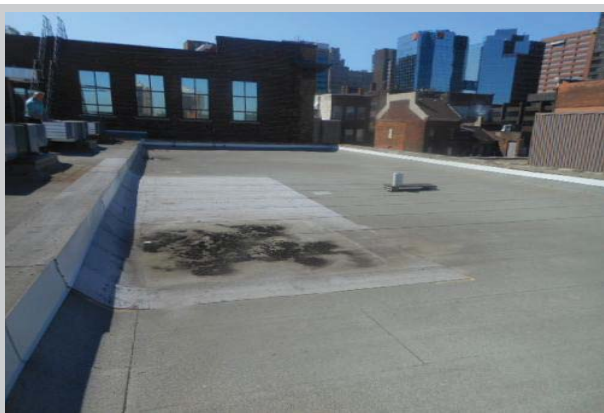
View of ponding water on the left which will only be rectified when tapered insulation is installed.

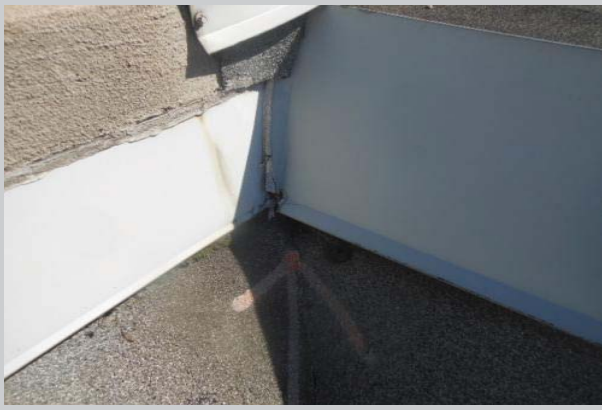
Moss growth seen here where water is getting in behind the membrane/metal flashing above

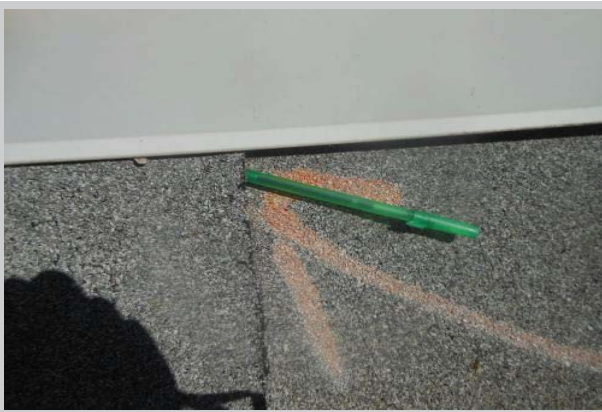
Membrane has delaminated as seen here by the corner of section 9

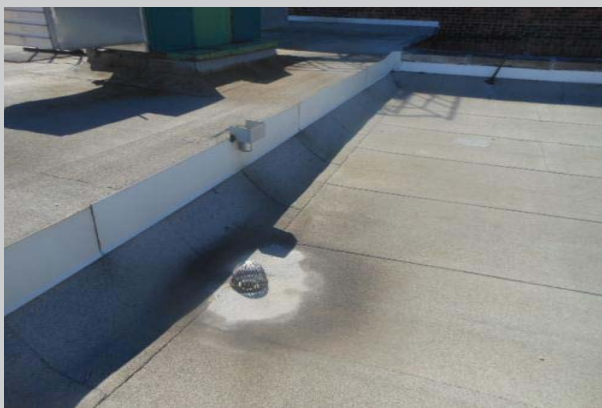
Minerals have badly deteriorated here from excessive water held here.

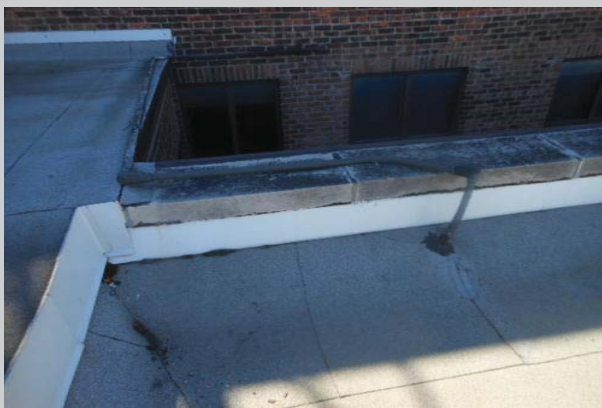
This conduit was not properly installed in a proper pitch pan.

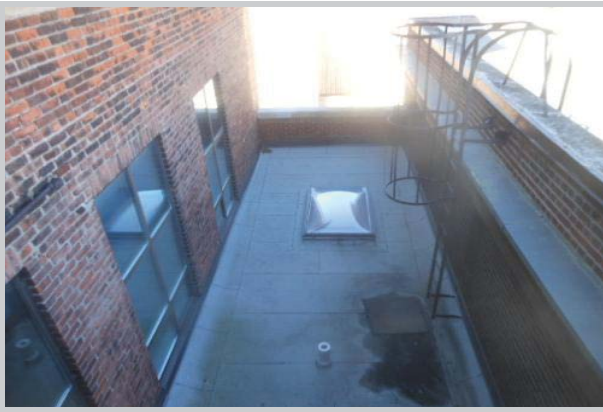
View of section 10, ponding water is excessive on the right

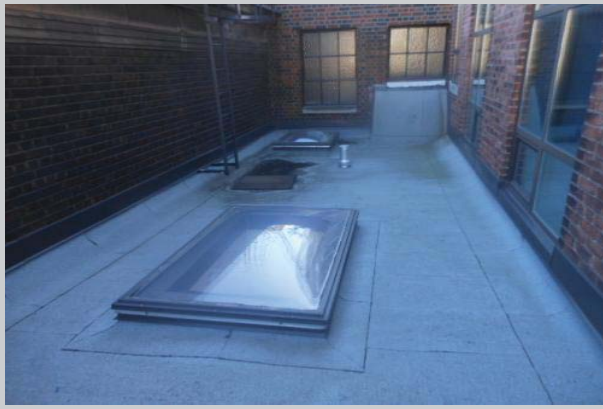
The lower roof #10,  
This roof has already been replaced because of sloppy workmanship and poor quality material.  
The insulation was soaked.  
The roof was replaced in approximately 2007

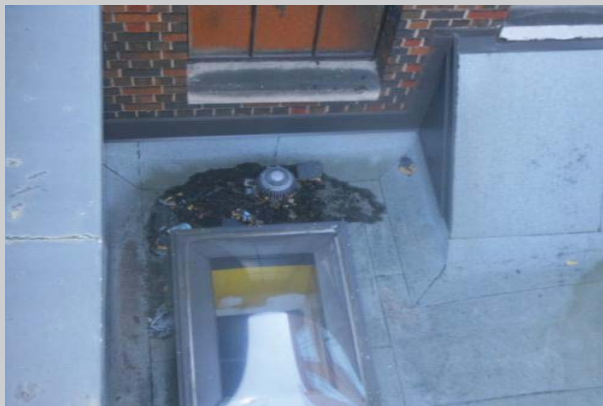
All the debris should be removed from the drain strainer over section 10

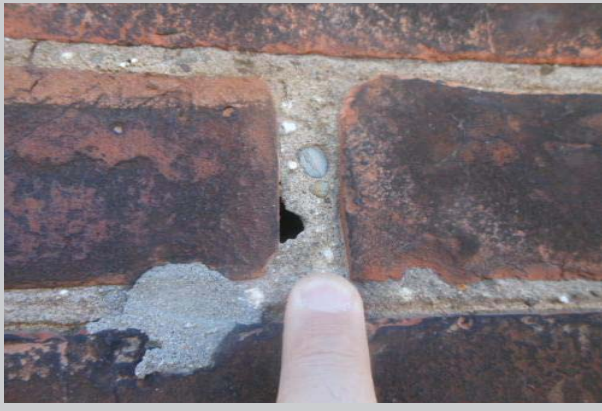
There are some mortar issues along the wall at the lower brick work of section 9

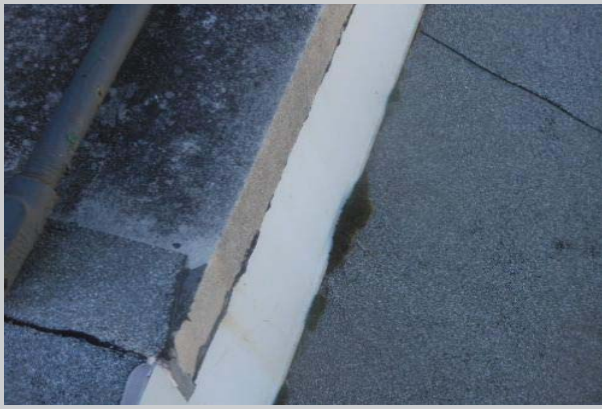
Moss growth from water that is getting from in behind the metal counter flashing.

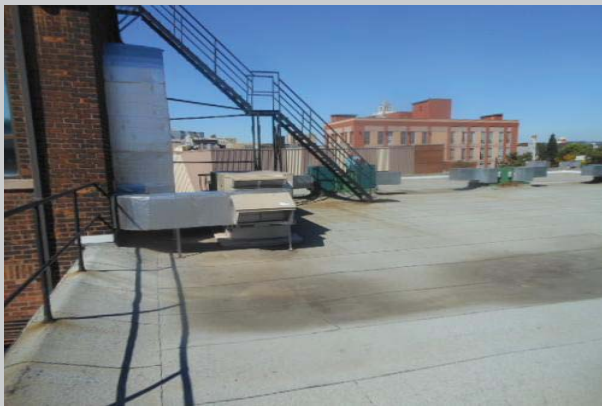
View of deteriorated membrane as seen on the right dark spots

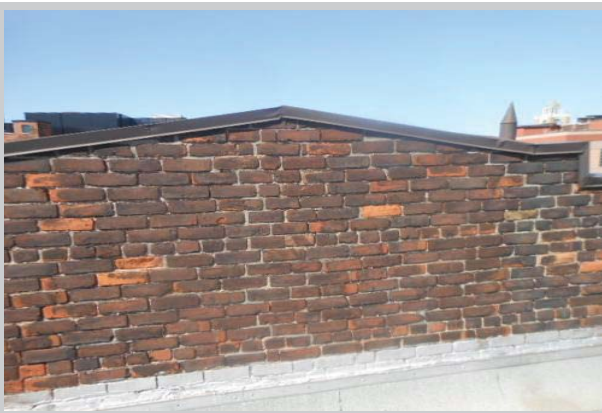
View of parapet wall located on the west side of section 6

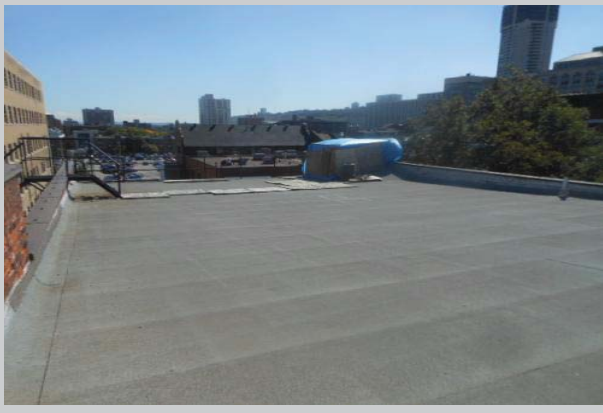
View of section 6 which is sloped 2:12

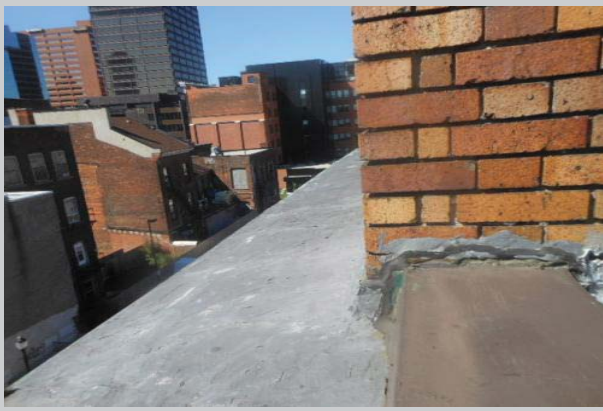
View of canopies that need to be repaired along the southwest corner that wraps around the corner of section 6.

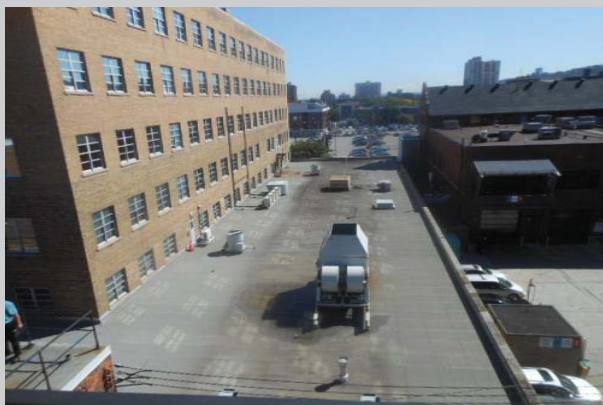
Overview of roof. Note that the middle of the roof shows signs of excessive ponding water. **Ponding:** ponding water occurs as rain or snow melt water collects in large pools on the surface of a roof system. These pools begin to form because of two reasons: (1) roof drains are blocked or clogged with debris, (2) roof drains are built along side building support columns which maintain a consistent height while the rest of the roof system is built on a deck which tends to move and deflect under the downward pressure of weight. In both cases, roof depressions that collect and hold water will tend to grow in size as the added weight of the ponding water will continue to deflect the roof deck even further.

Ponding water has many negative effects on a roof system. The added weight can crush insulation to the point where it becomes a useless thermal barrier - this will cost you big money since your HVAC system will have to work longer and harder to maintain a comfortable interior temperature. In the winter ponding water will expand as it freezes. This expansion will weaken small imperfections in the roof system. Small cracks and tears will widen until they rupture to allow water into the building. Ponding water also accelerates the aging of a roof. The natural waterproofing oils in the asphalt will separate from the membrane if the system remains submerged under water for periods longer than 48 hours. And finally, a negatively deflected deck becomes a structural concern. The deck's tolerances will only accept a limited amount of weight and deflection before it becomes a candidate for a roof collapse

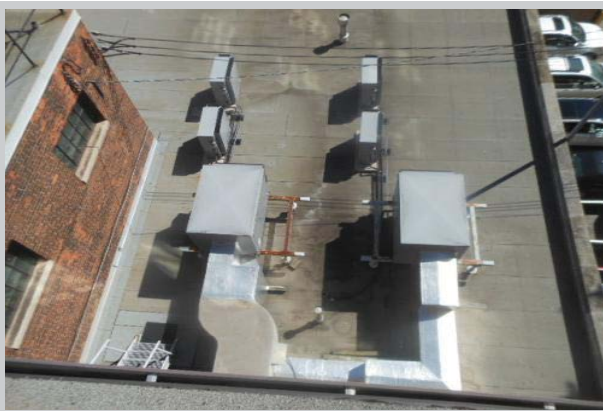
Busy part of roof where there are signs of significant ponding water.

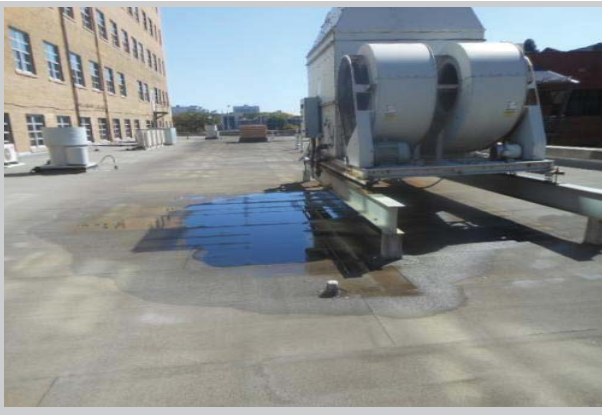
Example of ponding water around one of the larger HVAC units in the middle of the roof.

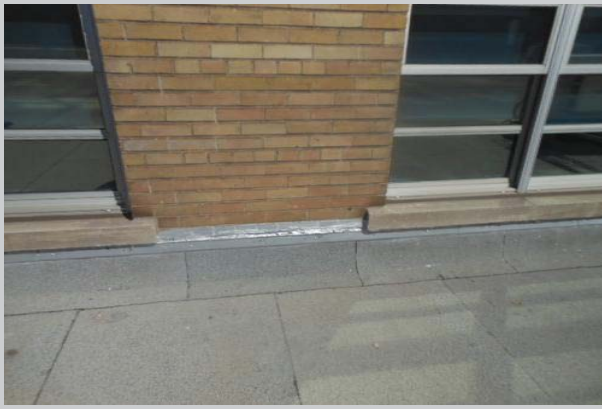
View of perimeter flashing along the base of the windows

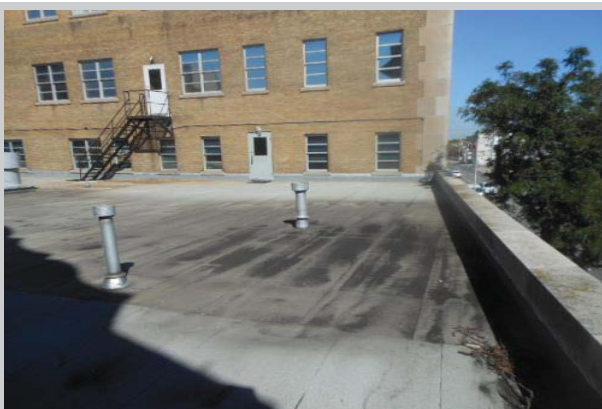
Signs of extreme ponding water. **Ponding:** ponding water occurs as rain or snow melt water collects in large pools on the surface of a roof system. These pools begin to form because of two reasons: (1) roof drains are blocked or clogged with debris, (2) roof drains are built along side building support columns which maintain a consistent height while the rest of the roof system is built on a deck which tends to move and deflect under the downward pressure of weight. In both cases, roof depressions that collect and hold water will tend to grow in size as the added weight of the ponding water will continue to deflect the roof deck even further.

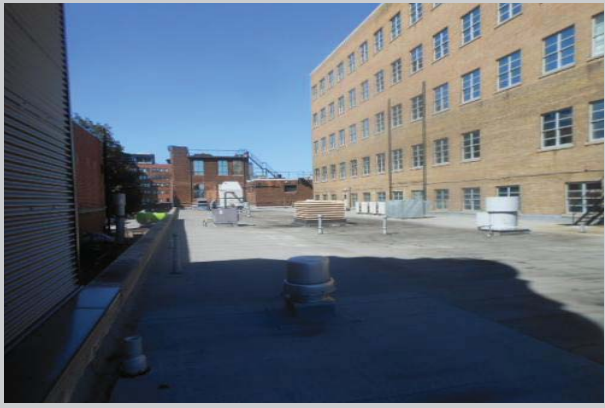
View of small area which was recently replaced.  
A wall from the firehall fell and collapsed the deck.

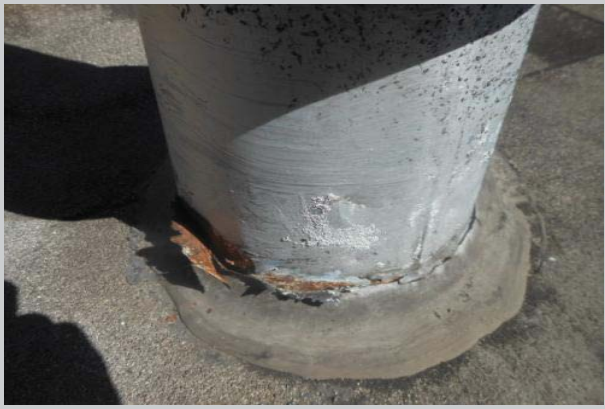
This cone will need to be replaced as the corrosion here has badly deteriorated the base.

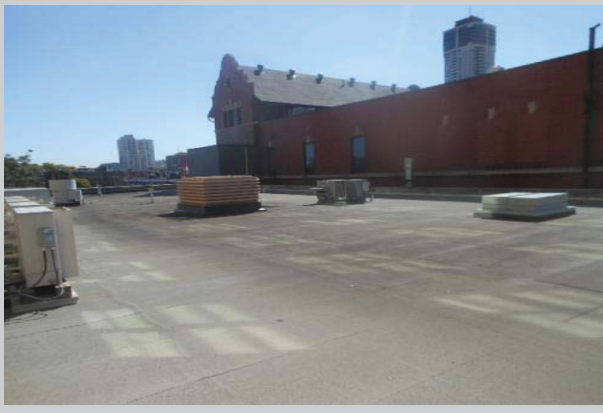
View of roof shows that the perimeter by the windows was tapered to the middle, however, the drains are not receiving the water well here.

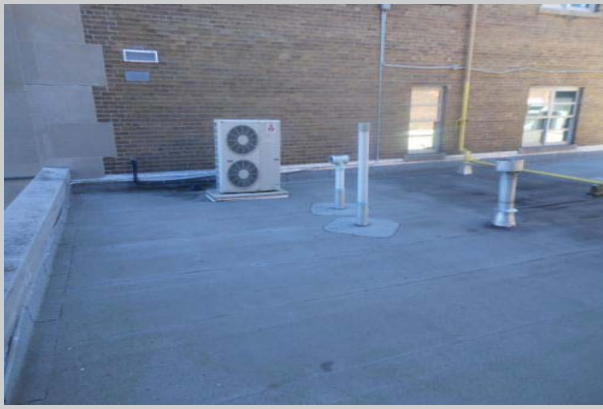
View of small part of section

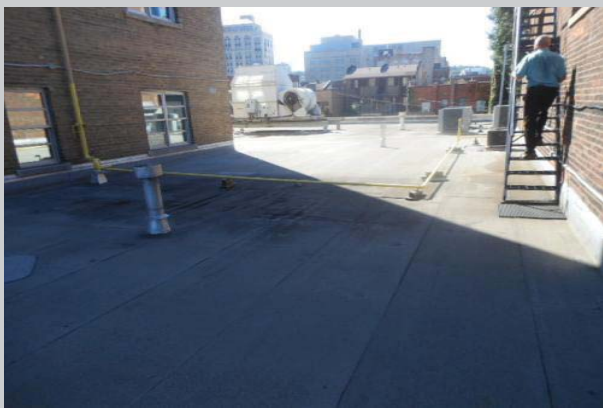
Another view of small part of section that leads to the stairs to section 8

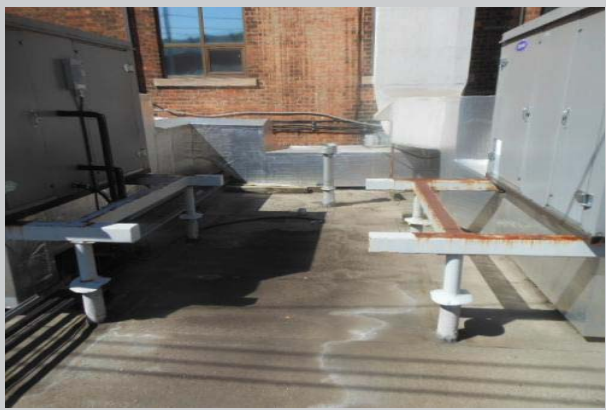
View of ponding water between the large units on section 11

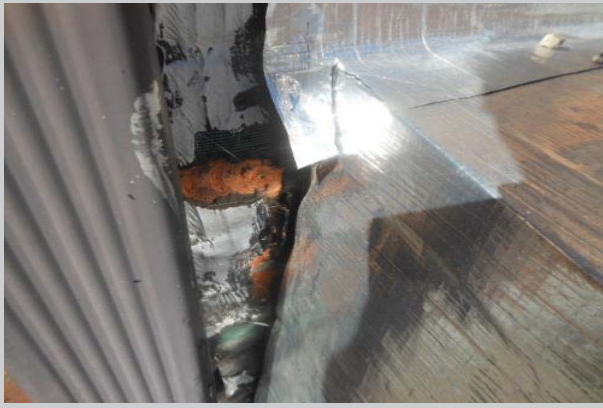
This detail around the HVAC unit that ties into the wall needs to be repaired.

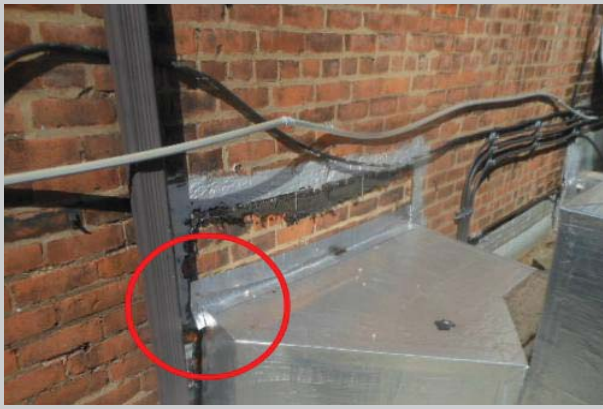
Area that needs to be repaired.

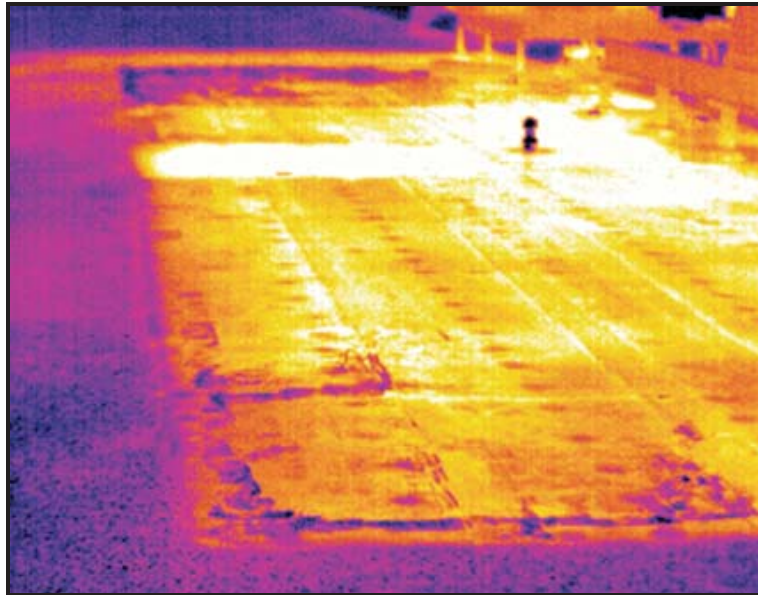
*When moisture penetration is suspected, analytical testing of a core sample may be required.  
This infrared scan reveals wet insulation that visual inspection alone could not detect.*
