**RE: EB-2016-0160 Hydro One Networks Inc. ("Hydro One") Transmission Rates
Application – Responses to Undertakings J3.3, J5.3, J6.1, J6.4, and J6.5**

UNDERTAKING – J3.3

TO PROVIDE FIGURE 10 OF THE NAVIGANT REPORT SHOWING JUST SUSTAINMENT CAPITAL

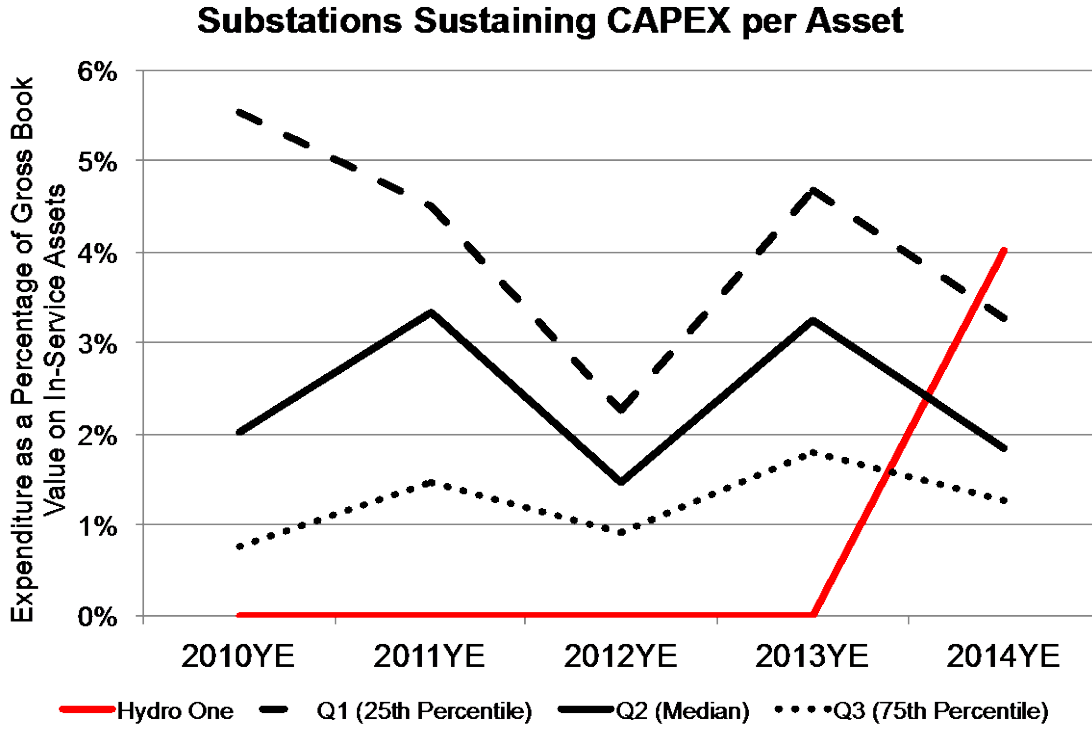
1 The figure below provides the results from Figure 15 of the Navigant report, but showing
2 only the Sustaining CAPEX, rather than Total CAPEX.

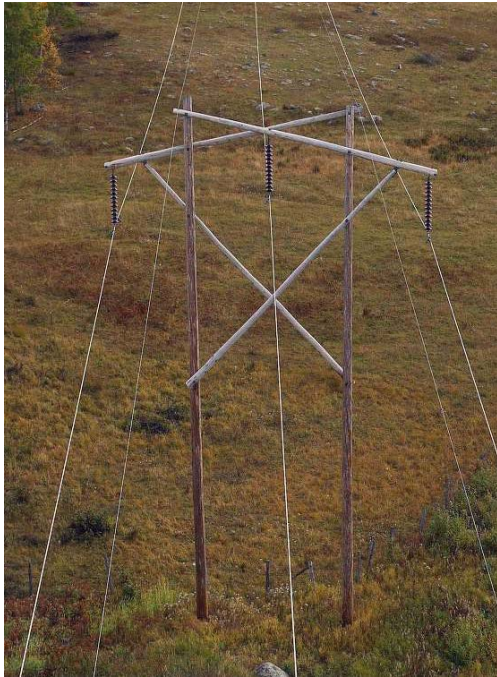
**Figure 7-1 – I-Suspension
(K23D, structure 4, 230 kV, porcelain)**

These materials, types and configurations are illustrated in Figures 7-1 through 7-6. A detailed asset description and history can be found in [6] and [7].

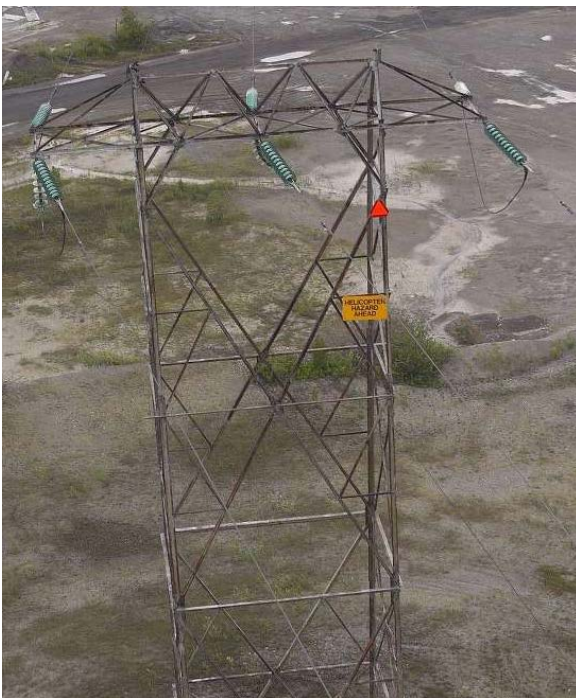
**Figure 7-3 – Dead-end with Idler
(C1P, structure 34, 115 kV, glass)**

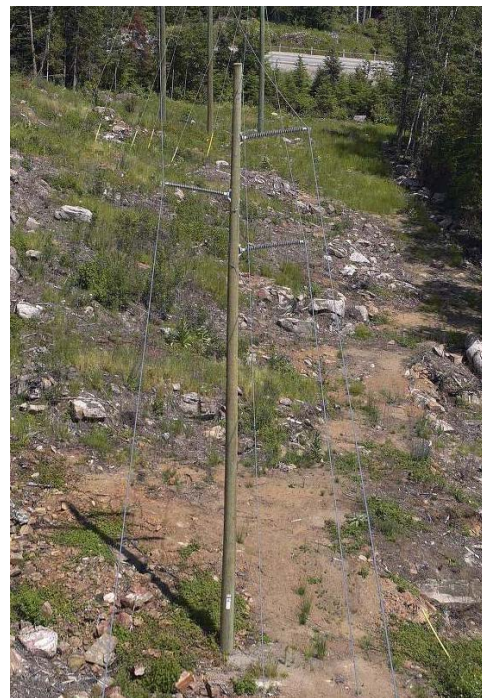
**Figure 7-4 – Post
(L5H, structure 444A, 115 kV, polymer)**

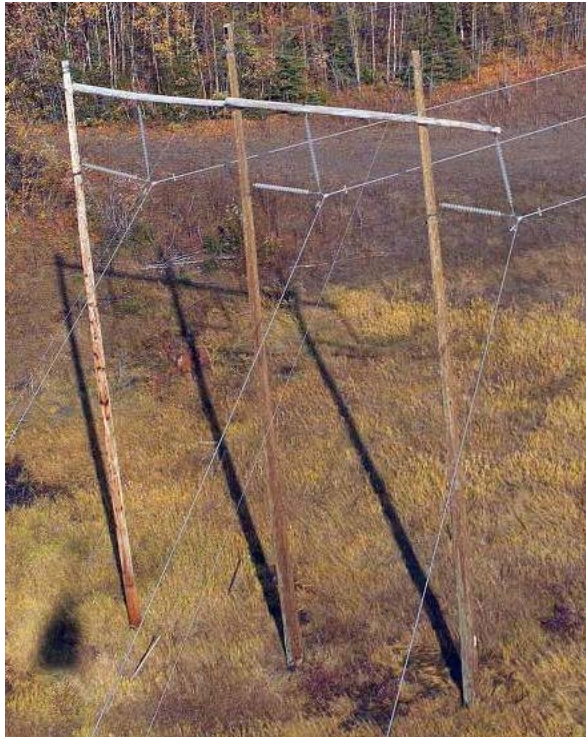
**Figure 7-5 – Semi-Strain
(L21S, structure 4, 230 kV, polymer)**

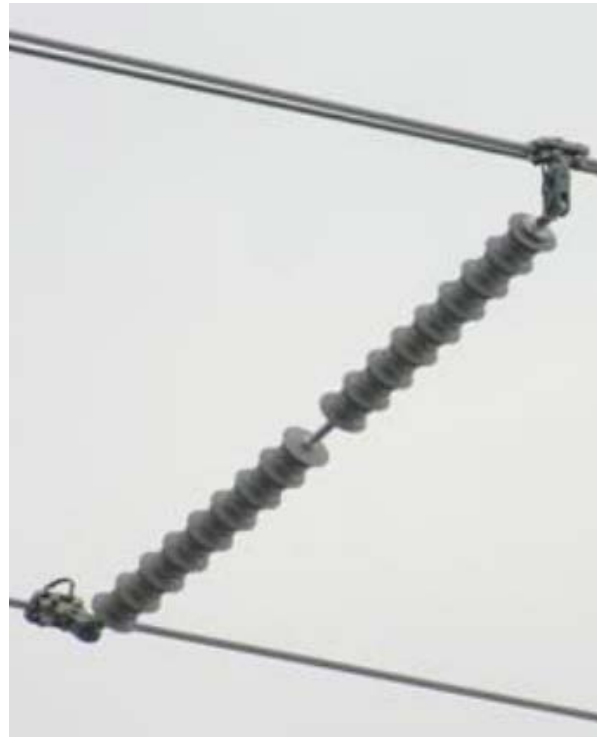
Figure 7-6 – Inter-Phase Spacer

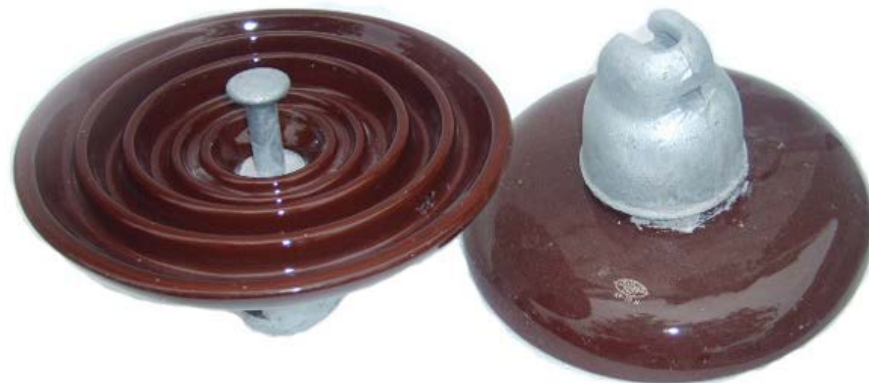
- Glaze Glass-like layer covering the porcelain. It provides a smooth surface and to adds strength to the porcelain shell.
- Cement Grout used to attach the hardware (pin and cap) to the shell.
- Bituminous /
Varnish Coating Protective coating between the pin/cap and cement.
- Pin Bottom metallic part of the insulator. Used to connect units (ball/socket connection) or conductor attachment hardware.
- Ball Term describing the shape of the lower part of the pin.
- Cap The top metallic part of the insulator. Used to connect units (ball/socket connection) or conductor attachment hardware.
- Socket Term describing the cavity in the cap.
- Sand Band Region where sand has been applied between the porcelain shell and cement.

Figure 7-9 - Porcelain Suspension Insulator Unit

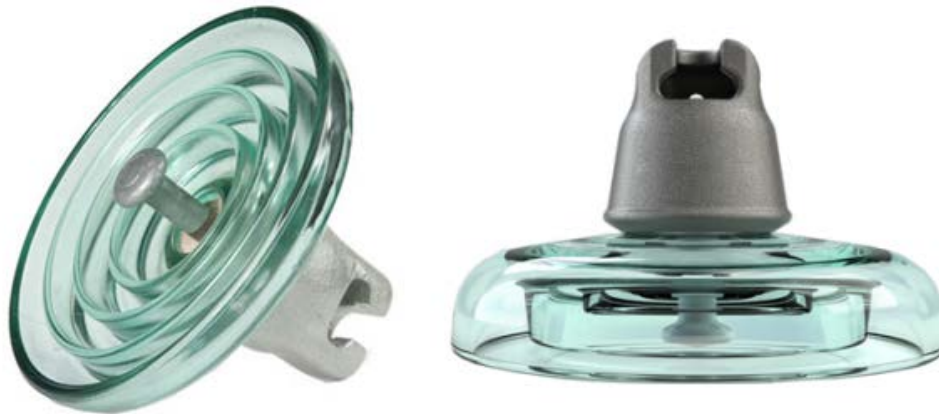
Figure 7-11 - Glass Suspension Insulator Unit

Glass insulators were developed in parallel with porcelain but initial designs using annealed glass were unsuccessful due to their lower mechanical shell strength. The first successful practical design was not implemented until 1930 when toughened glass was used to overcome the strength issue. Glass insulators were commonly installed from 1947 onward and have been applied to voltages up to 1,000 kV [6]. With the exception of the insulating material (glass), glaze (porcelain specific) and sand band (porcelain specific); glass insulators are identical to porcelain in structure and design. A typical glass insulator is shown in Figures 7-10 and 7-11.

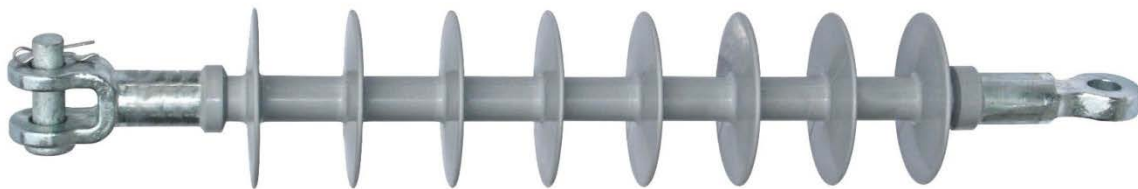
Figure 7-12 – Polymer Suspension Insulator

The first polymer insulator designs were established in the 1960s and installed during the 1970s. Initial designs were plagued with problems and especially suffered from material-aging effects. By the 1980s designs were improved and polymer became generally accepted and used in large numbers on transmission lines. They have been used worldwide on voltages up to 765 kV [6]. HONI began installing polymer at 115 and 230 kV in the mid-1980s. Polymer line insulators are not installed at 500 kV. A picture and schematic drawing is shown in Figures 7-12 and 7-13. Fundamental components include:

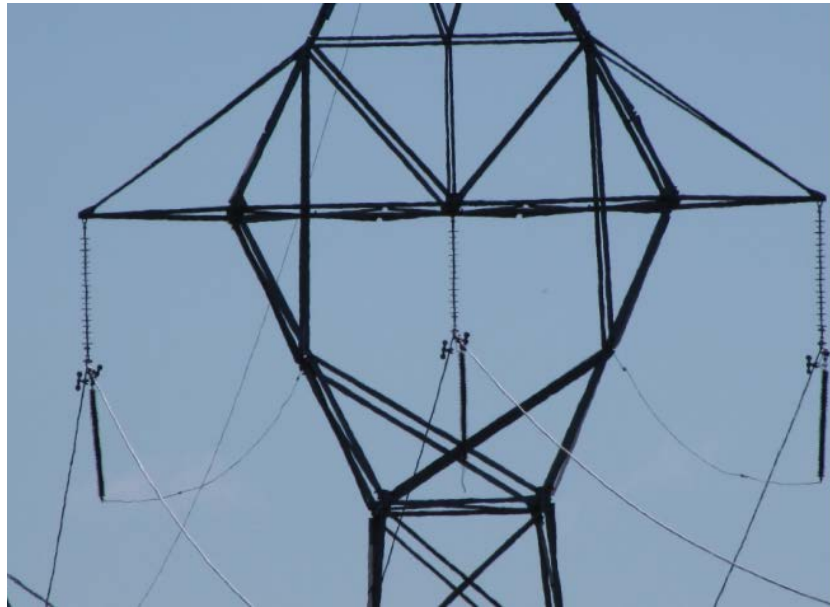
Figure 7-16 - Arrester Configuration – Suspended from Conductor (A1B, structure 2, 115 kV)

These configurations are shown in Figures 7-15 and 7-16. Installation configuration is dependent on clearances and work-methods used. Figure 7-17 illustrates fundamental arrester components.

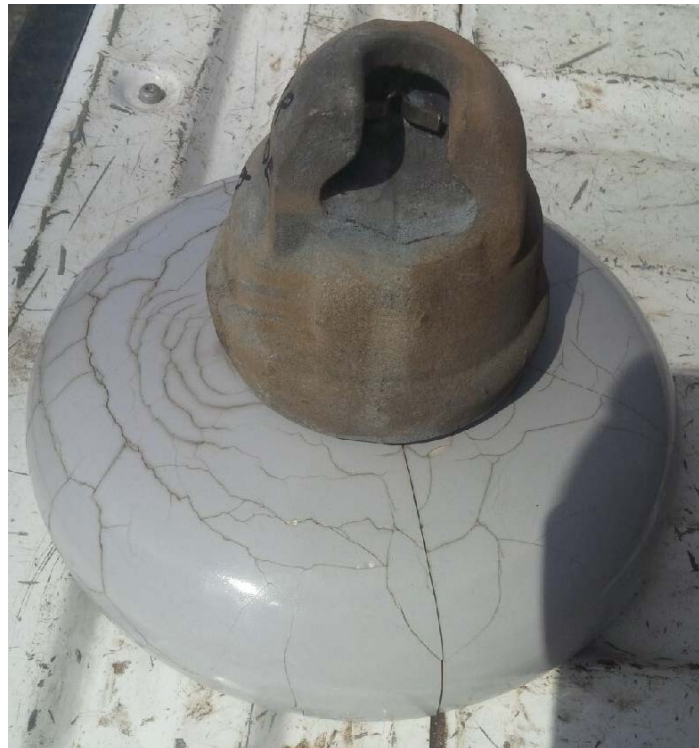
Figure 8-1 - Porcelain Insulator Unit Affected by Cement Expansion (V79R, Structure 50E, April-2015)

It is well known that insulators manufactured by Canadian Ohio Brass (COB) and Canadian Porcelain (CP) between 1965 and 1982 suffer from a phenomena known as cement expansion or cement growth. The purpose of the cement is to bond the pin to the porcelain, refer to Figure 7-10. Cement expansion creates radial cracks in the cement and porcelain shell resulting in two possible failure modes:

This phenomenon is illustrated in Figures 8-1 and 8-2.

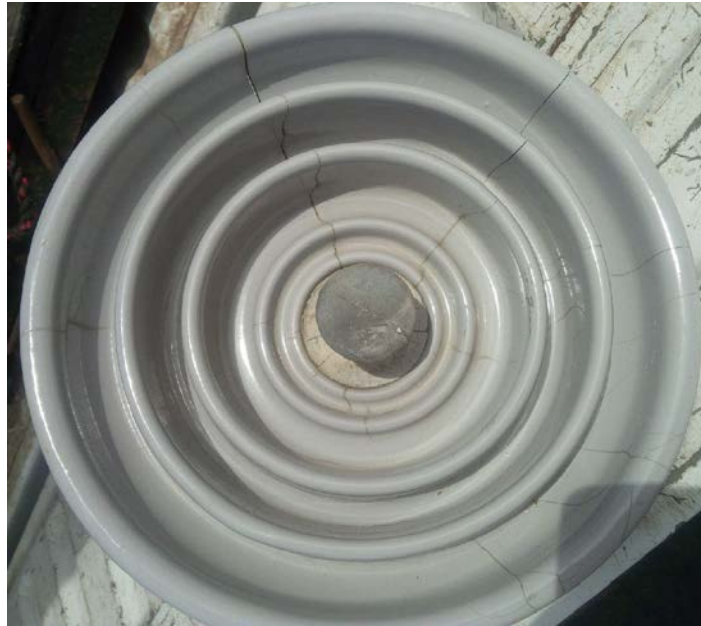
Figure 8-2 - Porcelain Insulator Unit Affected by Cement Expansion (V79R, Structure 50E, April-2015)

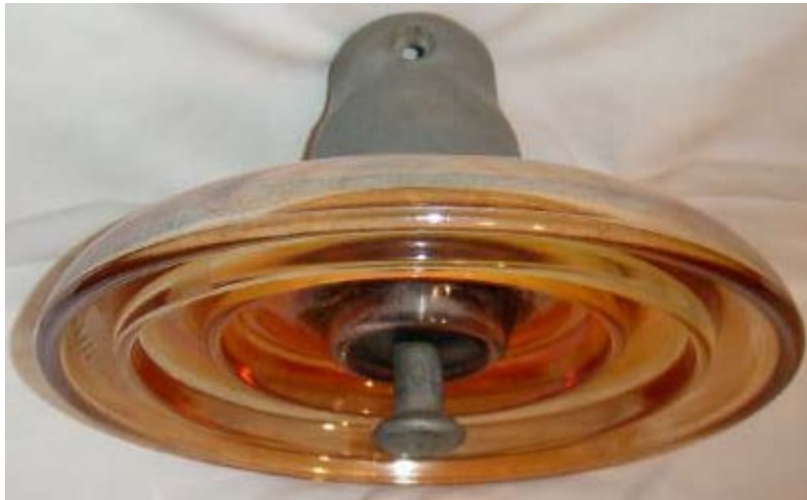
Glass insulators manufactured by the Pyrex Corporation do not use toughened glass. Therefore, these insulators must be evaluated using the same methodology as porcelain, since punctures may not cause shattering. Pyrex insulators can be identified by their translucent, brownish colour, compared to the clear or greenish tint normally found in glass insulators. A Pyrex glass insulator is shown in Figure 8-3.

Figure 8-3 - Pyrex Glass Insulator

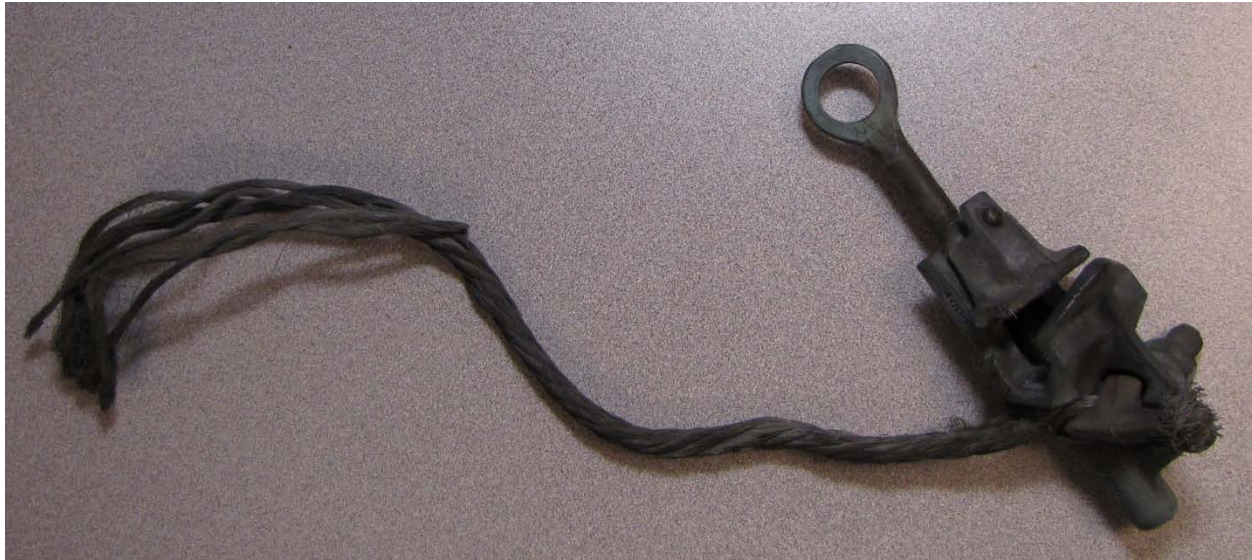
Figure 8-4 - Failed Arrester Bond Wire

Arrester bond wires, typically stranded tinned copper conductor, fatigue over time, especially if under tension, resulting in failure. This failure mechanism is exacerbated by wind-induced motion. Examples of failed and frayed bond wires are shown in Figures 8-4 and 8-5. New arresters address this issue by weaving the bond wire through a chain, alleviating bond wire stress.

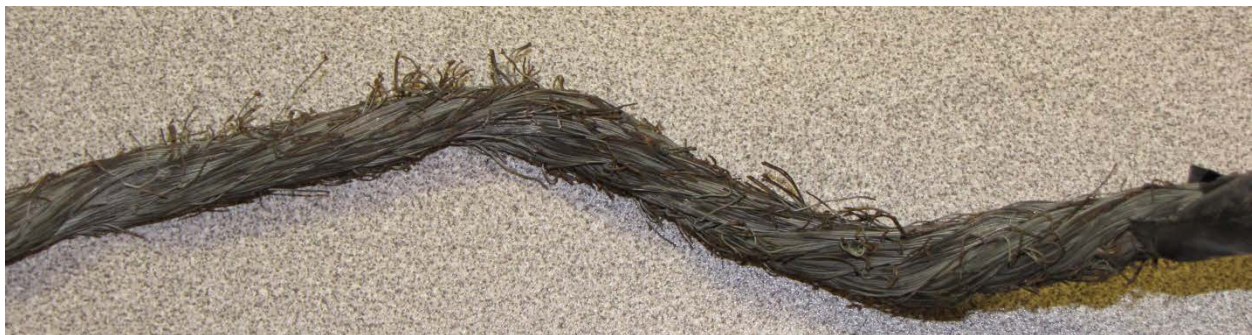
Figure 8-5 - Frayed Arrester Bond Wire

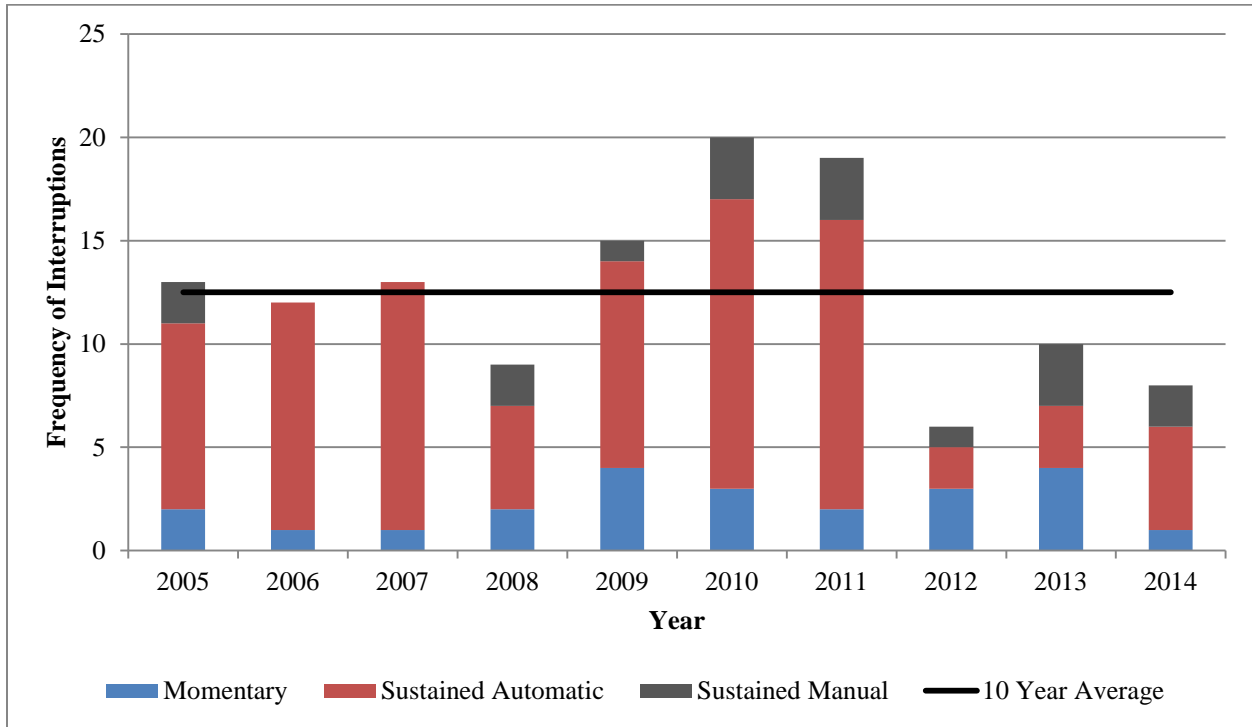
Figure 10-2 – Insulator Frequency of Interruption

Figures 10-2 and 10-3 illustrate the frequency and duration insulator caused forced interruptions between 2005 and 2014 and is summarized in Table 10-1. Outage data does not identify insulator type (ie. porcelain, glass or polymer) or root cause. Detailed data is not available through the Transmission Outage Data System (TODS). The accuracy

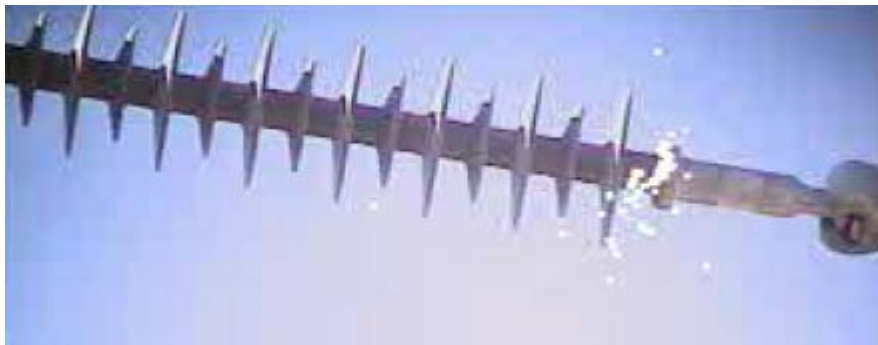
Figure 11-1 – Corona Activity

system components (especially polymer insulators). Corona at the energized end fitting of a polymer insulator is shown in Figure 11-1.

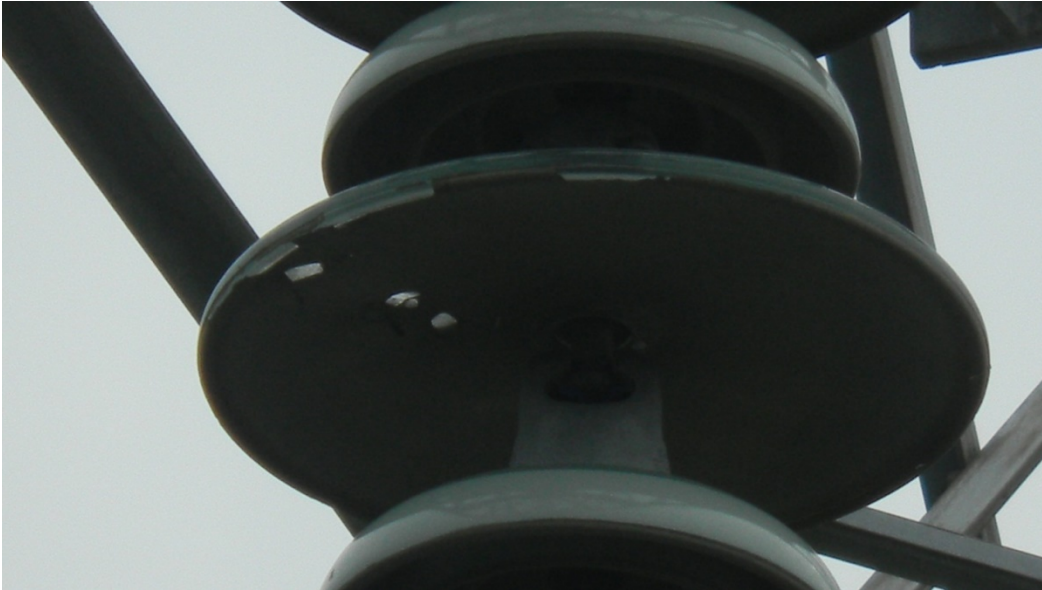
Figure 11-2 - Silicone on Glass Insulator

Polymer coated or silicone on glass insulators are conventional glass insulators coated in a silicone layer. See Figure 11-2. The silicon adds hydrophobic properties improving its ability to withstand contamination. For evaluation purposes, Sediver’s silicone on glass insulators were trialed on M570V structure 109B and M571B structure 109 in 2012. This area is subject to significant contamination (near Highway 407) and requires frequent insulator washing. Trial insulators were not washed. In 2015 they were visually inspected. The polymer coatings appeared to be in good condition, no significant aging or deterioration was observed. The colour of the polymer had changed from the original light gray to dark gray but this may be due to contamination build up. It was noted that the coating is extremely delicate and it is almost impossible for it not to damage during transportation, handling and installation. This technology is still under evaluation. Refer to Figure 11-2

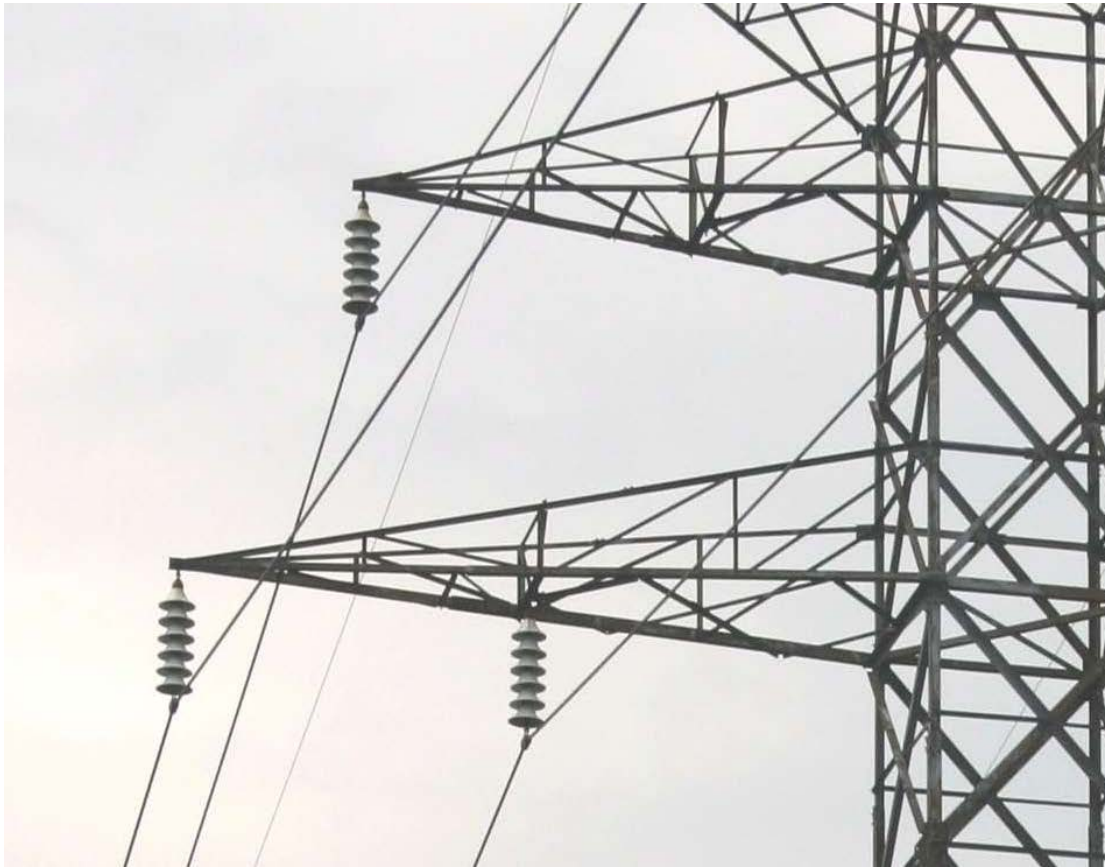
**Figure 12-1 - Semi-conductive-Glaze Bell-Shaped Insulators
(C14L/C17L, str 7, 230 kV, porcelain)**

In the early 1970s, Ontario Hydro Research developed a novel insulator design, semi-conductive-glaze bell-shape (SGB), as part of their compact line R&D program [18] [19]. These insulators can be seen in Figure 12-1. A semi-conductive glaze in combination with a redesigned insulator shape reduced string lengths by 50% and allowed 230 kV lines to be constructed to 115 kV clearances. While SGBs proved successful for Ontario Hydro, they have not been used for some time and it is not known whether other utilities adopted the design.

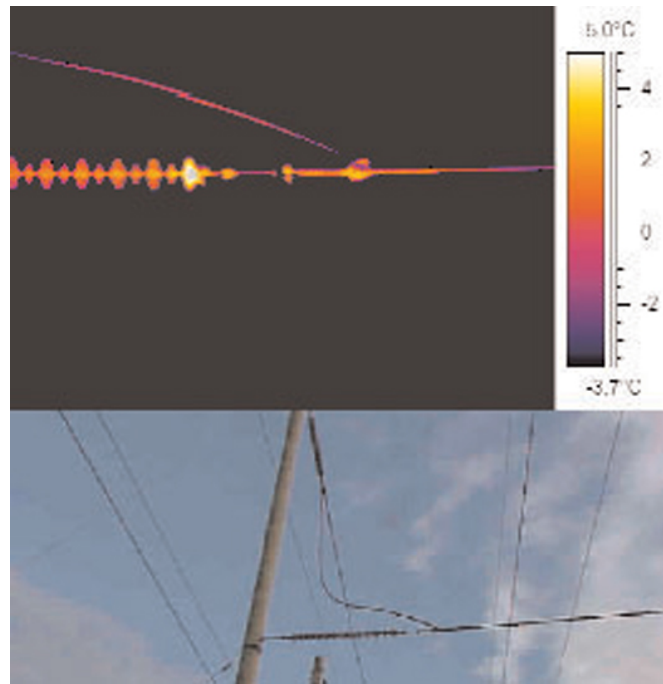
Figure 12-2 - Polymer Insulator Temperature Anomaly

IR thermography is a common technique used by utilities to assess polymer. It is particularly sensitive to developing defects between the housing and core. Generally, any polymer insulator showing a heat rise on the shaft is tracking internally. Figure 12-2 illustrates a temperature anomaly.

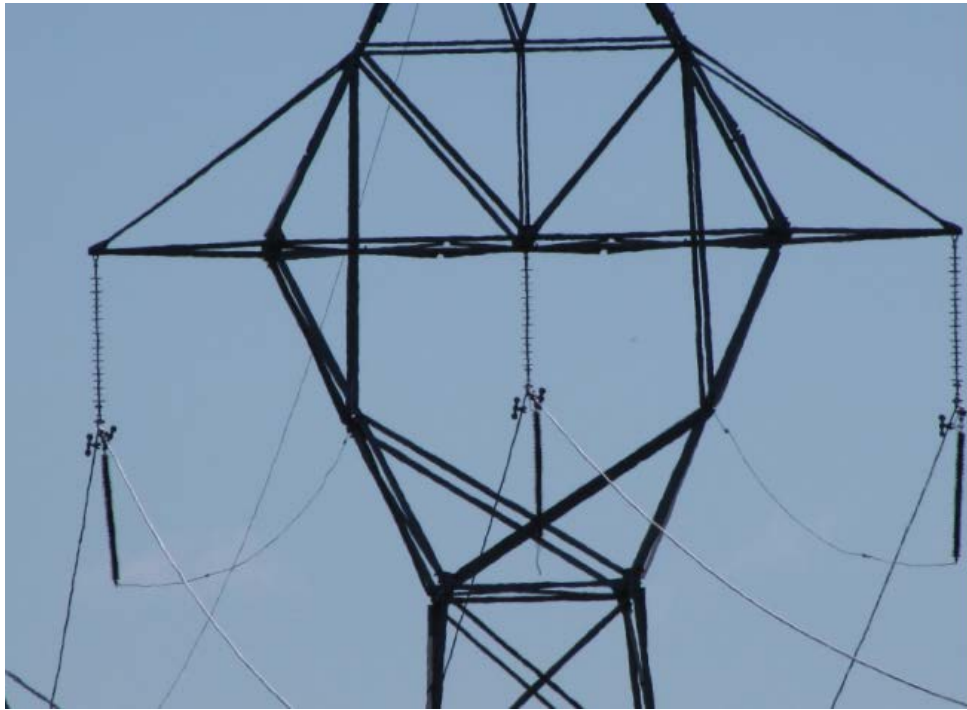
**Figure 12-8 - Surge Arrester Connected Bond Wire
(A1B, structure 2, 115 kV)**

Arrester bond wires are visually inspected from the air or ground, this is the most common and cost effective assessment method used by utilities. Disconnected or failed bond wires can be easily identified, refer to Figures 12-8 and 12-9.

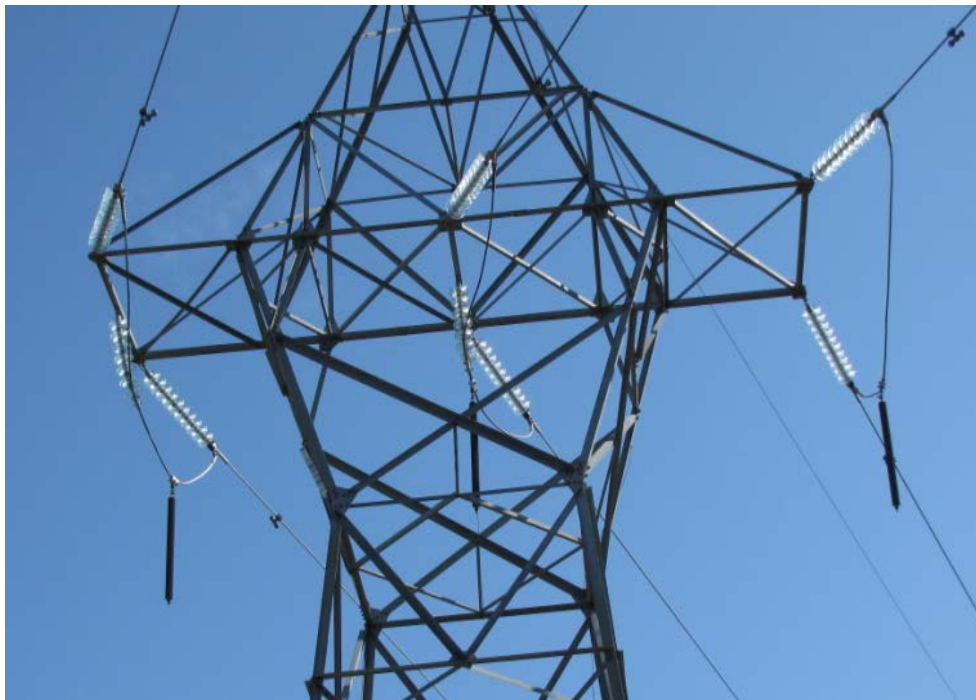
**Figure 12-9 - Surge Arrester Disconnected Bond Wire
(A1B, structure 1, 115 kV)**

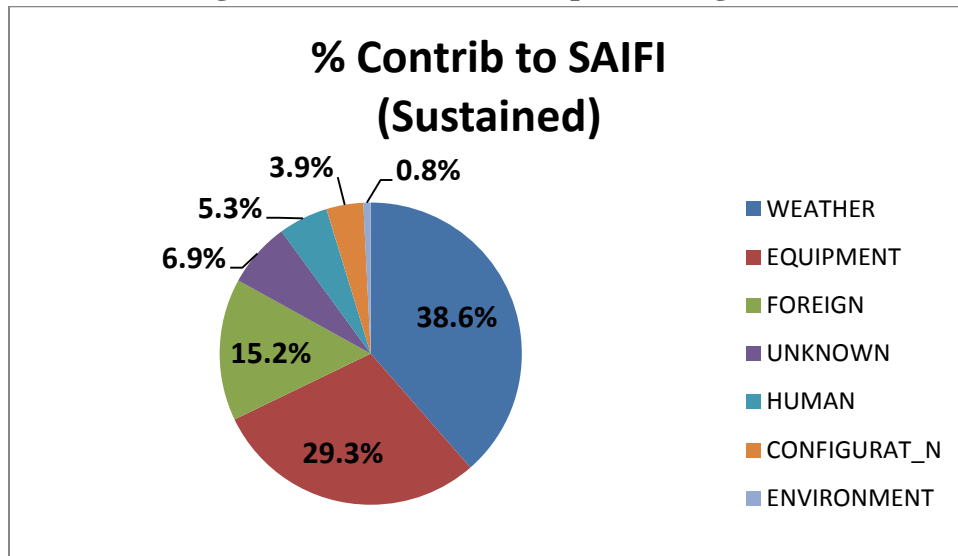
Figure 2: Sustained Interruption Categories
