1       **3.3.2    Asset Strategy**

9  
10 **3.3.3 Asset Assessment Details**

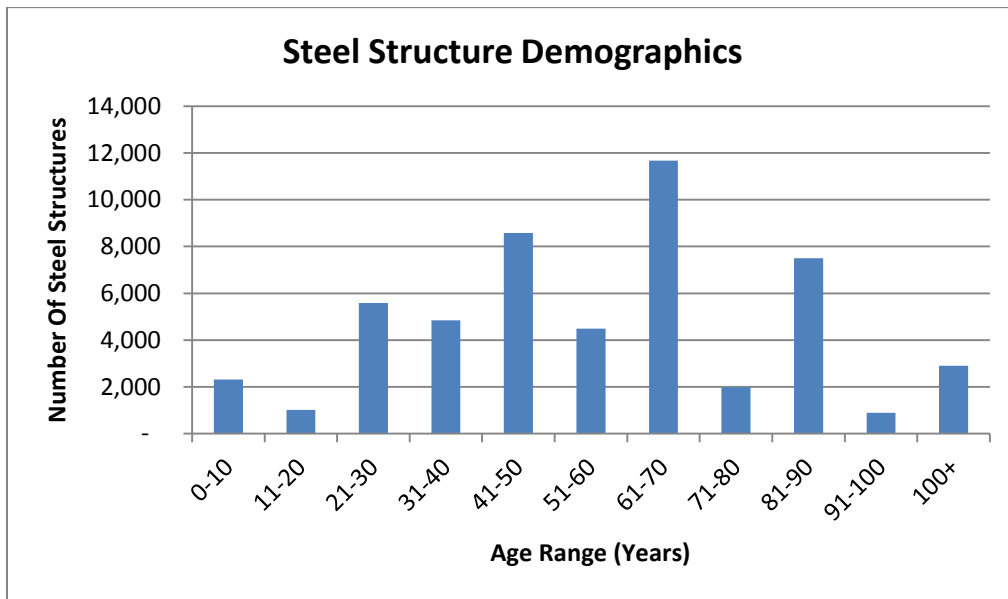
12 Hydro One has approximately 52,000 steel structures; the demographic of the steel  
13 structure population is outlined in Figure 33. There are approximately 13,000 steel  
14 structures are located in heavy corrosion zones such as Windsor, Sarnia, Hamilton and  
15 GTA. 7,500 of them currently meet tower coating criteria and approximately an  
16 additional 4,700 steel structures will meet this tower coating criteria over the next 10  
17 years if the historical coating rate is maintained. The demographic of the steel structures  
18 in heavy corrosion zones are outlined in Figure 34.

**Figure 33: Demographics of Steel Structure Fleet province wide**

1 Hydro One uses an average expected service life (“ESL”) of 80 years for steel structures  
2 if the structures are not re-coated. Currently 2,100 structures in high corrosion zones are  
3 beyond ESL and exceed the coating criteria. These structures will need detailed  
4 engineering assessment and potentially require heavy refurbishment or even complete  
5 replacement.

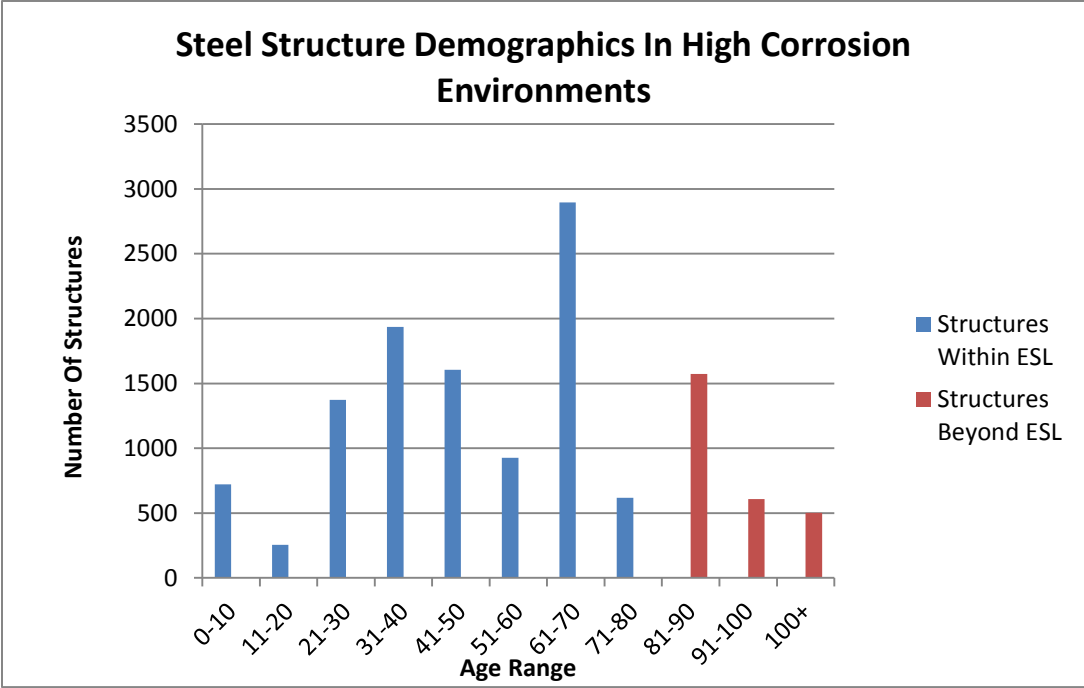
**Figure 34: Demographics of Steel Structure Fleet in Heavy Corrosion Zones**

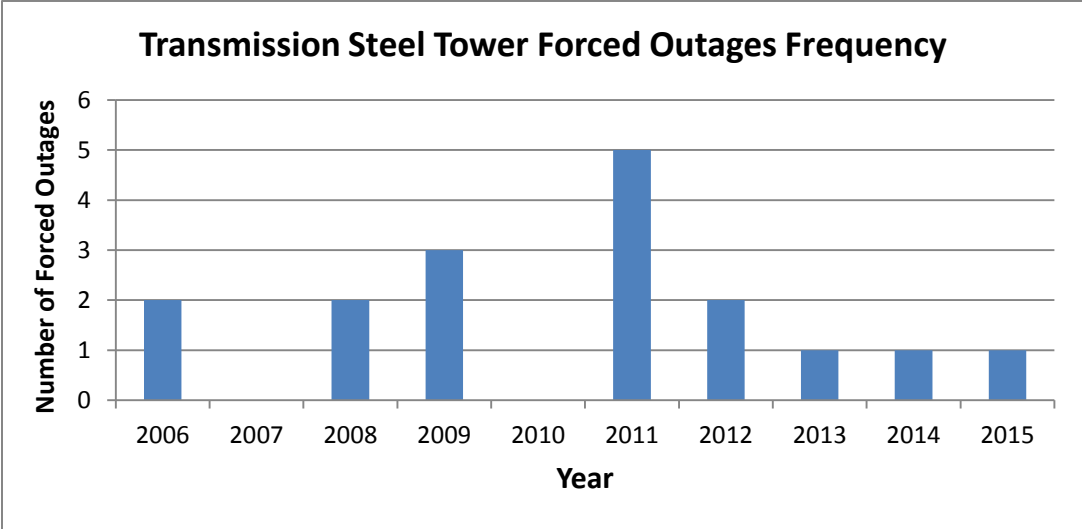
9  
10 The number of forced outages due to steel structure failures has shown slight decrease  
11 over the past 10 years as outlined in Figure 36. With the current condition of the steel  
12 structures and the demographics of the fleet, it is expected that increased capital programs  
13 will be required to prevent future increases in forced outages due to steel structure  
14 failures.

**Figure 36: Forced Outages due to Steel Structure Failures**

5 Forced outages for steel structures represent the number of times an outage is caused by  
6 steel structure failure such as complete tower collapse, or a broken (or bent) tower  
7 member. It excludes forced outages caused by external interferences such as animal  
8 contact and weather related incidents.

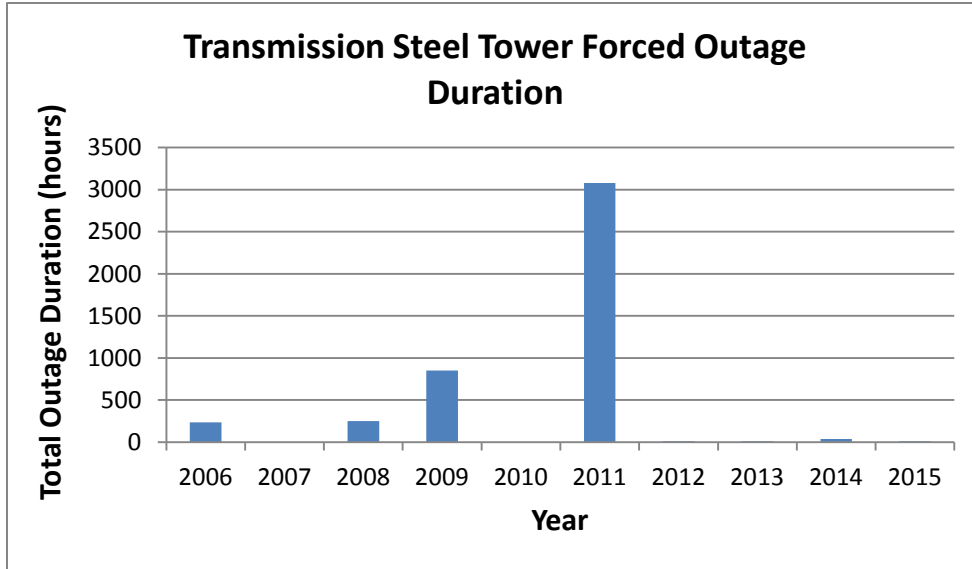
The forced outage duration due to steel structure failures, displayed in Figure 37, demonstrates a stable outage duration trend over the last 10 years, except for the spike in 2011. This type of spike is not unexpected given the very remote locations of some of the circuits with difficult access. This can place considerable strain on the system as it may result in loss of supply to large customers including local distribution companies and generation connections.

**Figure 37: Forced Outage Duration due to Steel Structure Failures**

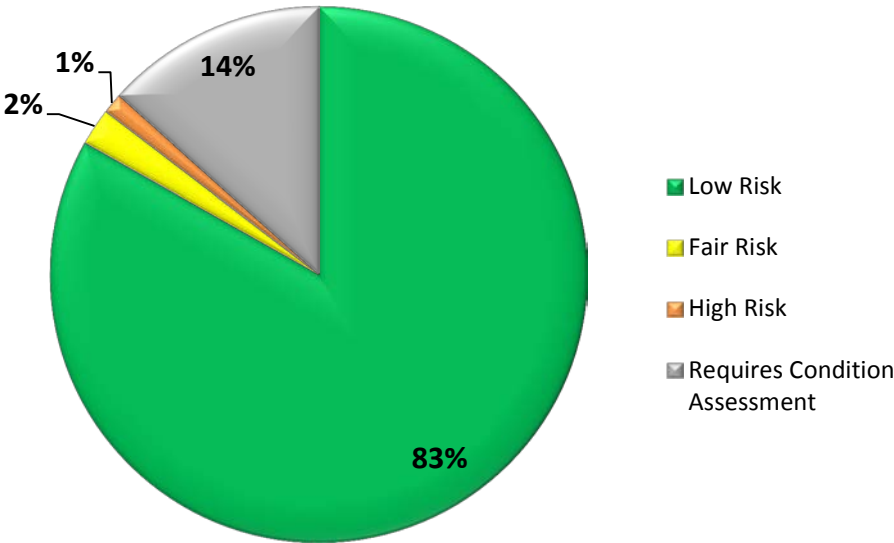
8 Based on the current assessment of condition, 3% of Hydro One Transmission steel  
9 structures have condition in the fair or high risk category, as outlined in Figure 40, and  
10 meet the current refurbishment/coating criteria. This assessment is continuously reviewed  
11 and adjusted as new conditions are reported or factors are considered. An additional 14%  
12 of steel structures need to be assessed in order to determine their condition.

15 **Figure 40: Steel Structure Fleet Condition Assessment**

2 The condition of the steel structures is determined through inspections, patrols and  
3 detailed corrosion assessment. Towers are visually inspected in accordance with NACE  
4 (“Nation Association of Corrosion Engineers”) guidelines on the degree of corrosion.  
5 Detailed corrosion assessment includes climbing towers and measuring the remaining  
6 thickness of protective coating, loss of metal if any and assessment of bolts and fittings.
