EB-2016-0105

**Thunder Bay Hydro Electricity
Distribution Inc.**

OEB Staff Compendium

June 29, 2017

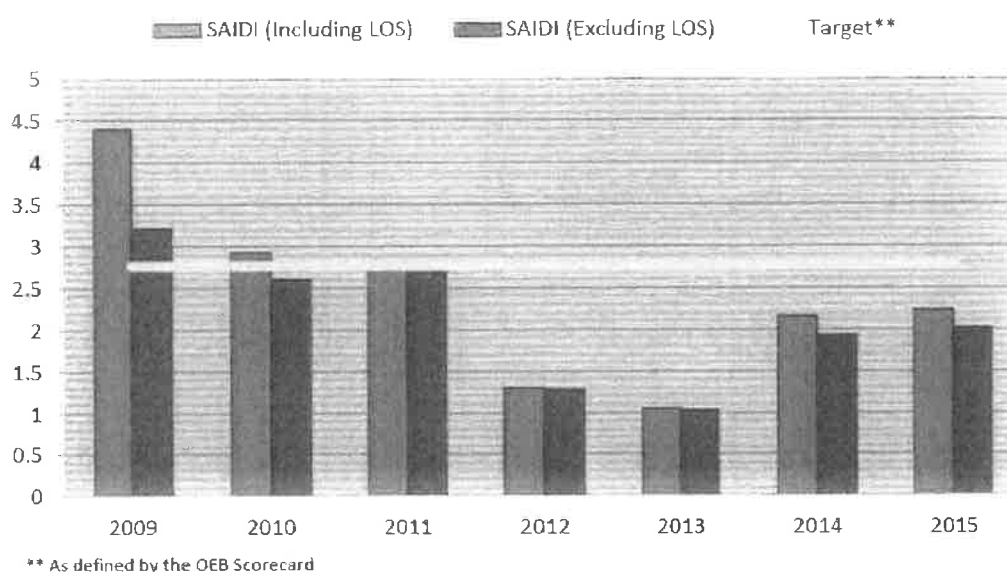
Figure 5.2.3-2 Historical SAIDI Performance

- Please explain the reasons for the comparatively high SAIDI in 2009.
- Please explain the reasons for the step improvement in SAIDI from 2011 to 2012.
- Please explain the reasons for the increase in SAIDI from 2012 & 2013 to 2014 & 2015.

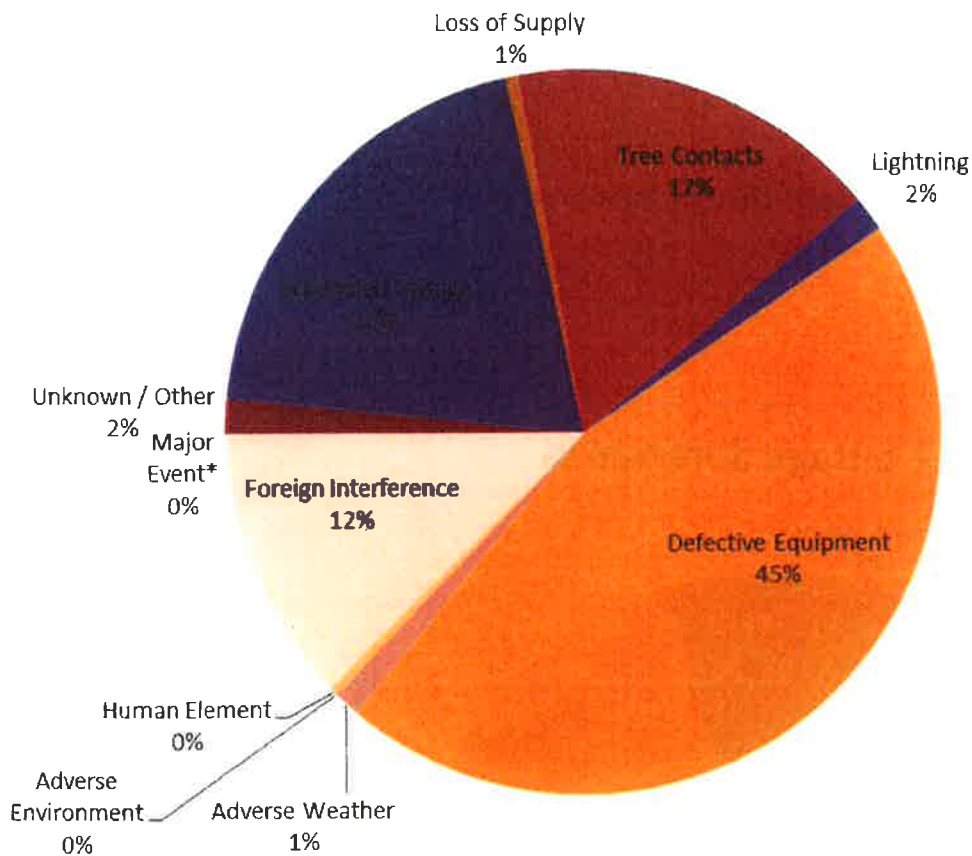
2013 outage duration %

- Figure 5.2.3-5 Outage Causes by Duration: Please provide Figure 5.2.3-5 separately for each of the following years: 2012, 2013, 2014, and 2015.
- Please provide a Figure that shows the Outage Causes by Duration for 2016.

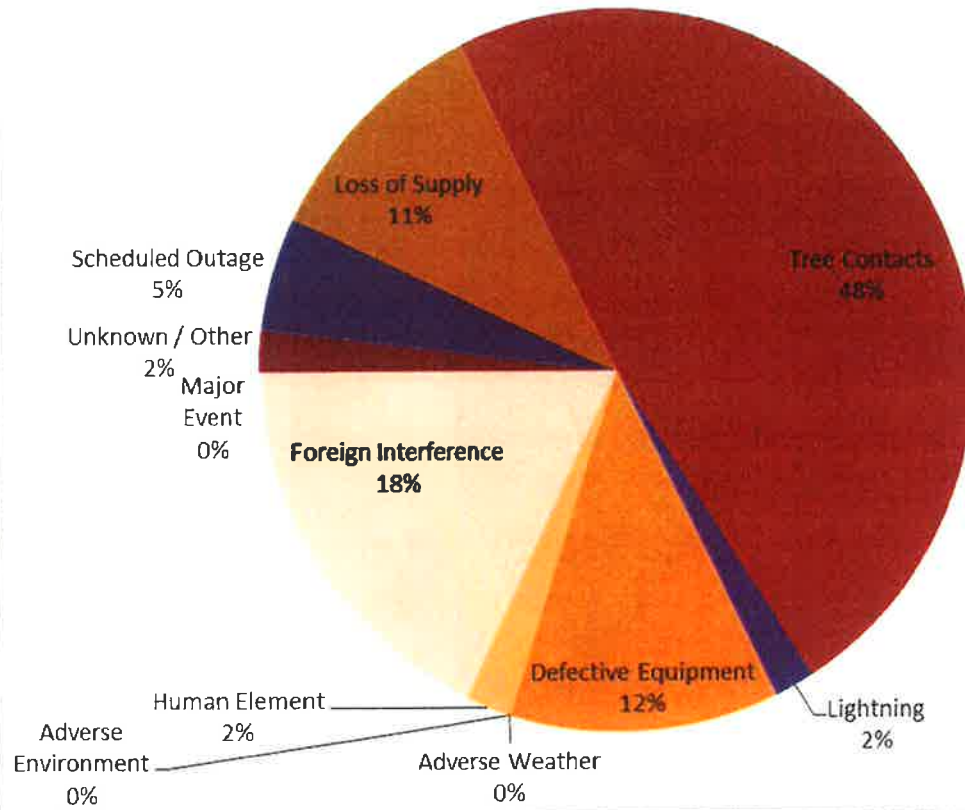
2014 outage duration %

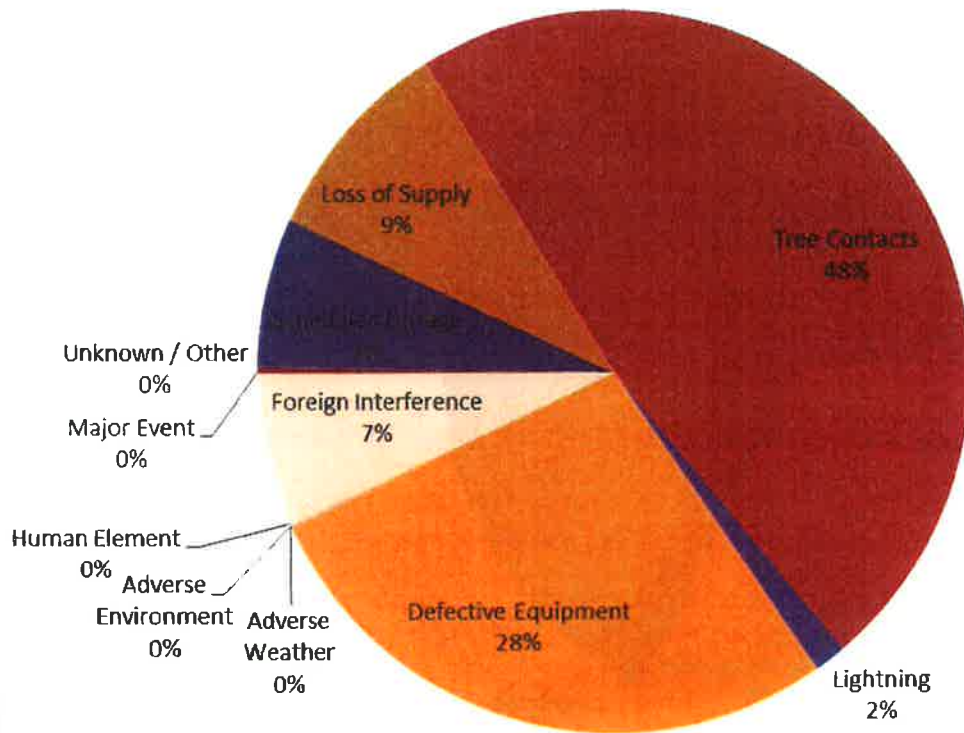
2015 outage duration %

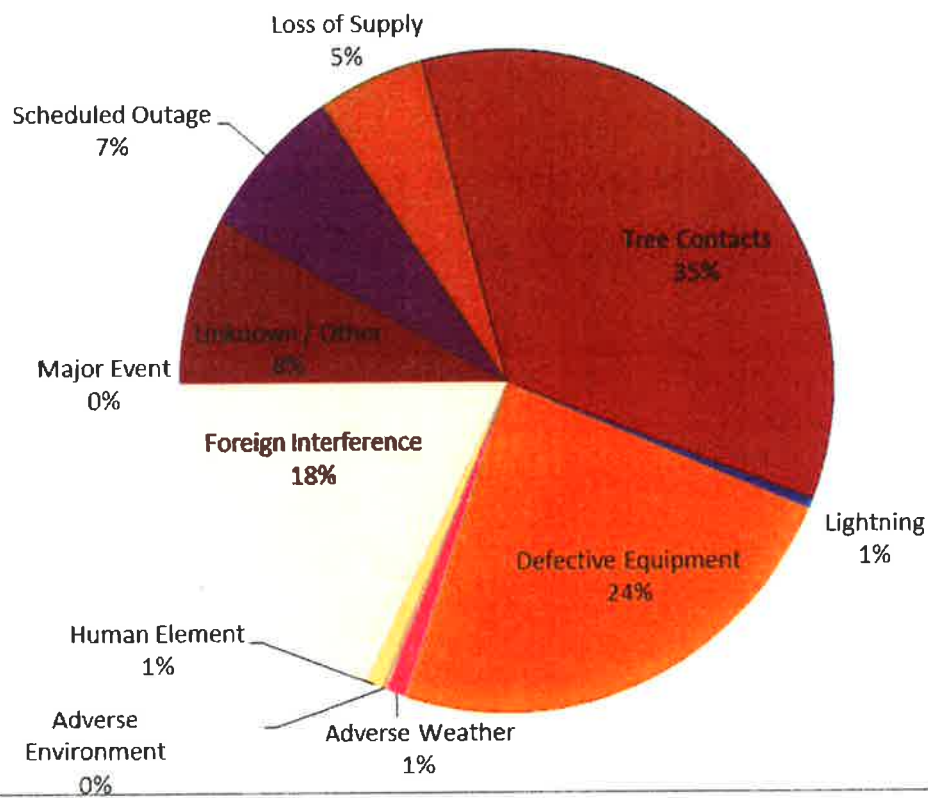
2016 outage duration %

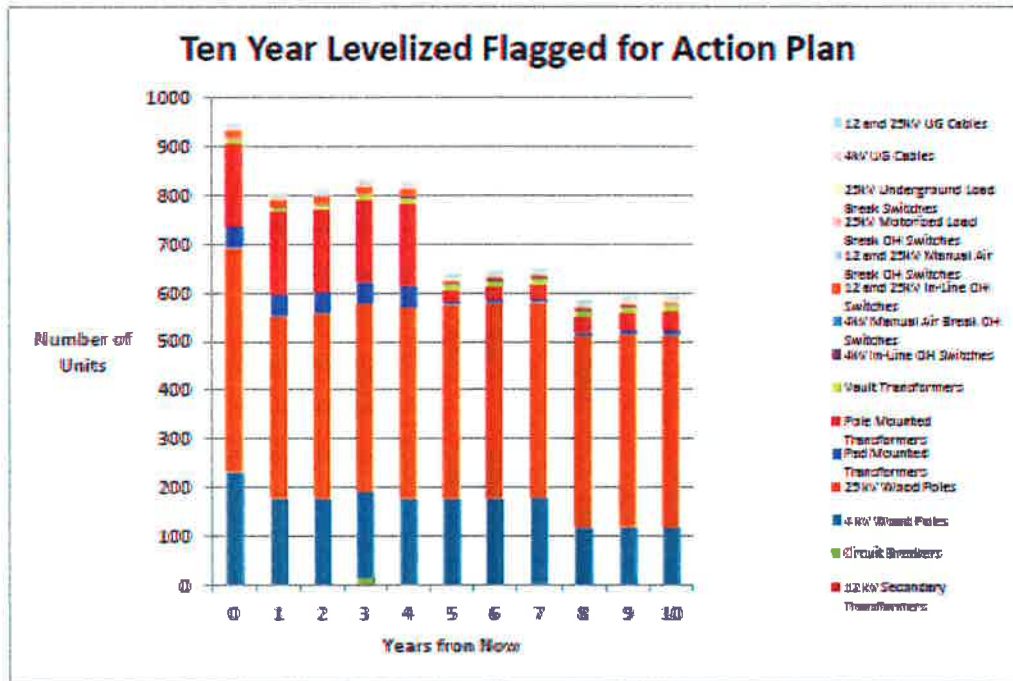
Figure 3 - TBHEDI's 10-Year FFAP

- Please explain the reasons for the significantly higher number of units flagged for action during the first five years (year 0 to 4) shown in Figure 3, and particularly the number of units in year 0. Please quantify the explanation, to the extent possible.

- Does the Flagged-for-Action Plan (FFAP) shown in Figure 3 incorporate the asset replacements forecast in the present filing? If not, please provide an updated version of Figure 3 that does incorporate the forecast replacements.

- What would be the anticipated reliability impacts of implementing a replacement program that was more evenly paced over the planning horizon shown in Figure 3?

- Please compare the FFAP with historical replacements for the 5 year period immediately prior to year 0 in Figure 3.
- Please explain the reasons for any significant (>10%) inter-annual unit flagged for action counts over the historical and planned horizons, by asset class.

- a) The number of units flagged for action is derived from HI and generated failure curves as described in the Kinetrics ACA report included in Exhibit 2, Attachment 2-I, Appendix C. For those that are proactively addressed, specific units are flagged for action once their POF exceeds 0.8. The units with only age data available have a number of units expected to fail each year estimated
