**Thunder Bay Hydro Electricity
Distribution Inc.
Application for electricity distribution
rates beginning May 1, 2017**

**VULNERABLE ENERGY CONSUMERS COALITION
("VECC")**

CAPITAL EXPENDITURE PANEL

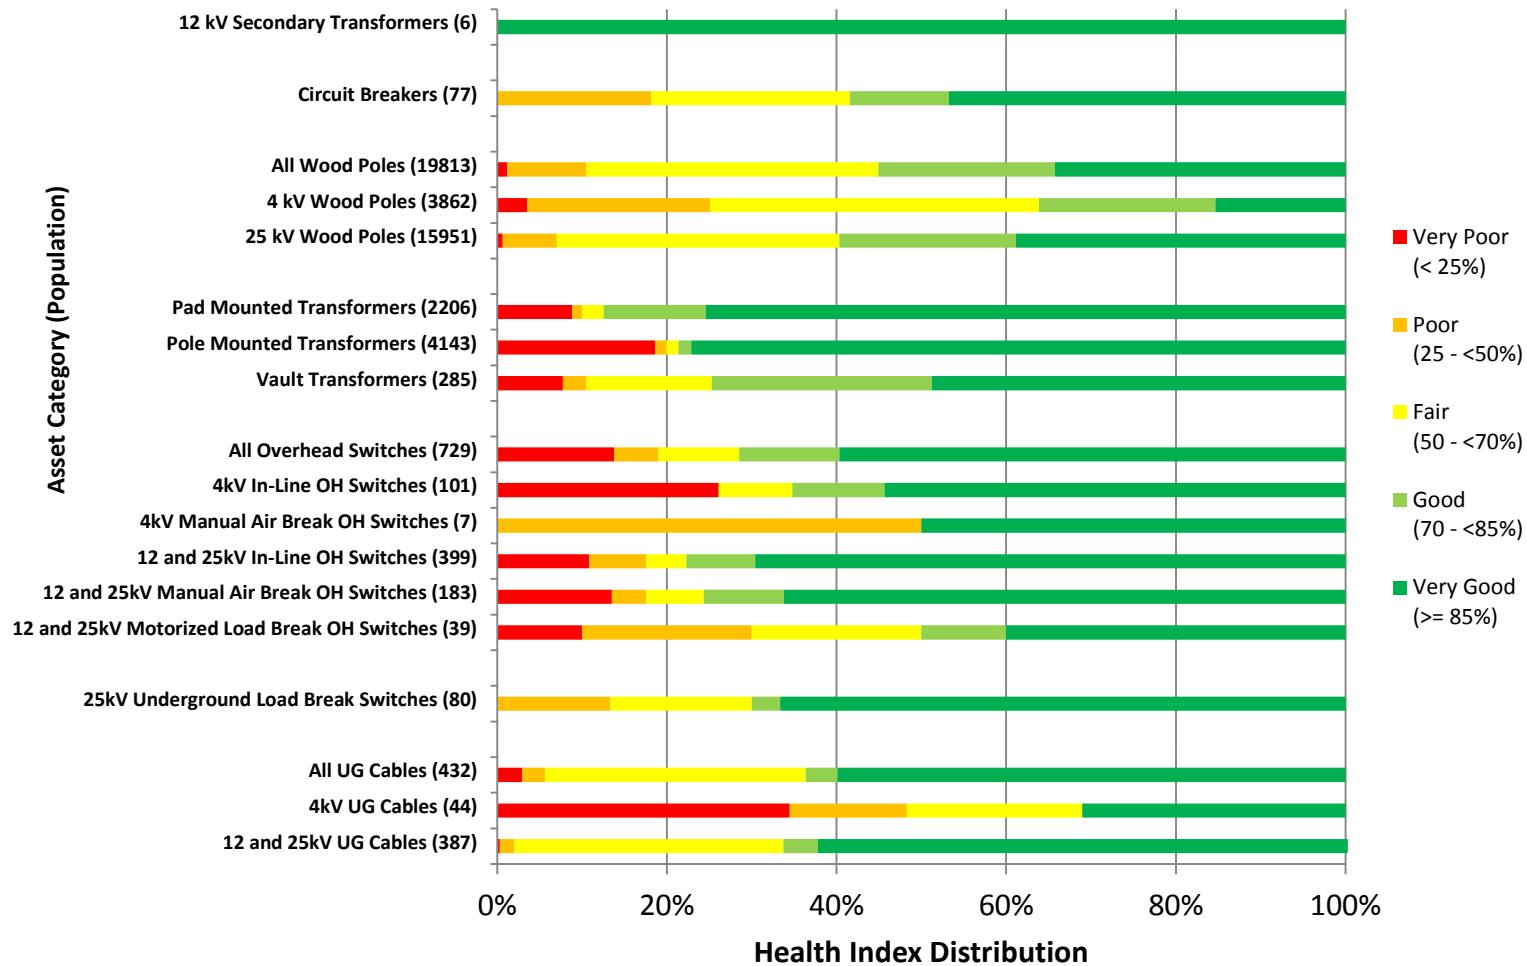
Figure 5.3.1-2 Health Index Results Summary 2015

As a result, and in order to better refine its asset condition assessment, Thunder Bay Hydro engaged Kinectrics to complete an ACA of key distribution assets. The results of which are summarized in Figure 5.3.1-2 below. The full ACA report is available for review in Appendix C.

As part of this study, the data gaps of each asset category are identified. In addition, the data items are ranked in terms of importance. There are three priority levels, the highest being most indicative of asset degradation.
