**EB-2016-0105**

**Thunder Bay Hydro Electricity Distribution Inc.**

**Application for electricity distribution rates beginning  
May 1, 2017.**

**AMPCO Compendium**

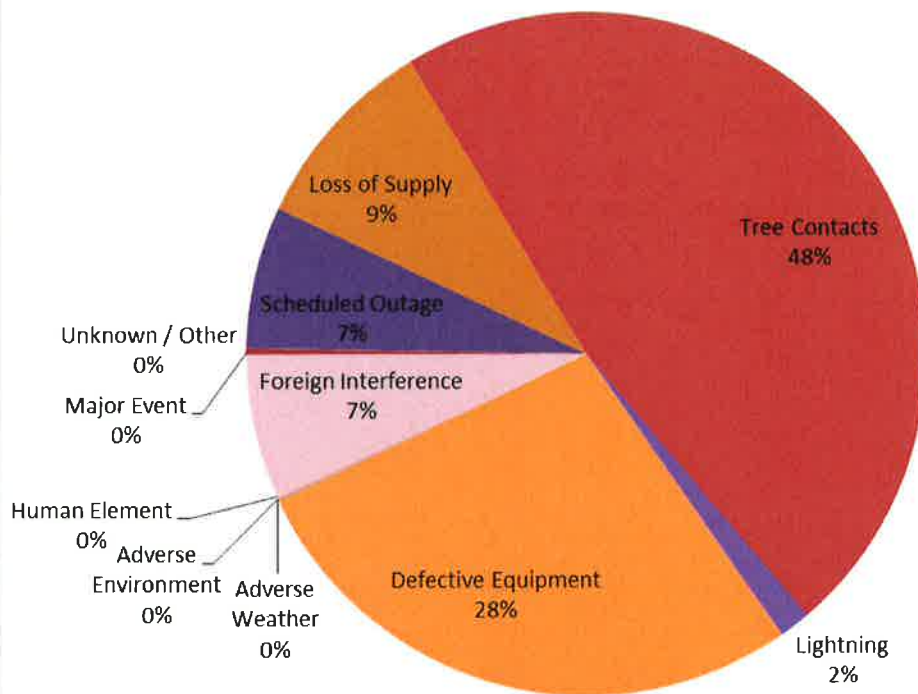
### 2016 outage duration %

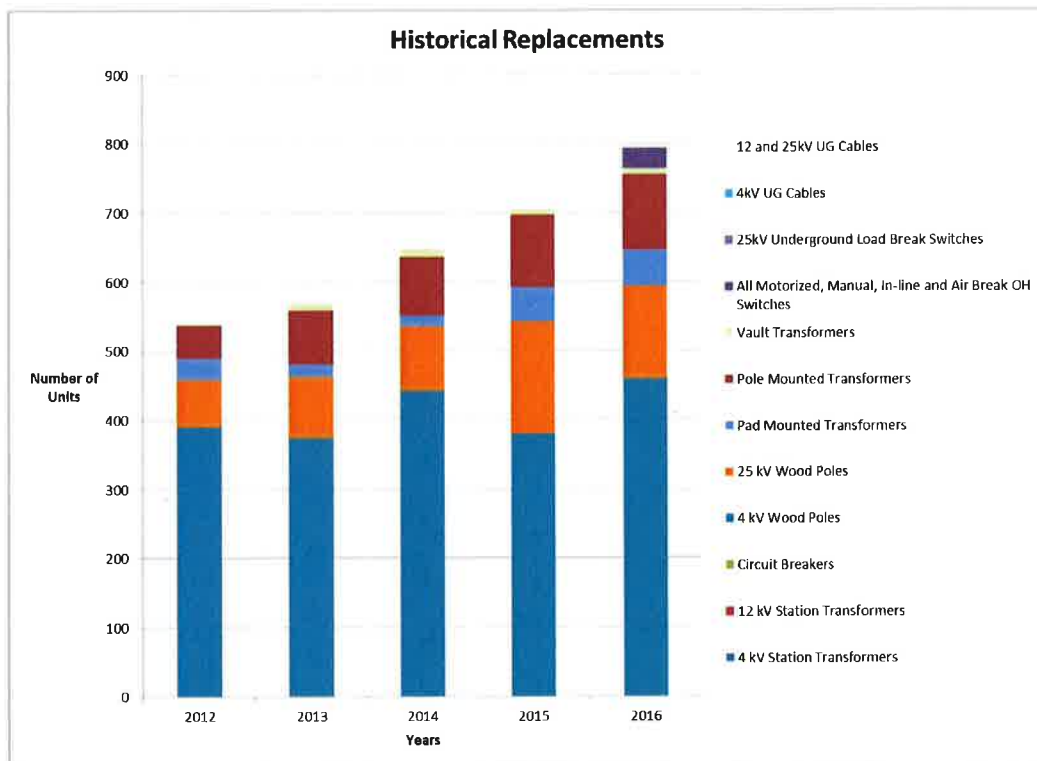
- d) Please see below the historical replacements for the 5 year period immediately prior to year 0.

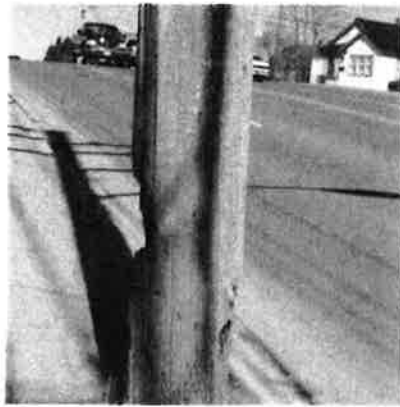
(d) Vehicular Collision

### Figure 1 - Common Wood Pole Damage

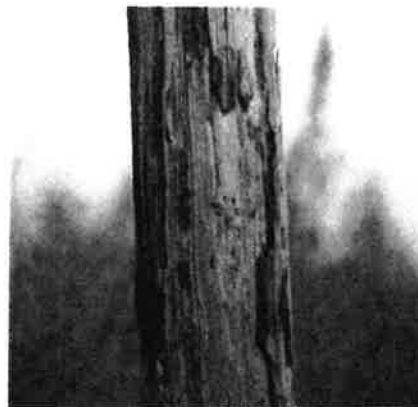
(e) Shell Rot Caused by Exposure

A wood pole may decay from the outside in (shell rot), from the inside out (heart rot), or both. The rate at which a pole decays is a function of the wood species, the preservative applied, the method of preservative application, the environment in which the pole is installed, and the degree to which the pole's protective treatment has been compromised. Regardless of the trigger the result is the same – given enough time, decay will reduce the thickness of the pole's sound outer shell which will result in reduced pole strength (refer to Figure 2). The CSA mandates that once the strength of a wood structure has deteriorated to 60% of the required design capacity, the structure shall be reinforced or replaced<sup>4</sup>. This means that, in the absence of alternate forms of damage, a wood pole should not be allowed to remain in service once its outer shell has deteriorated to 1-1/4" at any point along its length. The Local Distribution Company's challenge has been and continues to be, how to objectively evaluate the degree to which the wood pole population's strength is degraded.
