ATTACHMENT 47 – ICM BUSINESS CASES ENERSOURCE RZ

Business Case

The QEW – Evans Avenue to Cawthra Road Project

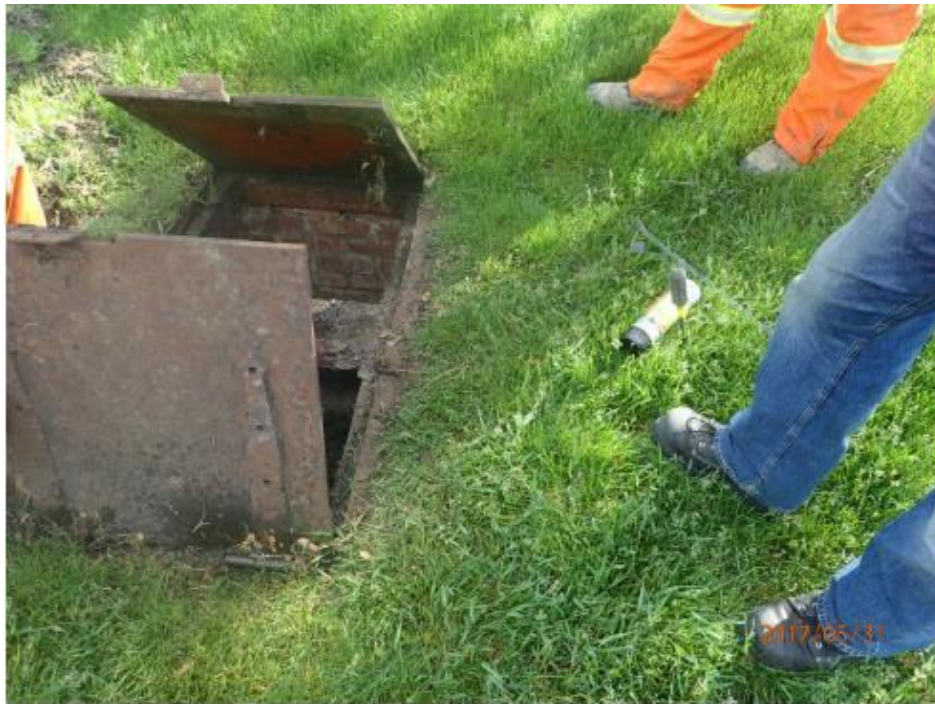
Figure 10 - Opening of Chambers

Figure 10 and Figure 11 illustrate the opening on grade and the narrow entrance through which Alectra Utilities' staff must travel to access the cables.

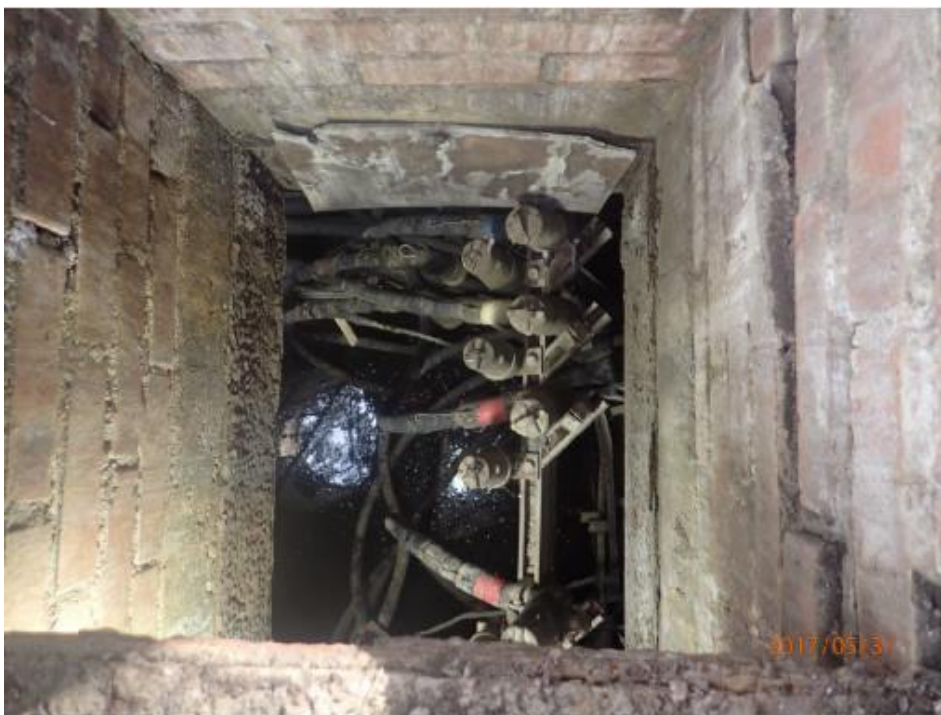
Figure 11 - Chamber View from Grade

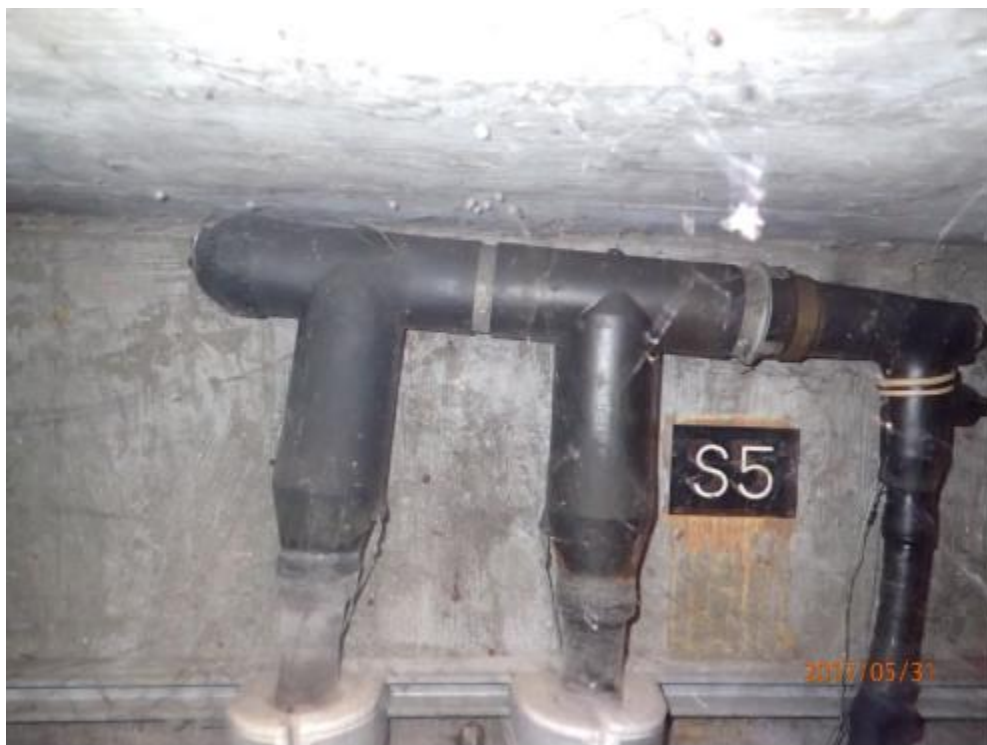
Figure 12 - Cable Connections

To access the cables, the entire chamber must be made safe by isolating the cables passing through this chamber. It takes considerable time to perform all the necessary switching as there are 15 medium voltage feeder cables in this chamber. These conditions pose a hazard to Alectra Utilities staff, as there is little room to maneuver. Further, since the only means of entry is through the on grade hatch, Alectra Utilities staff must enter overtop of the equipment used to provide protection. This equipment has not been utilized since installation, and elbow connections of this vintage are known to have issues with partial vacuum flashback during use. These cables were installed in the 1970s when work practices and methods were very different in comparison with present day safety practices. As an example, Figure 12 illustrates the use of back-to-back elbows as a splice to bond the cables.

Connections that are made in this manner complicate repairs since the middle connection requires more time to access, thereby increasing the length of time for the repair. The chambers are also not of standard size creating difficult working conditions in the chambers. Finally, the cables are laying in congested cables in trays, where several of the cables lie directly against each other, as seen in Figure 13. In the event of a cable fault, this leads to an increased risk of damage and failure to adjacent cables from the faulted cable.

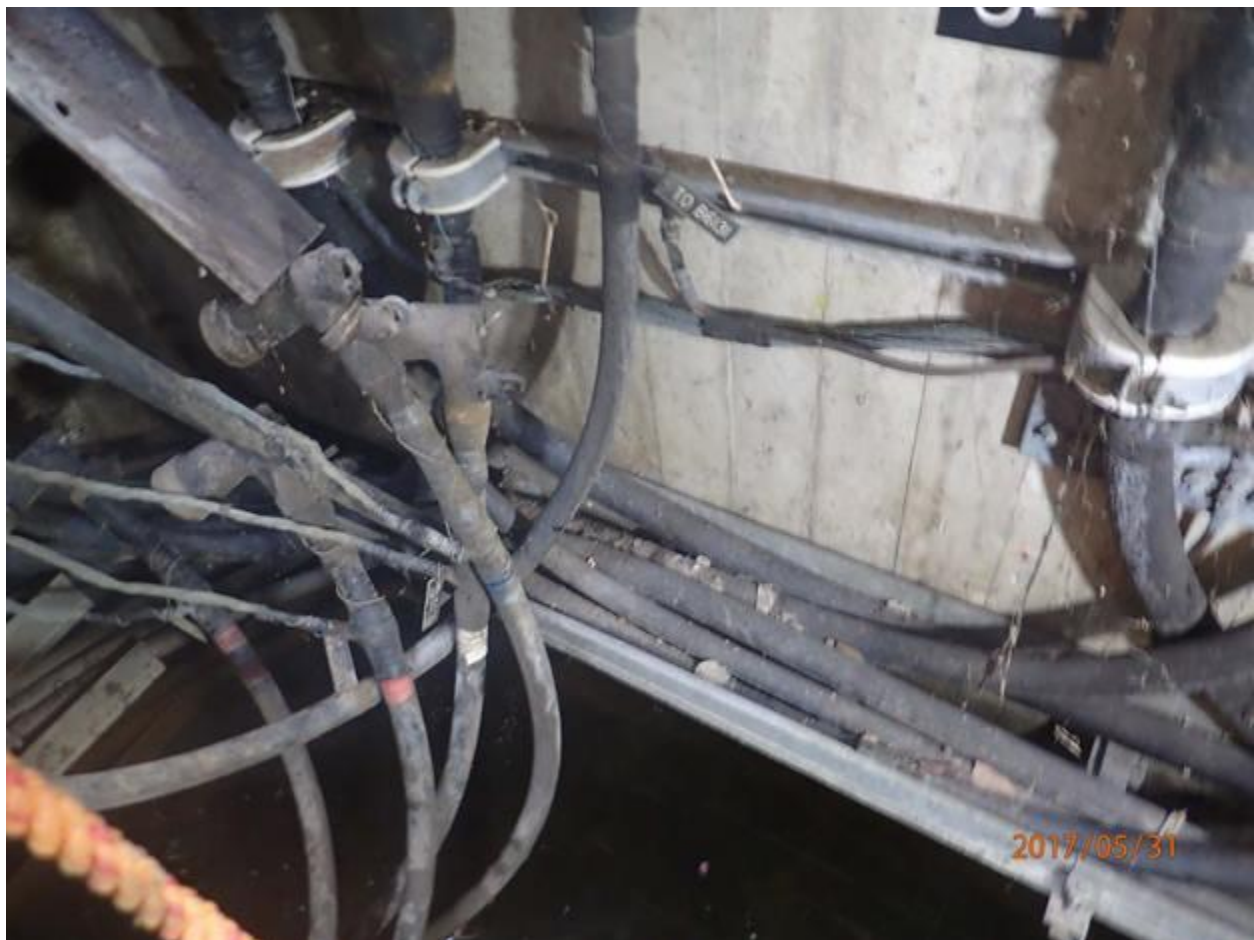
Figure 13 - Cables Laying Side-by-Side in Cable Tray

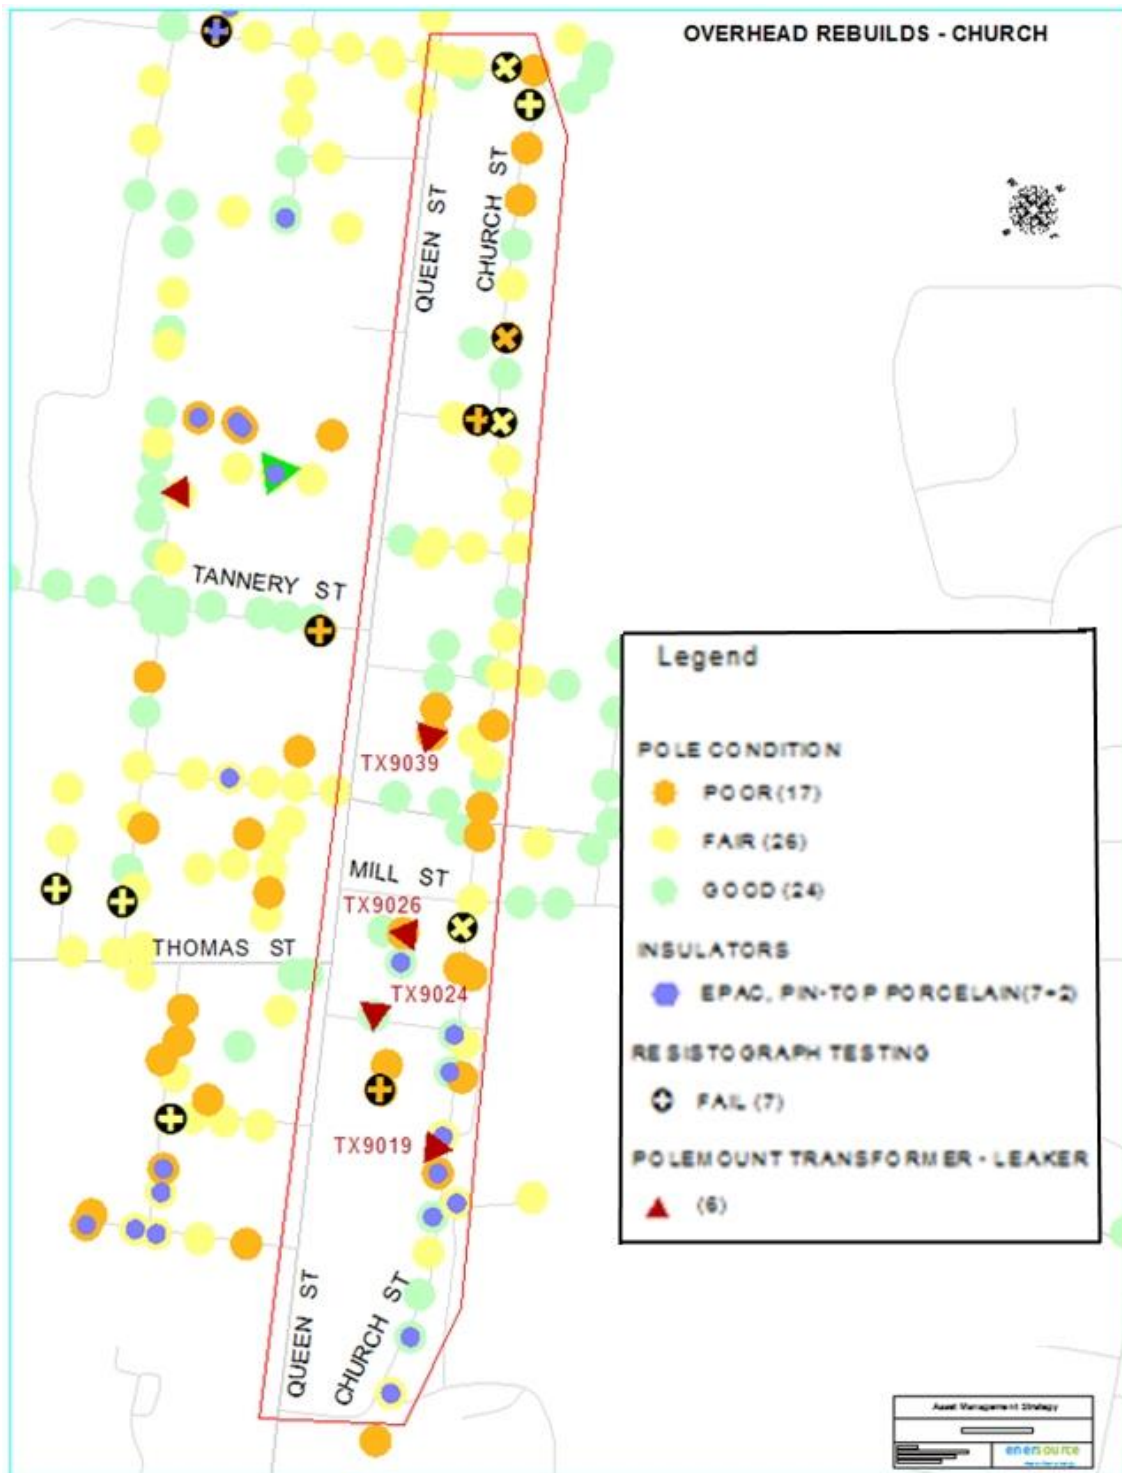
Figure 35 - Overlay Map of the Overhead System in the Church Street Service Area

To supplement and enhance the overhead system inspection, Alectra Utilities conducted additional testing of wood poles utilizing the resistograph technology. This provided Alectra Utilities with the ability to determine remaining pole strength through the detection of decay and cavities in wood poles. Based on the poor condition of the overhead assets, the number of failed poles, the identification pin-top porcelain insulators and the identification of a leaking transformer, the Streetsville area east of Queen Street along Church Street was identified as being in need of renewal investment.

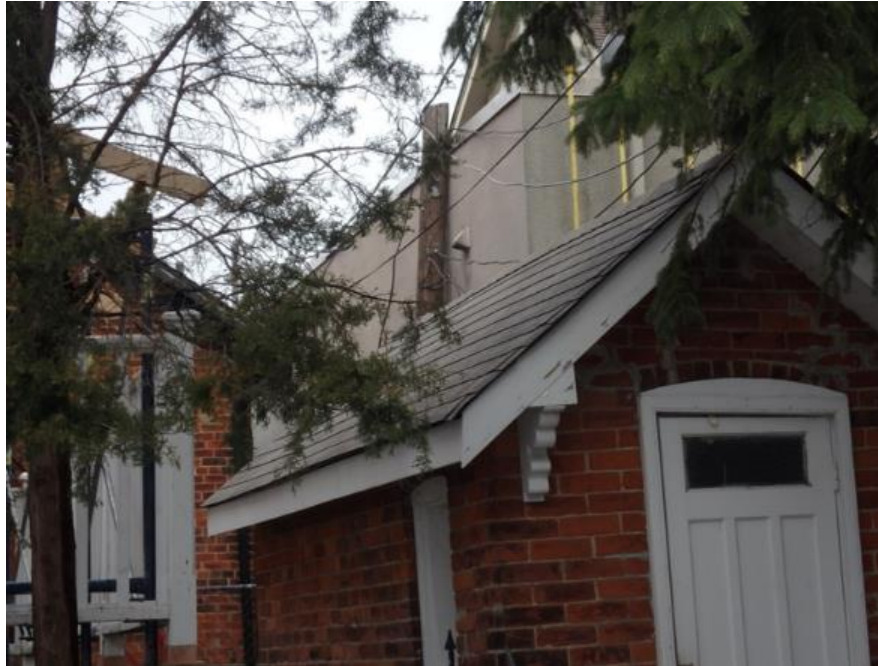
Figure 16 - Image of Pole Structures Encroached Upon by New Development

A number of the poles in the area were also identified as being inaccessible during the inspection. As development occurred in the area, the construction of structures near electrical distribution poles and lines created an access issue, which requires additional investment to address. In addition to accessibility issues, encroachment to electrically energized equipment creates a safety risk to the public and employees. Overhead system renewal investment in the Church Street area is required to address the inaccessible overhead system and redesign the overhead distribution to facilitate a safe and reliable distribution system.

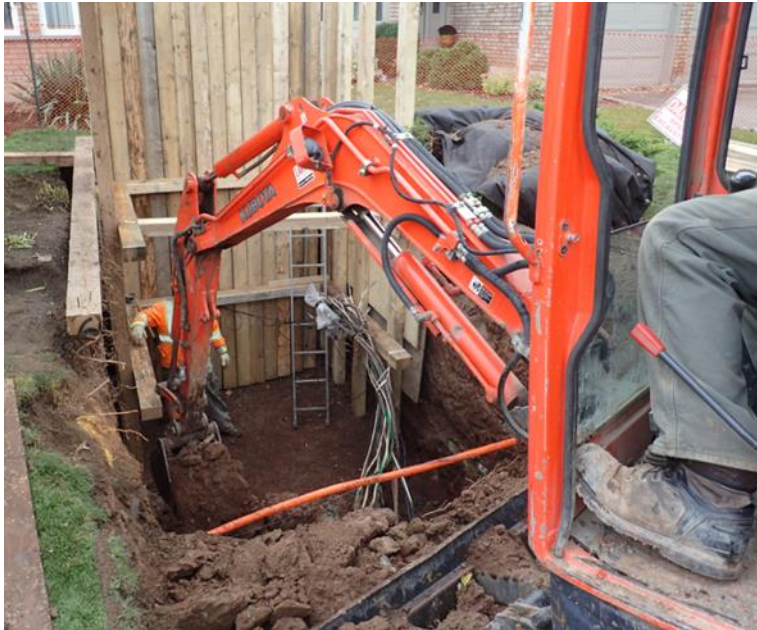
Figure 17 - Environmental Remediation due to Oil Contamination

Alectra Utilities is committed to environmental stewardship and regulatory compliance, and is highly cognizant of the impact of oil spills on the environment, on customers and on the general public. In order to minimize the risk of environmental contamination and regulatory non-compliance, from 2013 to 2016, Enersource replaced 2,052 transformers that were identified as showing signs of oil leaks and/ or containing PCB. Over this time period, environmental remediation and transformer replacements were completed at 103 sites impacted by oil leaks. Enersource incurred approximately \$5.6MM in environmental remediation costs and \$19.4MM in capital expenditures for replacements that have not been included in rates. Figure 17 provides an image of the environmental remediation work being undertaken to address oil contamination from a leaking transformer. Table 1 identifies the number of transformers replaced from 2013 to 2016.
