**EB-2017-0049 Hydro One Networks Inc. 2018-2022 Distribution Custom IR Application
(the "Application") – Undertaking Responses**

UNDERTAKING – J 7.3

To provide the age profile of the poles that have failed tests.

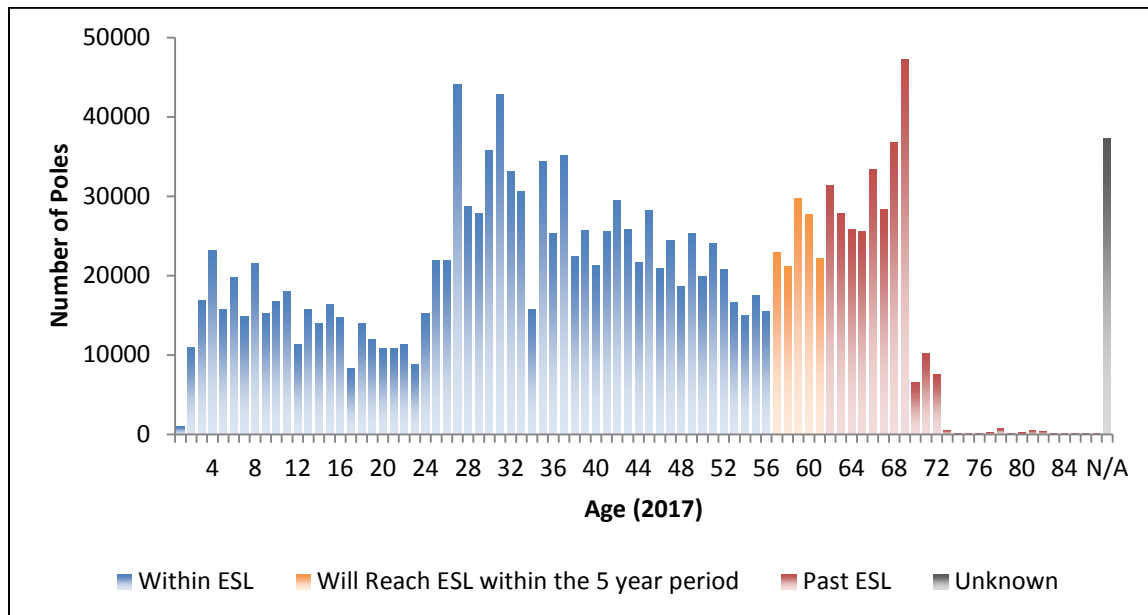
Figure 1: Pole Population Demographics

Hydro One's distribution system contains about 1.6 million wood poles. The current average age of the wood pole population is 38 years as shown in the demographics, illustrated in Figure 1. Based on Figure 1 below there are about 280,000, or 17% poles (illustrated by the red bars below) that are beyond their expected service life of 62 years with an additional 120,000 or about 7% poles (illustrated by the orange bars below) reaching their expected service life within the next five years.

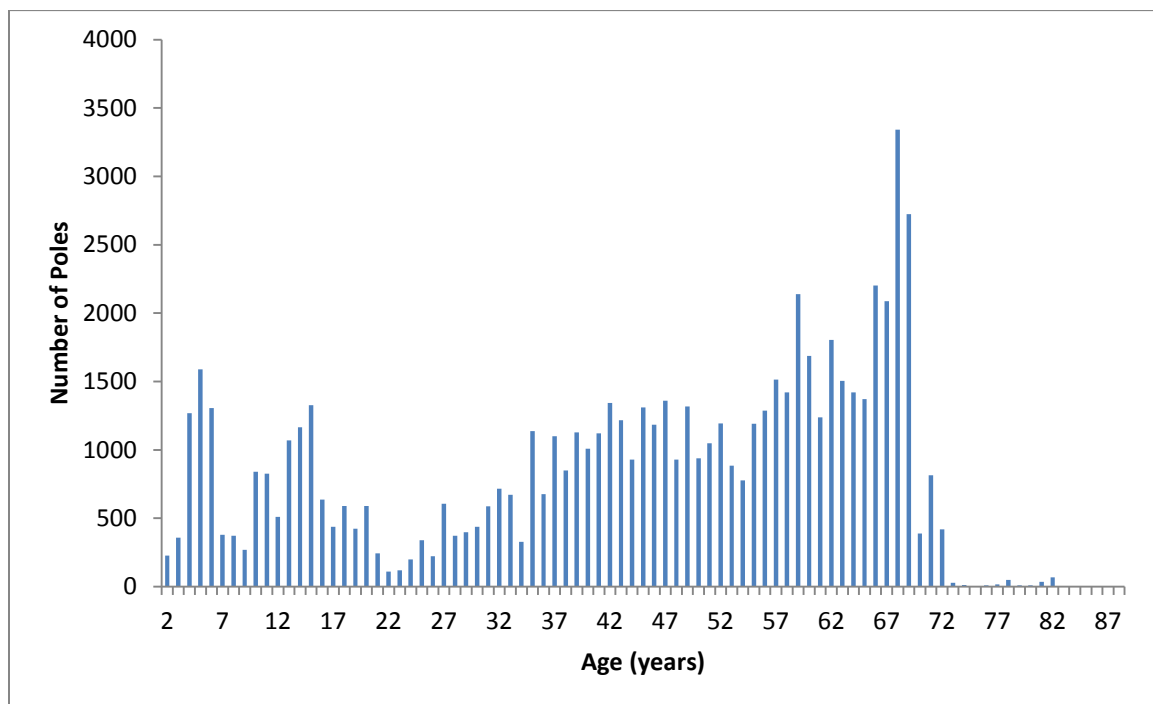
Figure 2: Demographics of Poles that are in Poor Condition

The demographics of poles in poor condition are shown in Figure 2 below. The average age of these poles is 45 years. Figure 2 below shows an increasing failure rate as the population ages.
