Toronto-Hydro Electric System Limited

EB-2018-0165

Compendium

RESPONSES TO ND HANN INTERROGATORIES

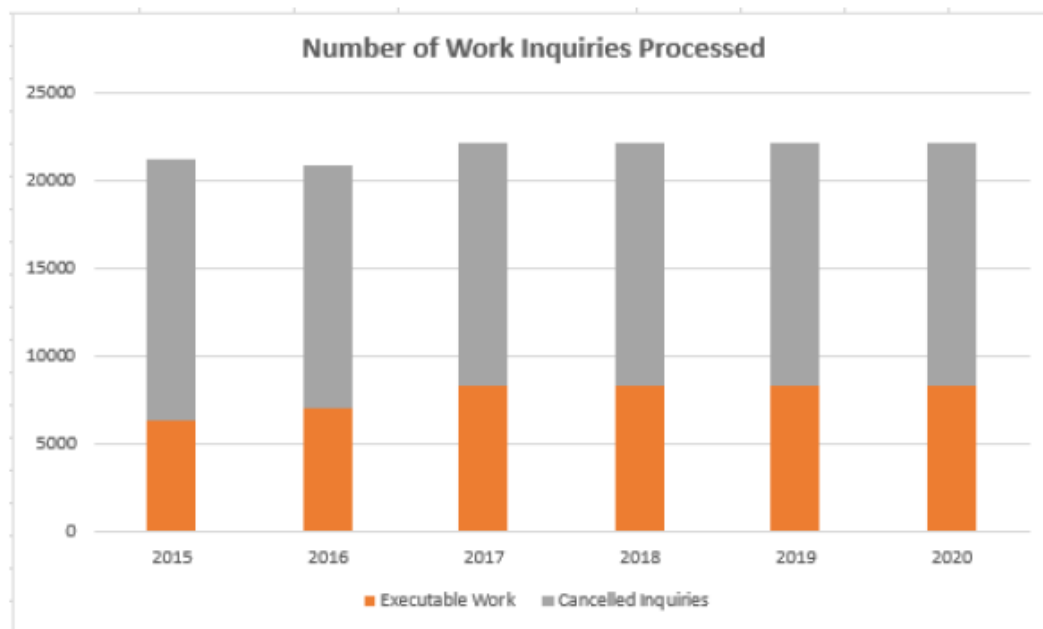
Figure 2: Work Inquiries Processed

2 As shown above, the 29,000 deficiencies identified are from planned inspections. The
 3 6,000 to 8,000 executable work deficiencies are generated from a combination of
 4 planned and reactive activities. Figure 2 in the reference should have more
 5 appropriately been entitled "Work Inquiries". In the process of preparing this
 6 response, Toronto Hydro also identified a data error in the 2015 results. Please see an
 7 updated figure below.

Figure 2: Number of Deficiencies Processed shows about 6000 to 8000 Executable work deficiencies annually. Even with cancelled inquiries the value does not reach 29000.

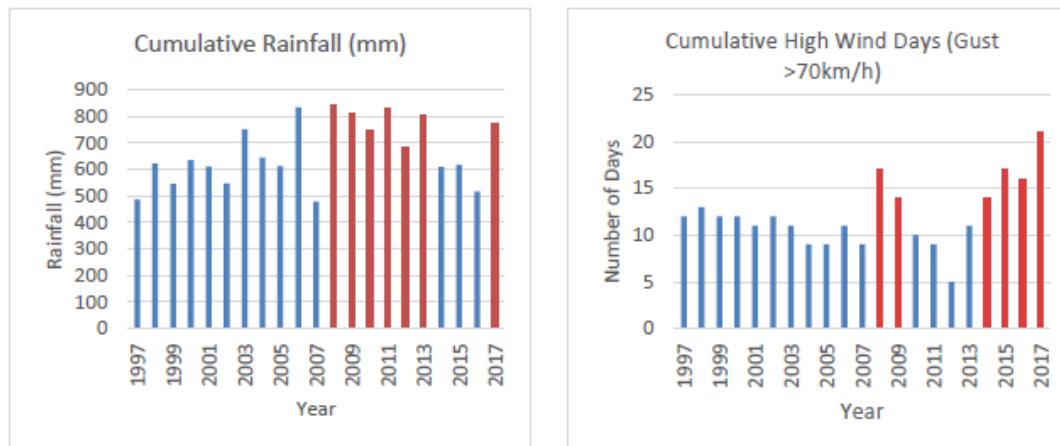
Figure 6: Cumulative Rainfall (left) and Number of High Wind Days (right) in Toronto²

In addition to extreme weather events, Toronto experiences a wide range of weather conditions that may not be classified as extreme, but nevertheless have the potential to adversely affect the distribution system at various times during the year. Heat, high winds, heavy rainfall, freezing rain, and heavy snowfall have the potential to cause major system damage and extensive outages. Not only are these weather conditions projected to occur more frequently and with greater severity in the future due to climate change, trends from the past 20 years suggest that these changes are already affecting the system. Figure 6 below contains two charts depicting cumulative rainfall and the number of high wind days (i.e. with wind gusts exceeding 70 kilometres per hour) in Toronto over the past 20 years. With respect to rainfall, seven of the 10 highest rain fall years have occurred in the last 10 years. Similarly, six of the 10 years with the greatest number of days of wind gusts above 70 kilometres per hour have also occurred in the last 10 years (these years are highlighted in red).

These weather trends have increased reliability risks for Toronto Hydro's distribution system. Parts of the underground system are sensitive to significant rainfall, and in particular flooding, while the overhead system in general is sensitive to high winds, freezing rain and wet snow events resulting in damage and outages (e.g. from vegetation impact in proximity to overhead lines). In extreme cases, broken trees and the weight of ice and snow accretions bring lines, poles and associated equipment to the ground.

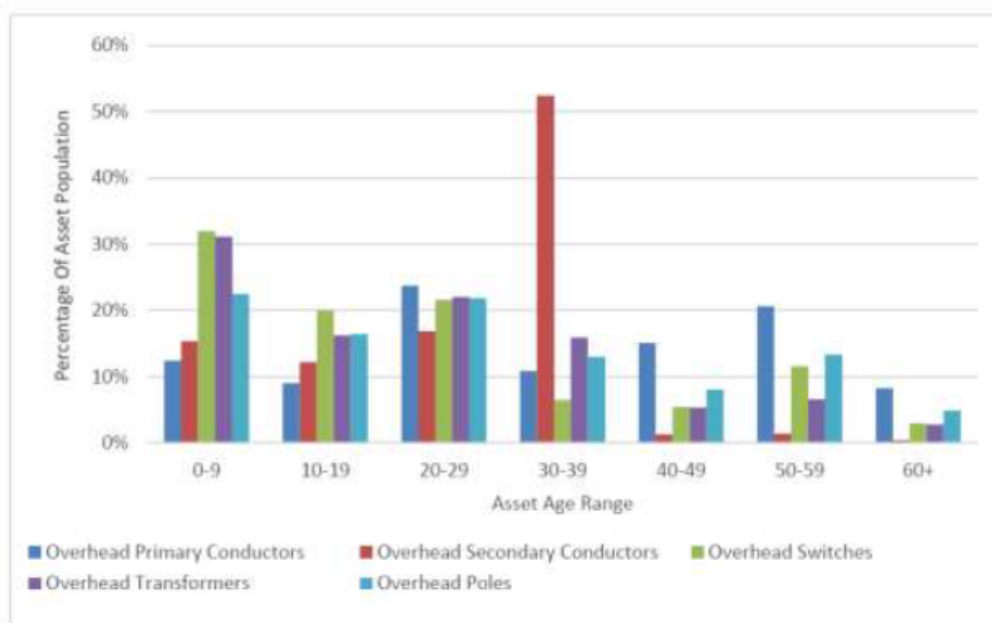
Figure 9: Overhead Assets Age Demographics as of 2017

What is the relationship with failed components and their age? In terms of forced interruptions what are the failure rates by age category?
