Toronto-Hydro Electric System Limited

EB-2018-0165

Compendium

**RESPONSES TO ND HANN INTERROGATORIES**

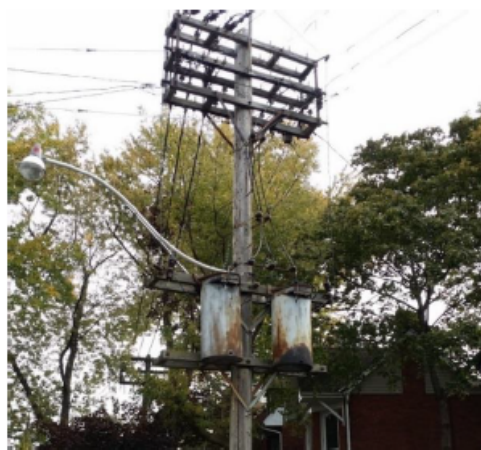
**Figure 4: Box Construction in a Backyard with Leaking Equipment**

2     Toronto Hydro operates in a mature, congested urban environment, which presents  
3     significant cost and operating challenges. For instance, Figure 4, below, provides an  
4     example of aging box construction feeders from the pre-amalgamation City of Toronto.

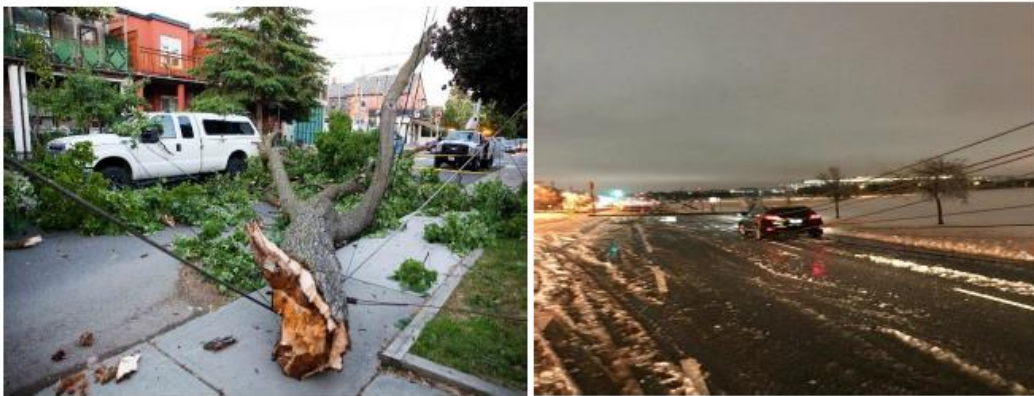
6 **Figure 7: Damage due to Weather Events**  
7

1 Extreme weather events in 2017 resulted in a 72 percent increase in the number of  
2 customer interruptions attributed to tree contacts compared to the average of the  
3 previous five years. Similarly, in 2018, Toronto Hydro experienced four extreme storms  
4 during the first half of the year, leaving nearly 160,000 customers without electricity.  
5

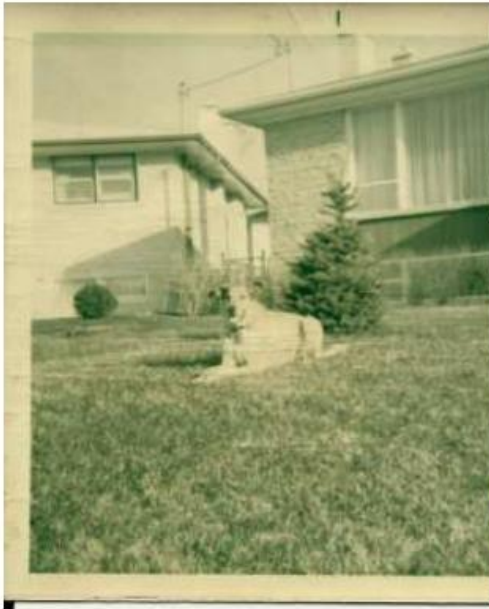
Blue spruce – photo taken in 1969

Please note that these 2 trees are on the same property separated by 49 years. This is one small example of how the urban vegetation environment has changed.

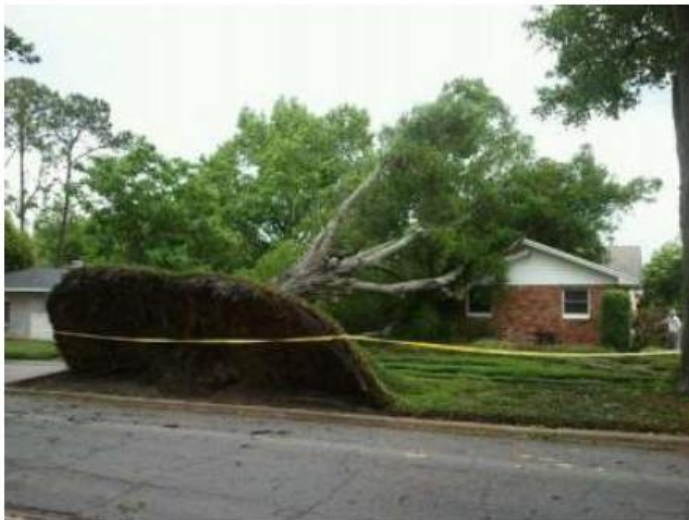
Another example is root system support failure. This tree's root system is contained on 3 of 4 sides. The

lack of horizontal room for growth of the root system makes the tree vulnerable to wind and ice load above the ground so 40 years ago, this tree would have not caused an interruption or damage to the system. Today it would even though the house may have experience the same ice or wind storm 50 years apart.

Was the tree failure above due to high wind or the fact that the roots are contained on 3 of 4 sides?

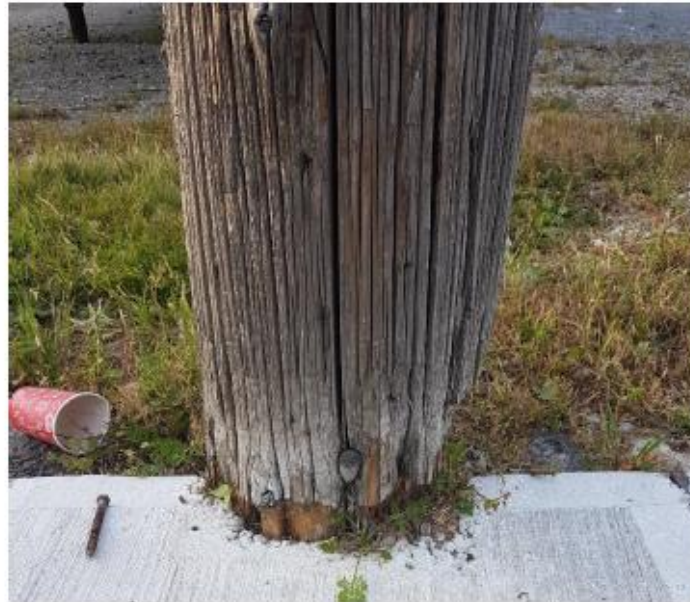
Figure 12: Deterioration at the base of a pole

In the photo in Figure 12: "Deterioration 1 at the base of a pole" provided,

a) The photo of the pole in Exhibit 2B, Section E2, p. 23, Figure 12 was included for illustrative purposes. For this reason, the estimated percent reduction in load carrying capacity of this specific pole cannot be provided.
