Toronto-Hydro Electric System Limited

**EB-2018-0165**

Compendium

**RESPONSES TO ND HANN INTERROGATORIES**

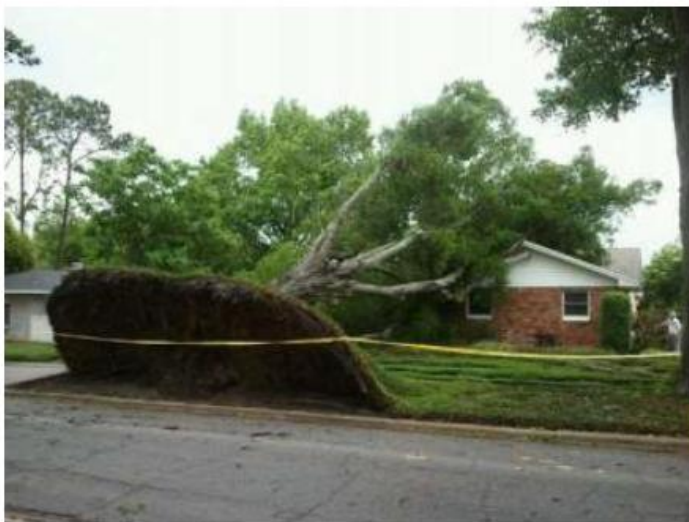
Another example is root system support failure. This tree's root system is contained on 3 of 4 sides. The

lack of horizontal room for growth of the root system makes the tree vulnerable to wind and ice load above the ground so 40 years ago, this tree would have not caused an interruption or damage to the system. Today it would even though the house may have experience the same ice or wind storm 50 years apart.
