Toronto-Hydro Electric System Limited

EB-2018-0165

Norman Hann

Compendium

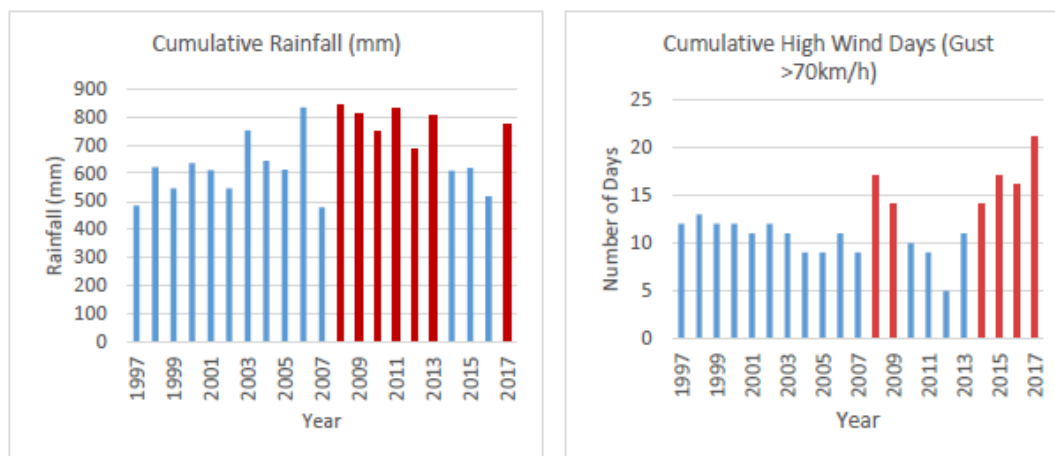
15 **Figure 4: Cumulative Rainfall (left) and Number of High Wind Days (right) in Toronto⁴**

9 Not only are these weather conditions projected to occur more frequently and with greater severity
 10 in the future due to climate change, but trends from the past 20 years suggest that these changes
 11 are already affecting the system. Figure 4 below depicts cumulative rainfall and the number of high
 12 wind days in Toronto over the past 20 years. With respect to rainfall, seven of the 10 highest rain fall
 13 years have occurred in the last 10 years. Similarly, six of the 10 years with the greatest number of
 14 days of wind gusts above 70 kilometres per hour have also occurred in the last 10 years.
