**Ontario Energy Board**

**AND IN THE MATTER OF** the Application Toronto Hydro - Electric System Limited for an Order or Orders approving or fixing just and reasonable distribution rates and other charges, effective January 1,2020 to December 31, 2024.

**Argument**

**Norman D. Hann P. Eng**

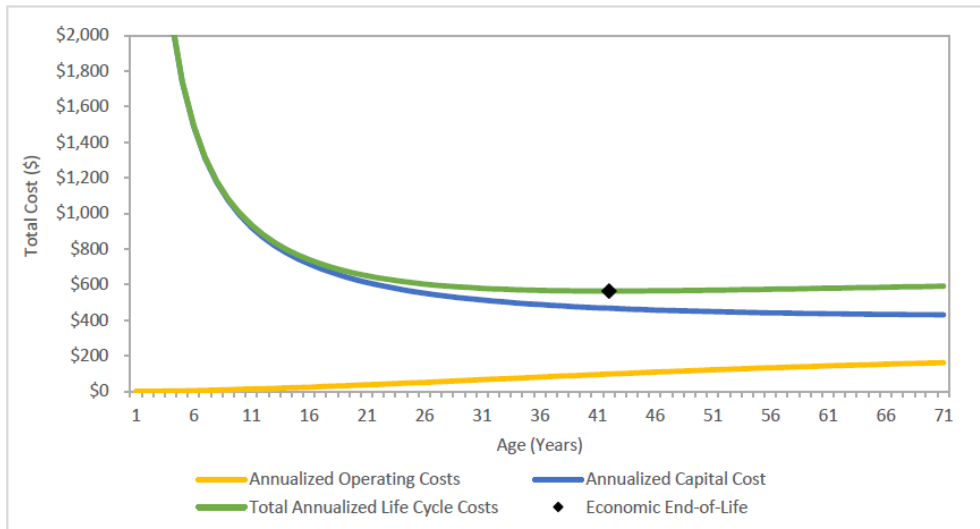
**Figure 1: Total Annualized Life Cycle Cost of a Sample Wood Pole**

Which has a very different shape and message to an actual chart for a sample wood pole.<sup>5</sup>

A shape that is essentially flat and could have the Economic End of Life extend from 41 years to over 70 years with very little impact on OM&A
