Collus PowerStream Corp. Asset Management Plan

Automated Solutions International Inc. - Peter Krotky, P.Eng.

December 2012

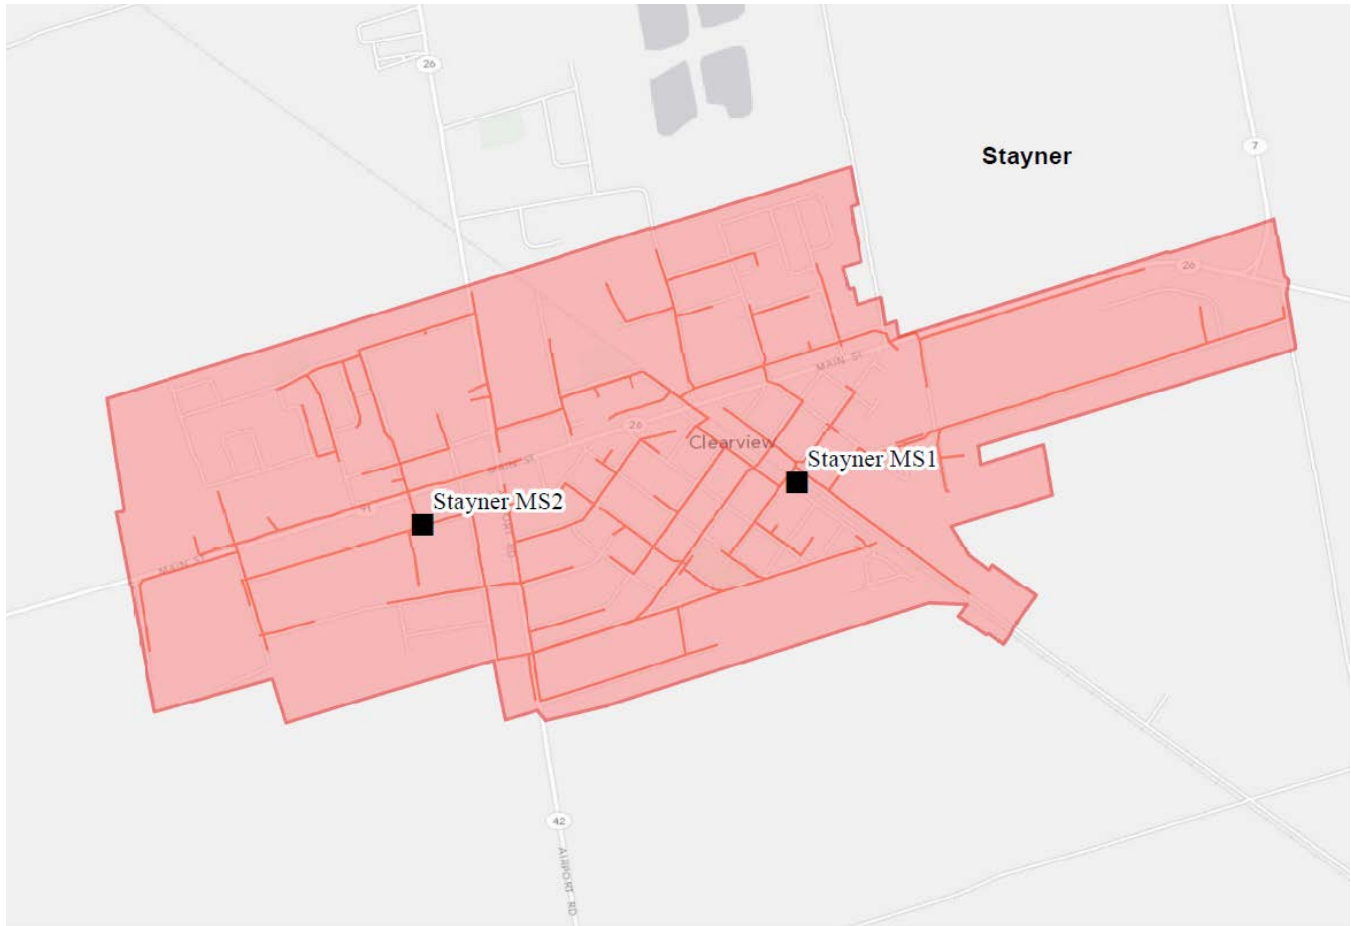
Figure 3 - Stayner Stations

In the Town of Stayner CPS currently owns and operates two municipal stations which are fed by 44kV. These stations provide 4.16kV feeders which supply the Town. The current number of stations allows for switching between feeders as required for operational and maintenance purposes and provides the capacity for a low number of customer outages.

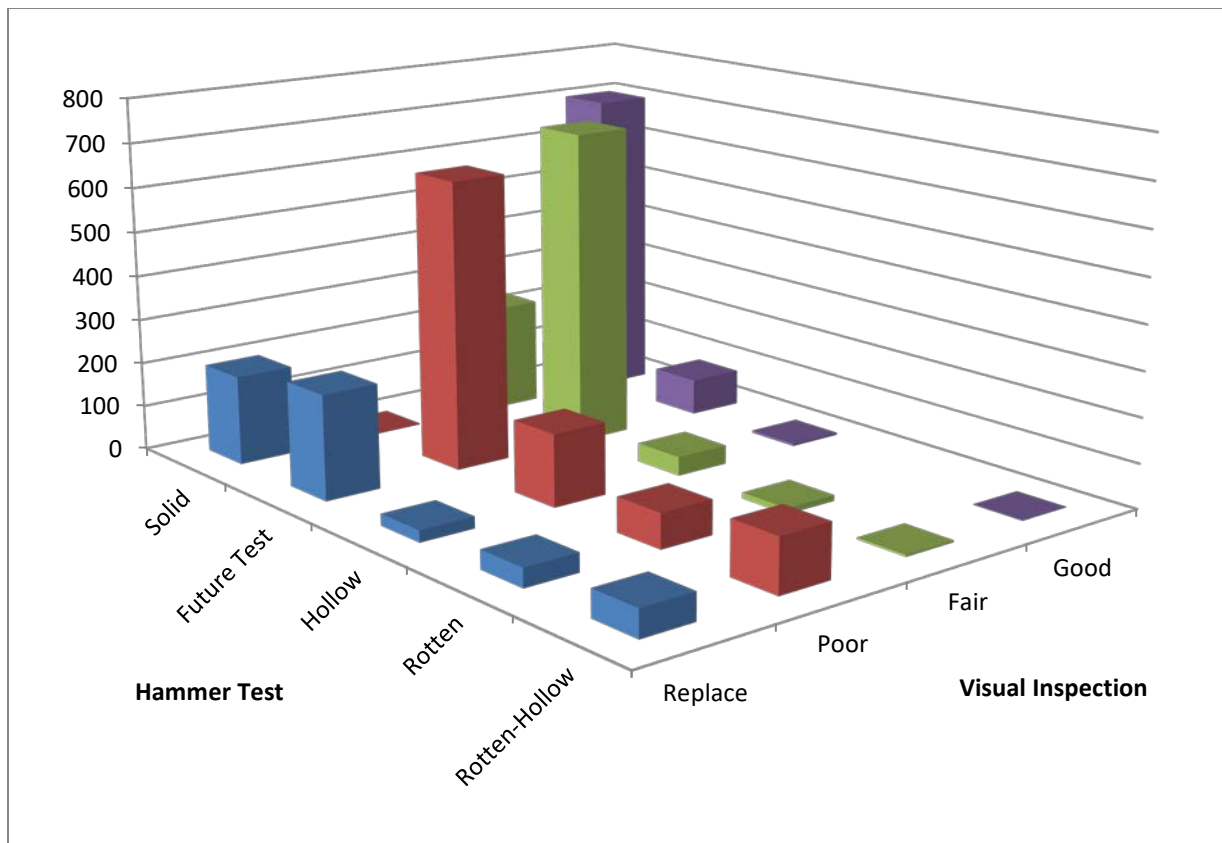
Figure 6 - Pole Count by Test and Visual Inspection

Figure 6 correlates the visual inspection (depth axis) of CPS poles with hammer tests (horizontal axis) made on the same poles. The poles shown toward the front of the chart are those which:

- were found in need of replacement or of being in poor condition during the visual test
- were found to be hollow, rotten or both by the hammer test

486 poles were found to meet both these criteria. These poles will have priority for replacement in this proposed five year plan. This represents approximately 10% of CPS poles over five years, or 2% each year. Wherever possible they will be replaced as part of a project where copper conductor and other equipment are also replaced. The order of priority for replacement of the above poles will be determined by the pole utilization and its condition.

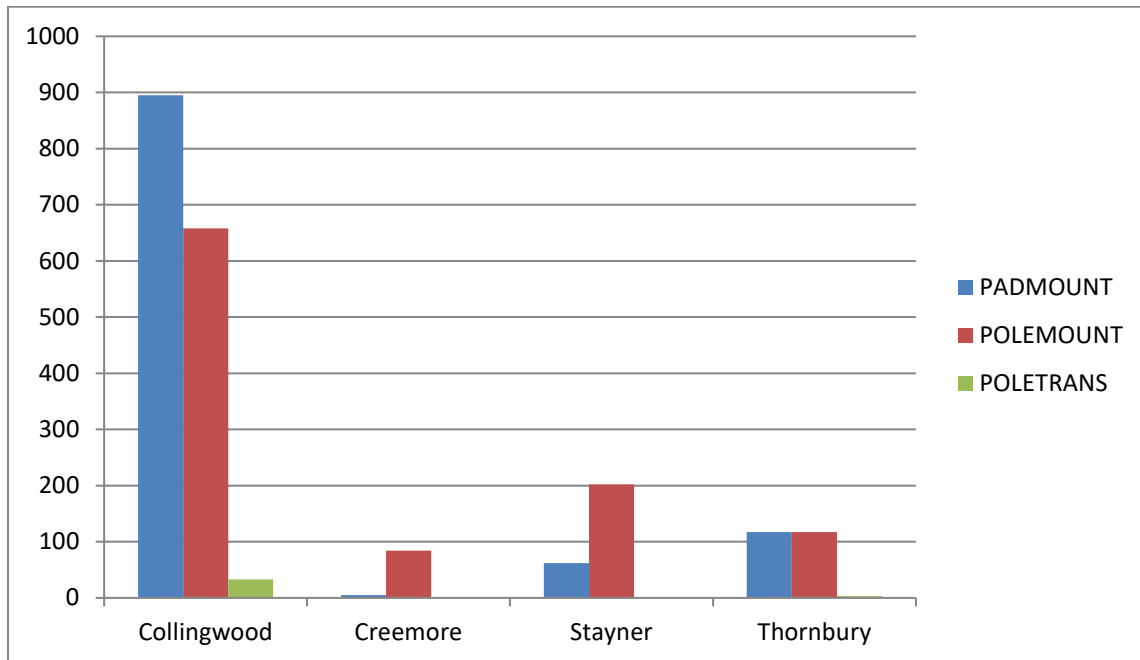
Figure 8 - Transformer Count by Community

As seen in Figure 8 each of the communities serviced by Collus Power has a different mix of padmount and polemount units. This is attributed to the separate philosophies adhered to by the individual community utilities before becoming part of CPS.

It should also be noted that Creemore, the town with the oldest plant, has a majority of overhead transformers while in Collingwood where there has been more new construction shows a larger number of padmount units. This follows a trend in the industry towards new subdivisions using underground distribution systems with padmount transformer.

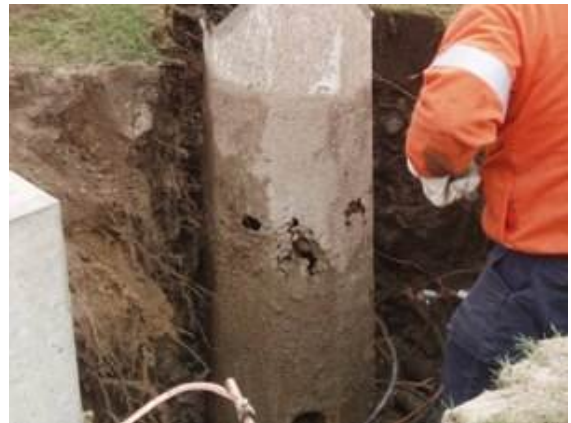
Figure 9 - Sample Corroded Poletran base

The CPS system currently includes 41 poletran units which are being phased out of service. The replacement of these poletran units has been made a priority as their bases have begun to deteriorate beyond acceptable levels as seen in Figure 9. 38 of the 41 poletran units are installed in Collingwood. Due to high cost of replacement, five poletrons will be replaced every year above and beyond any identified system maintenance. These replacements have been identified in Section 10 of this report and represent approximately 2% of all transformers.
