1 ***EXHIBIT 2 – RATE BASE AND DISTRIBUTION SYSTEM PLAN***

2
3 ***Interrogatory 2-Staff-10***

4
5 ***Capital Projects***

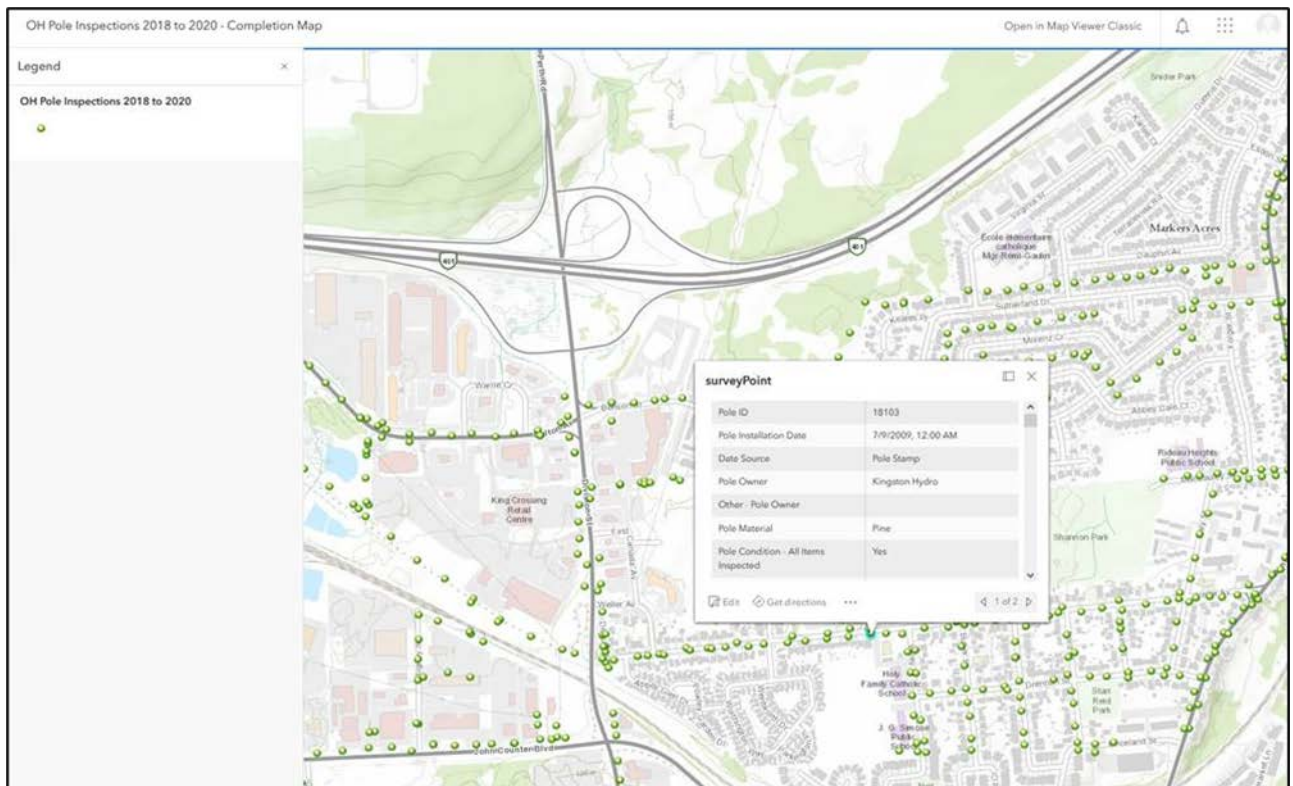
This information is constantly reviewed by staff to identify projects and to prioritize projects due to their condition assessment. For example, a group of inspected poles have been deemed critical condition along the same pole line. This will be looked at closer by the engineering technologists to make this grouping of poles into a pole replacement project.

Example of pole inspection data collected:

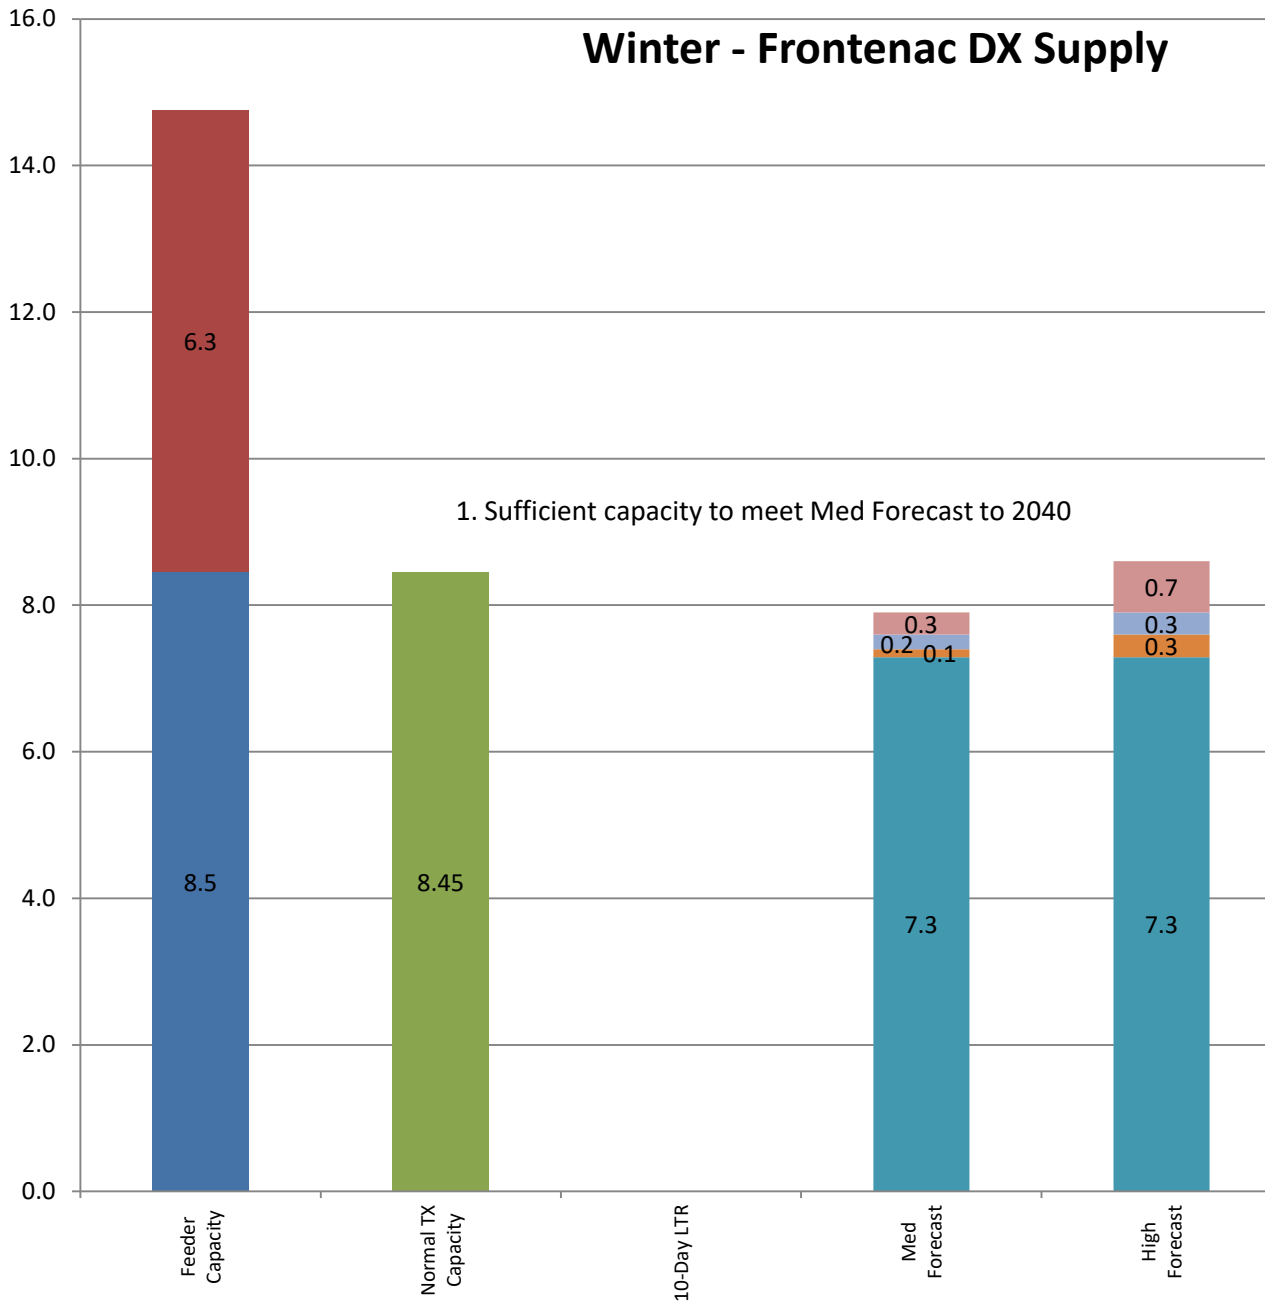
1. Sufficient capacity to meet Med Forecast to 2040

- 2029-2040 Forecast
- 2024-2028 Forecast
- 2020-2023 Forecast
- 2019 Nominal Load
- 10-Day LTR Allocated TX Capacity
- Normal Allocated TX Capacity
- Emergency Capacity
- Normal Capacity

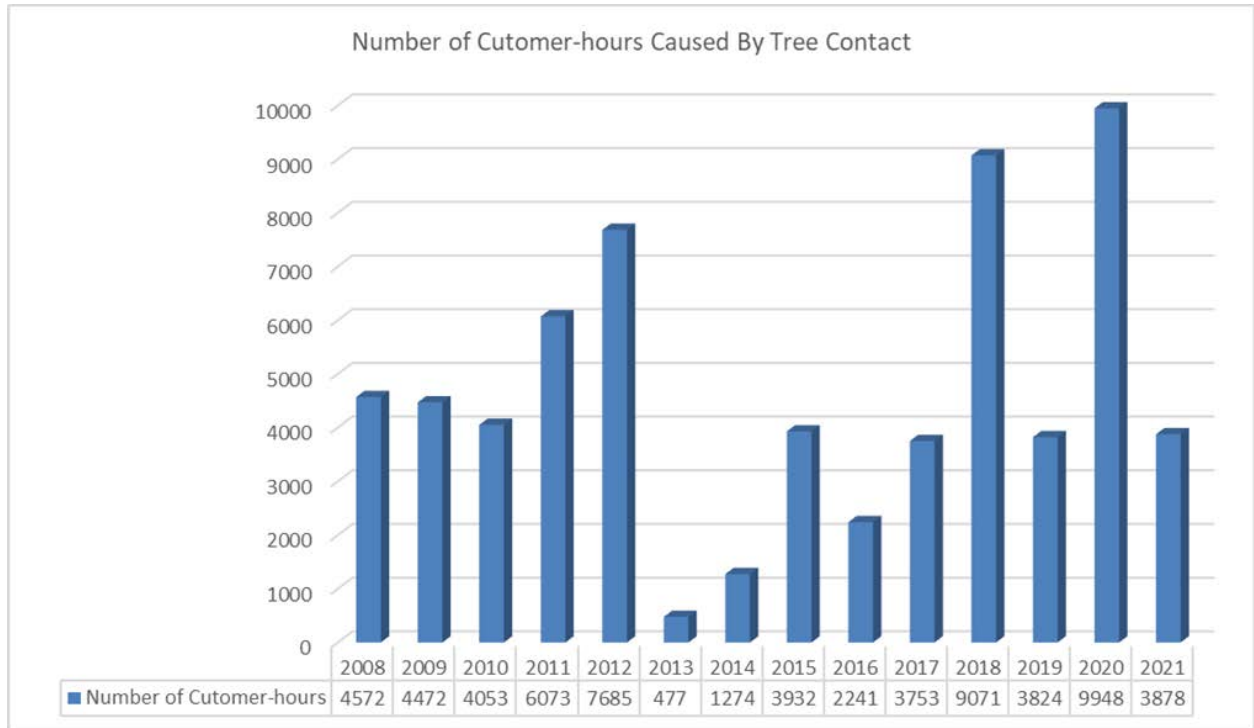
- a) The TCHI due to tree contact for 2008 to 2021 is summarized in the following chart.***

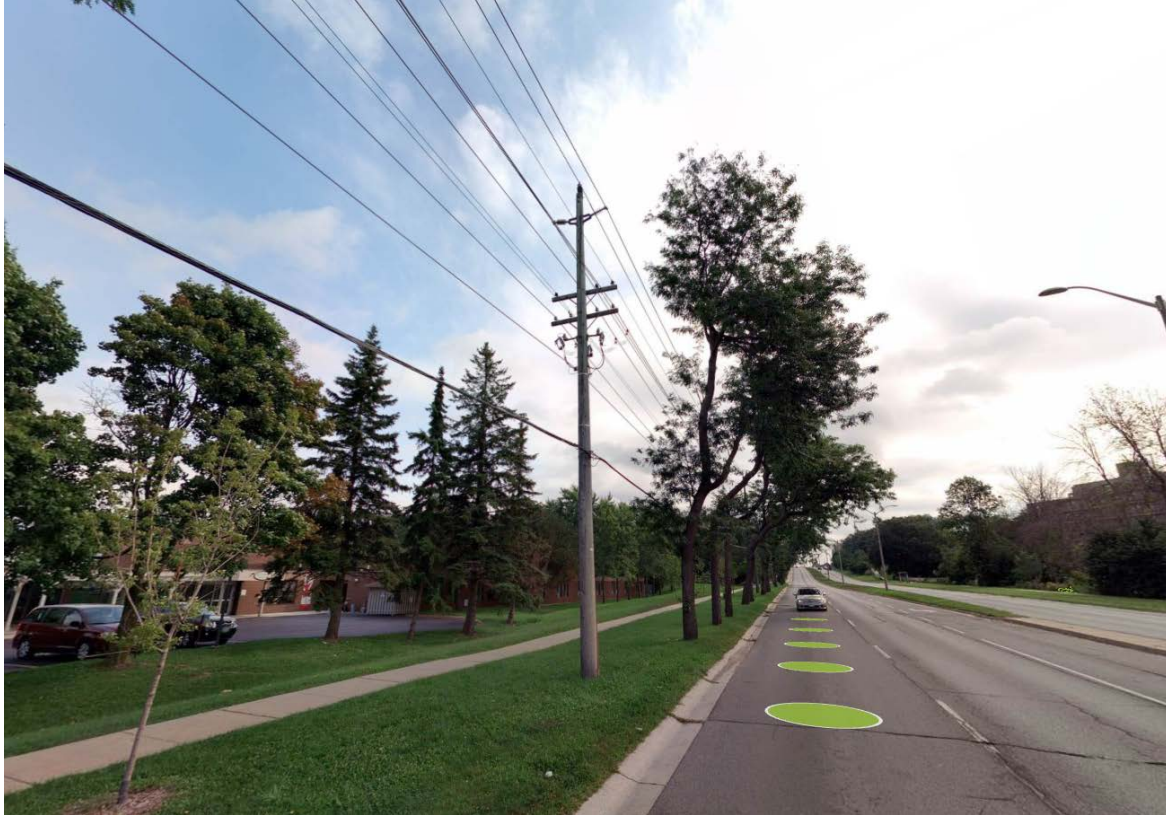
The old open bus 120/240V conductor were replaced with spun bus 120/240V conductor to avoid unplanned outages caused by contact from tree limbs. The 3 transformers were replaced with 3 transformers, and relocated to new poles with proper clearance and configured to better distribute the load.

75 **Figure 1 – Existing pole line**

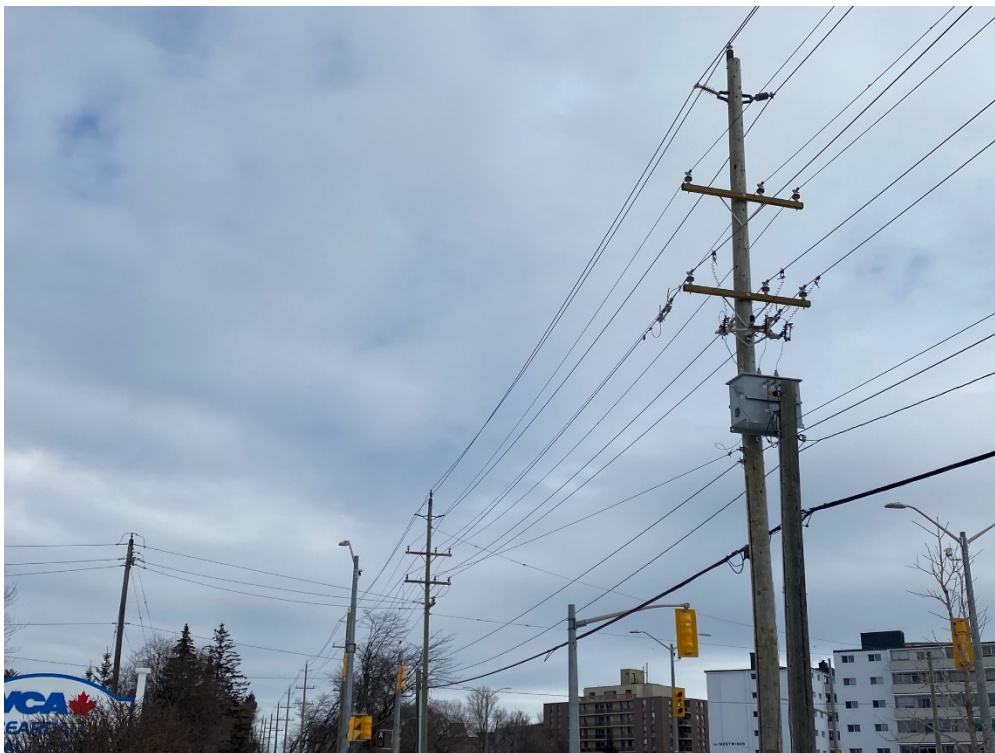
77 **Figure 2 – New pole line**

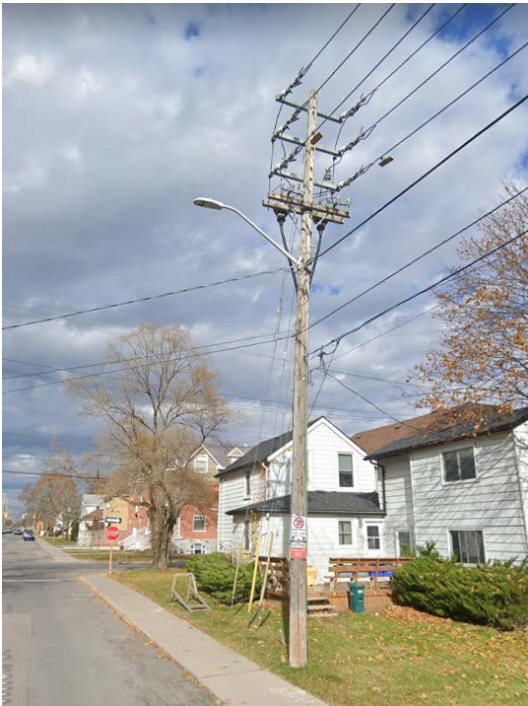
Figure 1 – Existing 203 and 206 Circuit riser pole showing legacy and non-standard construction with reduced working clearances and pole congestion

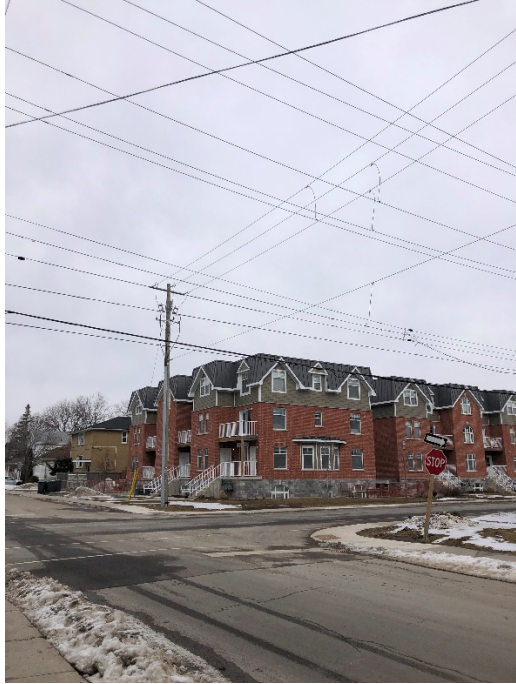
104 **Figure 2 – New 203 Circuit riser constructed to modern standards and new overhead circuit connection**

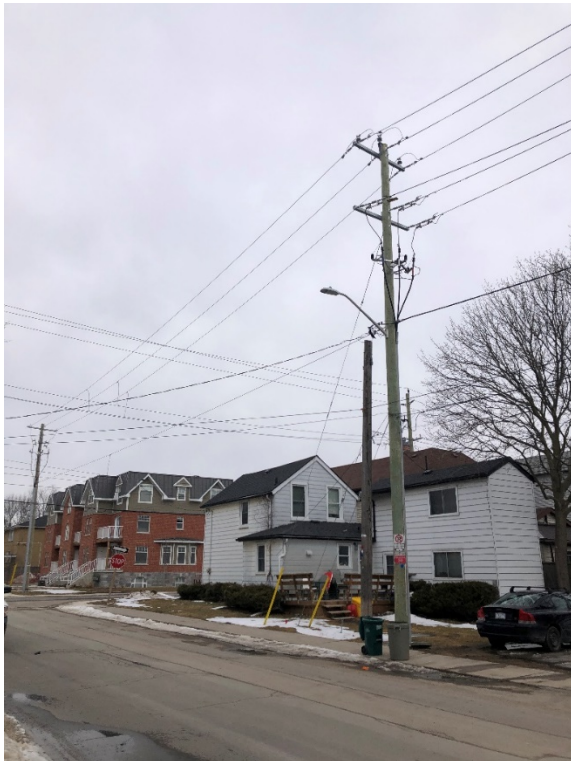
106 **Figure 3 – New 206 Circuit riser pole constructed to modern standards and increased clearances**

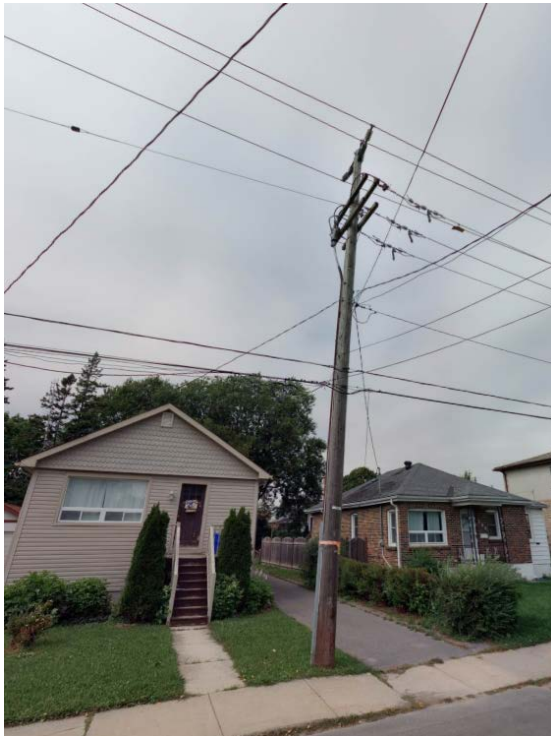
Figure 1 – Existing 207 Circuit riser pole showing legacy and non-standard construction with reduced working clearances

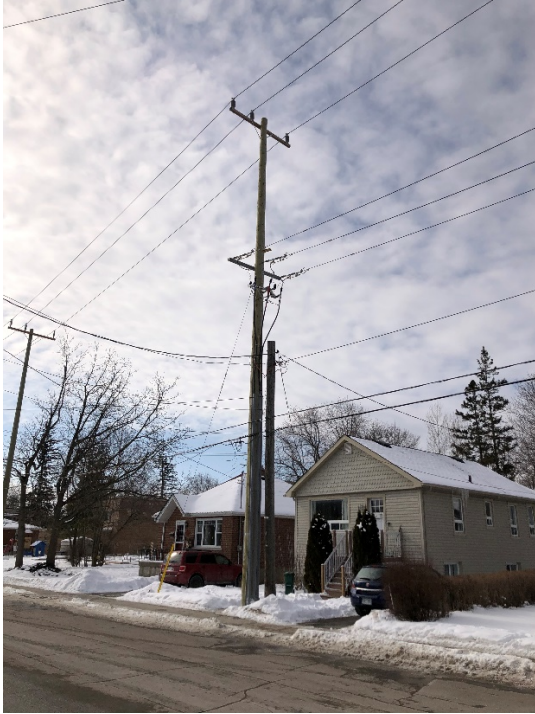
101 **Figure 2 – New 207 Circuit riser constructed to modern standards and increased clearances, note additional space**
 102 **on poles for future 201 and 208 circuit extensions**

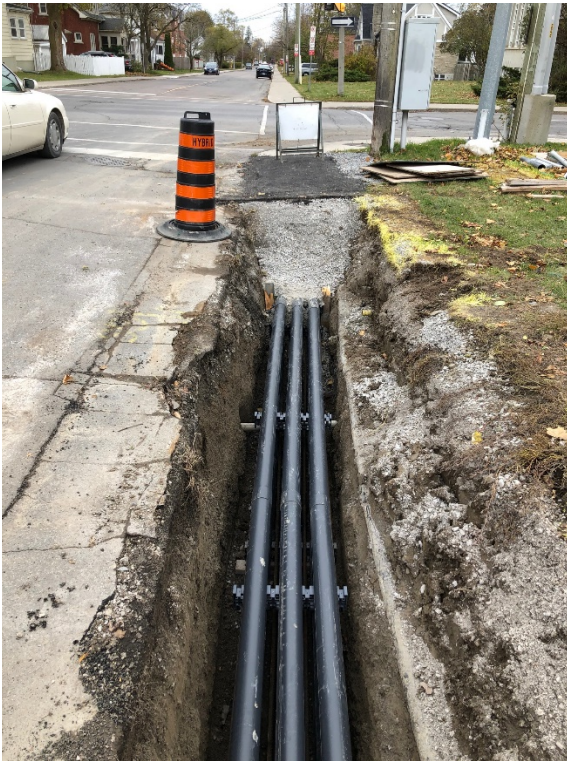
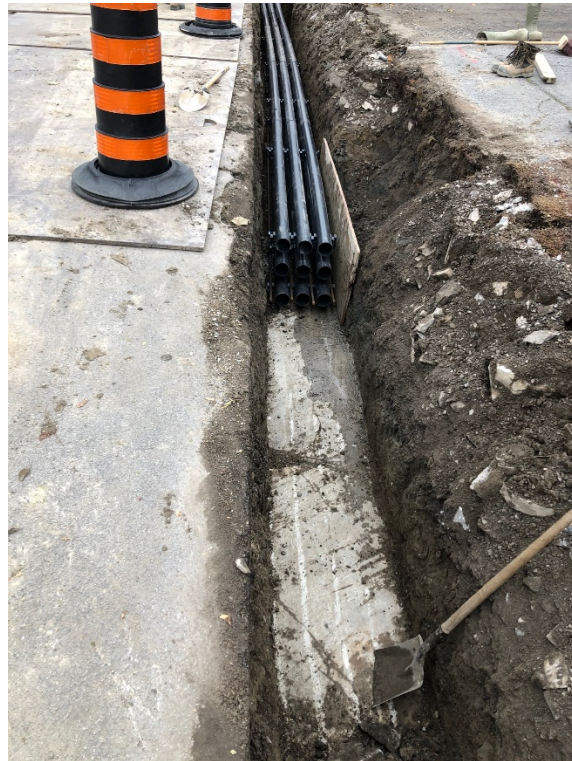
104 **Figure 3 & Figure 4 – New 207 circuit ducts, future use 201 and 208 circuit ducts installed on MacDonnell Street**

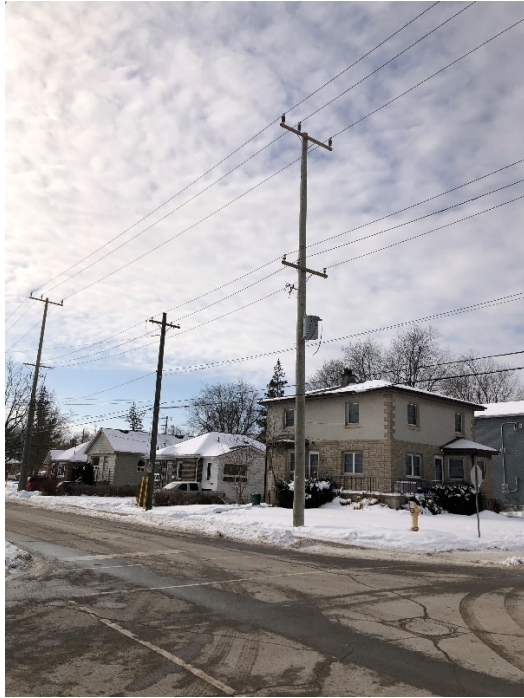
106 **Figure 5 – New pole constructed to modern standards and increased clearances in comparison to an existing**
107 **pole, note additional space on poles for future 201 and 208 circuit extensions above 207 Circuit**

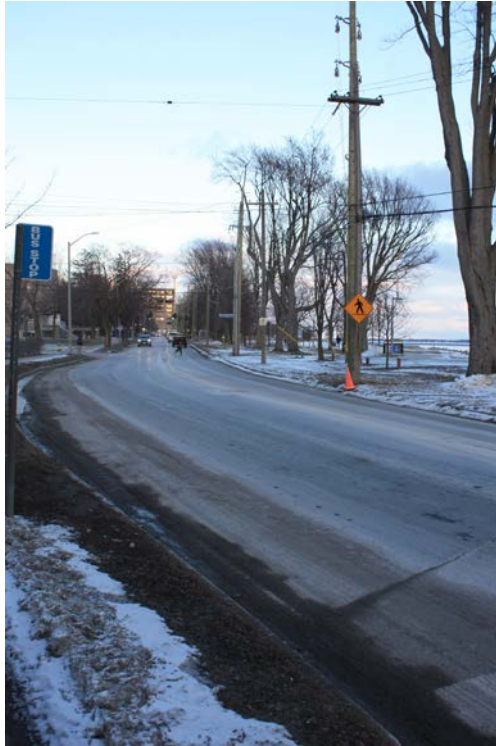
74 **Figure 1 – Existing poles showing new poles working around canopy with improved working clearances**

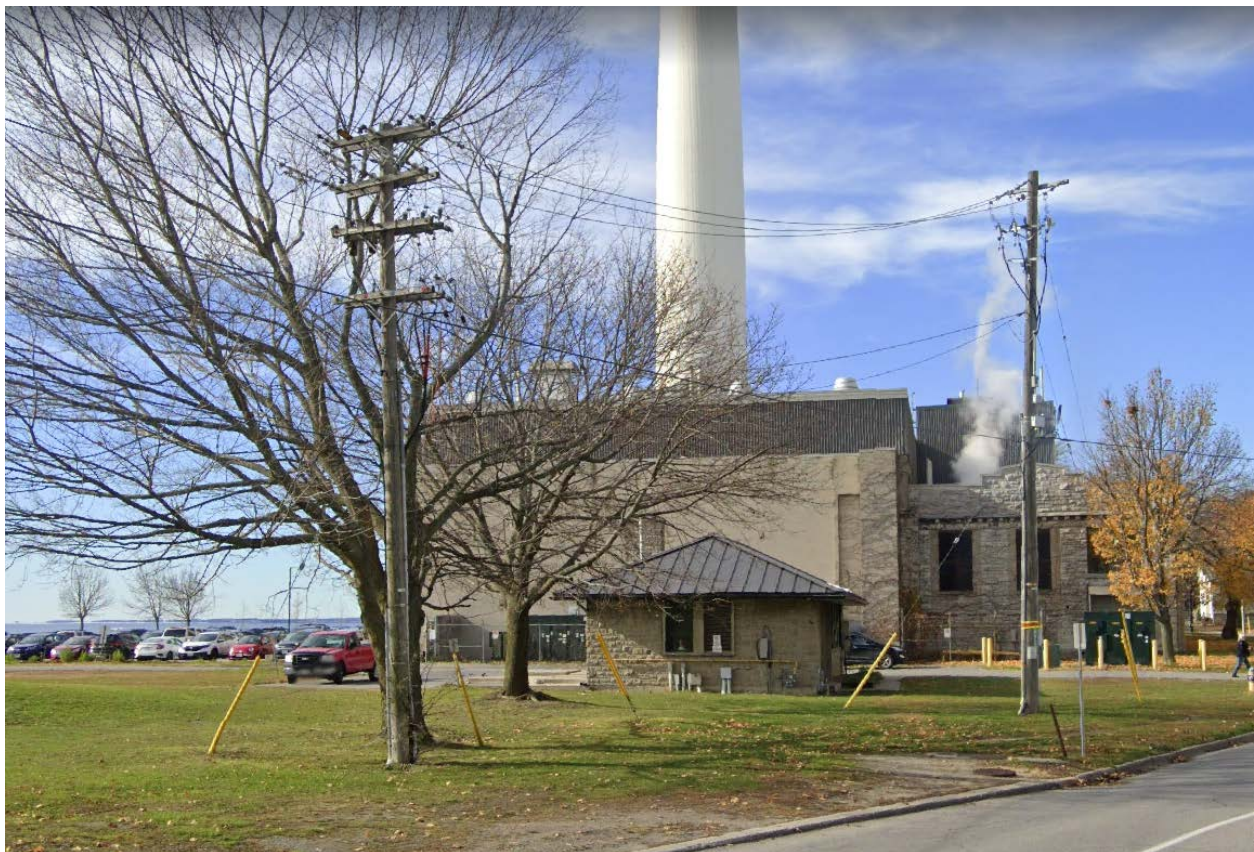
76 **Figure 2 – Existing pole showing legacy construction standards.**

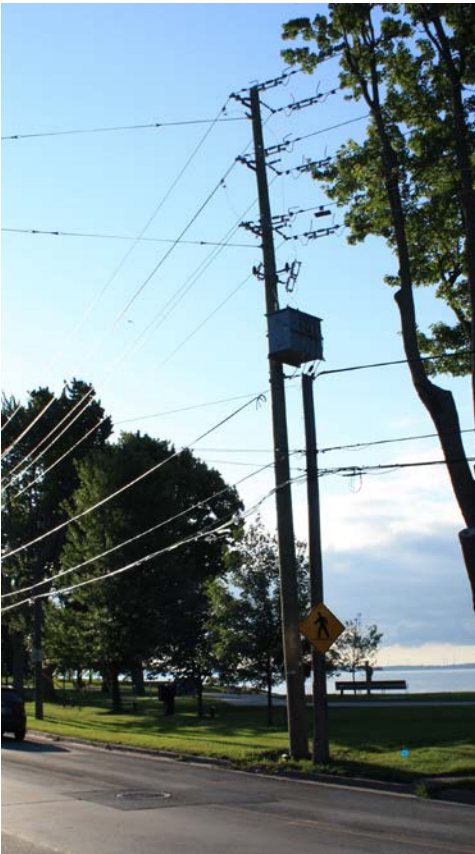
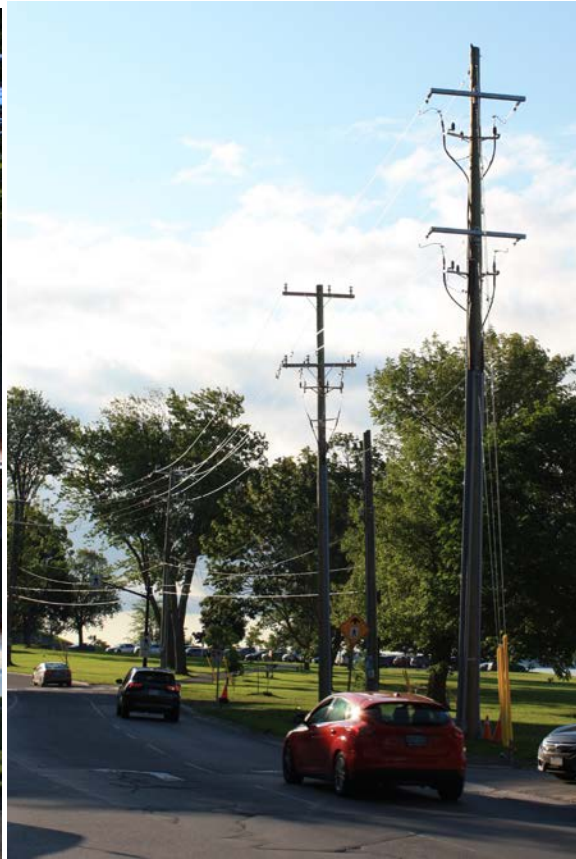
78 **Figure 3 & 4 – New poles showing modern construction standards and equipment**

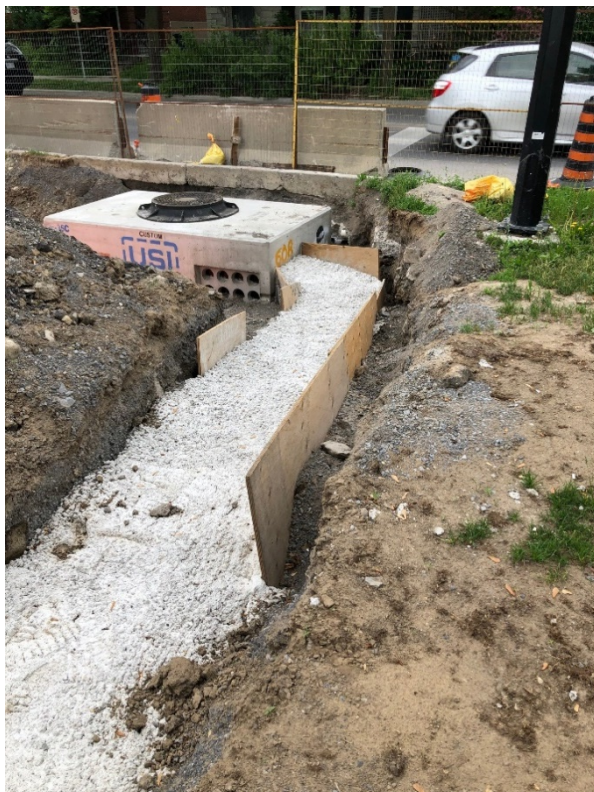
71 **Figure 1 – New 608 and 609 circuit concrete encased duct bank**

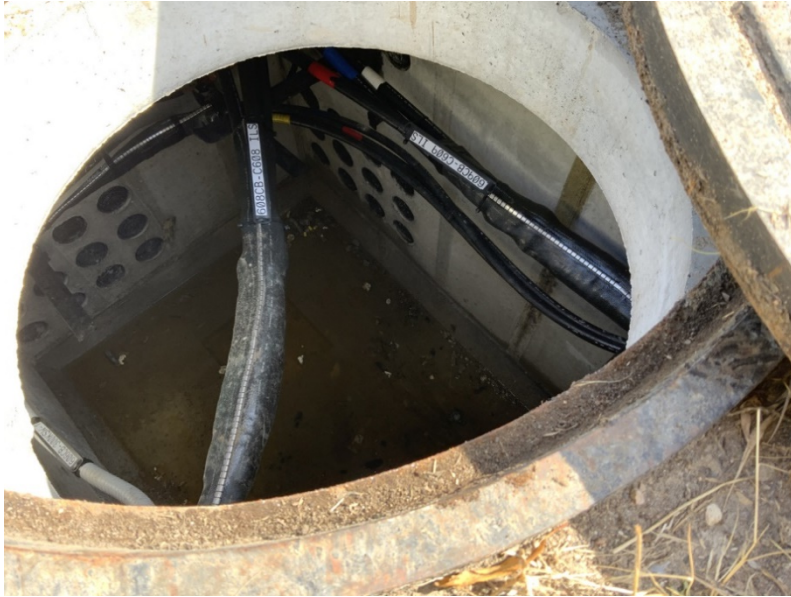
73 **Figure 2 – New EM36 with completed cabling and transition splices to the existing PILC cables of both 608 and**
74 **609 circuits**

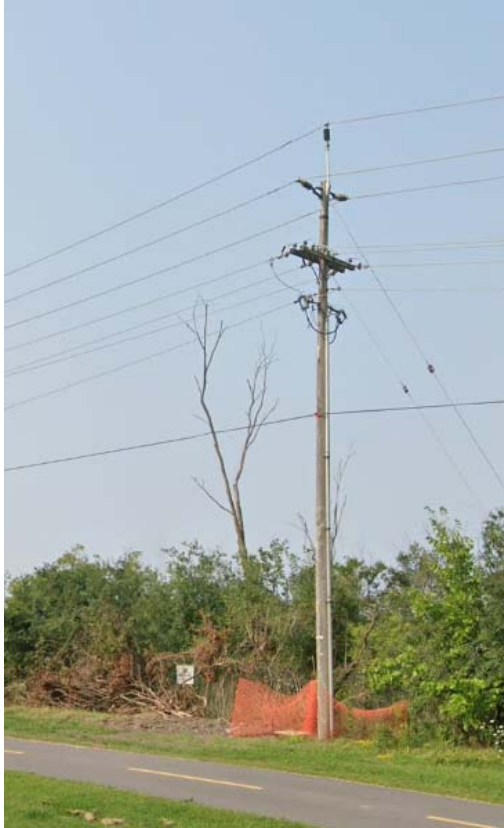
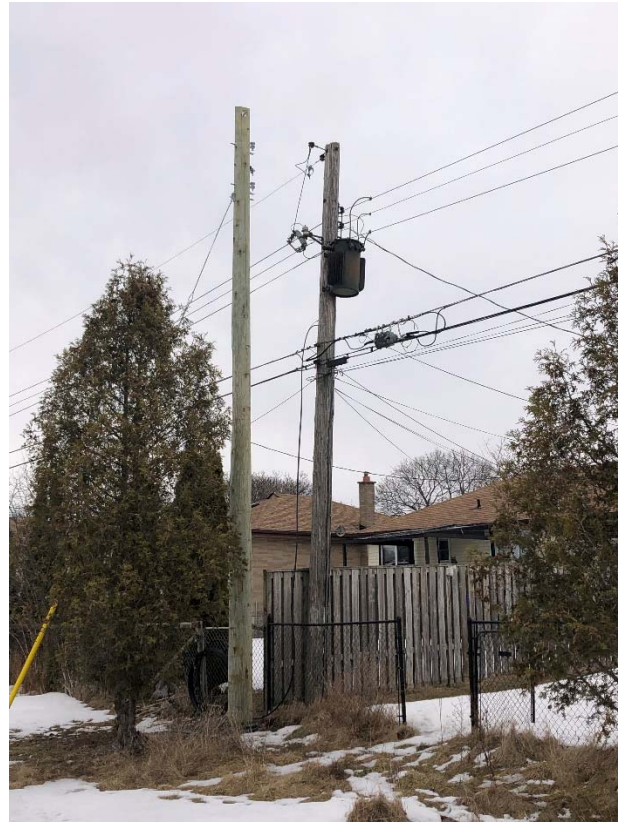
Figure 1 & 2 – Existing poles showing legacy construction standards, limited working space and poor pole conditions

51 Wood poles are visually inspected at least once every three years in accordance with Ontario Energy
52 Board requirements. A competent line person may also perform a hammer test in addition to the visual
53 inspection depending upon the pole condition and history. Many poles on Leroy Grant Drive were

identified by pole inspections and prioritized for action due to condition and the assets connected to this pole line. The limited working clearances and separation between overhead circuits pose maintenance and operational restrictions.

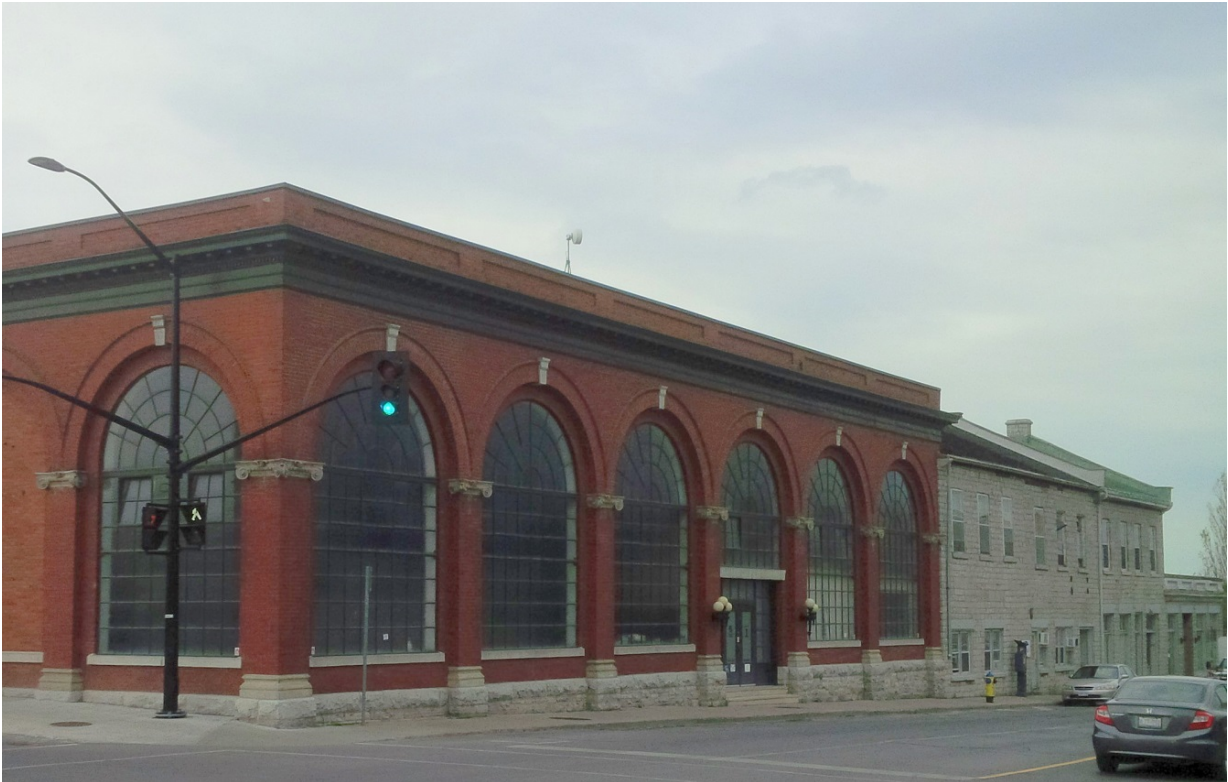
C. Figure 1 - View of Substation No. 1 from Queen Street– May 2015

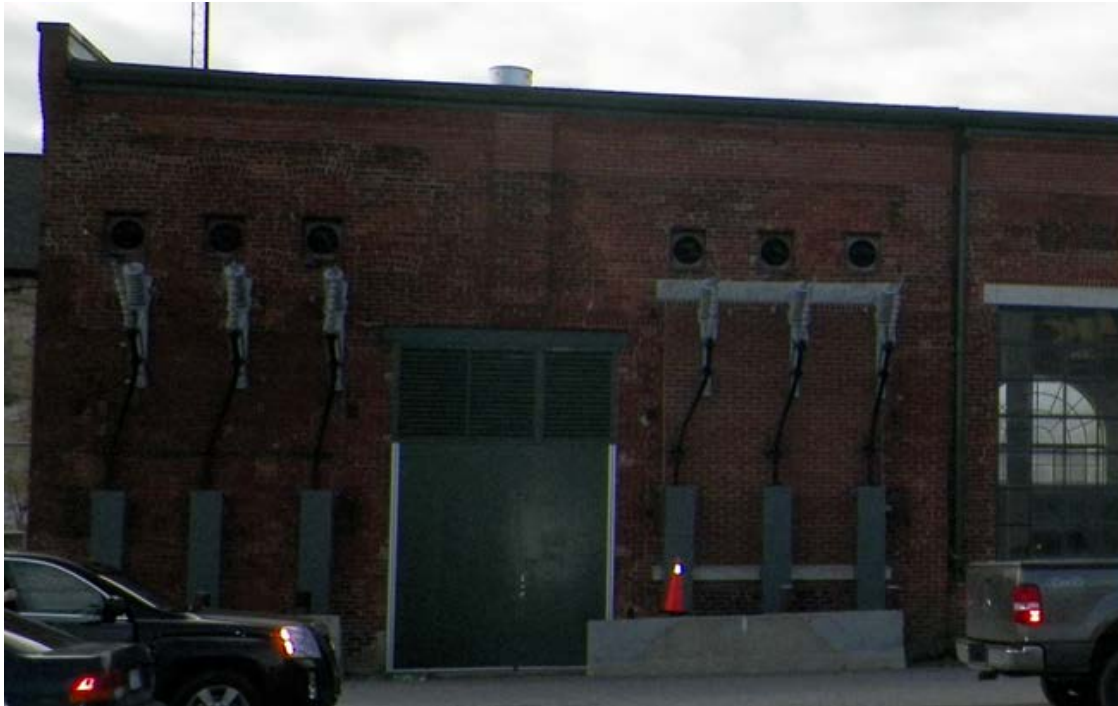
Exterior View of North Wall Before Relocating 44kV Cable Risers

Up until 2006, Substation No.1 was fed from two 44kV overhead lines. The 44kV overhead conductors were terminated at high level on the exterior rear north wall of the substation and fed the 44kV distribution inside Substation No.1 through the wall via existing 44kV bushings. In 2006, the two 44kV overhead lines were replaced with underground cable from Barrack Street to Substation No.1 to allow for the construction of a new Large Venue Entertainment Centre (LVEC) one block north of Substation No.1. Kingston Hydro had not yet developed a plan to rebuild Substation No. 1 so the new 44kV cables were terminated at high level on the exterior north wall of Substation No. 1 and the existing 44kV wall bushings were reused. In 2016, Kingston Hydro extended the 44kV ducts into Substation No.1 and relocated the 44kV cable risers from the exterior to the interior face of the rear north wall of the substation. Relocating the cable risers inside Substation No. 1 reduces the risk of foreign contact with the live 44kV cable terminations thus creating a safer and more reliable supply. Several 44kV potential transformers associated with 44kV protection had to be replaced and relocated inside Substation No. 1 to facilitate the relocation of the 44kV cable risers.

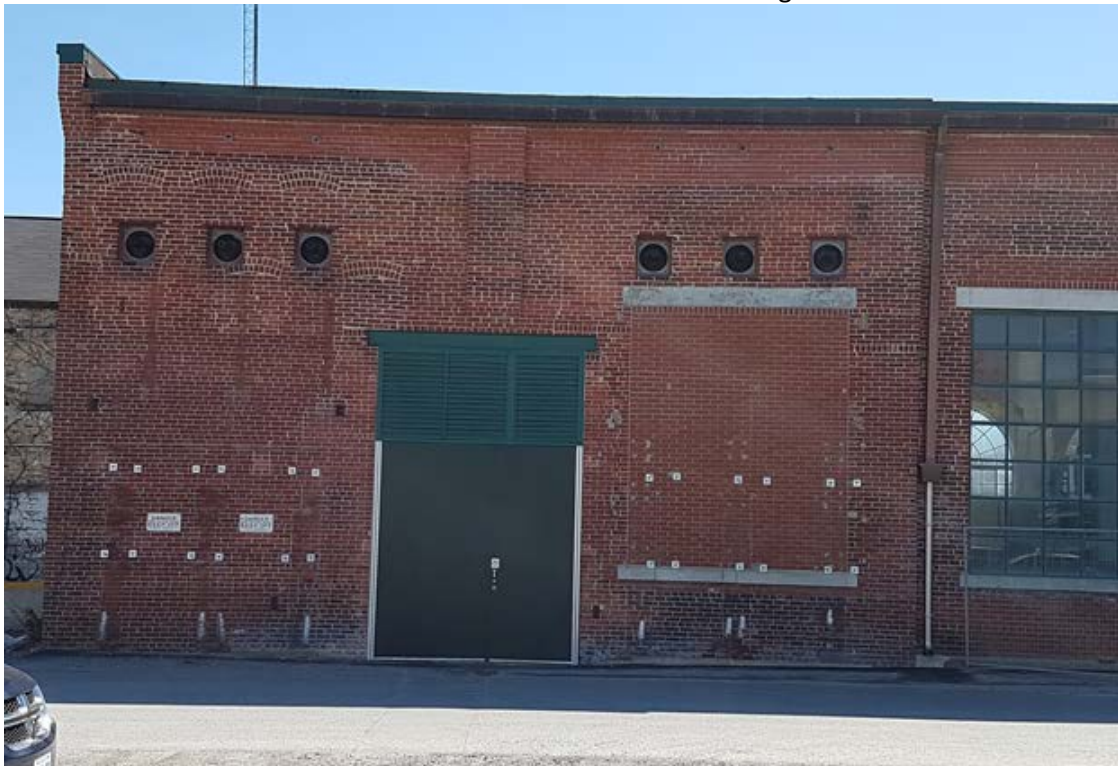
Exterior View of North Wall After Relocating 44kV Cable Risers

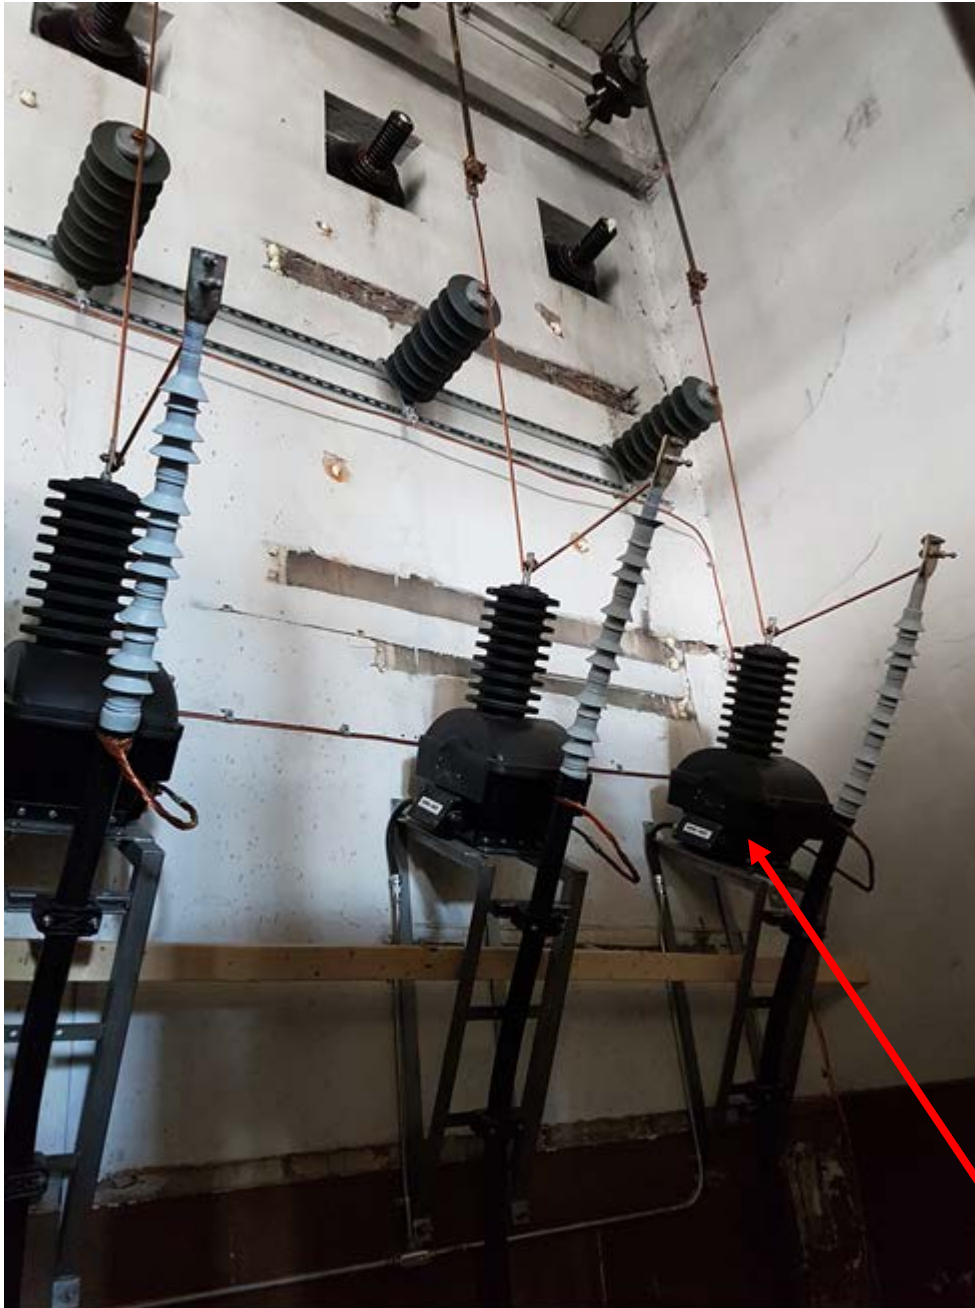
Interior View of North Wall After 44kV Cable Riser Relocation & New Instrument Transformer Installation

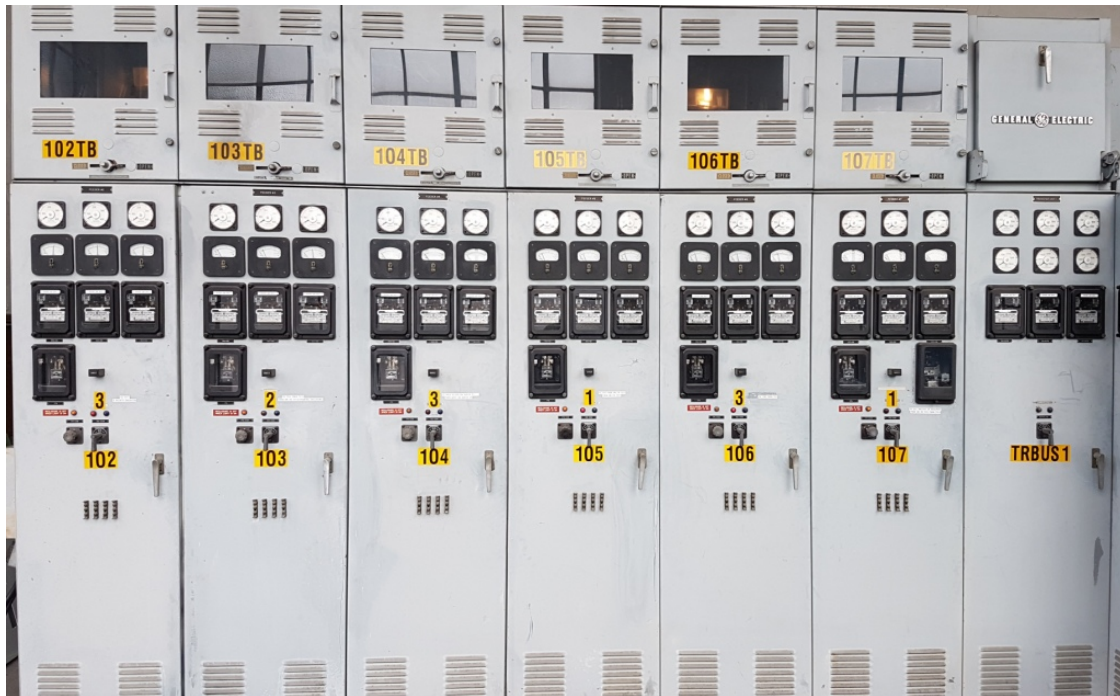
285 5kV West Bus – Before Feeder Protection Relay Upgrade (6 feeders + 1 transfer bus breaker)

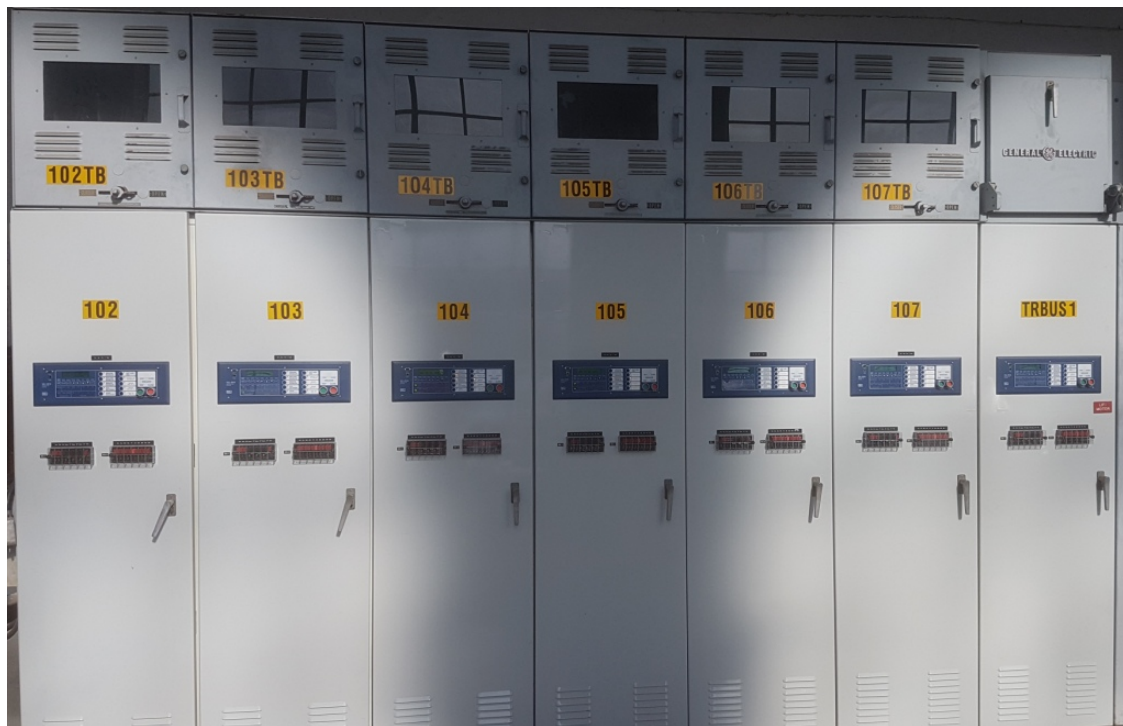
287 5kV West Bus – After Feeder Protection Relay Upgrade (6 feeders + 1 transfer bus breaker)

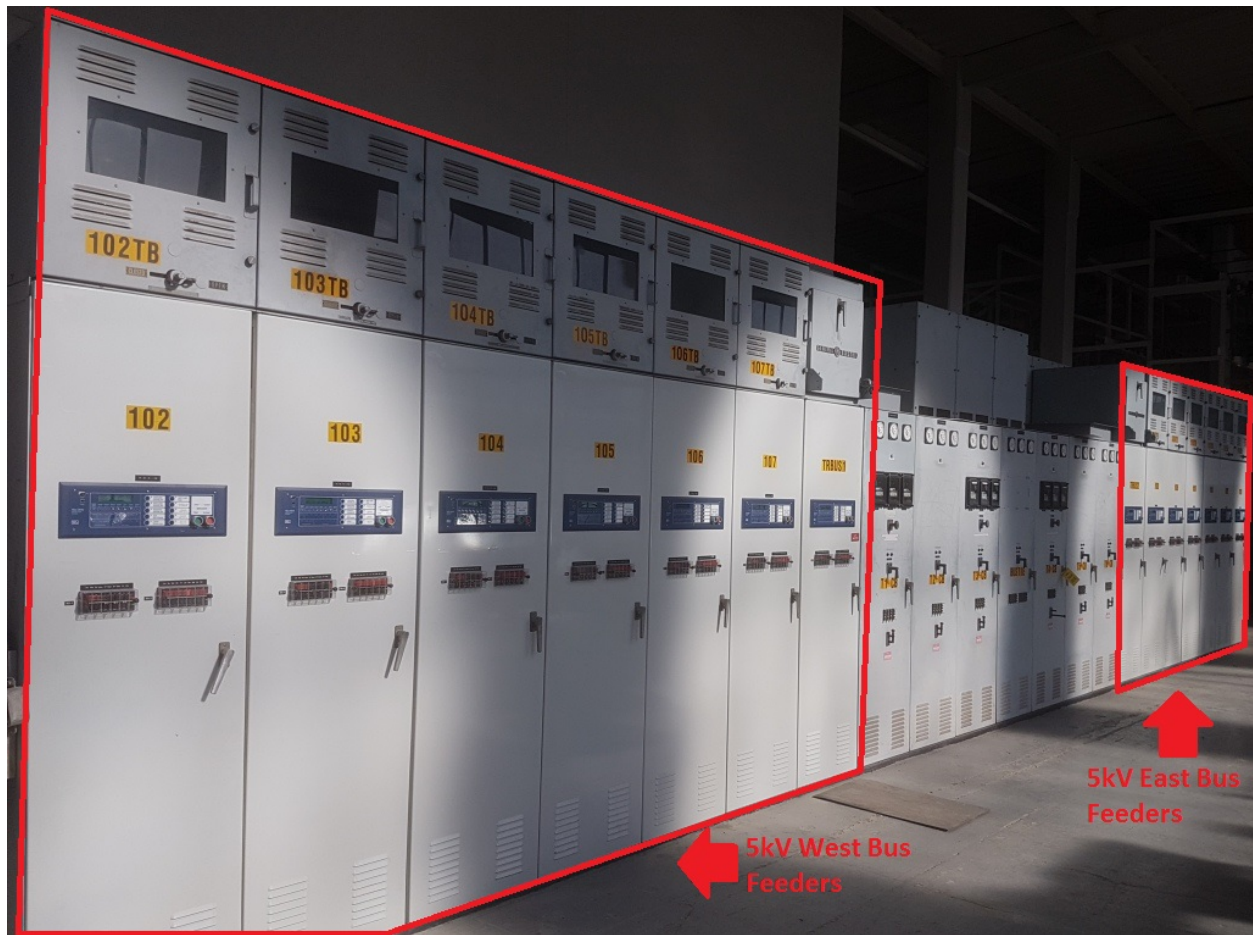
290 5kV Switchgear –West and East Bus Upgraded Protection Relays (12 feeders + 2 transfer bus breakers)

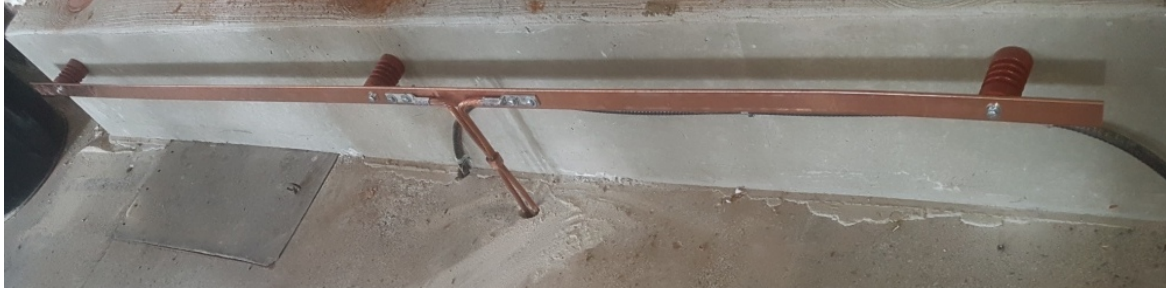
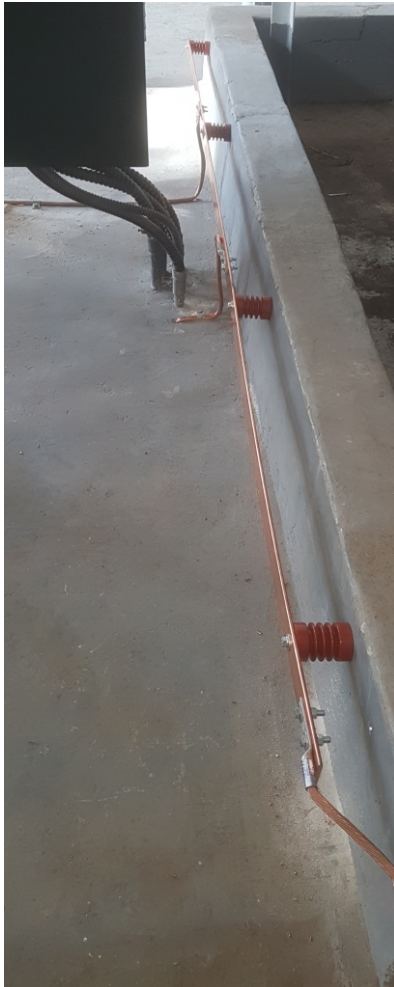
301 New Copper Grounding Bus (2 Examples of Upgrades Throughout Station)

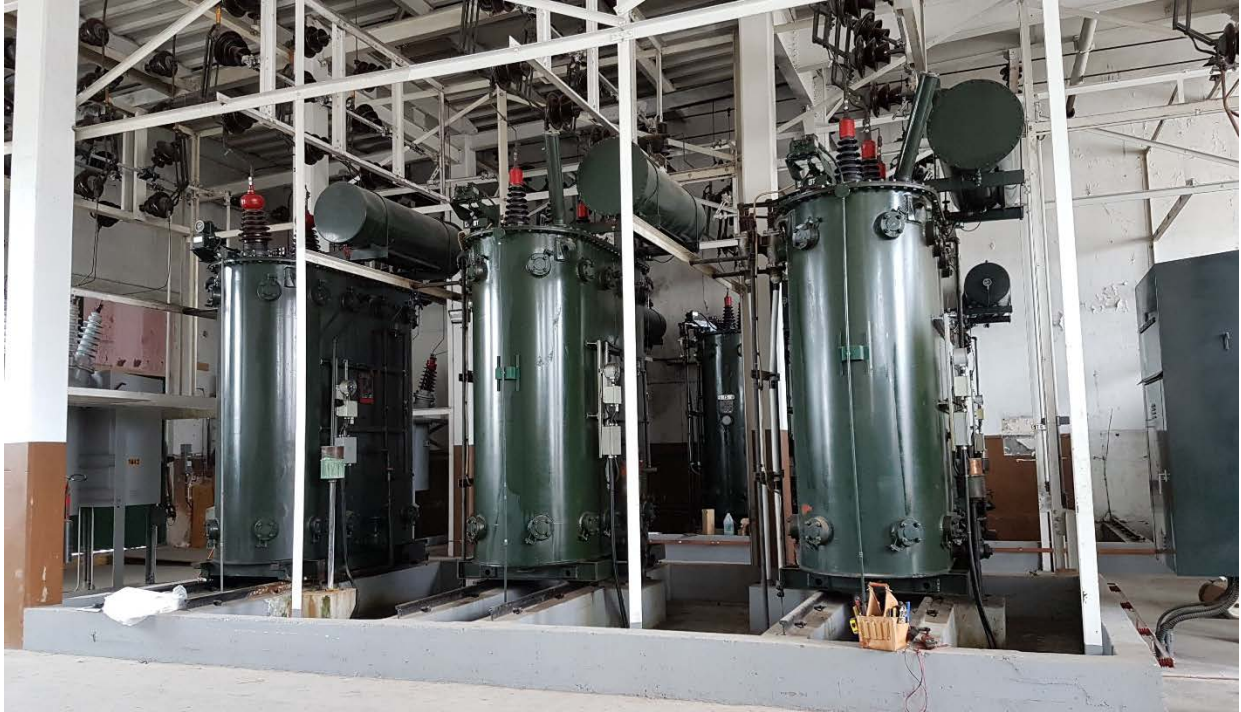
Existing Water-Cooling Transformers T1, T2 and T3

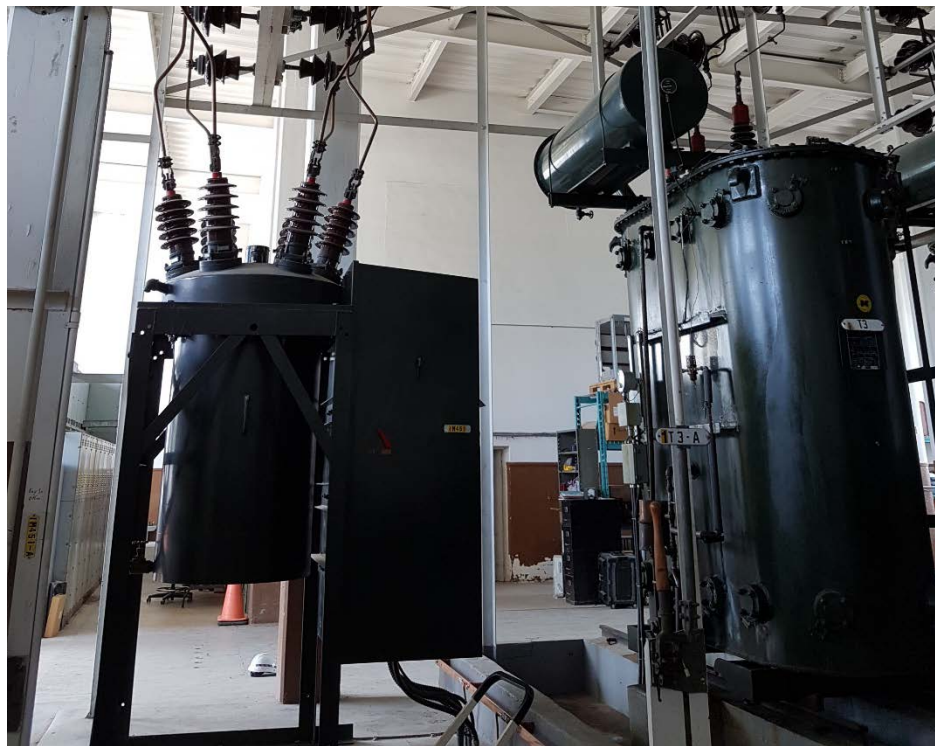
Existing 44kV Oil Circuit Breaker
