1 ***EXHIBIT 2 – RATE BASE AND DISTRIBUTION SYSTEM PLAN***

2
3 ***Interrogatory 2-Staff-10***

4
5 ***Capital Projects***

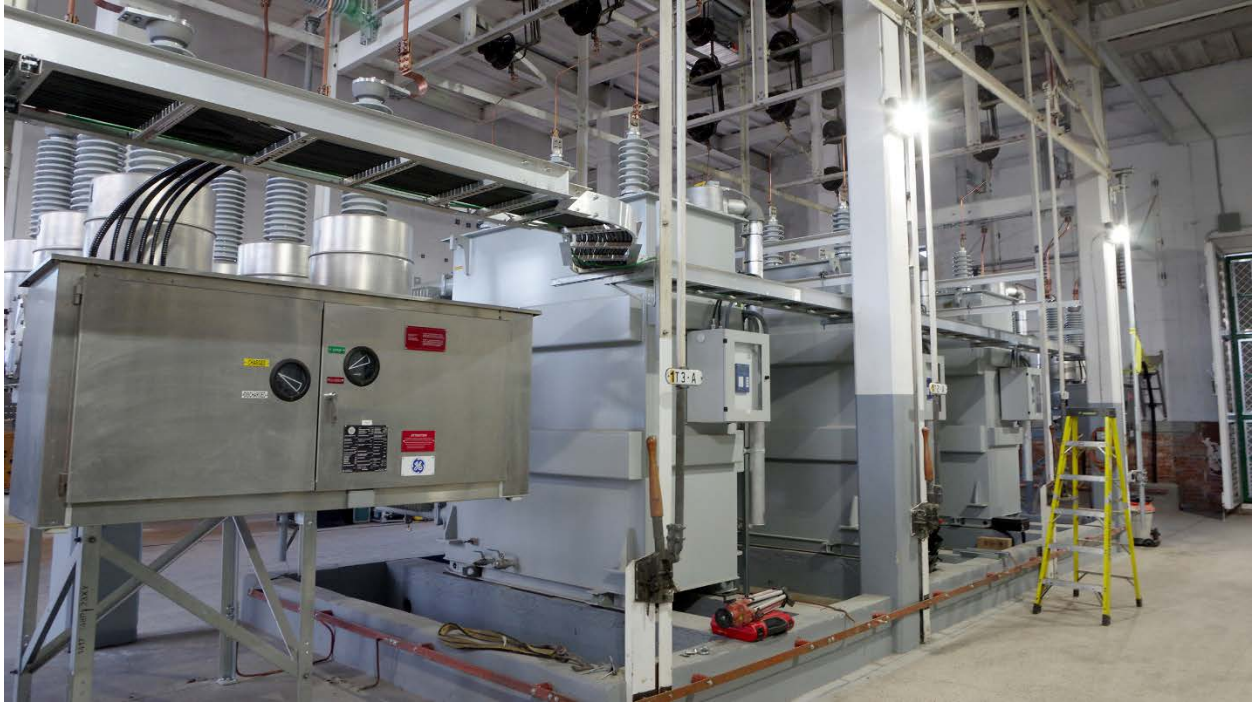
Upgraded 44kV SF6 Circuit Breaker and Natural Air Natural Cooling Transformers T1, T2 and T3

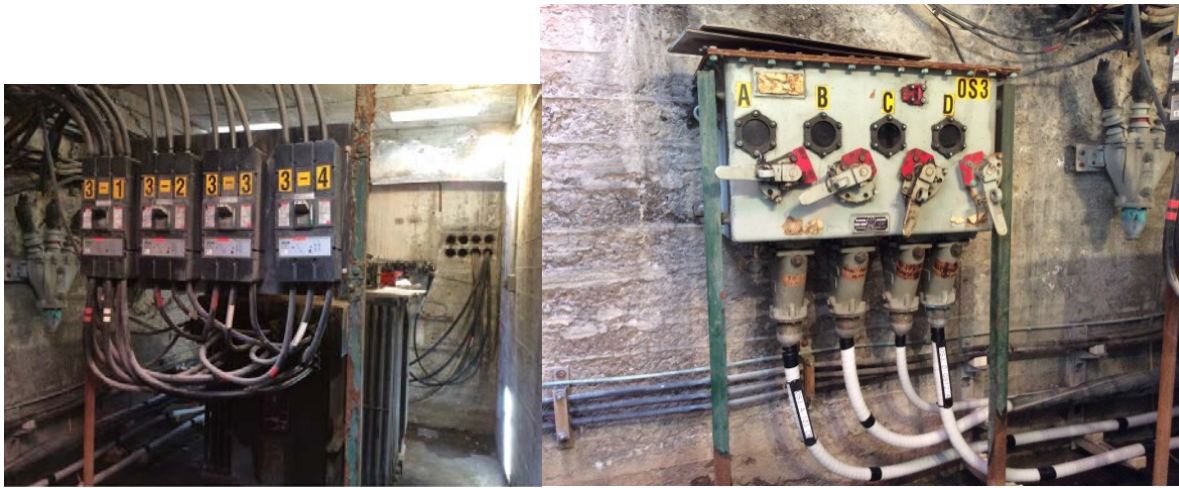
Previous Breakers and Oil Switch

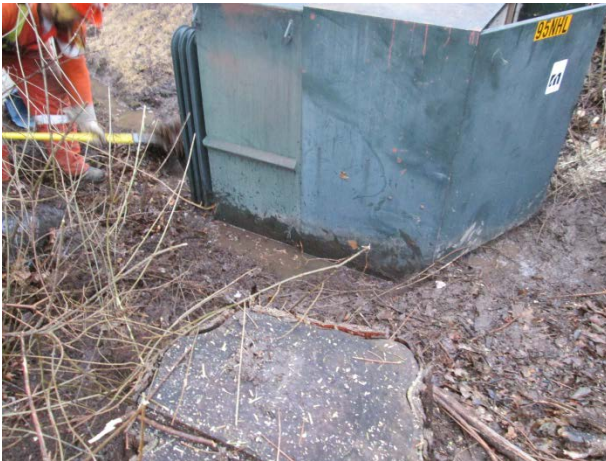
Figure 1: Flooded Pad Transformer at 95 Notch Hill Rd.

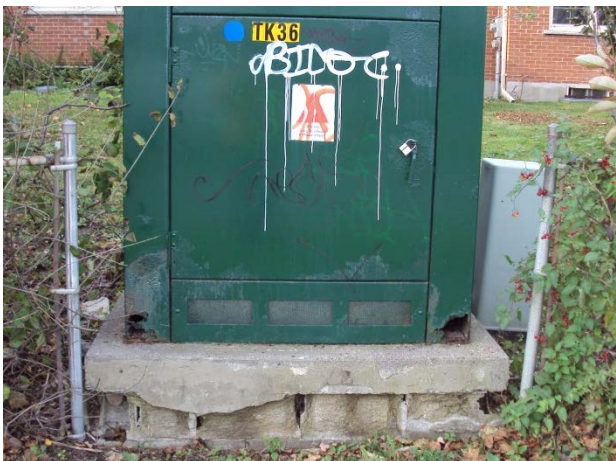
Figure 2: Rusty Enclosure & Deteriorated Foundation at TK36

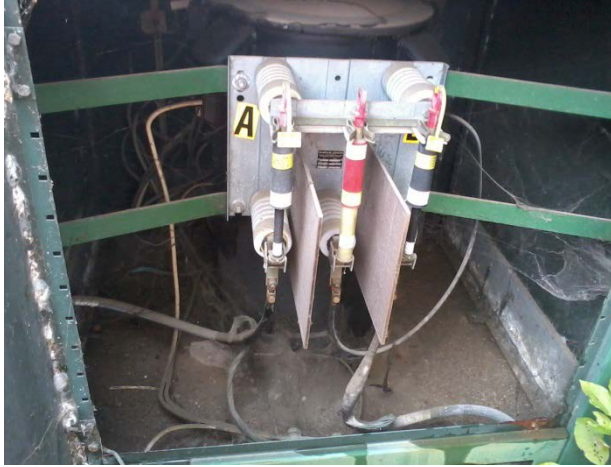
Figure 3: Old Style of Transformer Kiosk at 41 Wycliffe Cres.

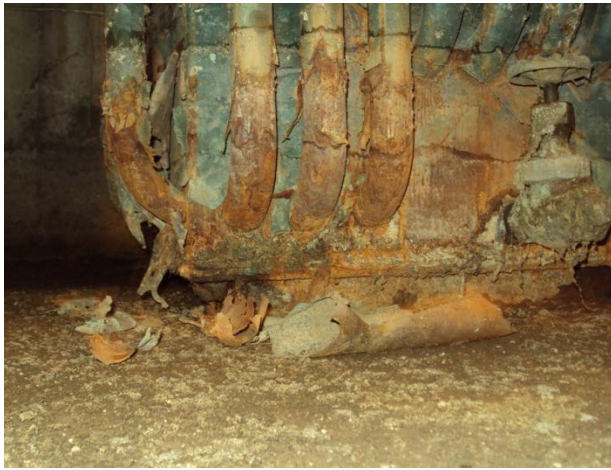
Figure 4: Rusted Vault Transformer at 180 Queen Mary Rd.

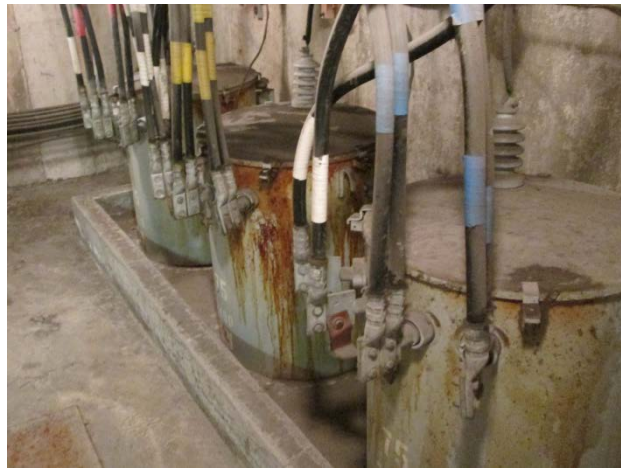
Figure 5: Leaking Vault Transformers at 2 Bay St.

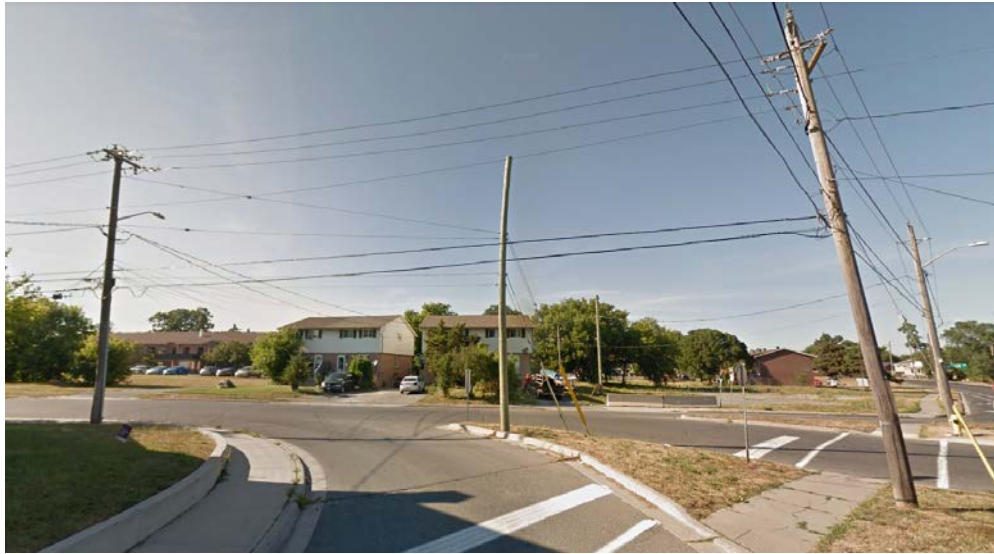
60 **Figure 1 – Existing poles showing poles in vulnerable locations.**

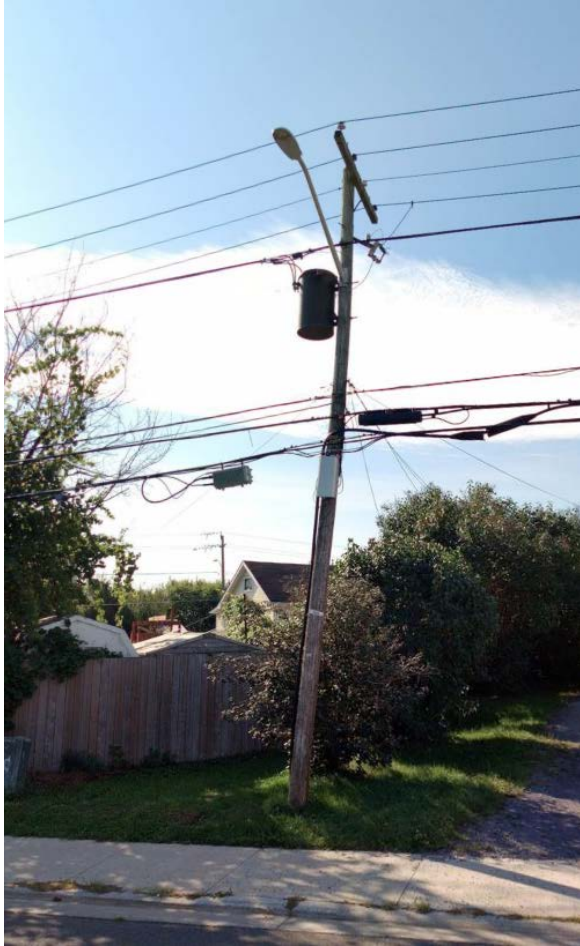
62 **Figure 1 – Existing pole showing legacy constructuion standards with the transformers below the**
63 **secondary distribution bus.**

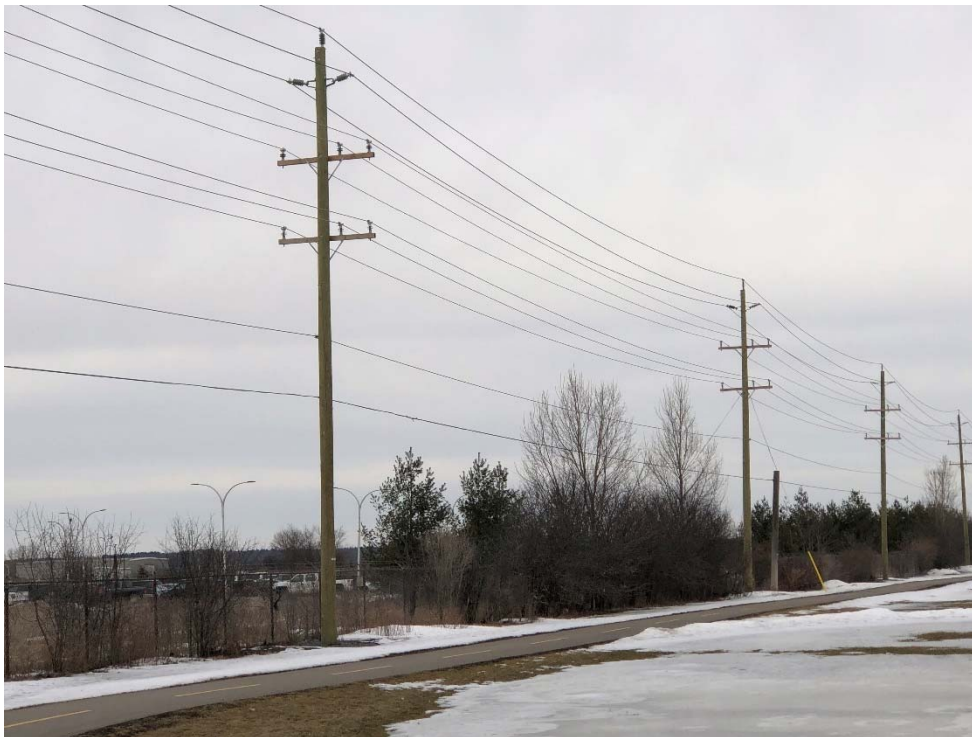
Figure 1 – New poles installed along the Leroy Grant Drive Trail with new 13.8kV circuit installed

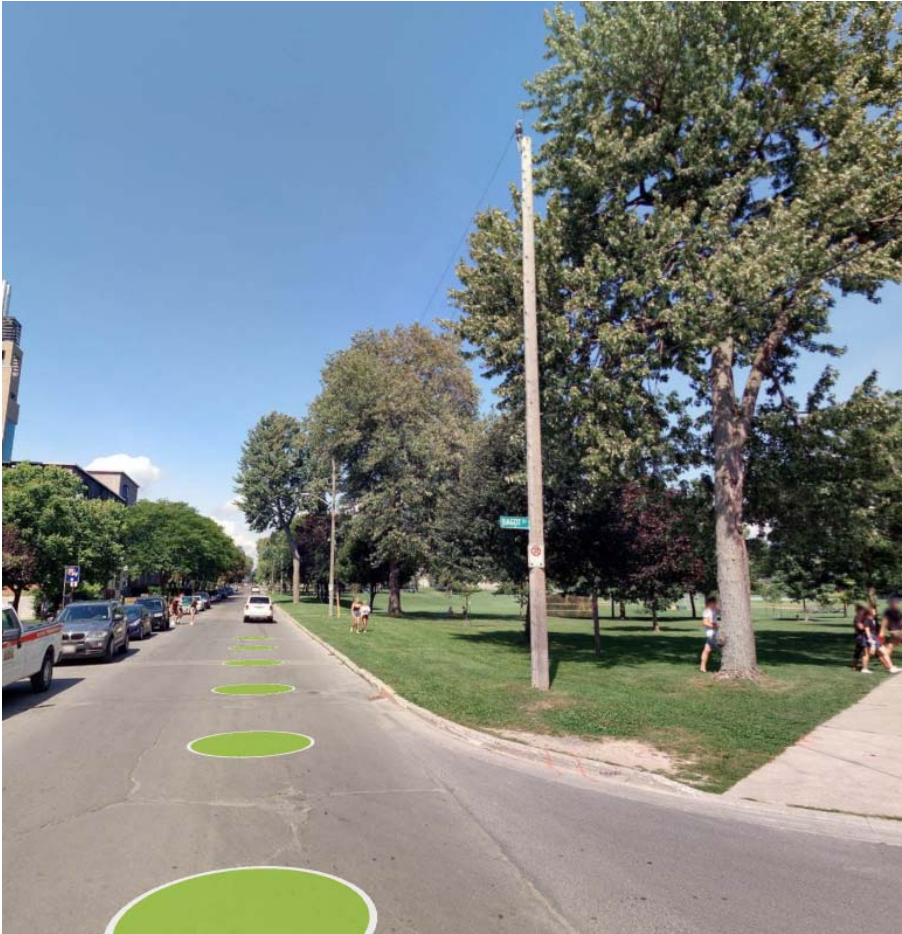
Figure 1 – Existing pole line on Barrie St

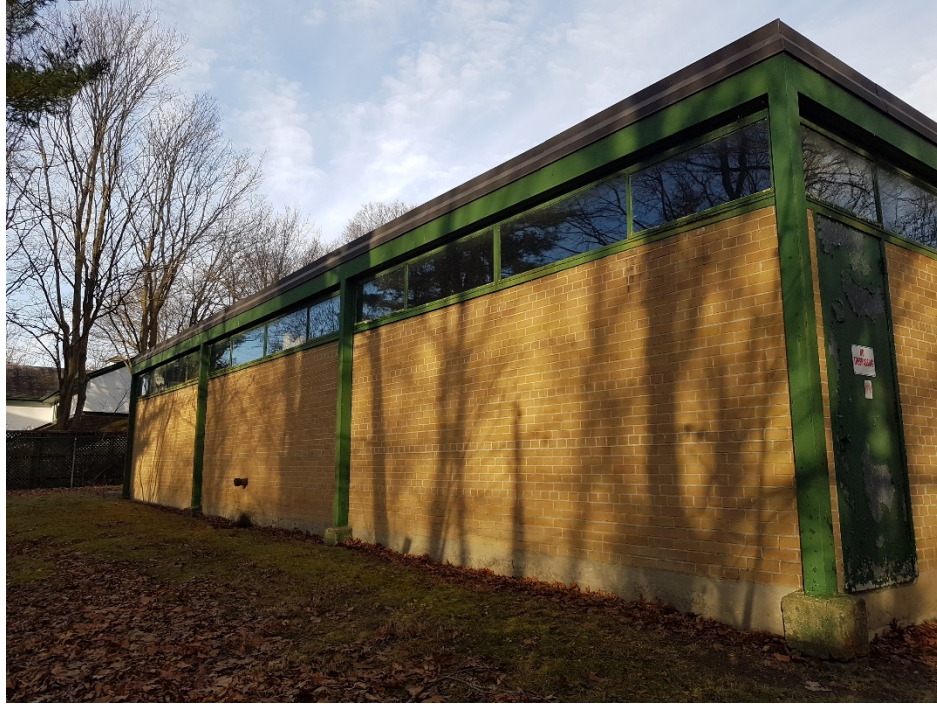
Fig. 1 – MS6 – view facing south

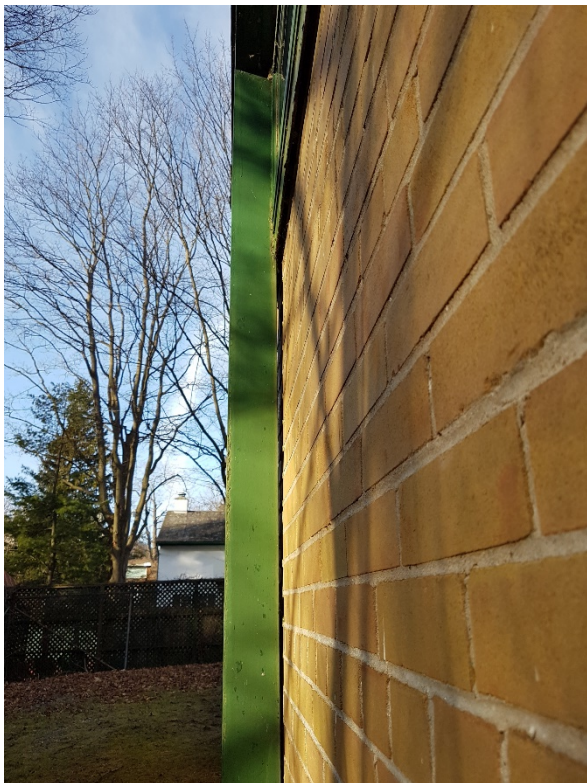
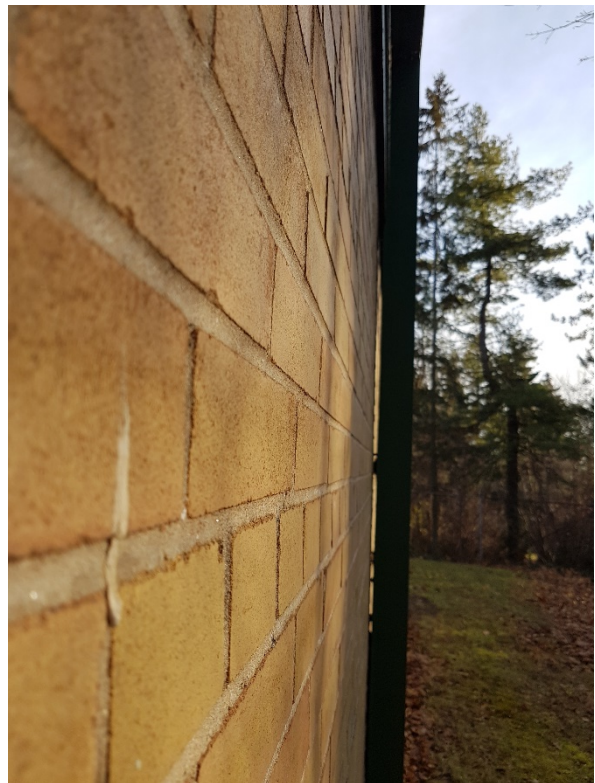
Fig. 2 – MS6 – Masonry Walls and Structural Steel Frame Shifted (Laterally Displaced)

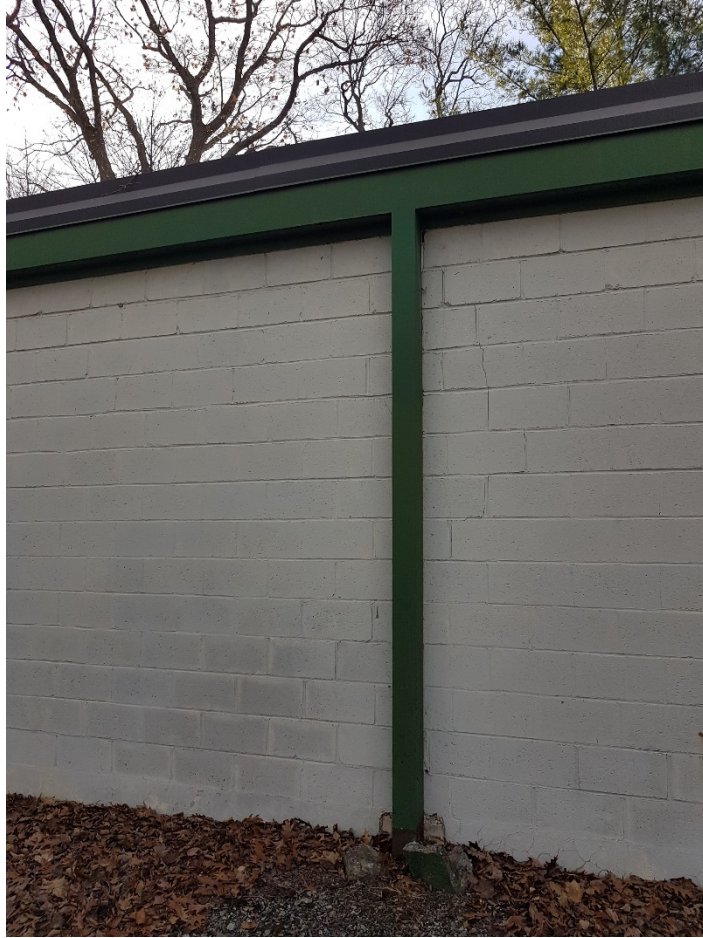
Fig. 3 – MS6 – Cracked Masonry North Walls

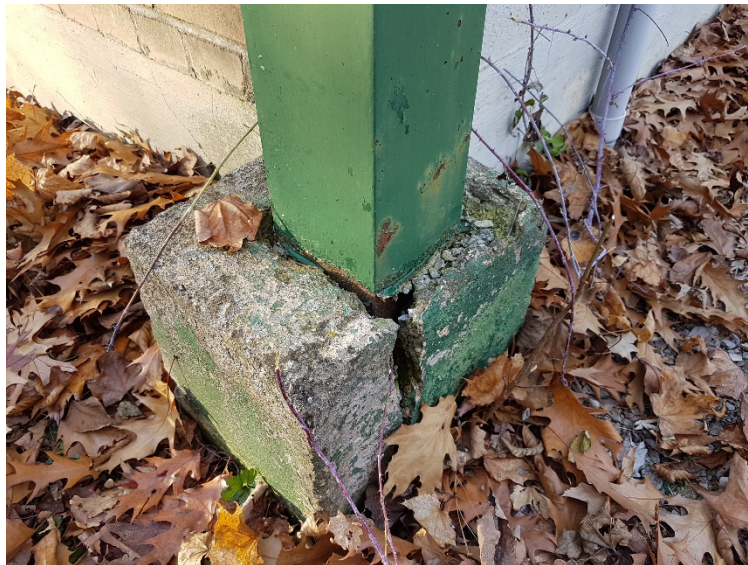
Fig. 5 – MS6 – Cracked Footing for Steel Column

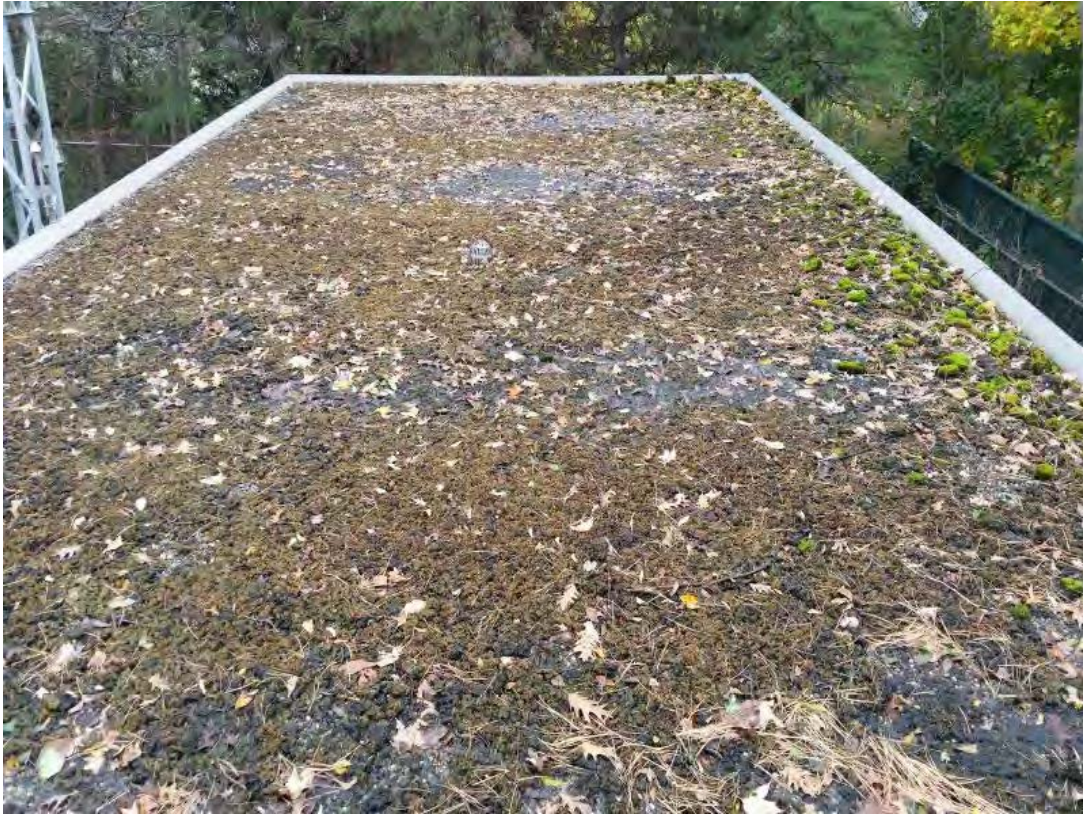
Fig. 6 – MS6 – View of existing deteriorated lower roof

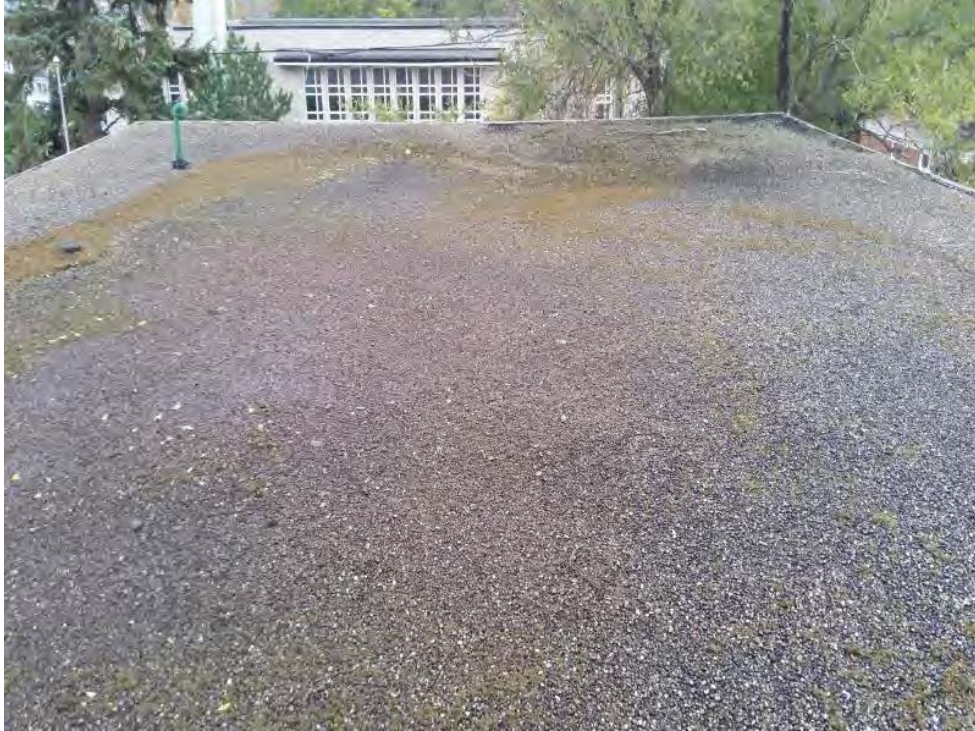
Fig. 2 – MS2 – View of existing deteriorated higher roof

4-ply tar, gravel roof should be replaced in 2020. The condition is poor.

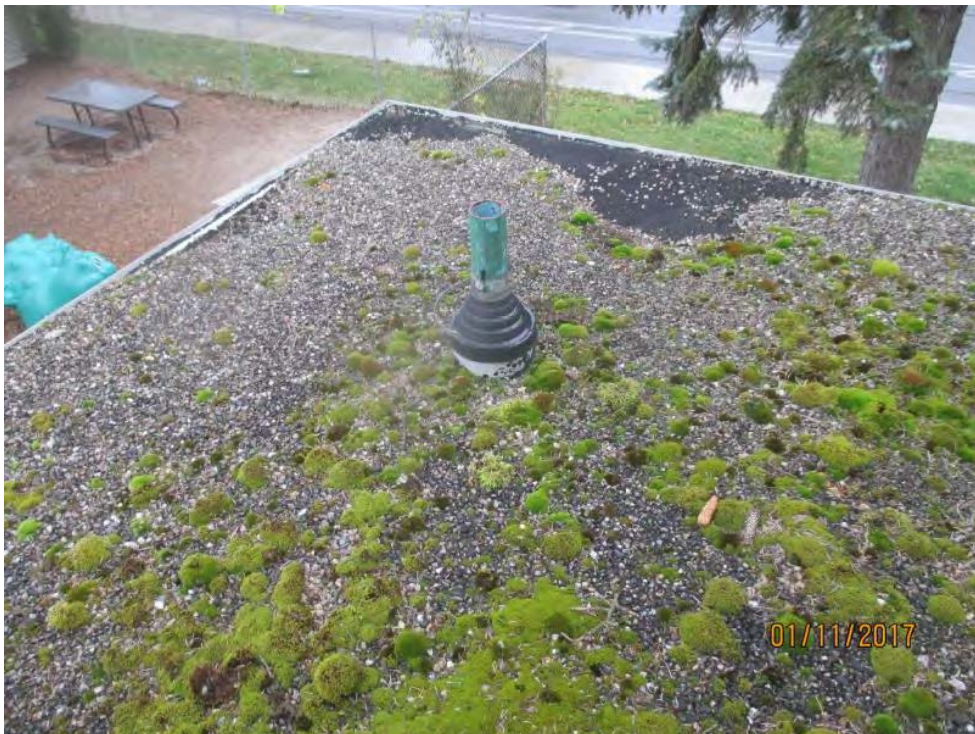
Fig. 3 – MS2 – View of existing deteriorated lower roof

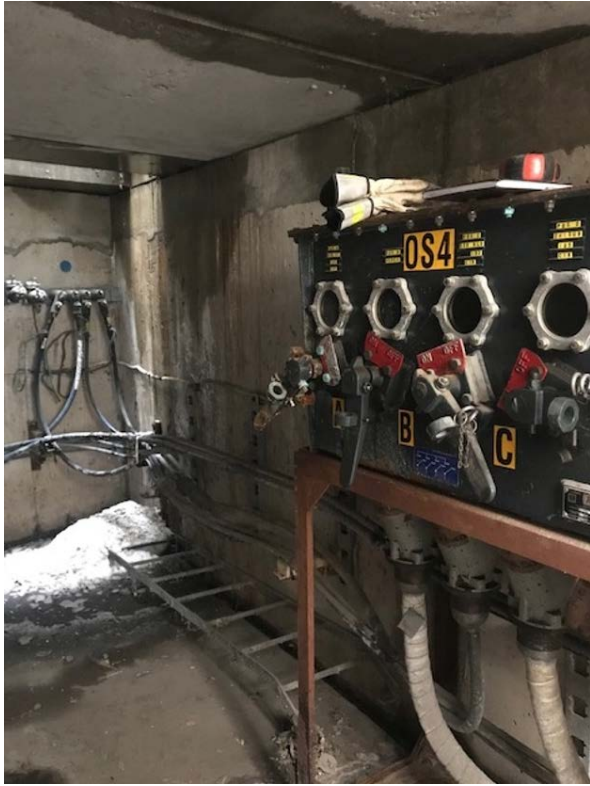
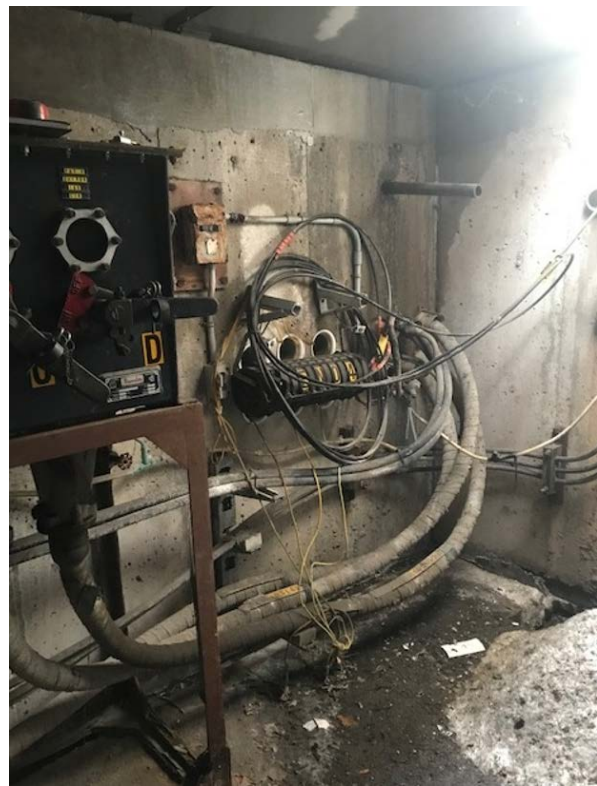
124 **Figure 1 & 2 – TV4 Legacy Oil Switch (OS4) and PILC cables**

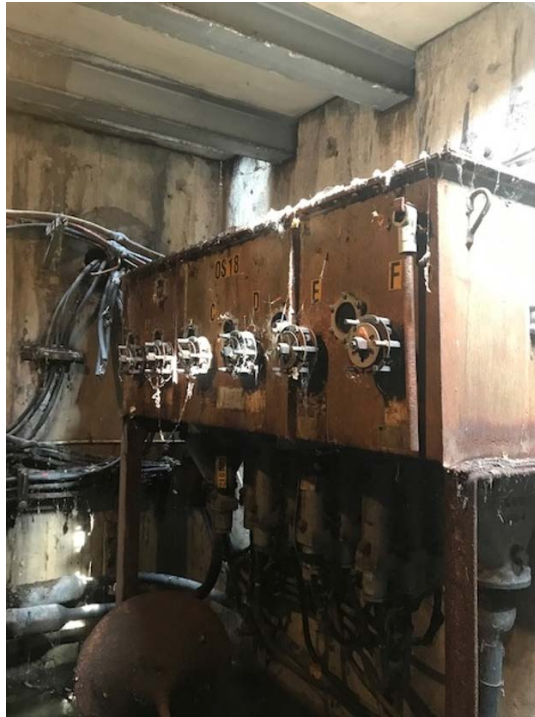
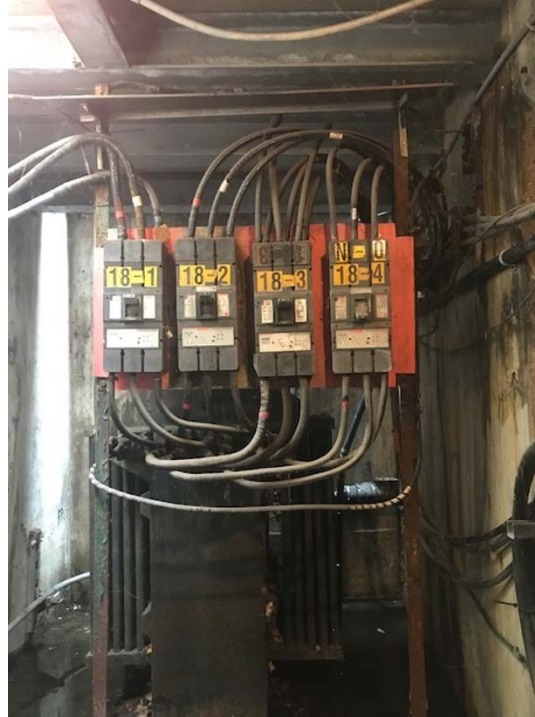
127 **Figure 1 & 2 – TV18 existing oil switch OS18, legacy secondary tie-breaker switches and vault**
128 **transformer**

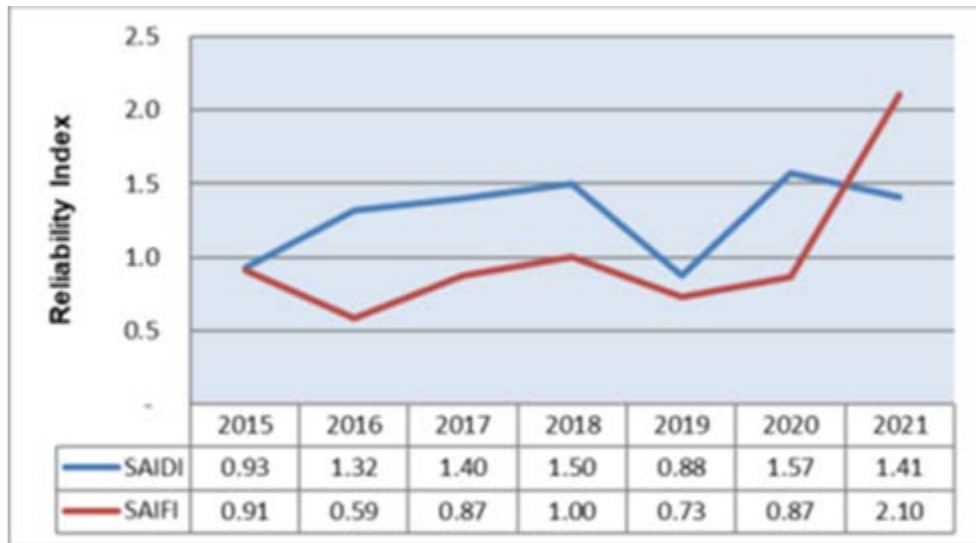
Figure 5.2-18 – 2015 to 2021 System Reliability Indices 2 Excluding Loss of Supply and Major Event Days
