Overview of Rate Base

Ex.2/Tab 1/Sch.1 - Rate Base Overview

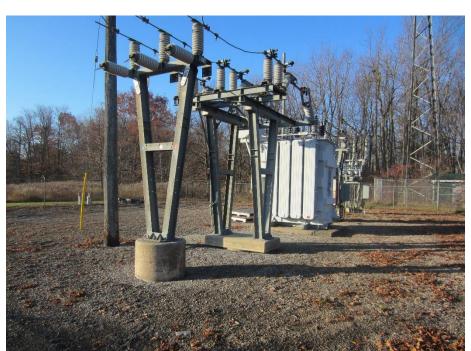
There is wood pole, vegetation and dry leaves present in the yard.

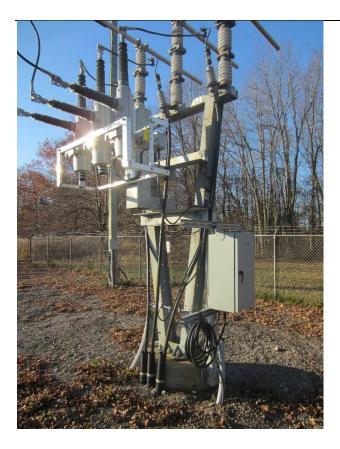
Cables are not properly supported.

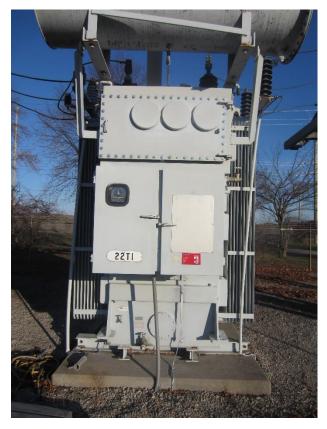
Transformer has no oil containment.

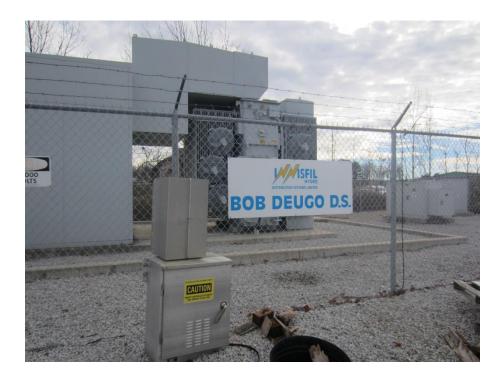
There is dry leaves along the fences.

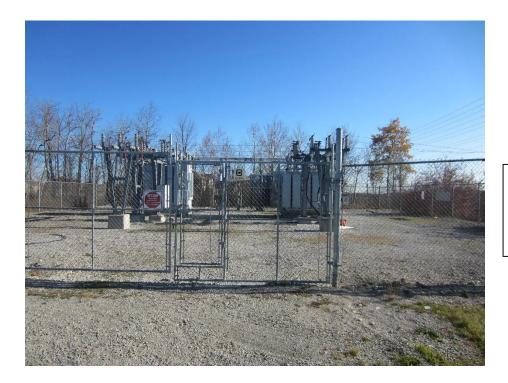
There is vegetation on the fences.

Vegetation is all over the yard.

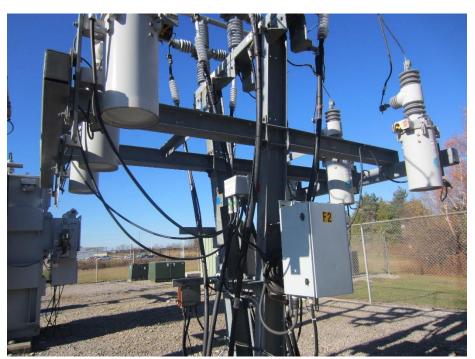
Cables are not properly supported.

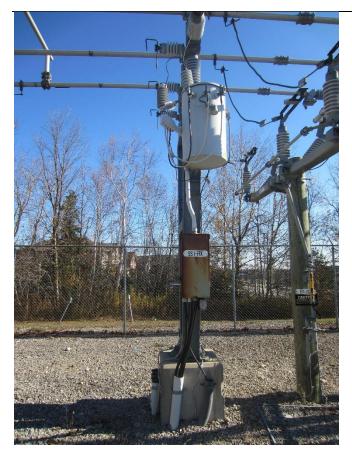
Wood pole present in the yard to support bus tie disconnect switch.

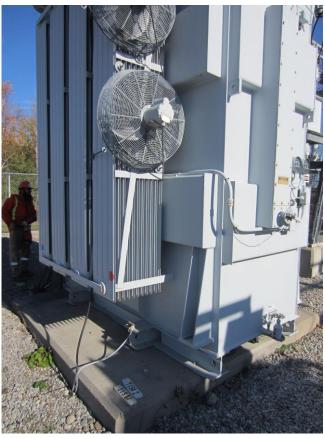
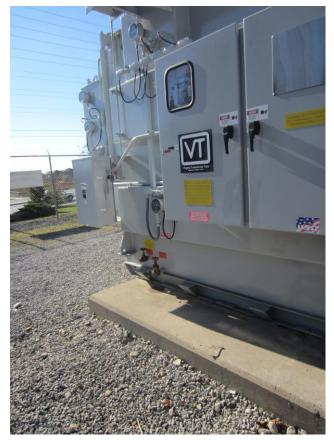
Neither the transformer T1 (left) nor T2 (right) has oil containment.

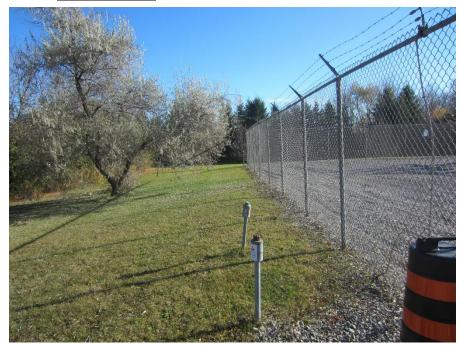
There is no gravel outside of the station.

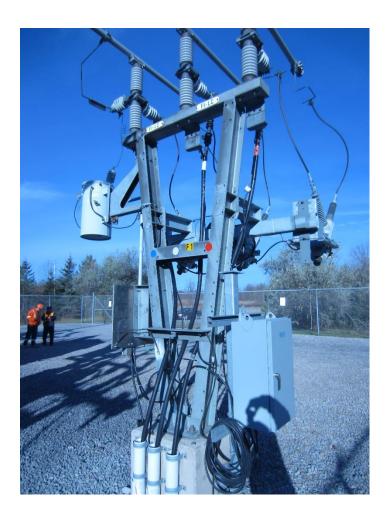
Cables are not properly supported.

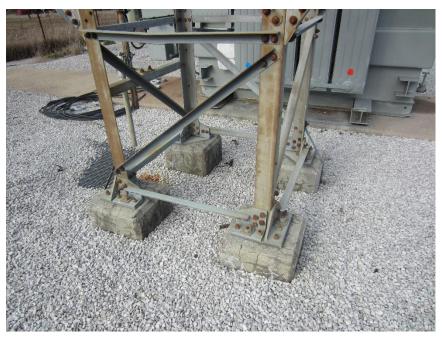
Cracked foundation of structural equipment.

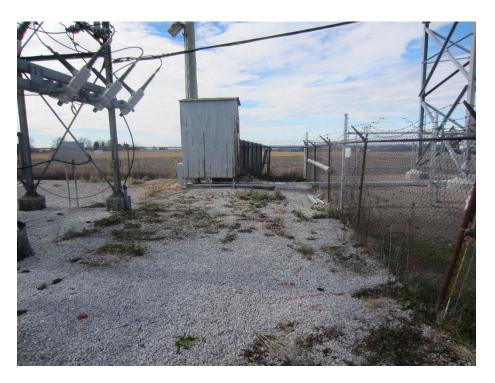
There is vegetation and dry leaves around the fences and in the yard.

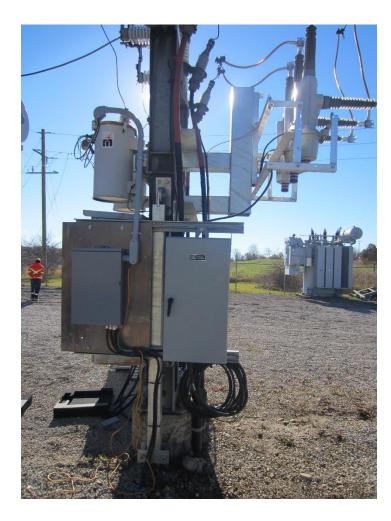
Cables are not properly supported.

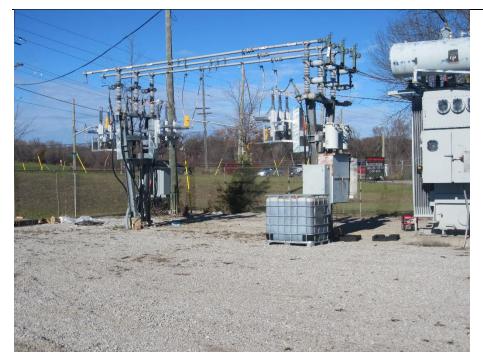
Wood pole present in the yard.

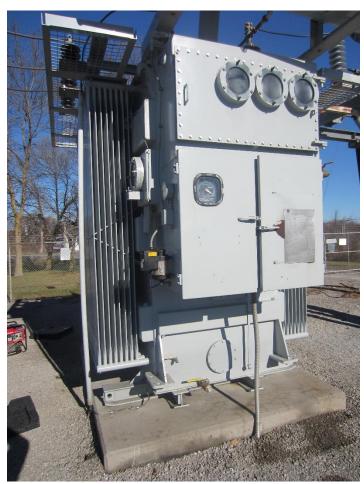
Transformer has no oil containment.

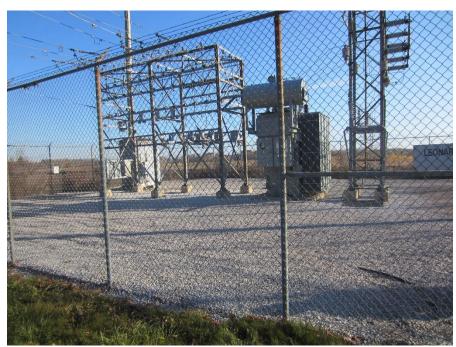
There is no gravel outside of the station.

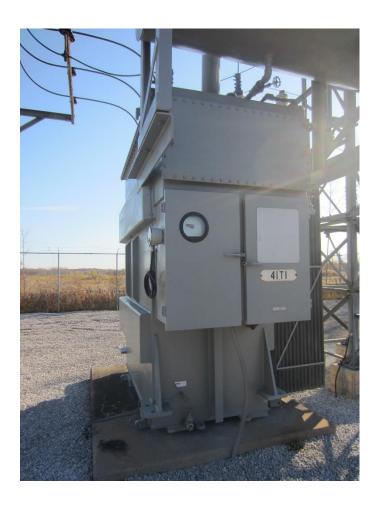
Transformer has no oil containment.

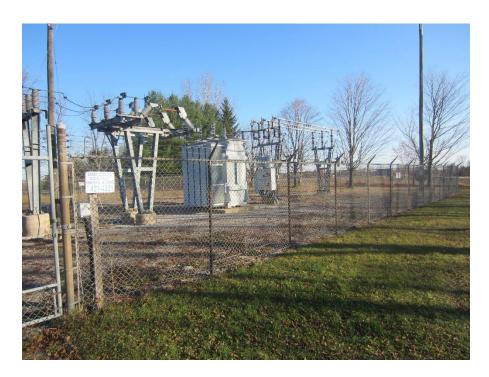
There is no gravel outside of the station.

There is vegetation and dry leaves around the fences and all over the yard.

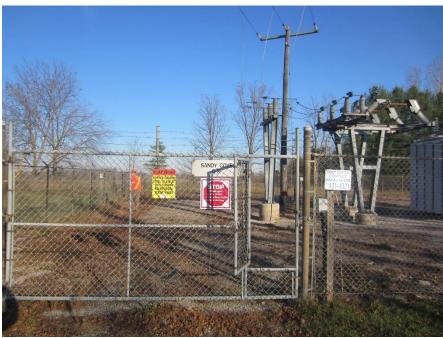
Wood pole present in the yard.

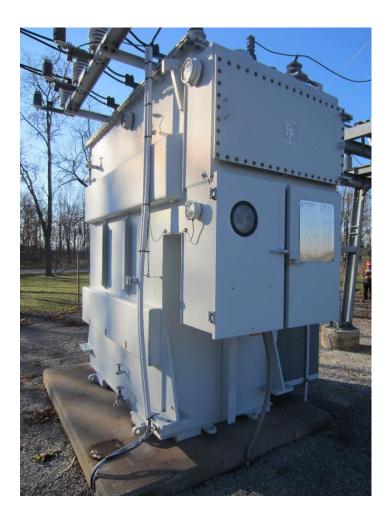
Transformer has no oil containment.

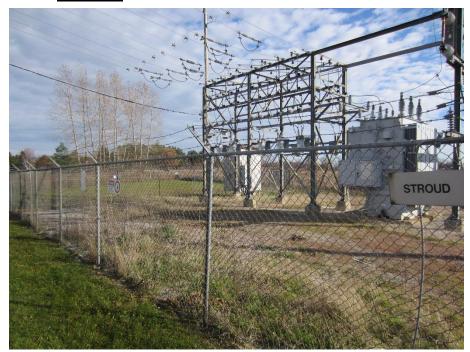
There is no gravel outside of the station.

There is vegetation and dry leaves around the fences and all over the yard.

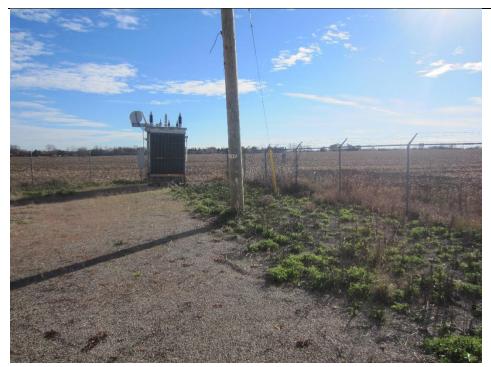
Wood pole present in the yard.

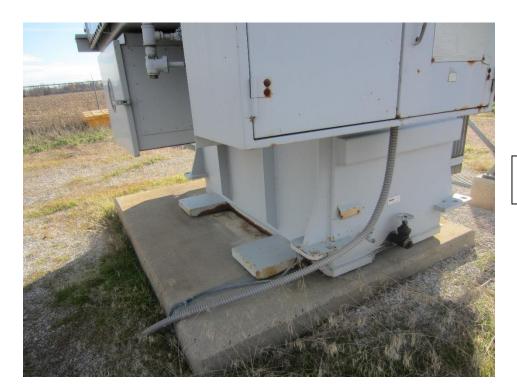
Transformer has no oil containment.
