**Re: Enbridge Gas Distribution Inc. (“Enbridge”)
EB-2016-0054 – Seaton Land Development Pipeline Project
Conditions of Approval – Post Construction Report**

**Enbridge Gas Distribution Inc.
Interim Post-construction
Environmental Monitoring Report
Pipeline to Serve the Seaton Land
Development
EB -2016-0054**

PRE-CONSTRUCTION AND POST- CONSTRUCTION PROPERTY CONDITION ASSESSMENTS

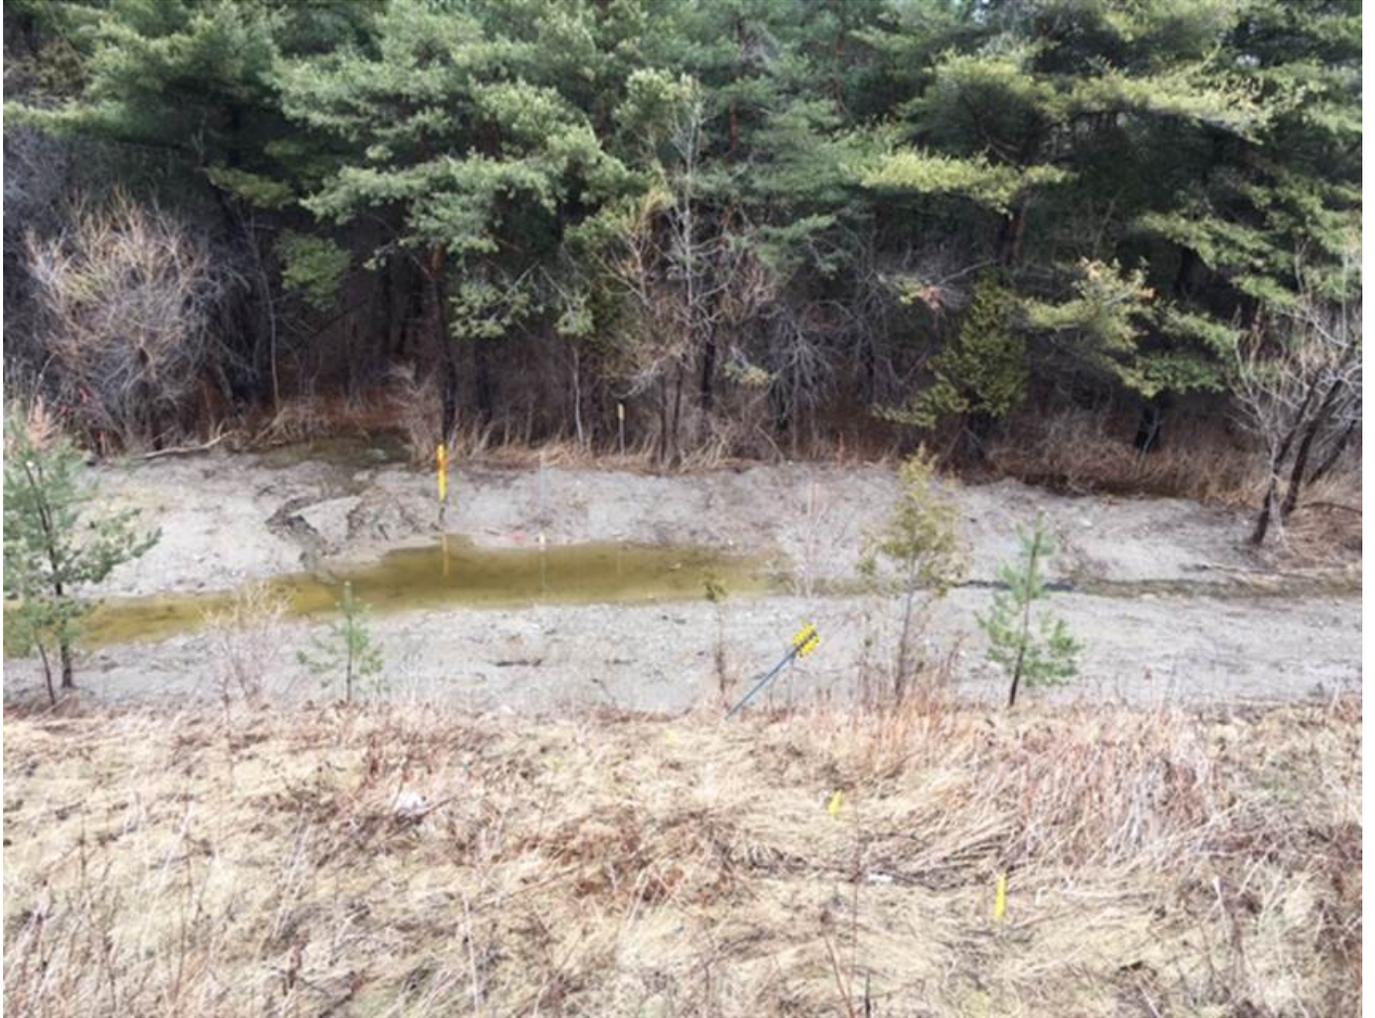
Photo #	Location	Current Condition	Action
Photo 1	Taunton Rd and Sideline 16 tie-in pit (looking North)	In complete. Drainage resembles pre-construction condition.	Further seeding required. No further action for the drainage.
Photo 2	Taunton Rd and Sideline 16 tie-in pit (looking North- East)	In complete. Drainage resembles pre-construction condition.	Further seeding required.
Photo 3	Regulator Station east of Brock Rd (looking north-west).	In complete. Construction was finished in December.	Requires grading and seeding
Photo 4	Regulator Station east of Brock Rd (looking East).	In complete. Construction was finished in December.	Requires grading and seeding
Photo 5	West of Brock Rd (looking east).	Complete.	Follow up required assessing vegetation growth.
Photo 6	East side of Urfe Creek (looking west).	Complete. The Creek was seeded and straw was placed over top as a temporary over-winter ESC measure.	Follow up required assessing vegetation growth.

Photo 1: Taunton Rd and Sideline 16 tie-in pit (looking north)

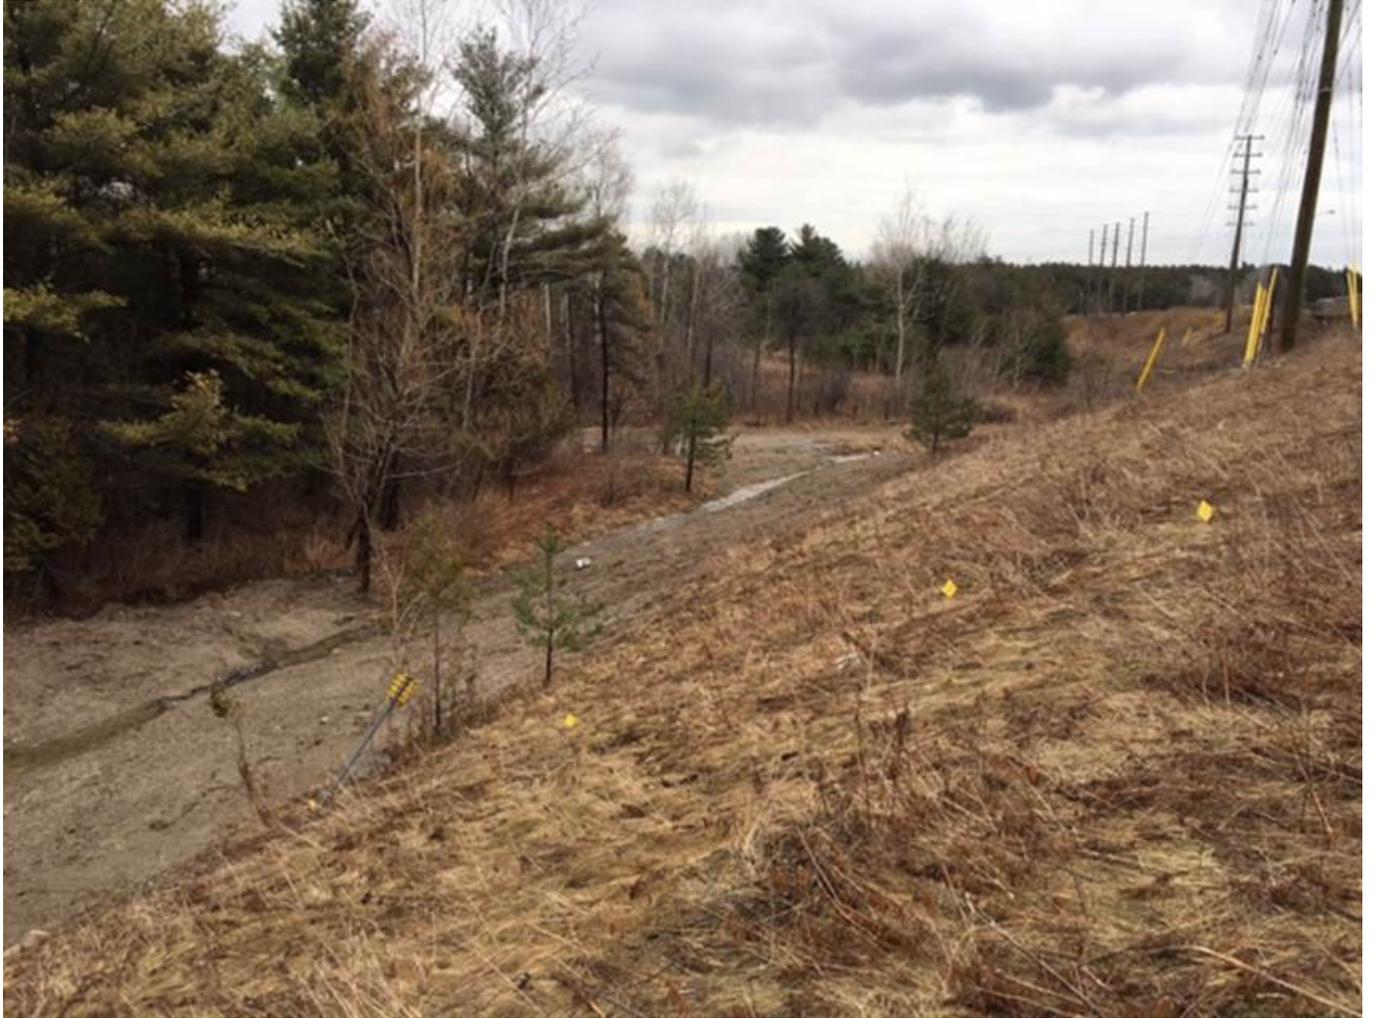
Photo 2: Taunton Rd and Sideline 16 tie-in pit (looking north-east)

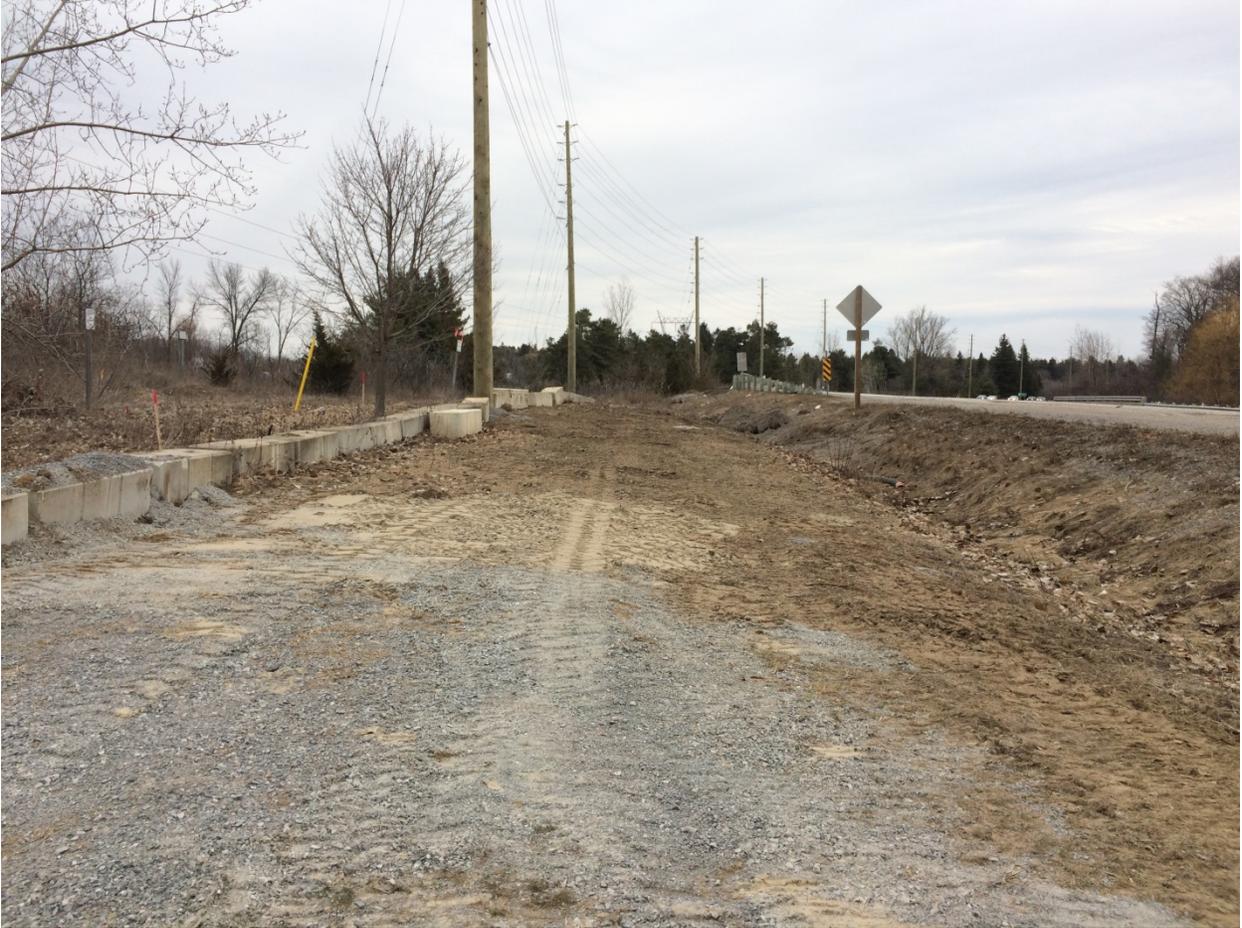
Photo 7	West side of Urfe creek (looking east)	Complete. The Creek was seeded and straw was placed over top as a temporary over-winter ESC measure. Area was shared by other utility companies as a staging area.	Follow up required assessing vegetation growth.
Photo 8	West side of Urfe Creek (looking west)	Complete. The Creek was seeded and straw was placed over top as a temporary over-winter ESC measure. Area was shared by other utility companies as a staging area.	Follow up required assessing vegetation growth.
Photo 9	East side of Ganatsekiagon creek (looking west).	Complete. The Creek was seeded and straw was placed over top as a temporary over-winter ESC measure.	Follow up required assessing vegetation growth.

Photo 7: West side of Urfe creek (looking east)

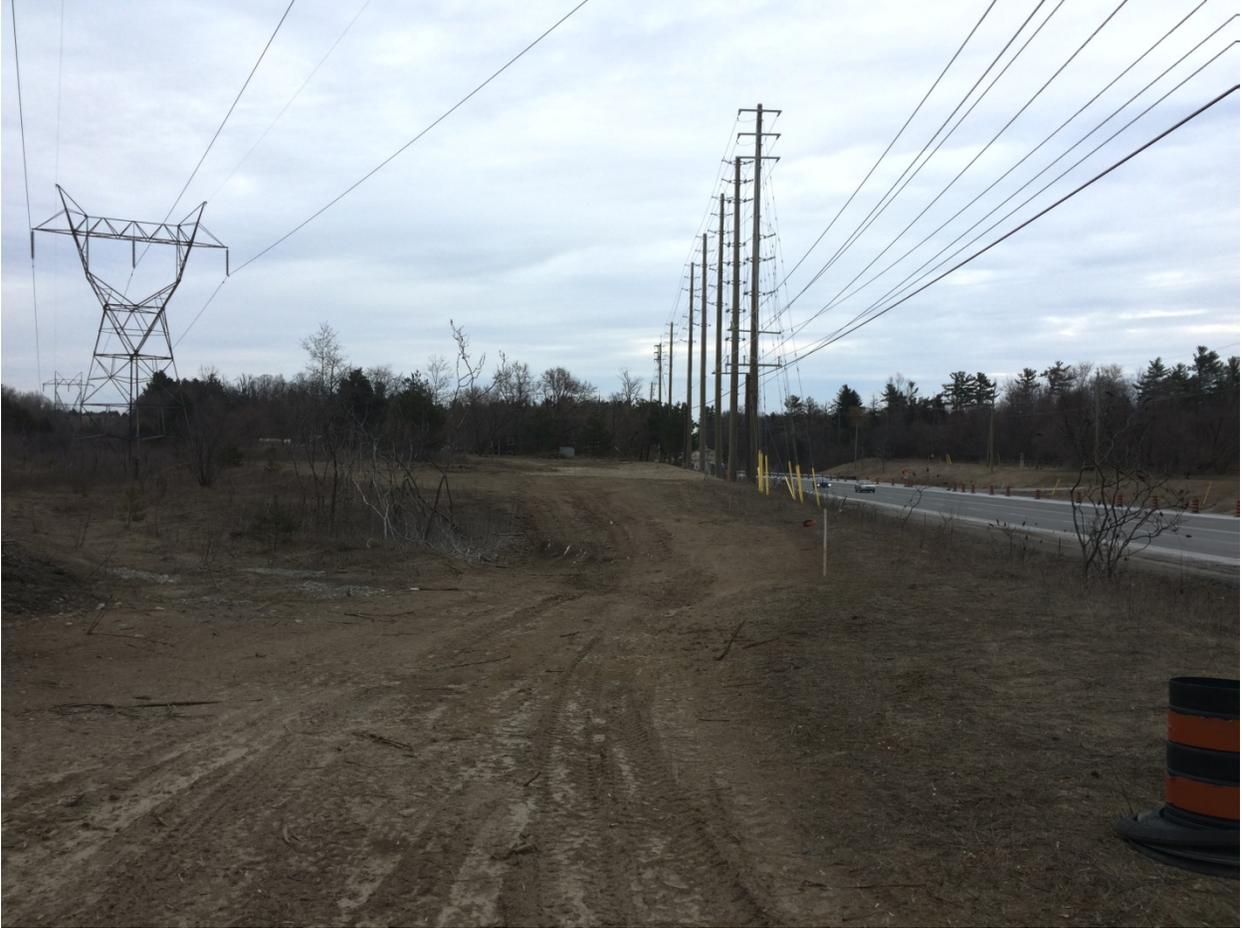
Photo 11: West of Ganatsekiagon Creek looking east. Hydro corridor crossing.

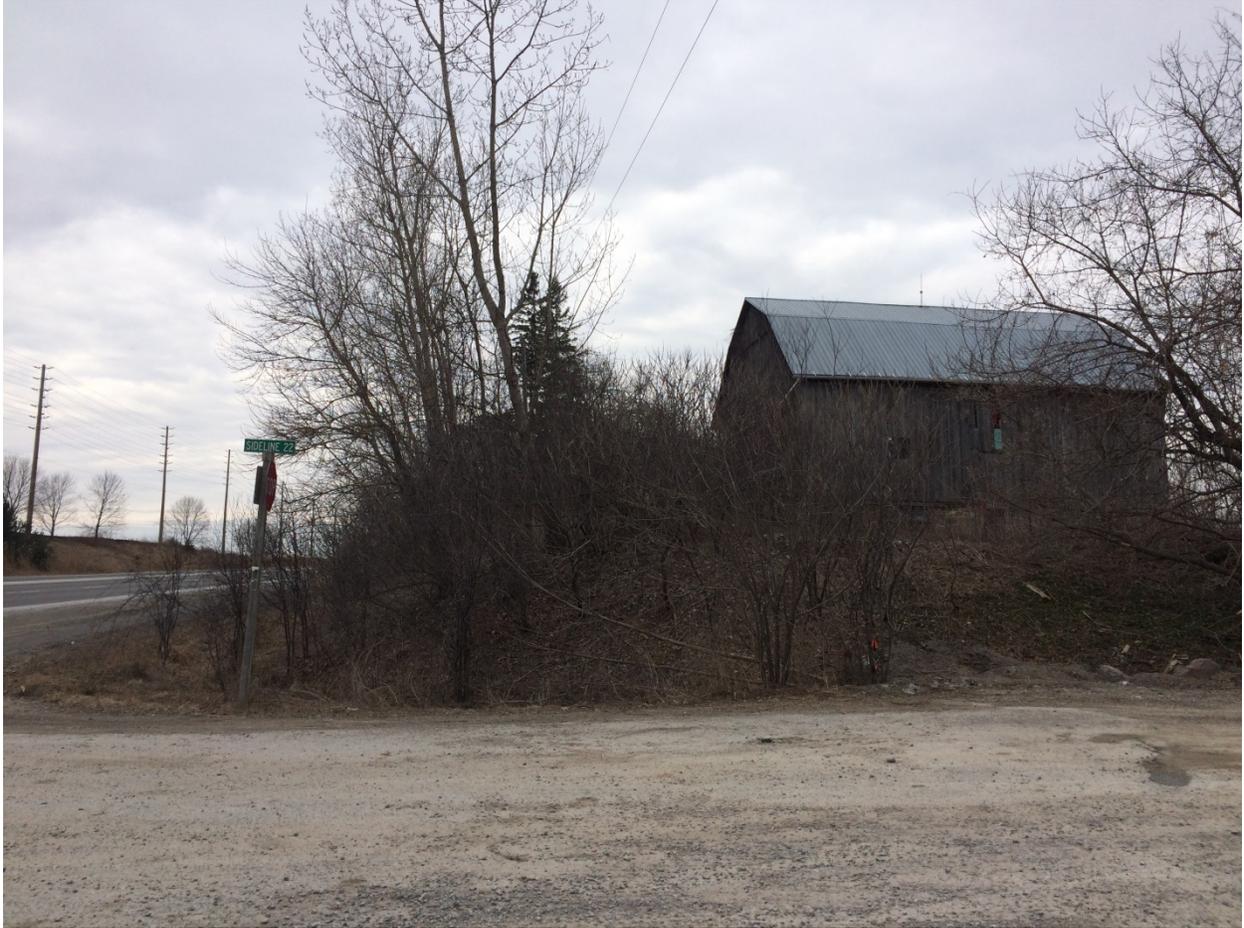
Photo 15	Heritage building at 1290 Taunton Rd (looking west)	Complete. No impacts were recorded during construction. Please see Appendix D	No further Action required.
Photo 16	Heritage building at 1290 Taunton Rd (looking north)	Complete. No impacts were recorded during construction. Please see Appendix D	No further Action required.
Photo 17	West of 1290 Taunton Rd (looking east)	In complete. Construction was finished in December.	Requires grading and seeding
Photo 18	West of 1290 Taunton Rd (looking west)	In complete. Construction was finished in December.	Requires grading and seeding
Photo 19	Sideline 24 and Taunton Rd (looking west)	In Complete. Construction was finished in December.	Requires grading and seeding

Photo 15: Heritage building at 1290 Taunton Rd (looking west)

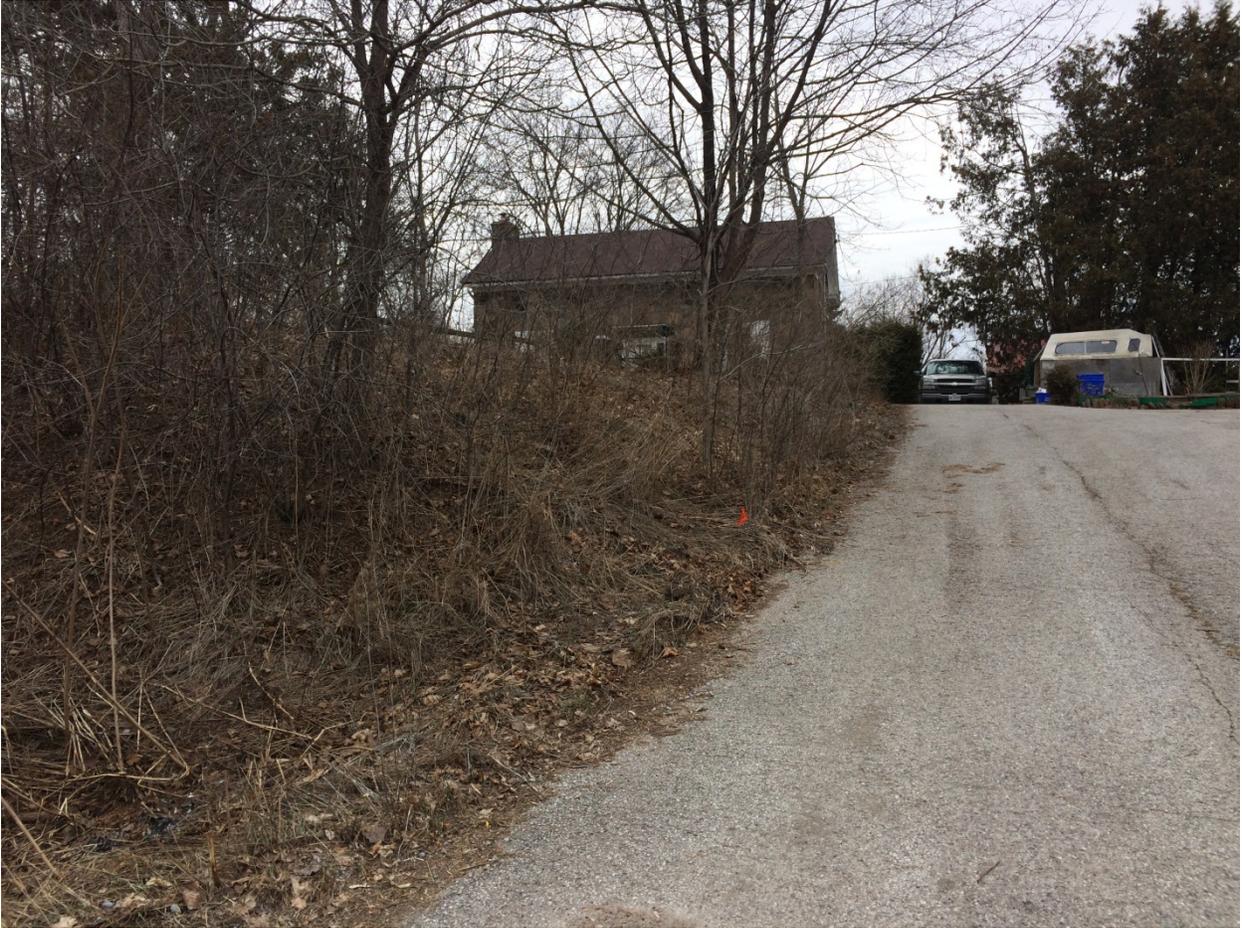
Photo 16: Heritage building at 1290 Taunton Rd (looking north)

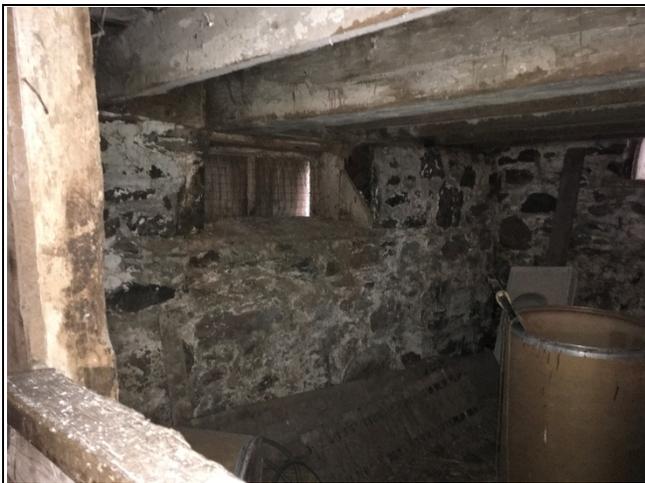
Photo 5: E3 – View of the southwest foundation wall

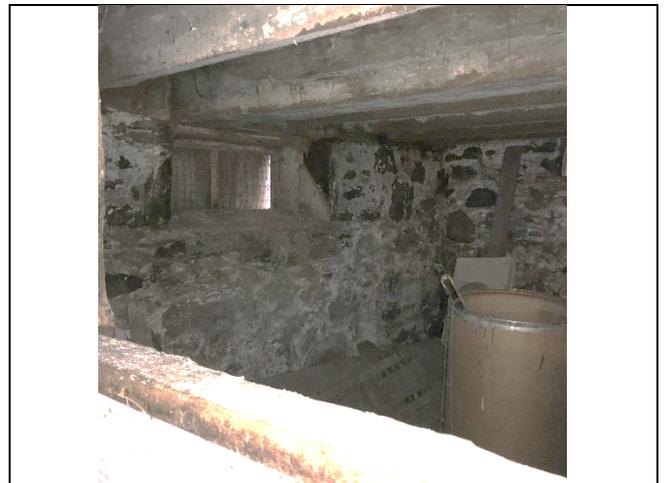
Photo 6: No significant change to the south foundation wall.

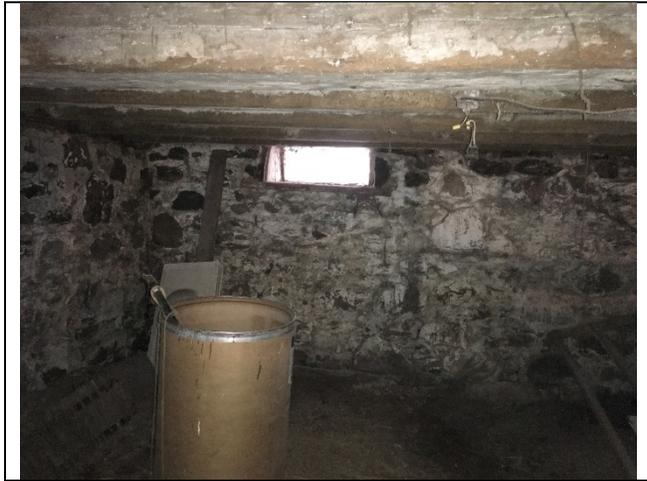
Photo 7: E4 –View of the west foundation wall

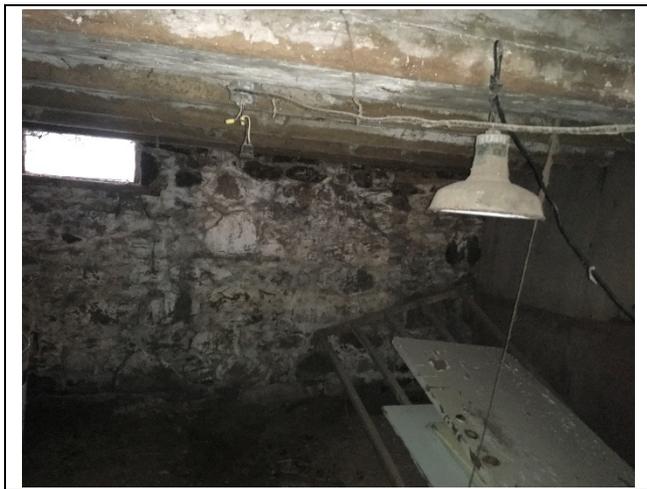
Photo 9: E5 – View of the west foundation wall.

E-5	Foundation Wall	West Elevation	View of the west foundation wall (See Photograph 9).	No significant change to the west foundation wall. (See Photograph 10).	
E-6	Foundation Wall	West Elevation	View of the west foundation wall (See Photograph 11).	No apparent change to the west foundation wall (See Photograph 12).	
E-7	Foundation Wall	West Elevation	View of a crack on the west foundation wall (Animal Stable # 3) (See Photograph 13).	No significant change to the crack on the west foundation wall was observed (See Photograph 14).	
E-8	Foundation Wall	North Elevation	View of a crack on the north foundation (See Photograph 15).	No significant change to the (north foundation wall) crack was observed. (See Photograph 16).	
E-9	Foundation Wall	East Elevation	On the east elevation a view of the basement door access (See Photograph 17).	The condition of the basement door access appears to be similar to the pre-construction assessment. (See Photograph 18).

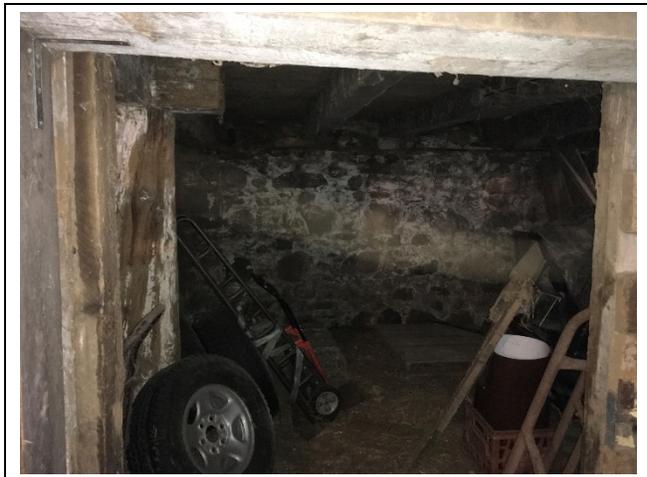
Photo 11: E6 – View of the west foundation wall

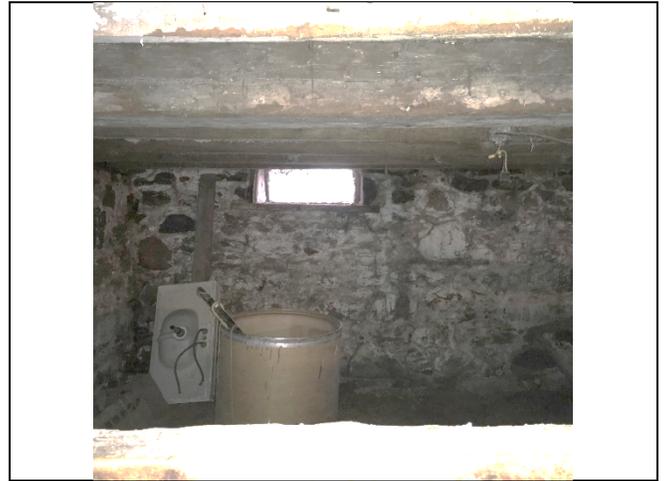
Photo 8: No significant change to the condition of the west foundation wall was observed following the construction.

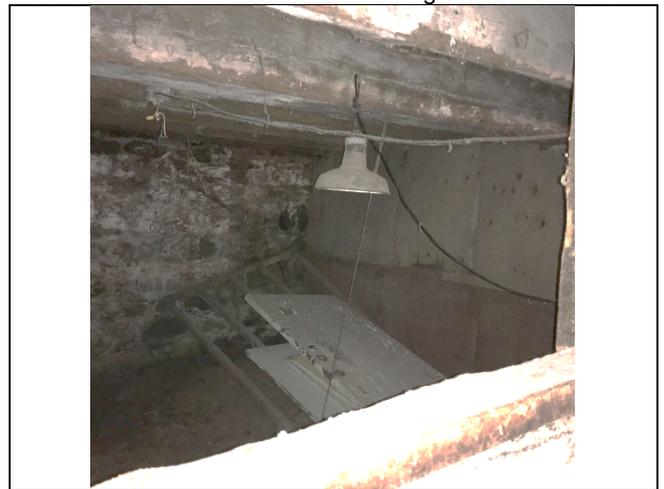
Photo 10: No significant change to the west foundation wall.

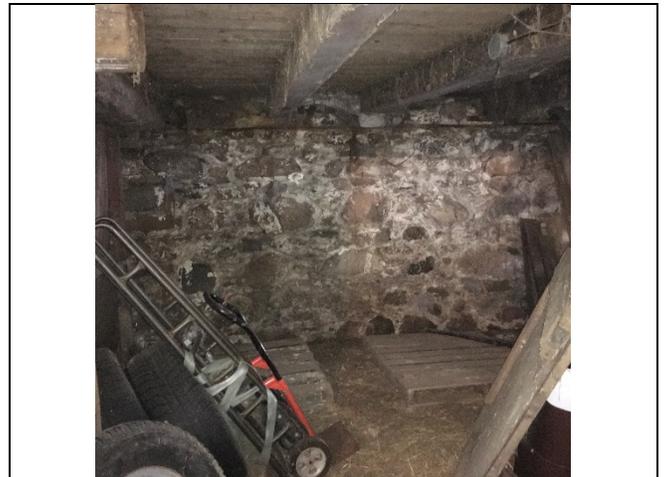
Photo 12: No apparent change to the west foundation wall

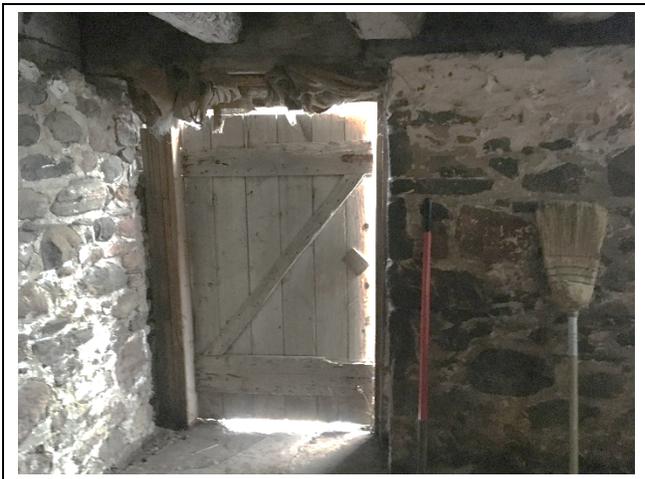
Photo 17: E9 – On the east elevation,- a view of the basement door access

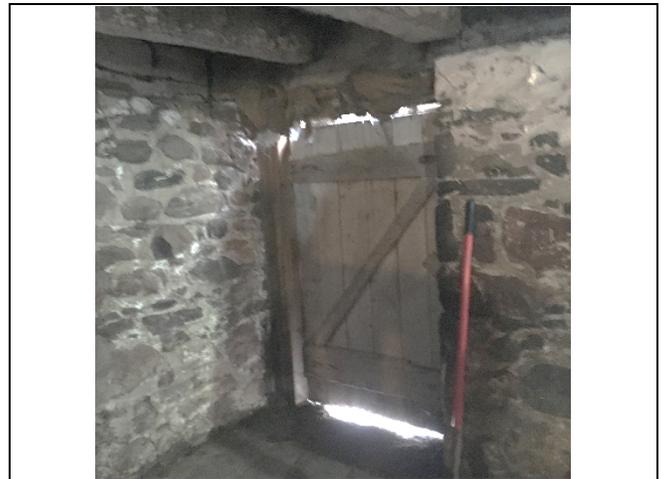
Photo 18: The condition of the basement door access appears to be similar to the pre-construction assessment.

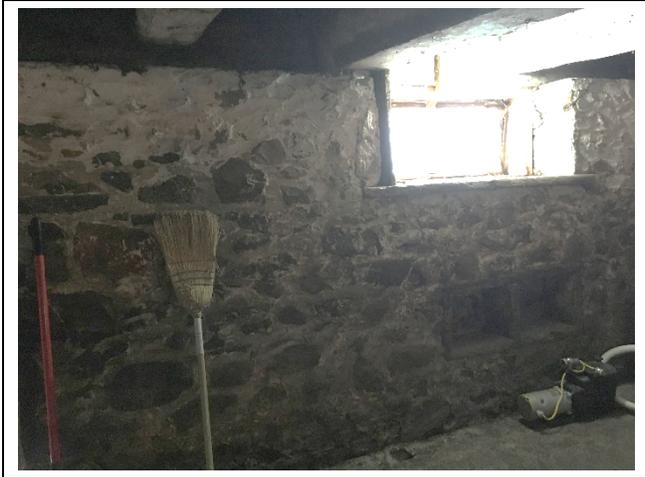
Photo 19: E10 – View of the east foundation wall

E-10	Foundation Wall	East Elevation	View of the east foundation wall (See Photograph 19).	The condition of the east foundation wall appears to be consistent with the initial assessment (See Photograph 20).	
E-11	Foundation Wall	East Elevation	Another view of the east foundation wall (See Photograph 21).	he east foundation wall appears to be similar to the pre-construction assessment (See Photograph 22).	
E-12	Foundation Wall	East Elevation	View of the east foundation wall towards the entrance door (See Photograph 23).	The east foundation wall appears to be consistent with the pre-construction assessment. (See Photograph 24).	
E-13	Foundation Wall	South Elevation	Exterior view of the south foundation wall (See Photograph 25).	The south foundation wall appears to be similar with the pre-construction assessment. (See Photograph 26).	
E-14	Foundation Wall	South Elevation	View of the south foundation wall around the window(See Photograph 27).	The condition of the south foundation wall appears to be consistent with the initial assessment (See Photograph 28).

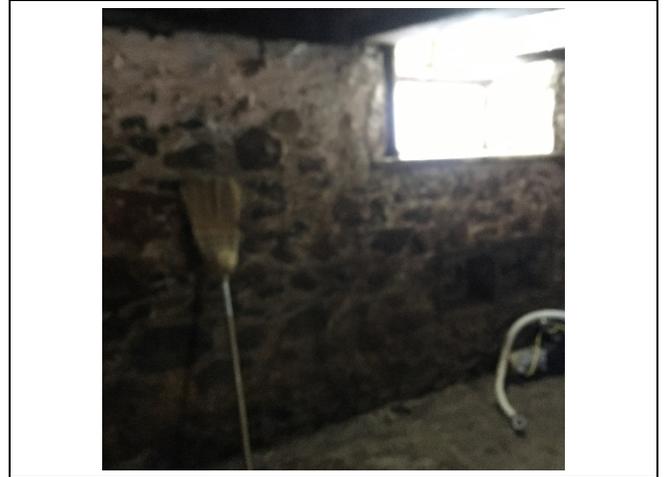
Photo 20: The condition of the east foundation wall appears consistent with the pre-construction assessment.

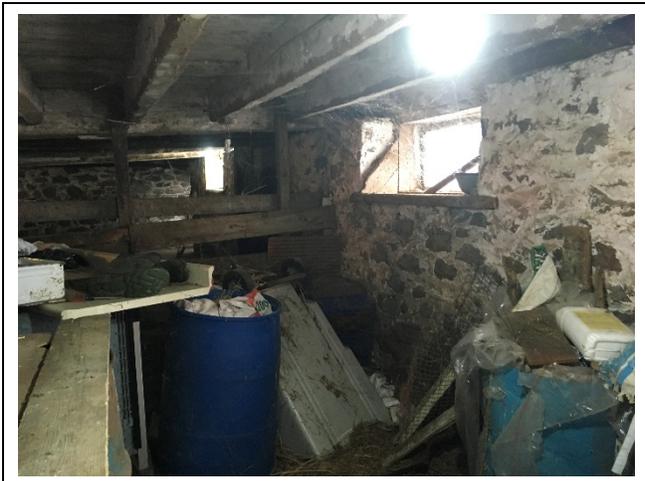
Photo 21: E11 – Another view of the east foundation wall

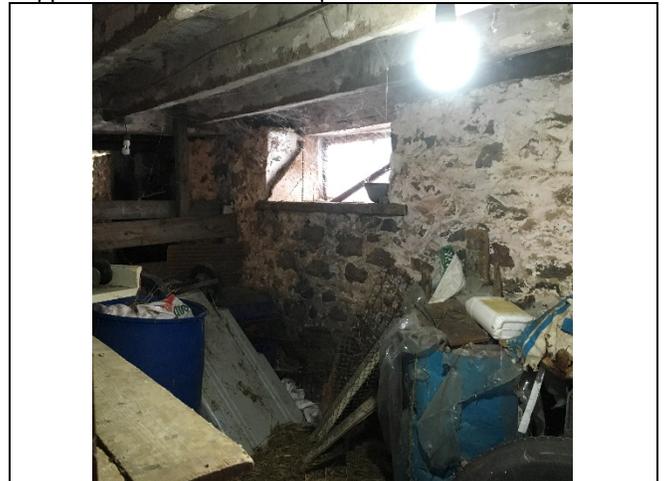
Photo 22: The east foundation wall appears to be similar to the pre-construction assessment.

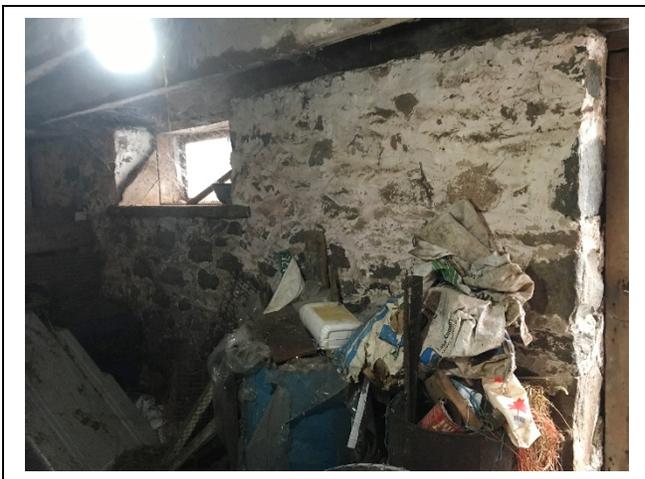
Photo 23: E12 –View of the east foundation wall towards the entrance door

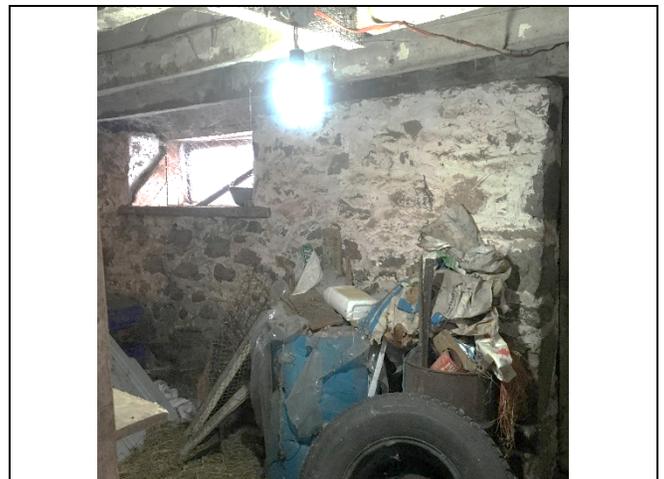
Photo 24: The east foundation wall appears to be consistent with the pre-construction assessment.

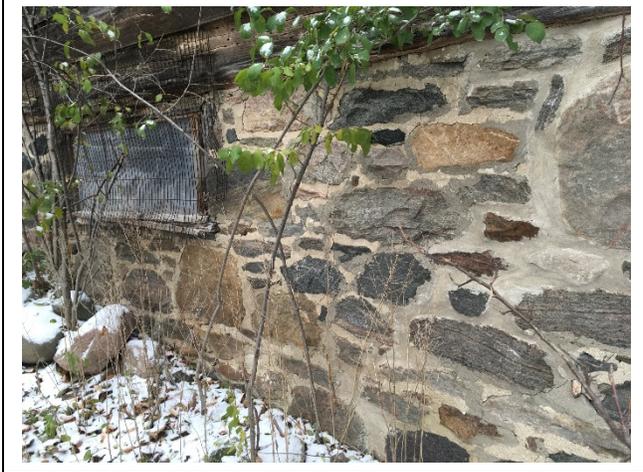
Photo 25: E13 – Exterior view of the south foundation wall

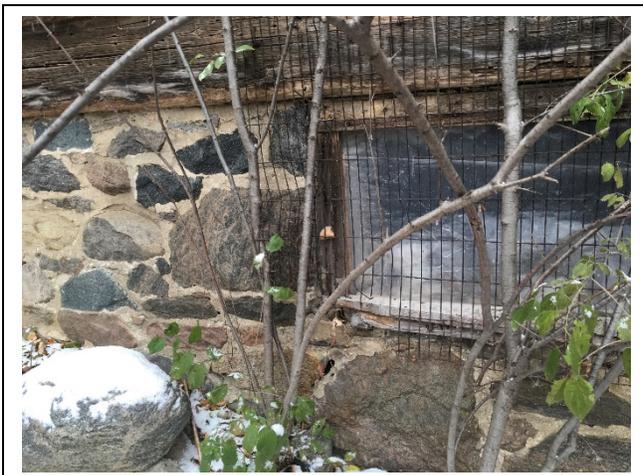
Photo 27: E14 – View of the south foundation wall around the window

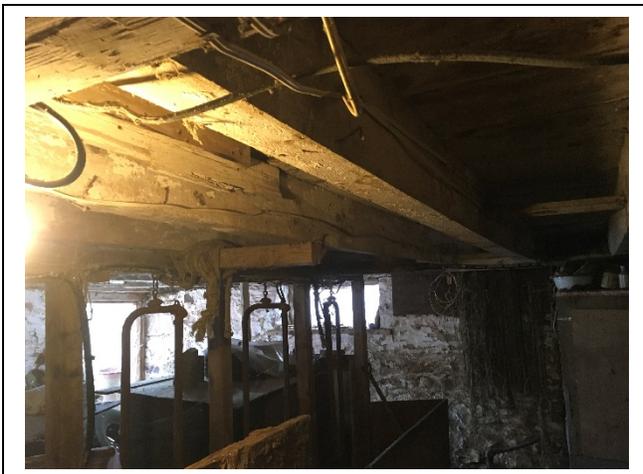
Photo 29: E15 – View of the floor joists in the basement

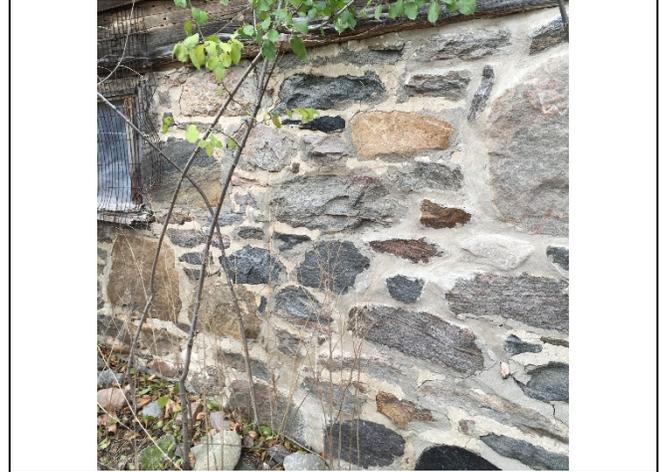
Photo 26: The south foundation wall appears to be similar with the pre-construction assessment.

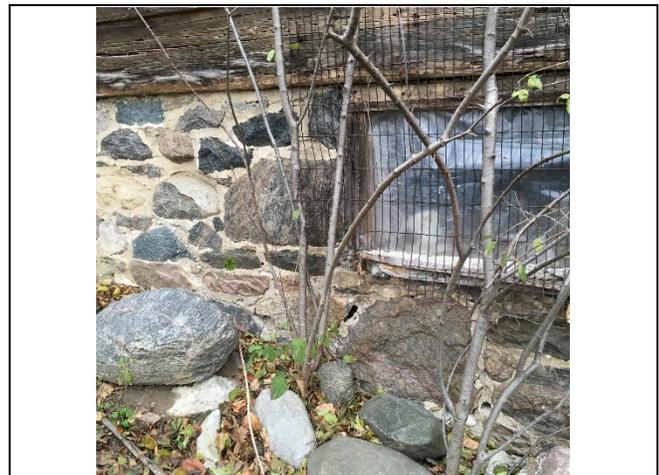
Photo 28: The observed condition is consistent with the pre-construction assessment.

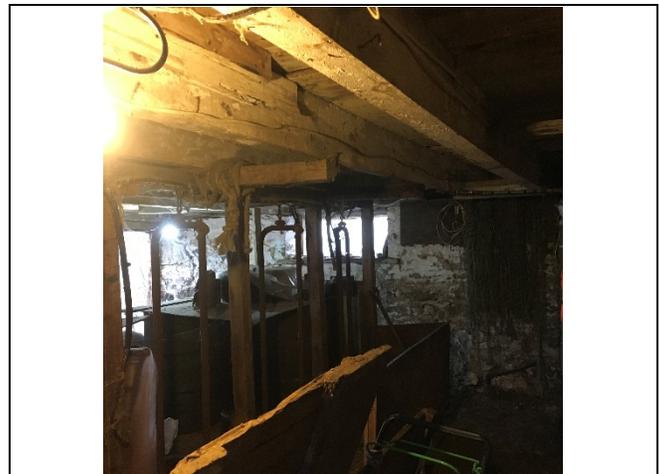
Photo 30: The condition of the floor joists appear to be similar to the pre-construction assessment.

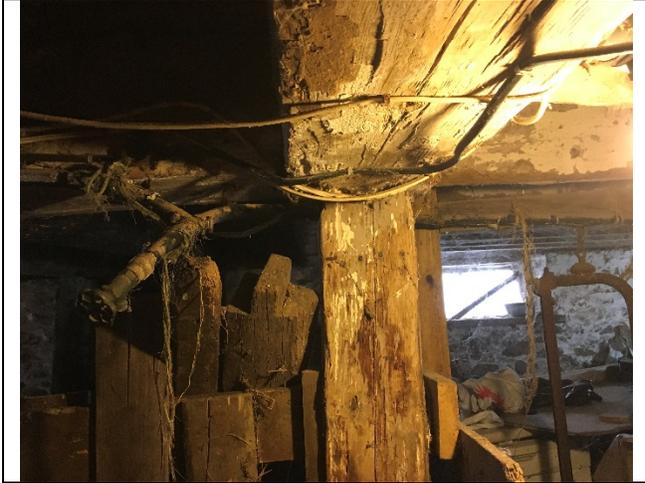
Photo 31: E16 – View of the wood post and floor joist in the basement

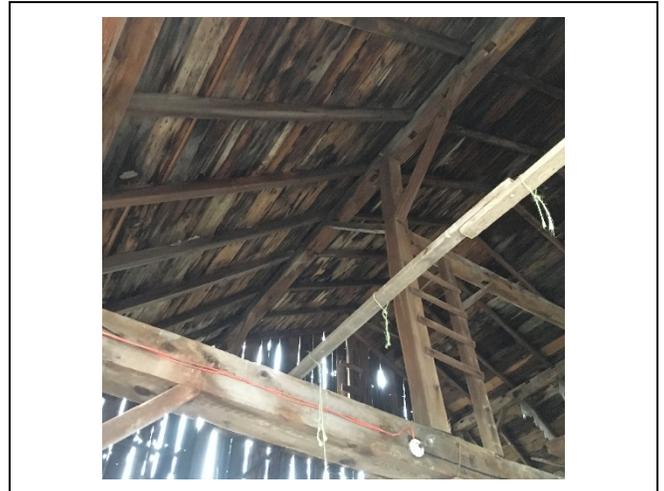
Photo 34: The first floor wood roof frame structure appears to be consistent with the pre-construction assessment

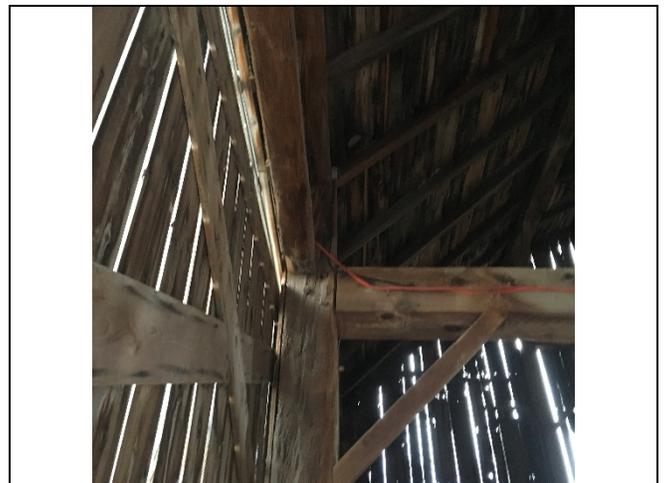
Photo 36: The condition of the wood roof frame structure appears to be consistent with the pre-construction assessment.

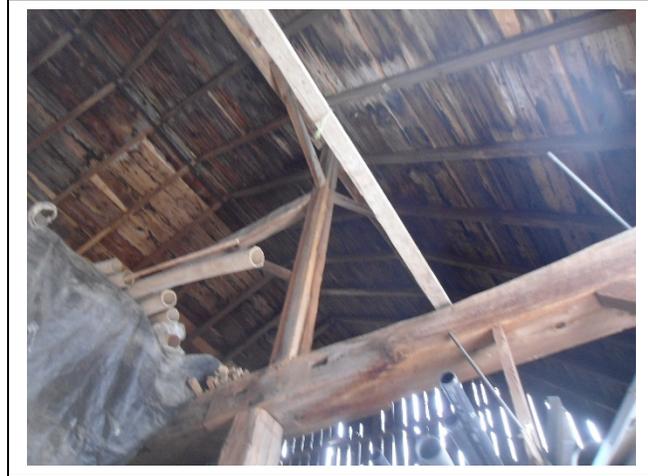
Photo 37: E19 – View of the roof wood frame structure

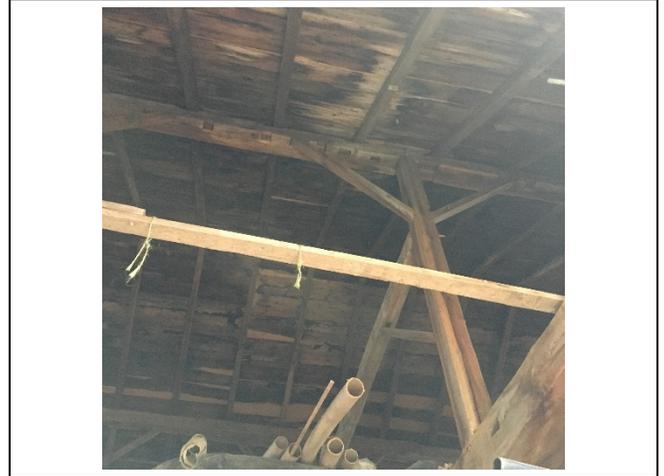
Photo 38: The condition of the wood roof frame structure appears to be similar with the initial assessment.

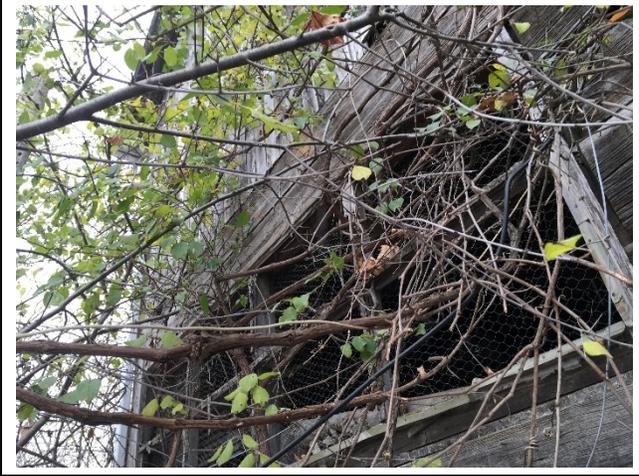
Photo 43: E22 – View of the south elevation storage opening

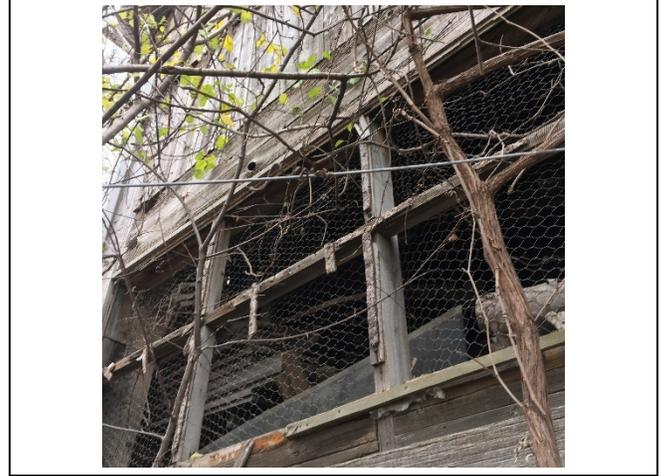
Photo 44: At the south elevation storage opening, no significant change was observed.

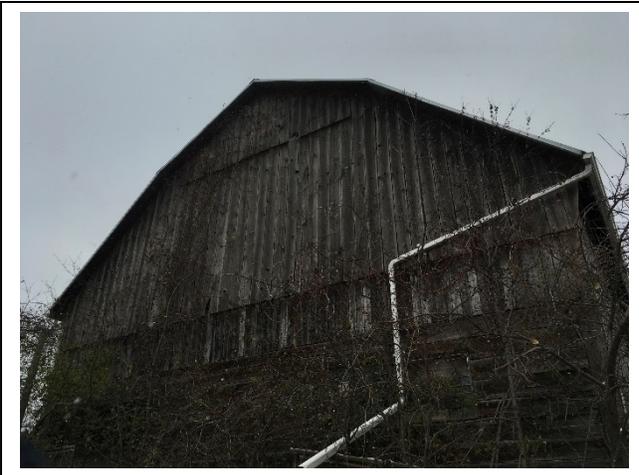
Photo 47: E24 – General view of the south elevation

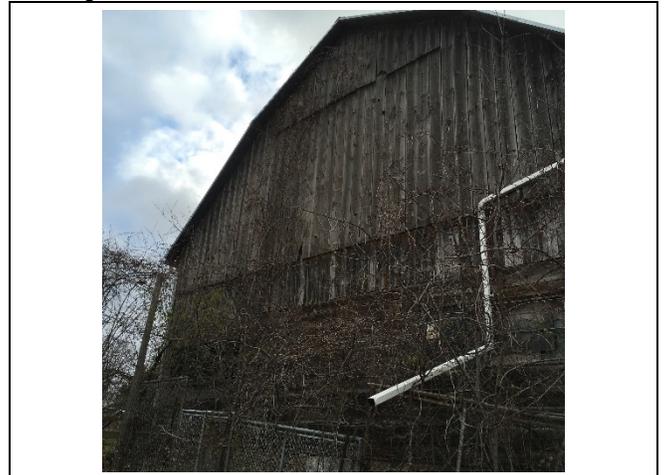
Photo 48: In general, the condition of the south elevation appears to be consistent with the pre-construction assessment.

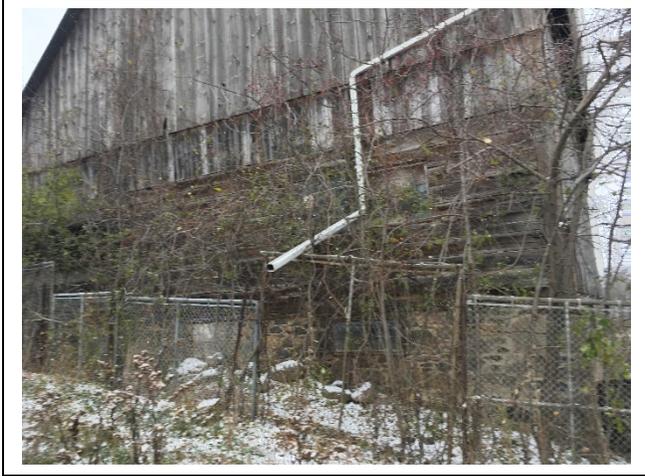
Photo 49: E25 – View of the south elevation

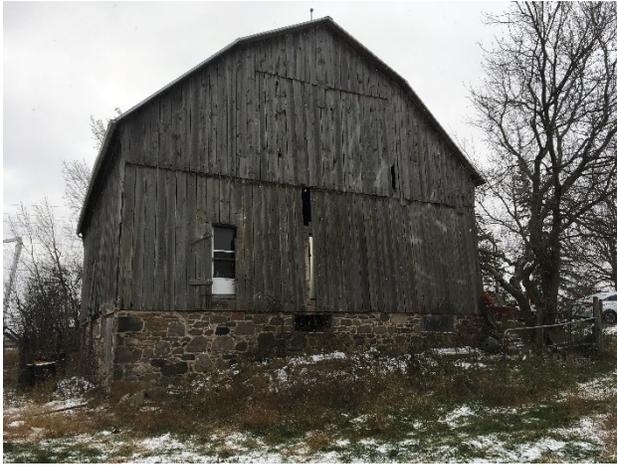
Photo 55: E28 – General view of the north elevation

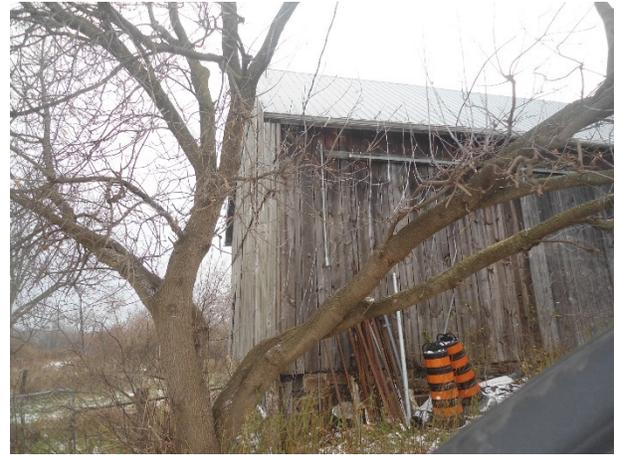
Photo 57: E29 – View of the west elevation

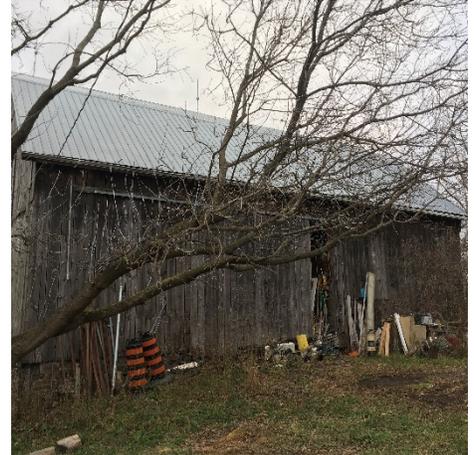
Photo 58: The condition of the west elevation appears to be similar to the pre-construction assessment.

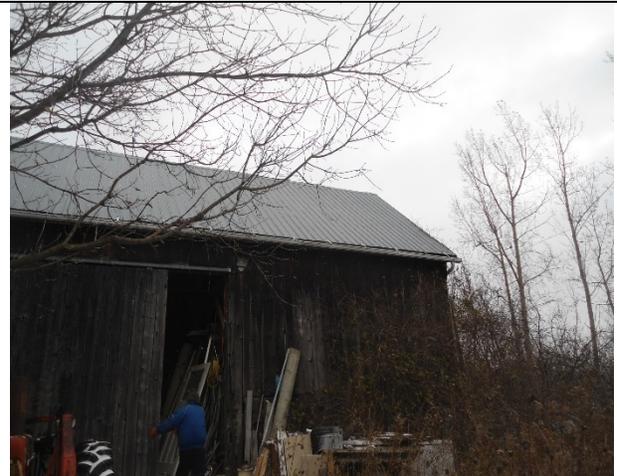
Photo 59: E30 – View of the north portion of the west elevation

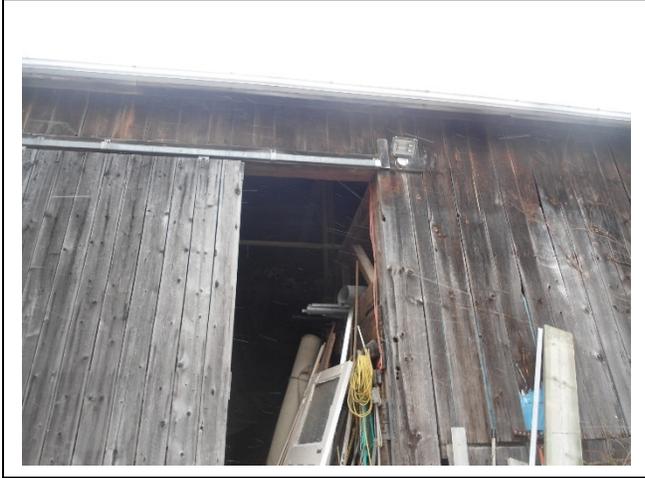
Photo 61: E31 – View of the wood boards above the sliding door

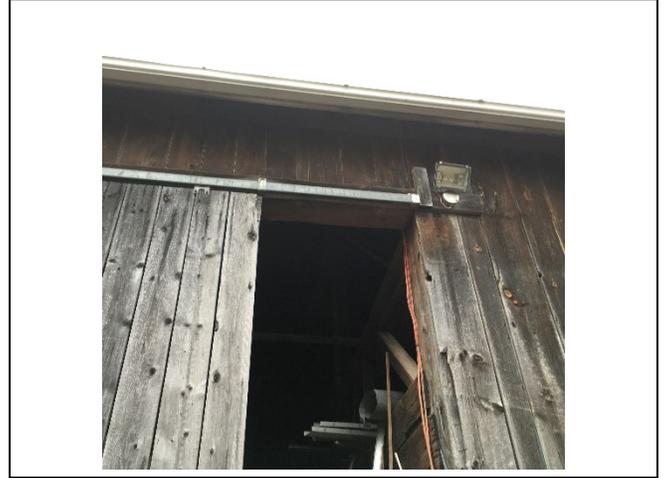
Photo 62: The condition of the wood boards above the sliding door appears unchanged.

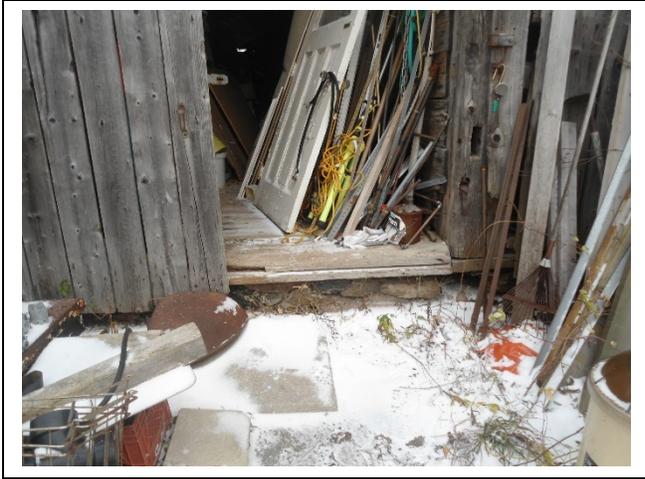
Photo 63: E32 –View of the lower portion of the sliding door
