Appendix L: Building Condition Assessment

Baseline Property Condition Assessment

100-102 Simcoe Street South,
Oshawa, Ontario

May 1, 2020

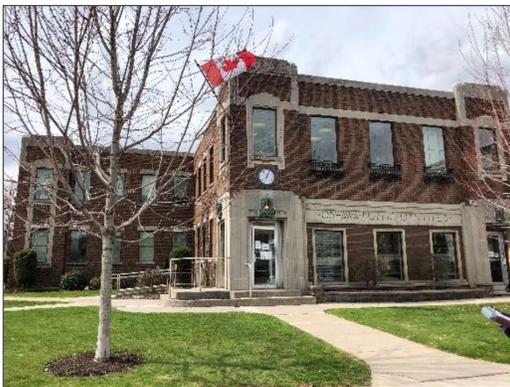
General view of the east elevation of Site Building A.

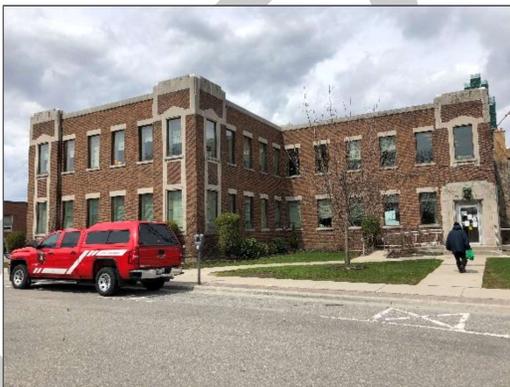
General view of the south elevation of Site Building A.

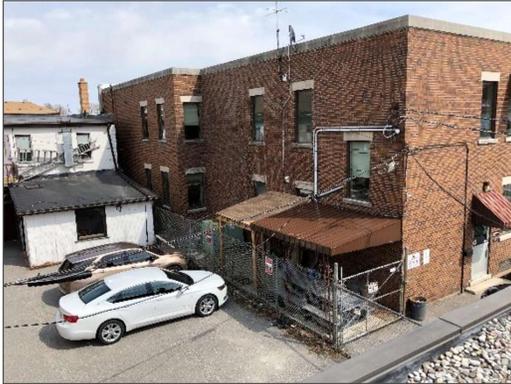
Partial view of the north elevation of Site Building A.

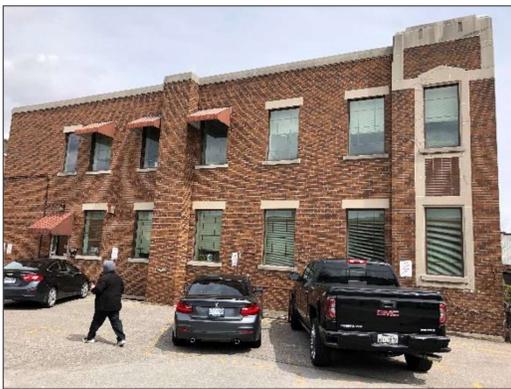
General view of the west elevation of Site Building A.

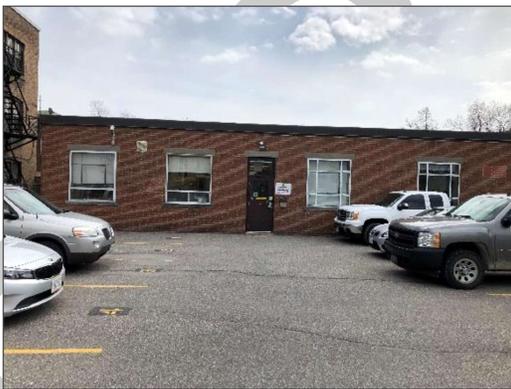
Partial view of the north elevation of Site Building B.

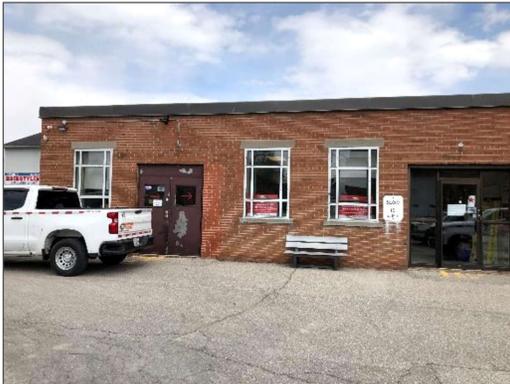
Partial view of the west elevation of Site Building B.

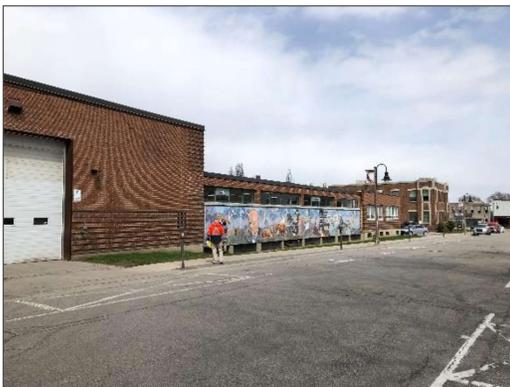
Partial view of the south elevation of Site Building C.

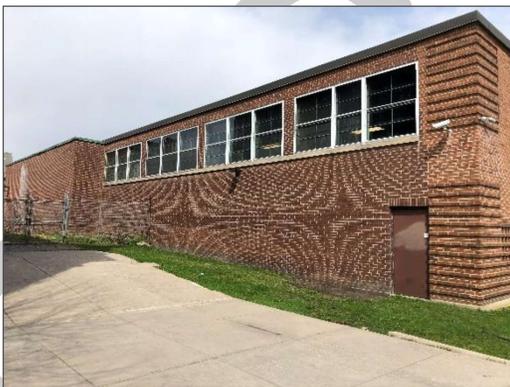
Partial view of the west elevation of Site Building C.

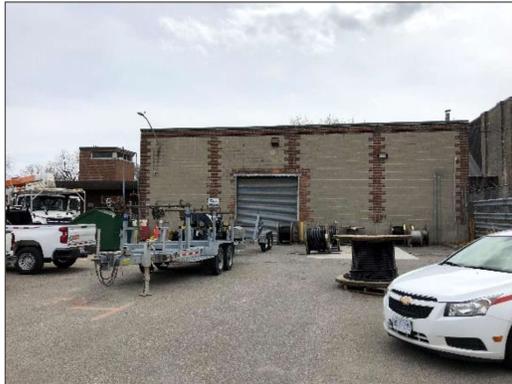
Partial view of the north elevation of Site Building C.

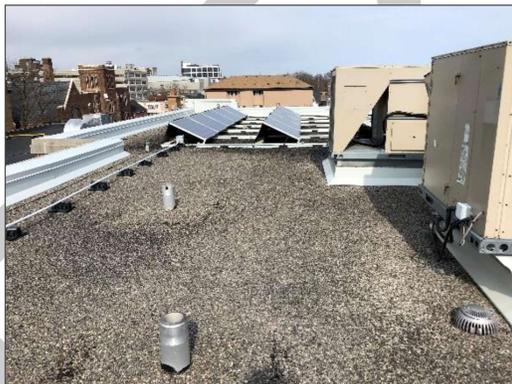
Typical view of the roof system atop Site Building A.

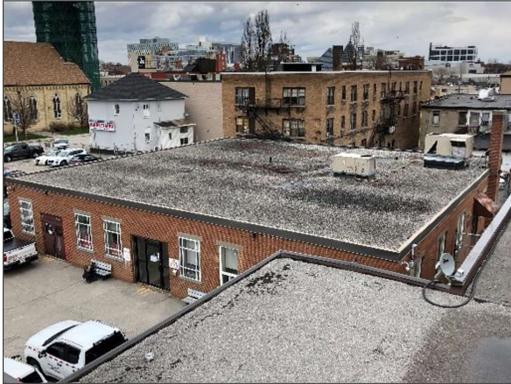
General view of the roof system atop Site Building B.

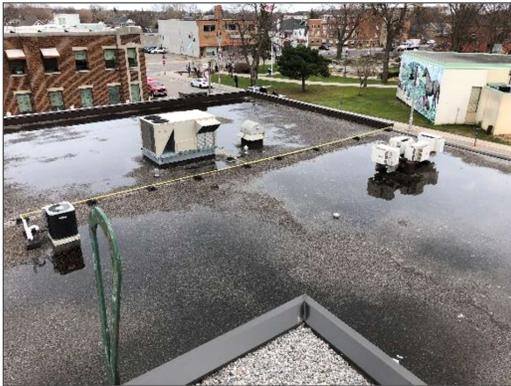
Typical view of the roof system atop the east portion of Site Building C.

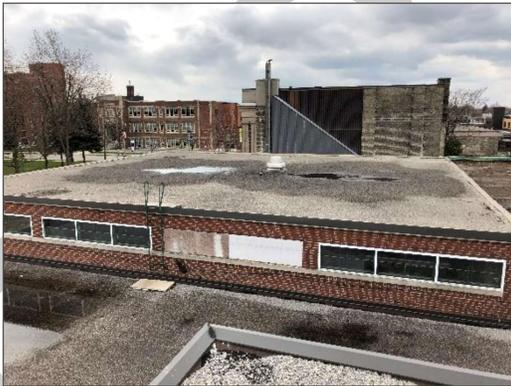
Active leaking within the roof system atop the original phase of construction of the garage portion of Site Building C was reported during the assessment. No active leaking within the remainder of the roof systems was reported, although evidence of moisture infiltration was noted on ceilings in various locations.

View of the roof system atop the south portion of the garage portion of Site Building C.

Pinchin has included an allowance for replacement of the BUR system atop the second phase of construction of the garage portion of Site Building C in year one and allowances to replace the remaining roof systems in the latter portion of the of the analysis. Pinchin recommends that regular annual maintenance be performed on the roof systems throughout the term of the analysis.

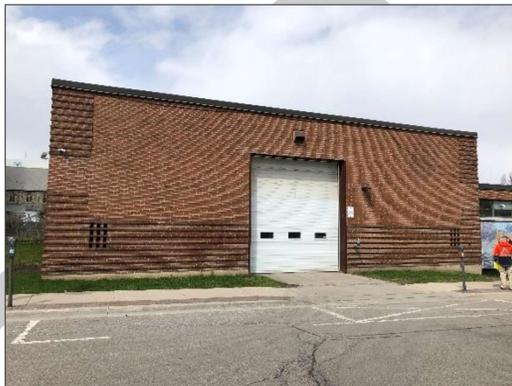
View of typical brick masonry veneer present on all elevations of the Site Buildings.

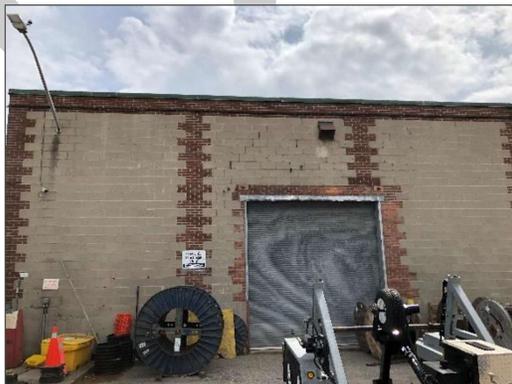
View of the concrete block masonry on the north elevation of the garage portion of Site Building C.

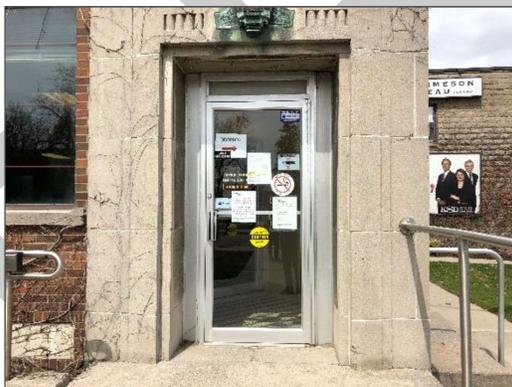
View of a typical SG unit in aluminum frame.

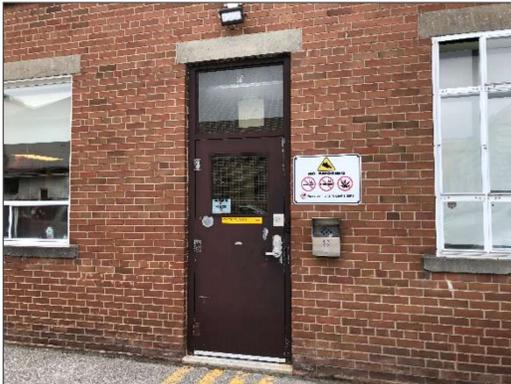
View of a typical hollow metal door within metal frame complete with GWG insert.

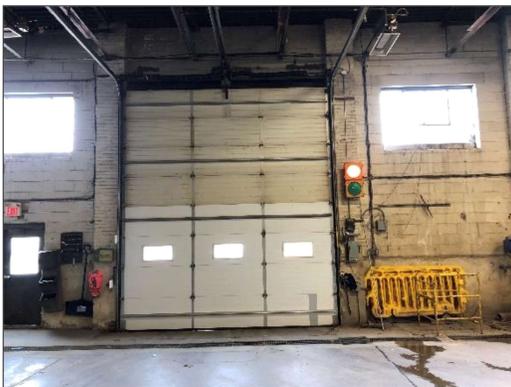
View of a typical sectional metal overhead door serving Site Building C.

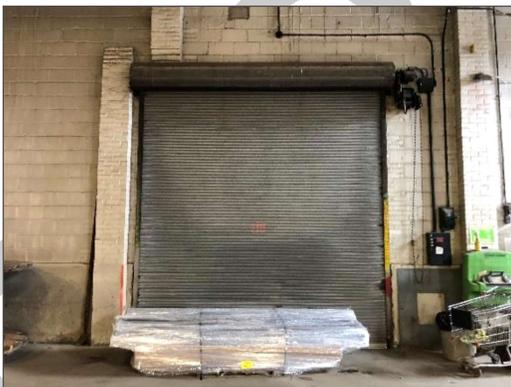
View of the steel roll-up door on the north elevation of Site Building C.

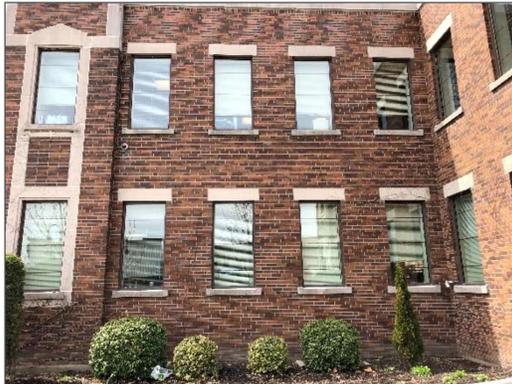
View of typical IG units in aluminum frames.

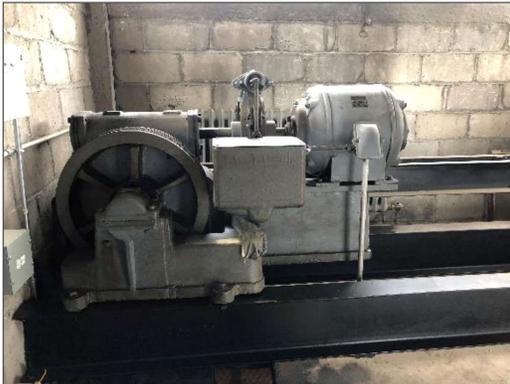
View of the elevator cable-drive system located within the elevator penthouse.

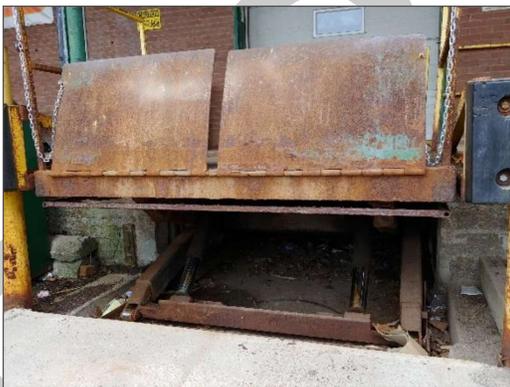
View of the hydraulic dock leveller serving the loading dock on the north elevation of Site Building C.

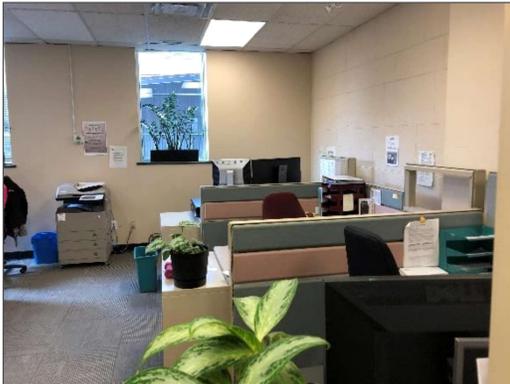
View of typical interior finishes within Site Building A.

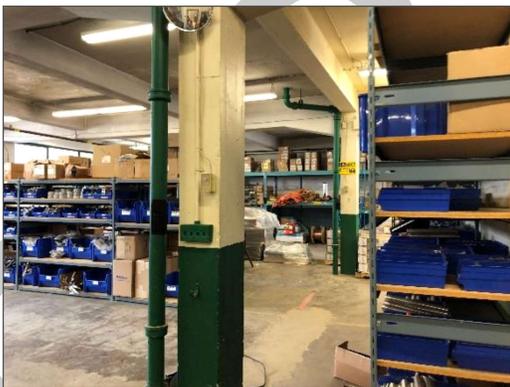
View of typical interior finishes within Site Building C.

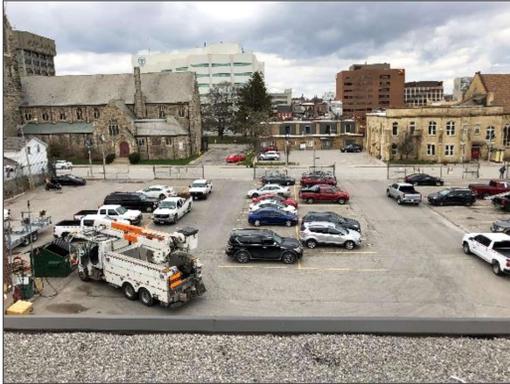
View of the asphalt paved parking area located on the north portion of the Site.

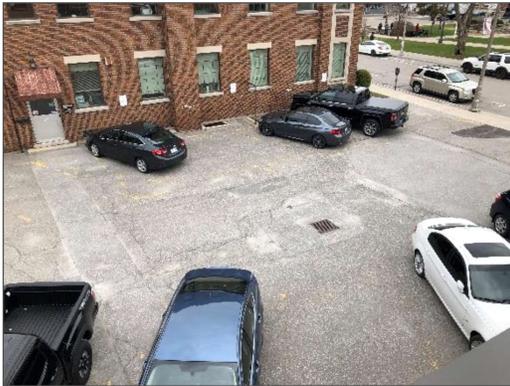
View of the asphalt paved parking area located on the south portion of the Site.

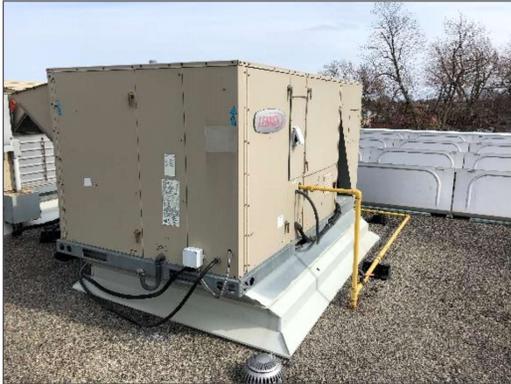
View of a typical "Lennox" natural gas-fired HVAC unit noted atop the Site Buildings.

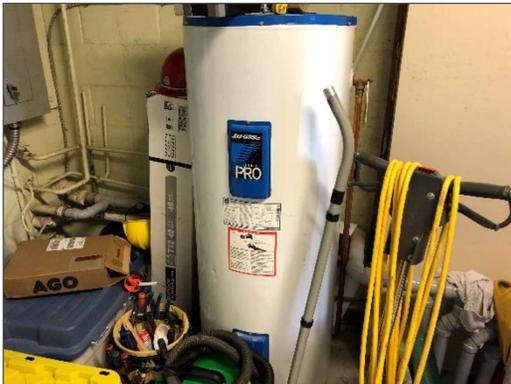
View of a typical electrically-powered self-contained DHW heater serving the Site Buildings.

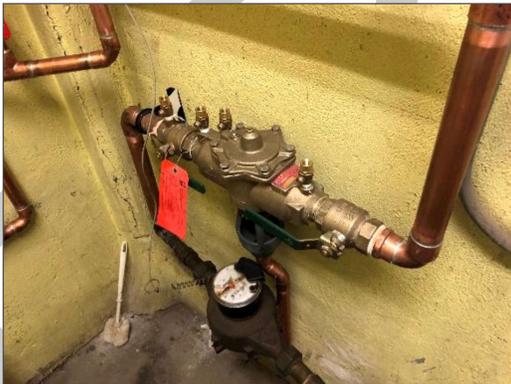
View of a typical backflow prevention device installed onto the main incoming water lines of the Site Buildings.

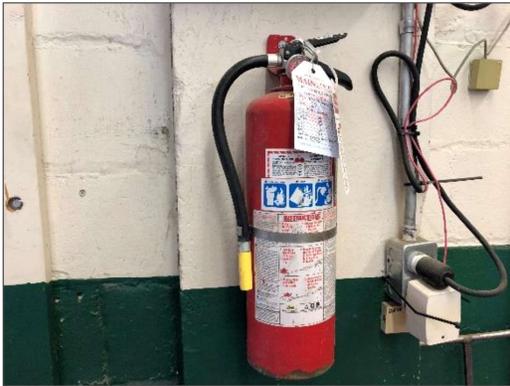
View of a typical stand-alone dry chemical fire extinguisher noted throughout the Site Buildings.

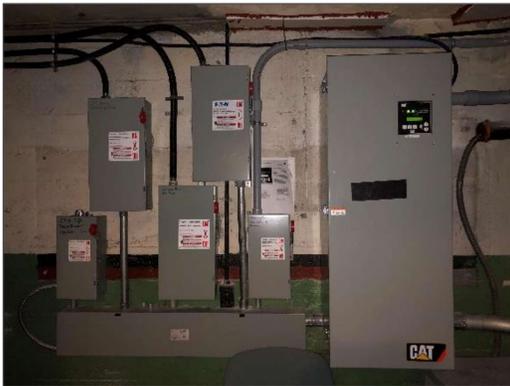
View of the main electrical equipment serving Site Building A.

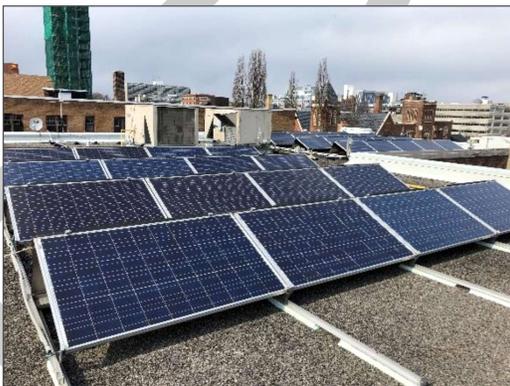
View of the photovoltaic solar panels located atop Site Building A.

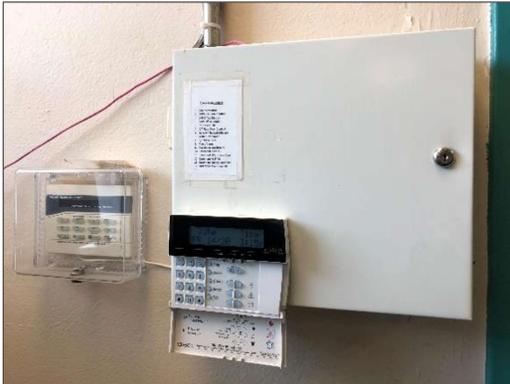
View of the "MaxSys" fire and security alarm panel.

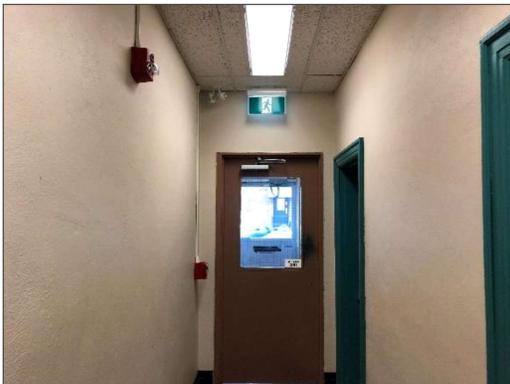
View of typical illuminated exit signage with emergency lighting and a hard wired fire alarm pull station located by the exits.
