**Re: 2009 Cost of Service Rate Application  
EB-2008-0227**

### EXECUTIVE SUMMARY

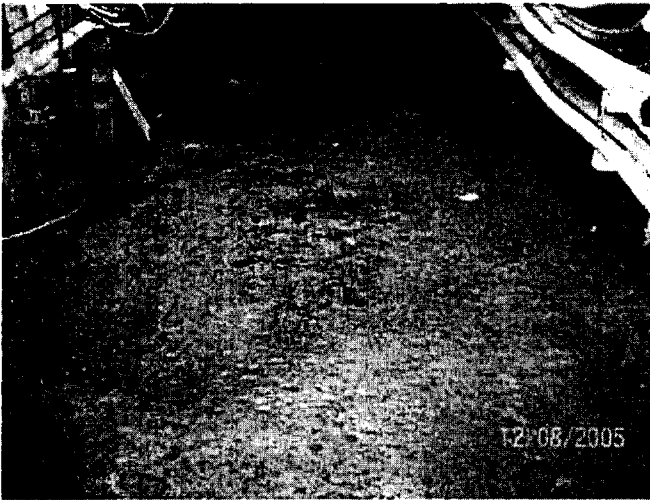
Roof (West to East)

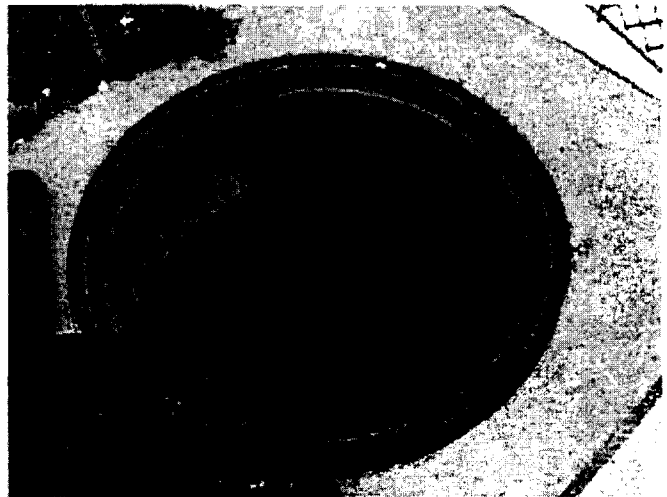
South Wall (West End)

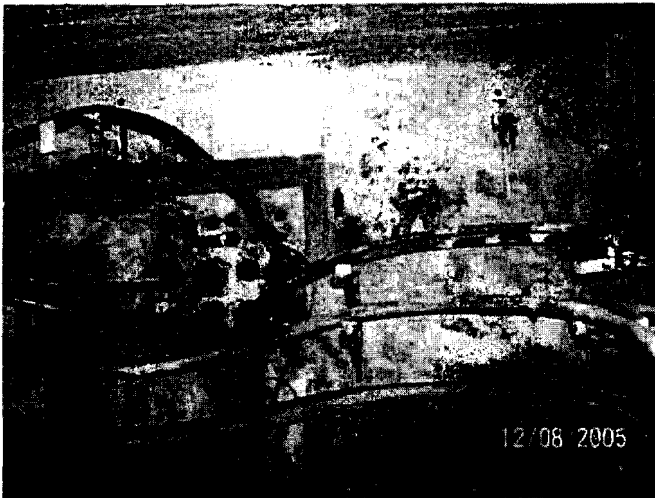
West Wall

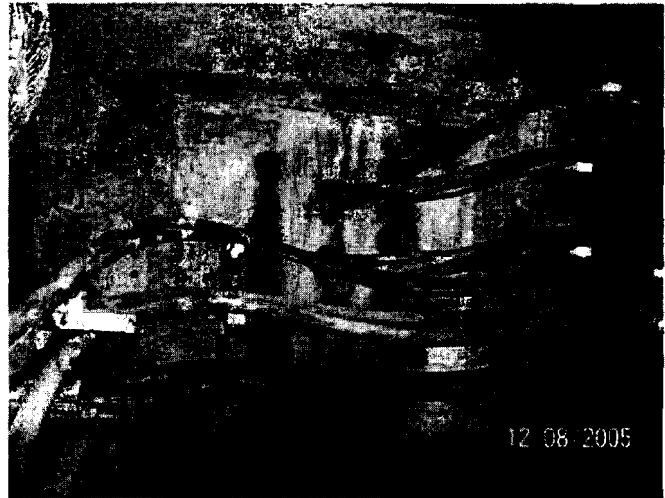
North Wall

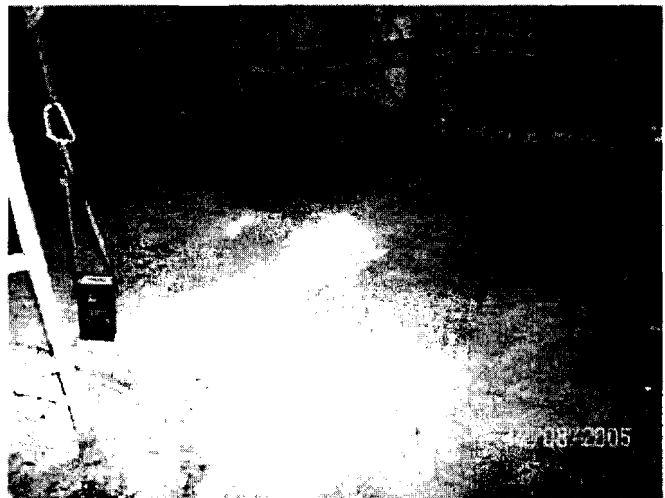
Floor

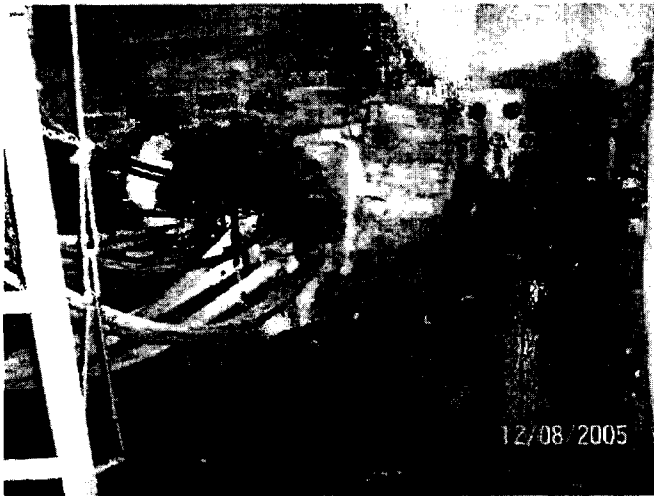
West Wall

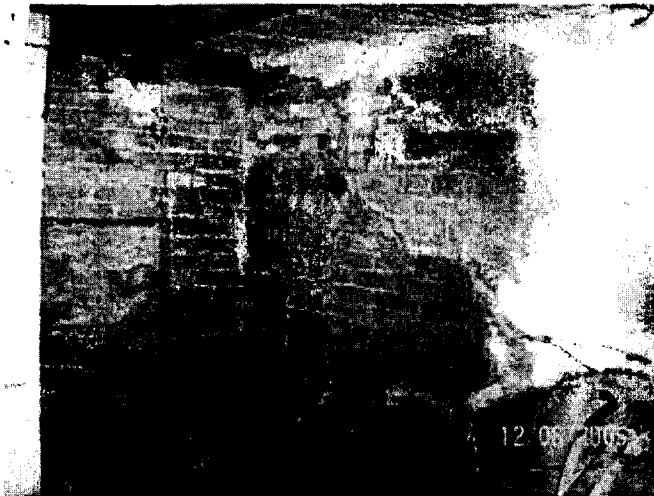
Northeast Corner

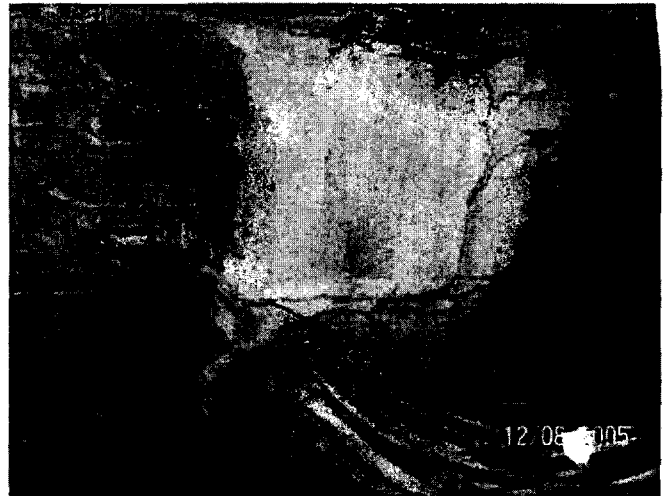
East Wall

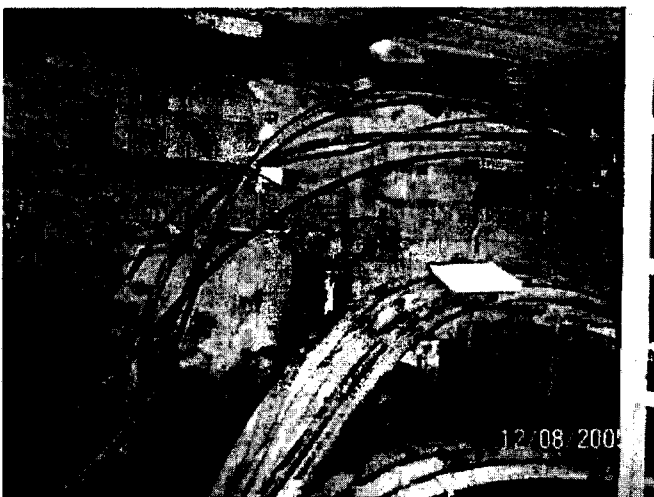
South Wall

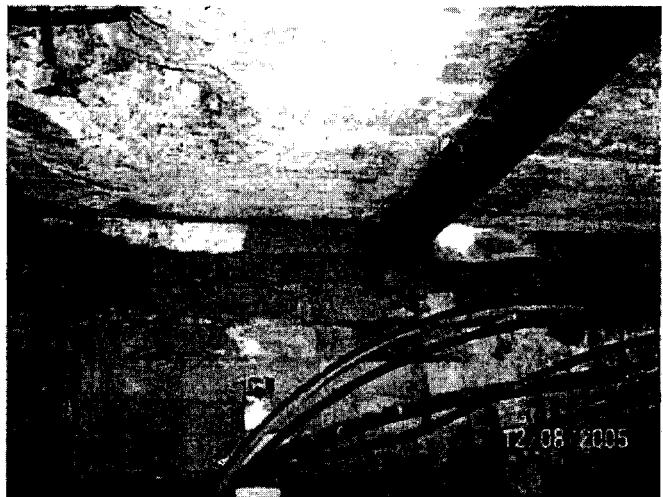
Roof

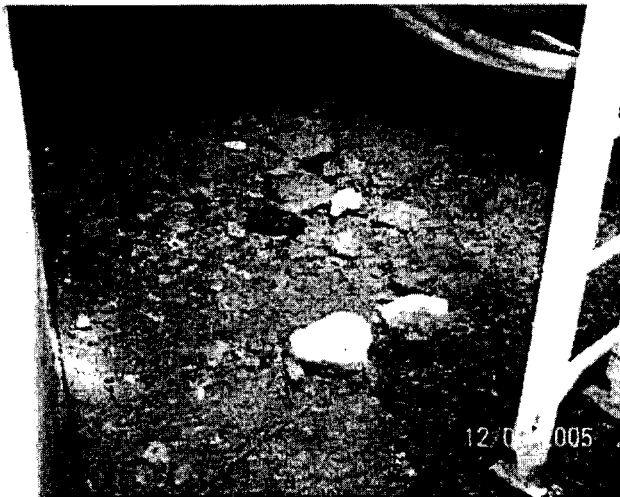
Floor

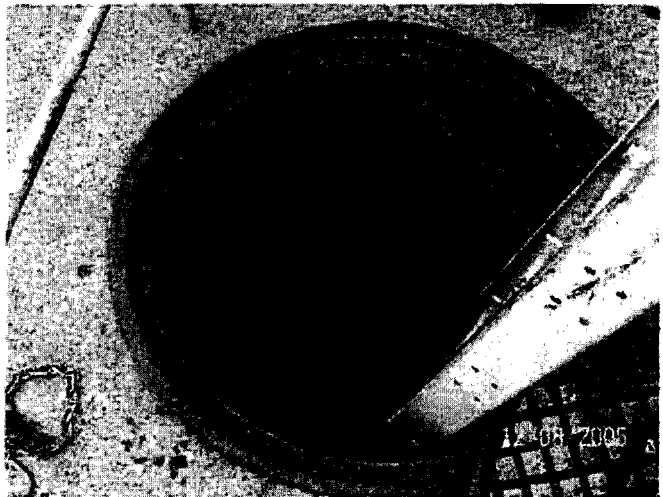
Chimney

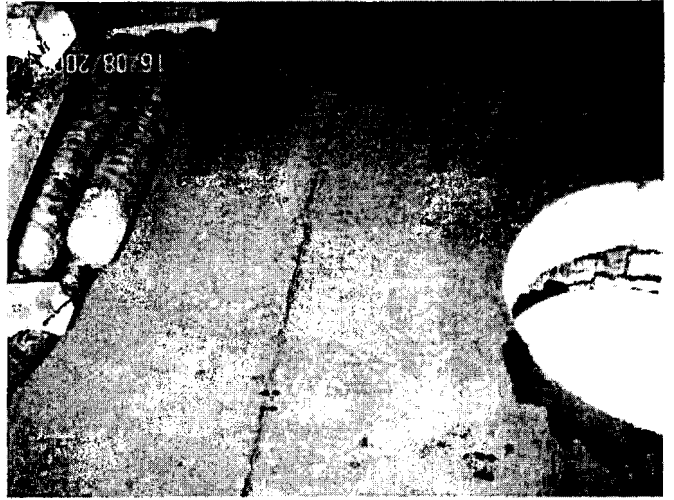
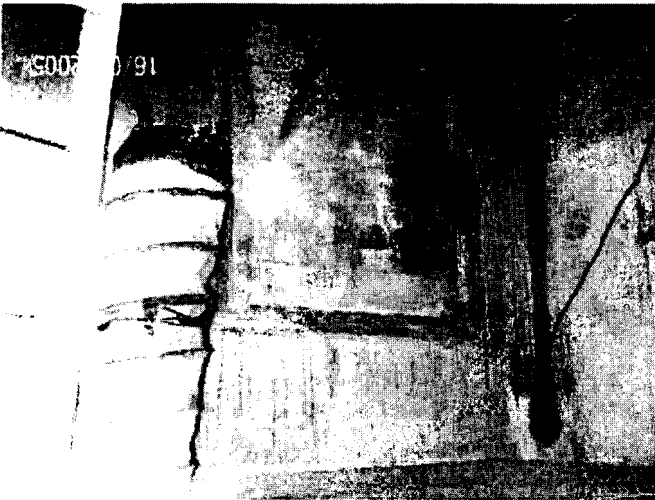
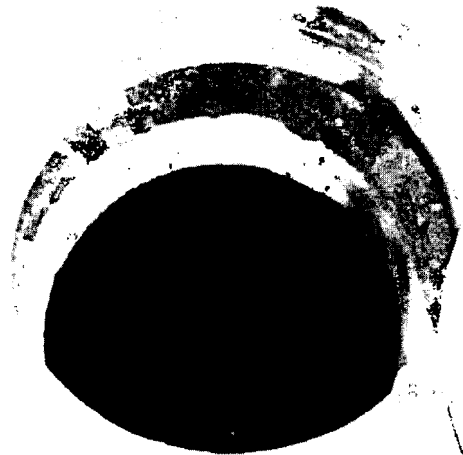
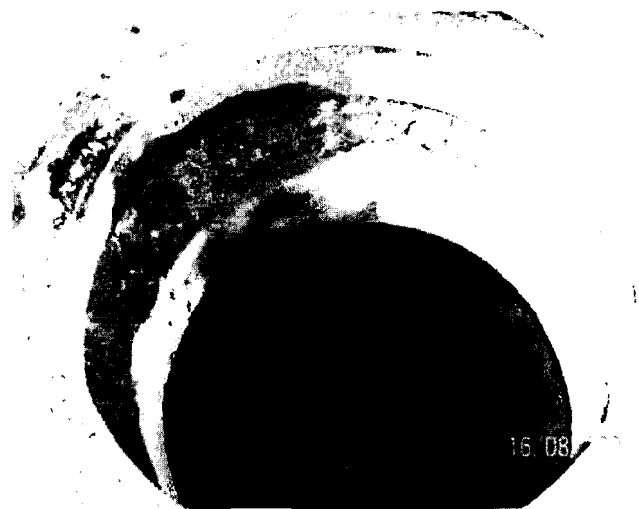
Manhole No. 32

LOCATION: NORTH SIDE OF ERIE, ALLEY WEST OF DOUGALL  
OVERALL CONDITION: GOOD RECENTLY RECONSTRUCTED  
REMARKS: MANHOLE HAS CONCRETE WALLS.

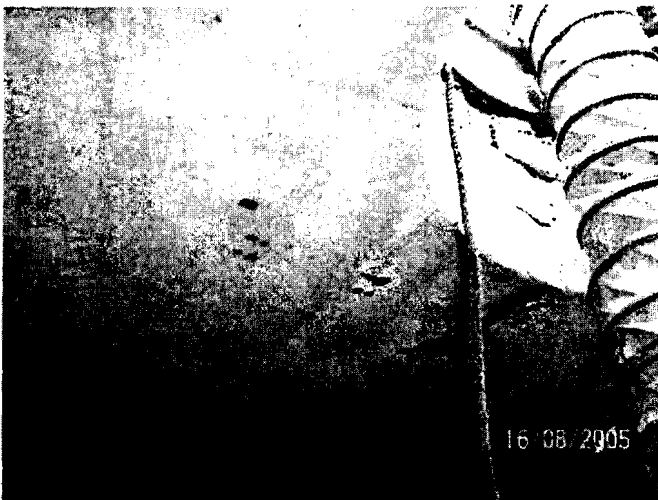
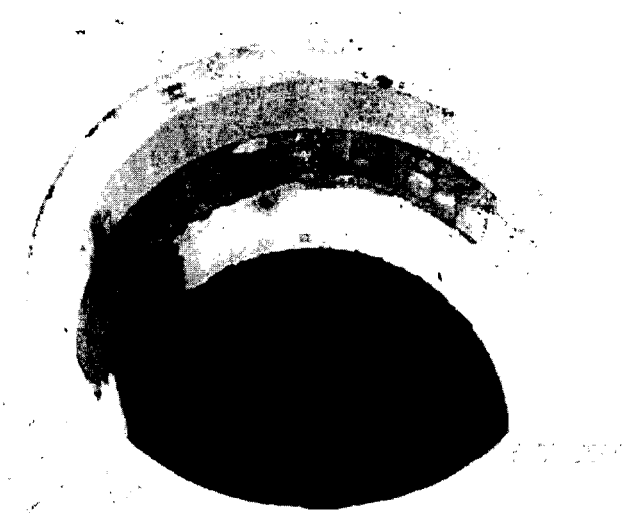
Manhole No. 33

LOCATION: NORTH SIDE OF ERIE, ALLEY WEST OF CHURCH  
OVERALL CONDITION: GOOD.  
REMARKS: MANHOLE HAS CONCRETE WALLS.

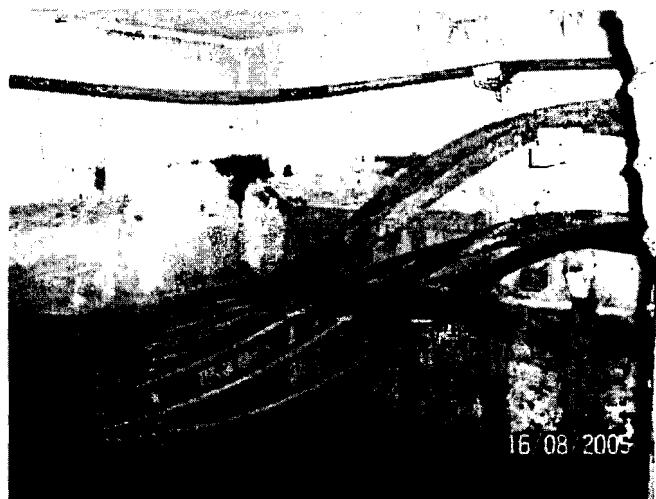
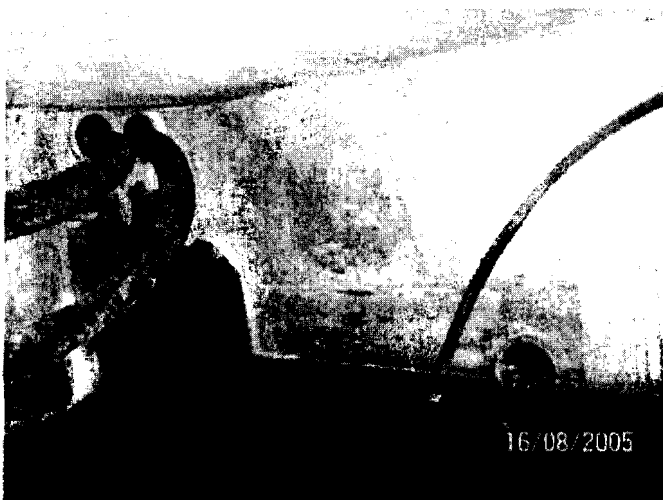
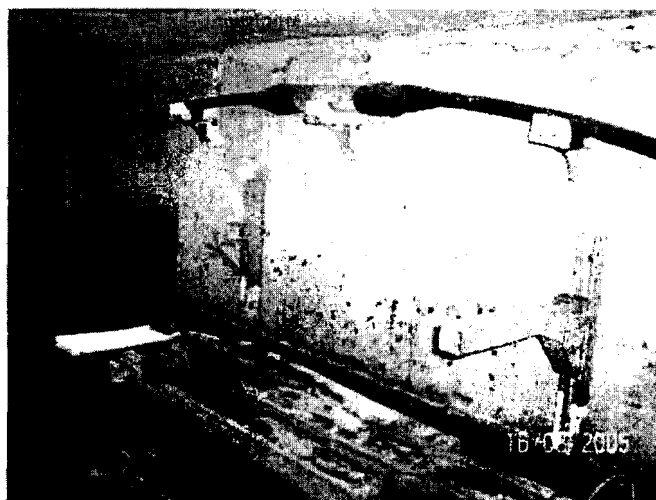
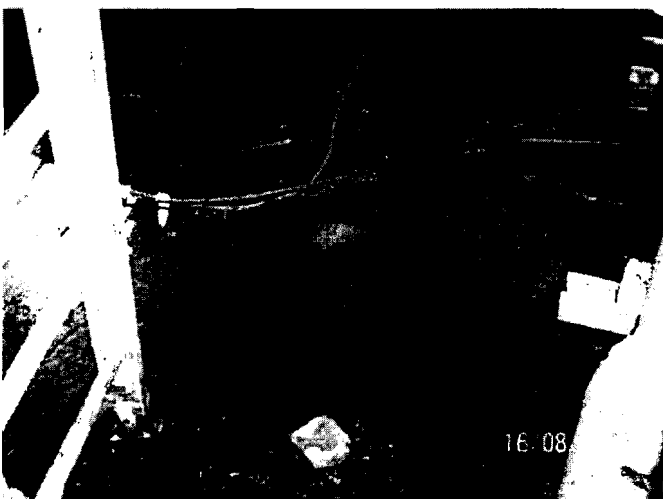
# MANHOLE No. : 34

LOCATION: NORTH SIDE OF ERIE, ALLEY WEST OF BRUCE  
 OVERALL CONDITION: GOOD.  
 REMARKS: MANHOLE HAS CONCRETE WALLS.
