Burlington **hydro** inc.

# Appendix L

## Fleet Management Plan

Fleet Management Plan

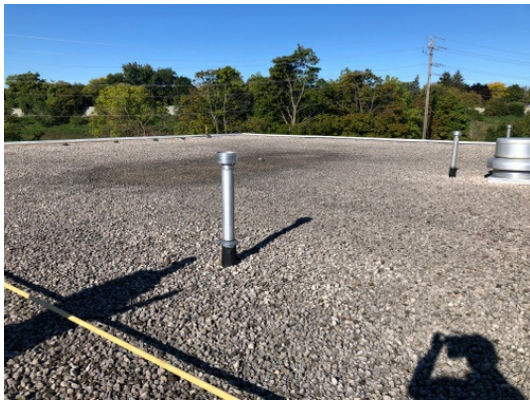
*Photo 1*

View of the EPDM ballasted roof system where there are large river rock over a single ply black rubber membrane

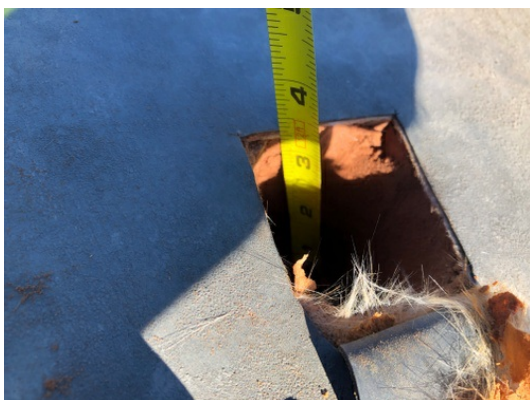
*Photo 3*

View of the core cut taken reveals a metal deck and 3" phenolic foam which corrodes the deck when it becomes wet.

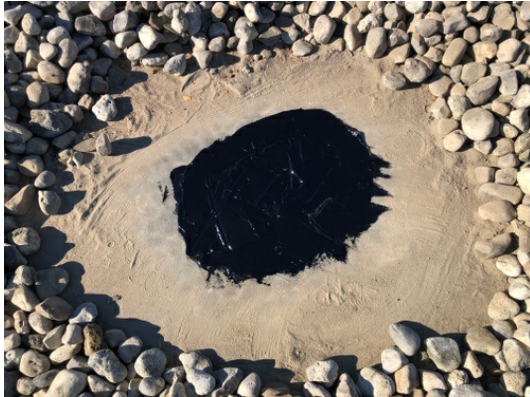
*Photo 5*

Core cut repaired

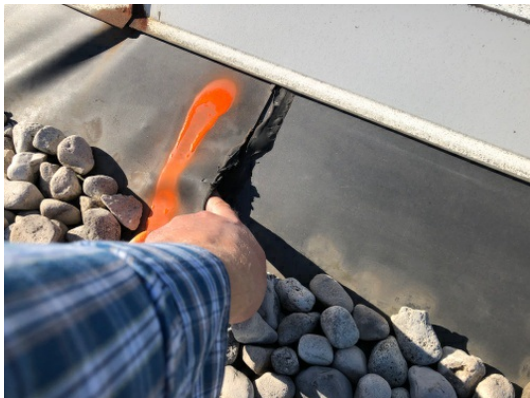
*Photo 6*

Example of multiple openings along the perimeter edge as seen here. These are all leaks sources.

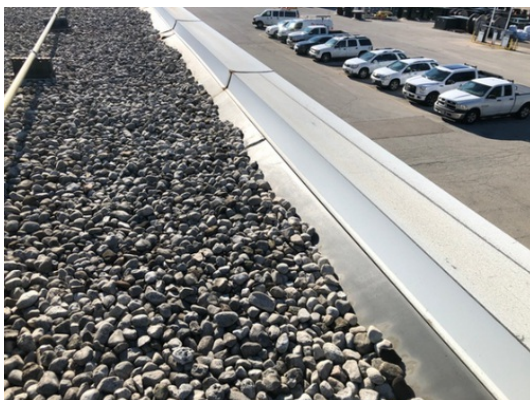
*Photo 7*

**Single Ply Tenting EPDM:** Single Ply Tenting occurs at the perimeter of the roof. As the single ply membrane is exposed to UV rays it shrinks. This in turn causes the perimeter to look like a tent and exerts extreme pressure on this 1 millimeter thin membrane. Couple this pressure with the brittleness of this old rubber membrane and multiple tears/punctures develop which in turn cause leaks inside the building and will lead to complete roof failure. The stretching and movement of the membrane in this case has caused the membrane to pull away from the termination bar and cause an opening for water to enter the building envelope.

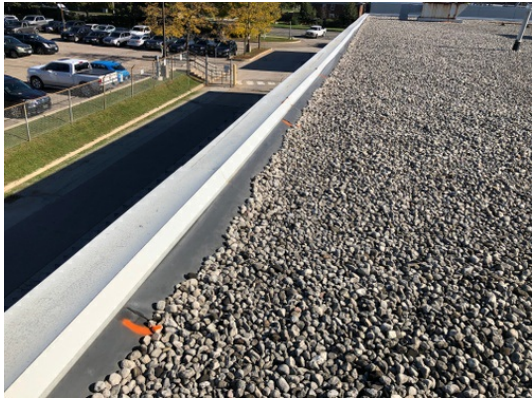
*Photo 8*

Further examples of severe tenting along the north side perimeter in conjunction with open vertical seams.

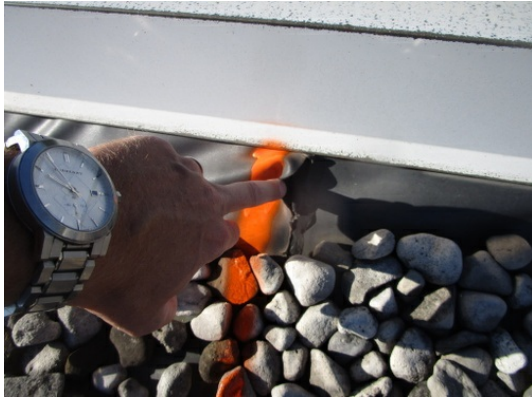
*Photo 9*

Open vertical seam along the perimeter

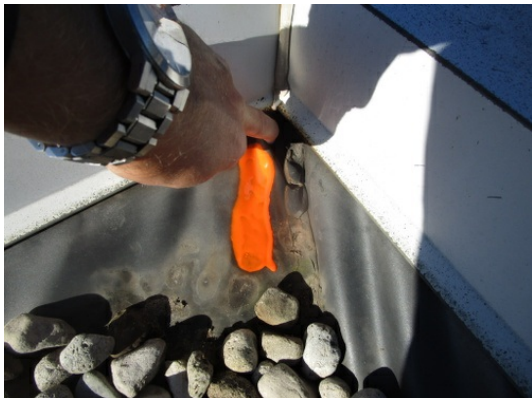
*Photo 10*

The corner is open

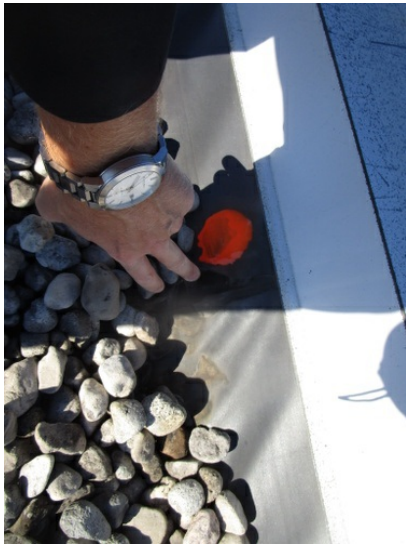
*Photo 11*

Another open seam

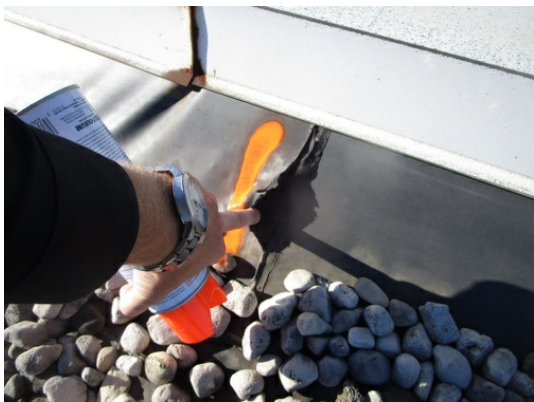
*Photo 13*

Open seam that needs to be repaired

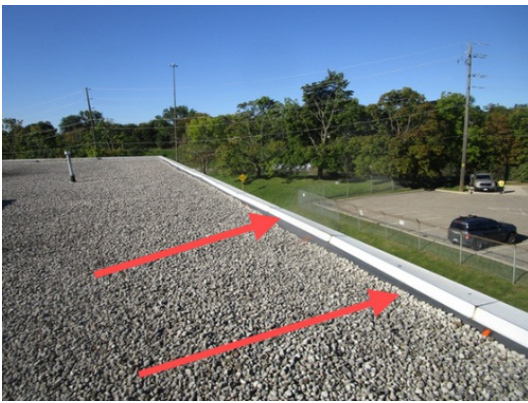
*Photo 15*

**Single Ply Tenting EPDM:** Single Ply Tenting occurs at the perimeter of the roof. As the single ply membrane is exposed to UV rays it shrinks. This in turn causes the perimeter to look like a tent and exerts extreme pressure on this 1 millimeter thin membrane. Couple this pressure with the brittleness of this old rubber membrane and multiple tears/punctures develop which in turn cause leaks inside the building and will lead to complete roof failure. The stretching and movement of the membrane in this case has caused the membrane to pull away from the termination bar and cause an opening for water to enter the building envelope.

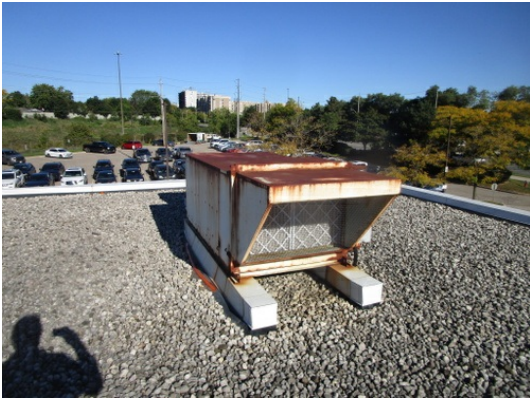
*Photo 17*

The old make up air unit is very corroded and likely leaks

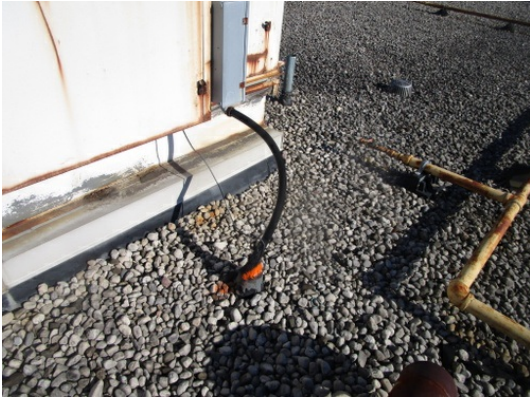
*Photo 18*

This cone should be re-sealed and coated silver

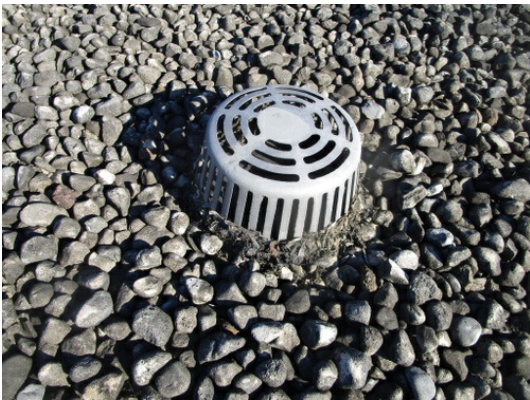
*Photo 19*

All debris around the drain strainer should be cleaned

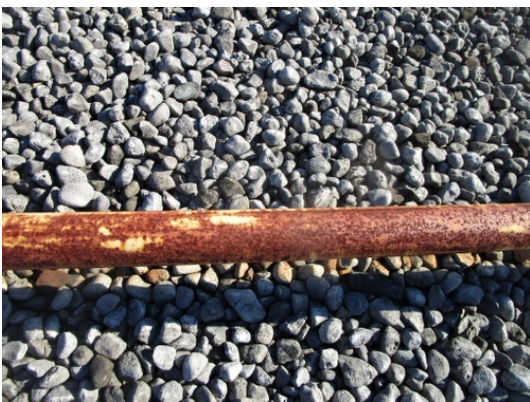
*Photo 20*

The corroded gas lines should be coated

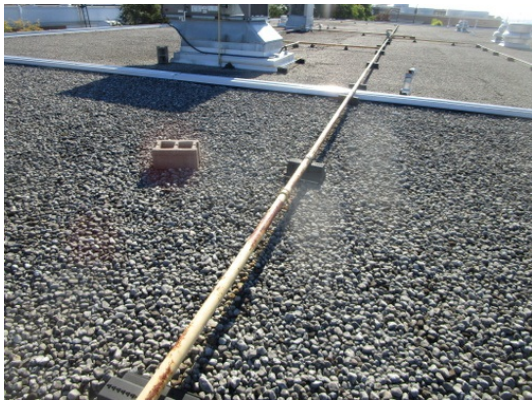
*Photo 21*

Most of the gas lines should be coated

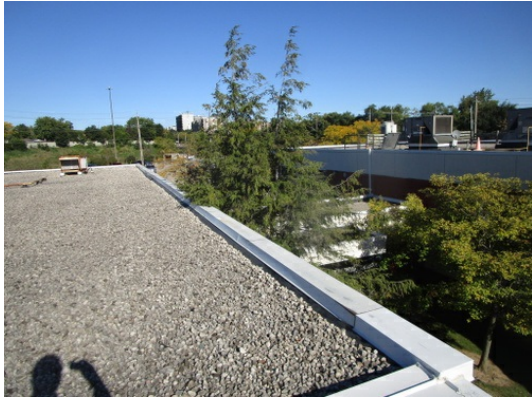
*Photo 22*

East side of the perimeter where the trees need to be pruned back and also had a split/ripped open flashings

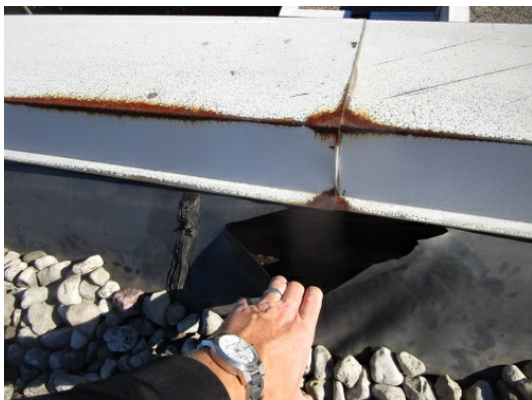
*Photo 23*

Flashings are wide open as seen here and the following photo

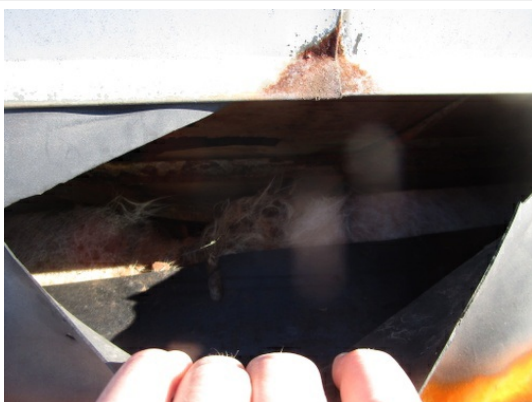
*Photo 24*

Severe water damage from the rubber membrane that has badly torn

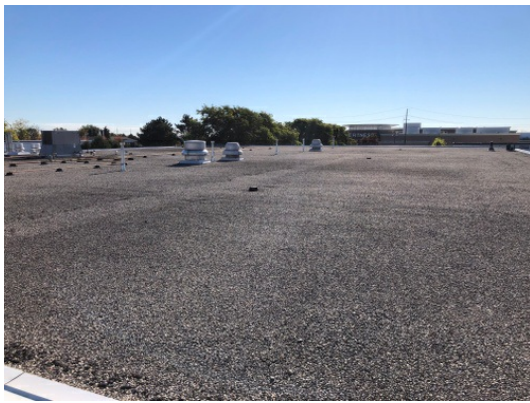
*Photo 1*

View of the asphalt built up roof system which is in much better condition than the rubber single ply roof system

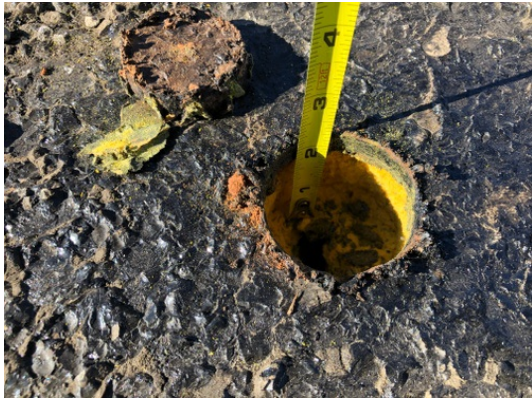
*Photo 3*

Core cut reveals 1.5" fiberglass and kraft paper vapour barrier

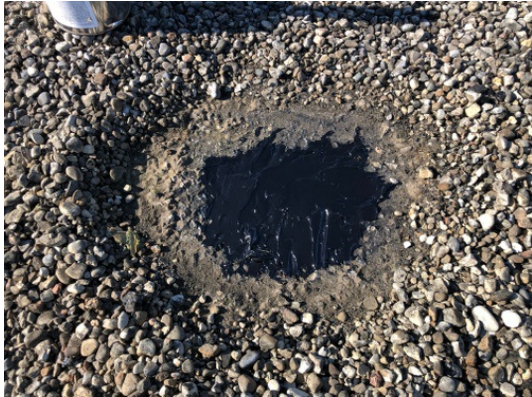
*Photo 4*

Core cut repaired with rubberized mastic

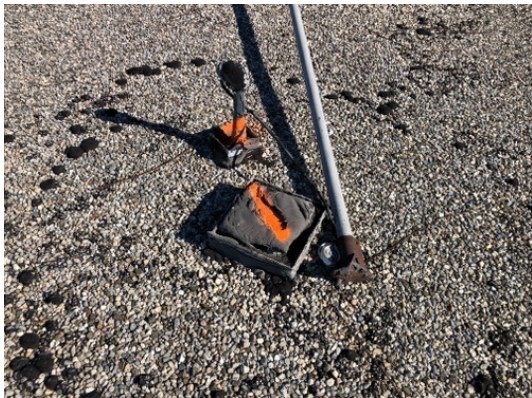
*Photo 5*

**Pitch Pocket Deterioration:** Metal protrusions that penetrate the roof system to allow conduits to run from the rooftop into the building. Movement from the protrusion can break the waterproofing compound, creating cracks. Over time, the release of solvents from the compound can cause the material to shrink, leaving gaps along the edges of the pan and around structural support. Water can enter through a defective pitch pan and find its way into the interior of the building. Moisture can also penetrate into the roof system leading to premature failure.

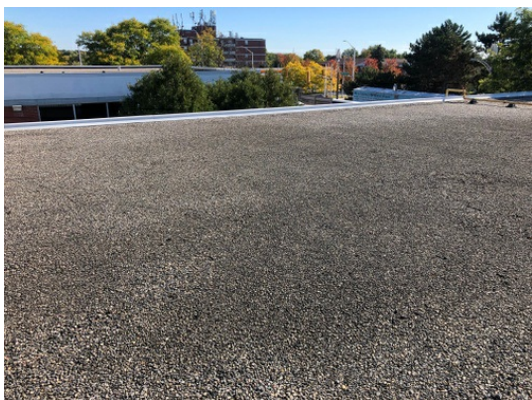
*Photo 6*

Area that requires a drain

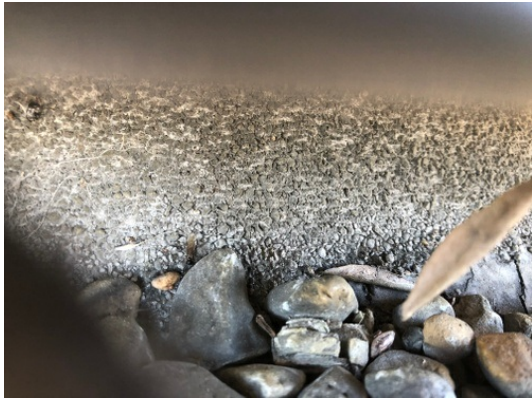
*Photo 7*

The flashings are in fair condition where spot checked

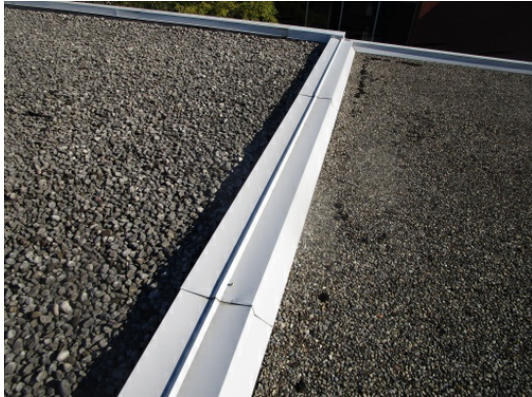
*Photo 8*

View of the expansion joint that has full metal

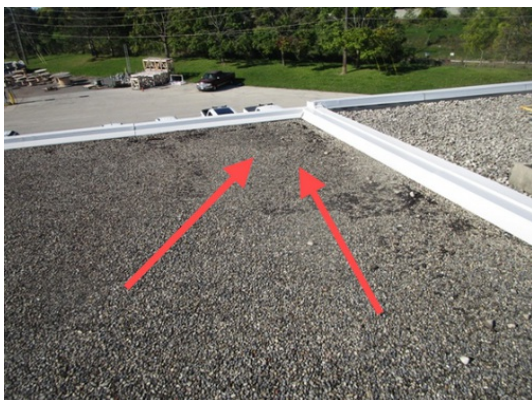
*Photo 10*

**Bare Felts:** Weathering causes the roofs surfacing materials to oxidize and wear away after a period of time. Loss of protection from the surfacing material results in accelerated deterioration of the primary waterpoofer asphalt, along with the systems reinforcement plies which provide the strength for the system. The exposed reinforcement will begin to absorb and wick moisture into the built up layers of the roof system. This condition leads to accelerated damage via blisters and interlayer delamination.

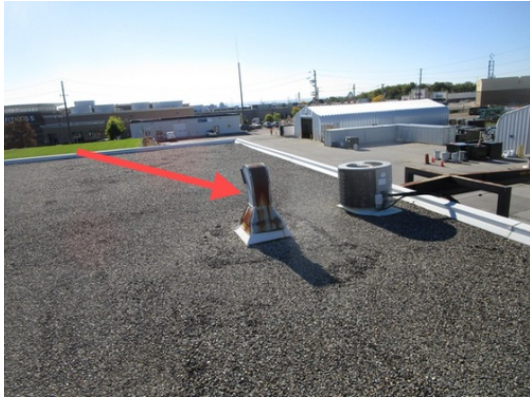
*Photo 12*

View of the corroded exhaust

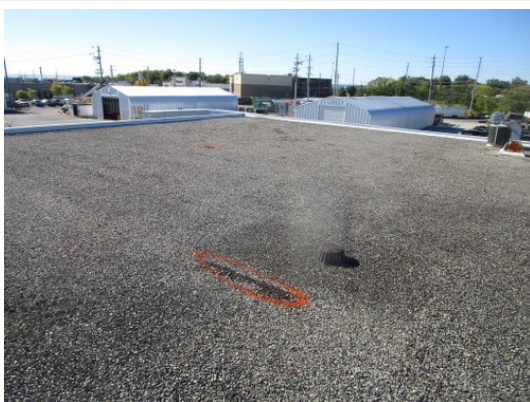
*Photo 14*

**Bare Felts:** Weathering causes the roofs surfacing materials to oxidize and wear away after a period of time. Loss of protection from the surfacing material results in accelerated deterioration of the primary waterpoofer asphalt, along with the systems reinforcement plies which provide the strength for the system. The exposed reinforcement will begin to absorb and wick moisture into the built up layers of the roof system. This condition leads to accelerated damage via blisters and interlayer delamination.

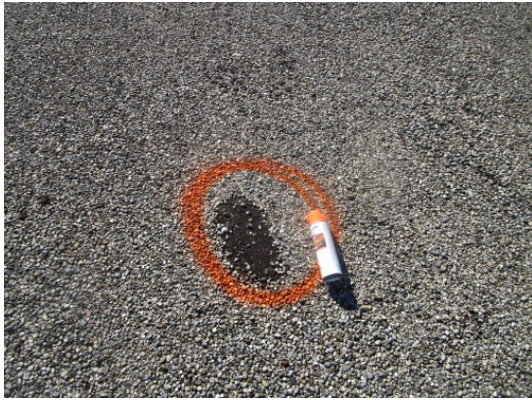
*Photo 15*

**Blisters:** Soft spongy pockets or swellings in the roofing material. They occur between layers of felt or between the roof membrane and substrate. Air or moisture vapor entrapped within a blister expands as the roof and outside air temperatures rise. This results in sufficient pressure to push the roofing felts upwards and apart. Blisters may be ruptured by roof traffic, expanding frozen water, or hail (especially during colder weather). Some blisters may become so large as to affect drainage, which may then cause ponding water. Laps could also be pulled apart, resulting in leakage. A ruptured blister will immediately allow water to penetrate and damage the roof system.

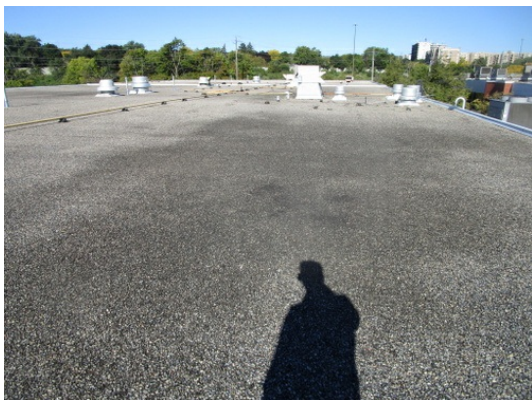
*Photo 18*

There is minor ponding water that requires an extra drain

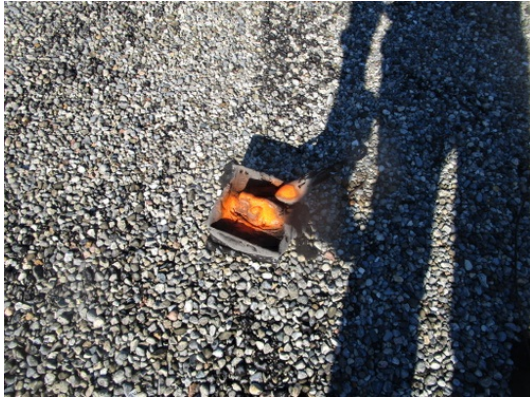
*Photo 20*

**Pitch Pocket Deterioration:** Metal protrusions that penetrate the roof system to allow conduits to run from the rooftop into the building. Movement from the protrusion can break the waterproofing compound, creating cracks. Over time, the release of solvents from the compound can cause the material to shrink, leaving gaps along the edges of the pan and around structural support. Water can enter through a defective pitch pan and find its way into the interior of the building. Moisture can also penetrate into the roof system leading to premature failure.

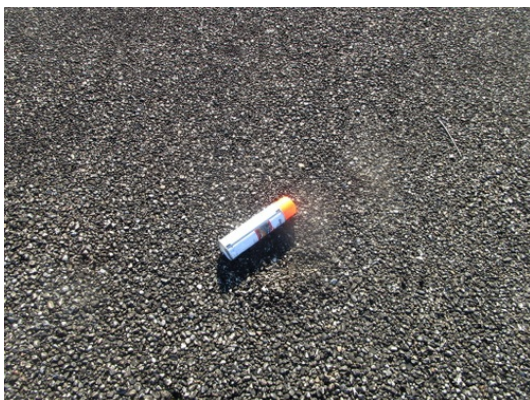
*Photo 22*

**Blueberries:** These are the result of dried out surface asphalt. They appear on the roof as small blue or black balls or berries. When the top pour of asphalt erodes to this stage, the roof system has lost at least 40% of its waterproofing ability.

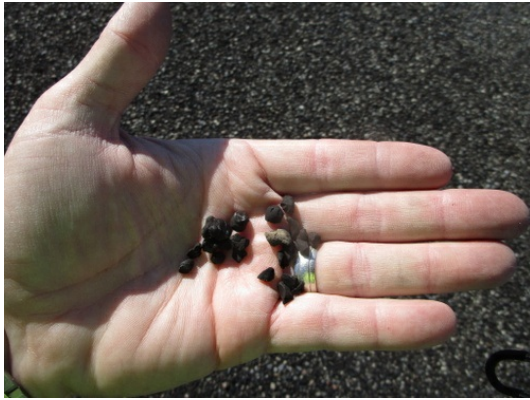
*Photo 23*

Close view of the blueberries

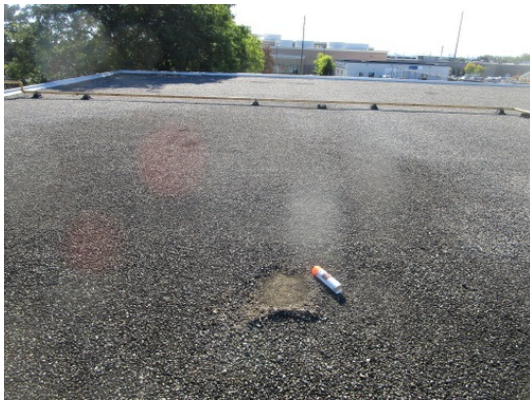
*Photo 24*

The top flood coat has dried out and eroded

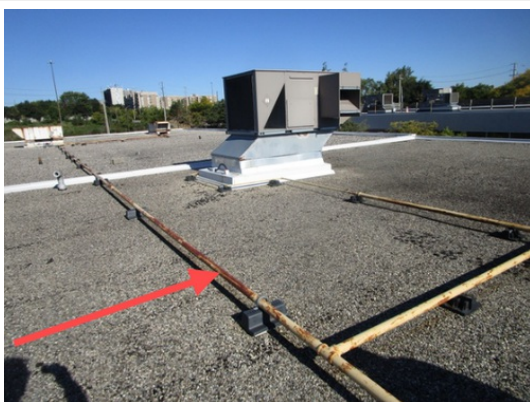
*Photo 26*

Corroded gas lines need to be coated

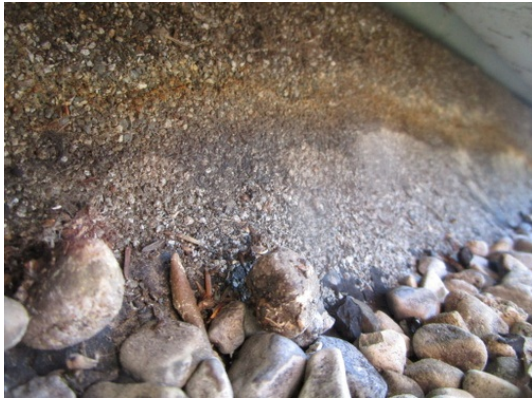
*Photo 27*

The flashings have a water line stain that confirms an additional drain is required on the east side of the roof

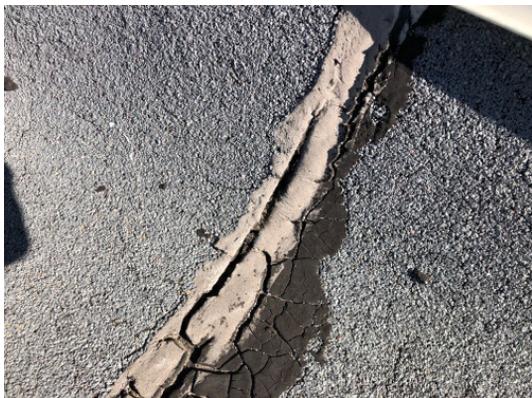
*Photo 3*

The vertical seam has opened up and needs to be repaired

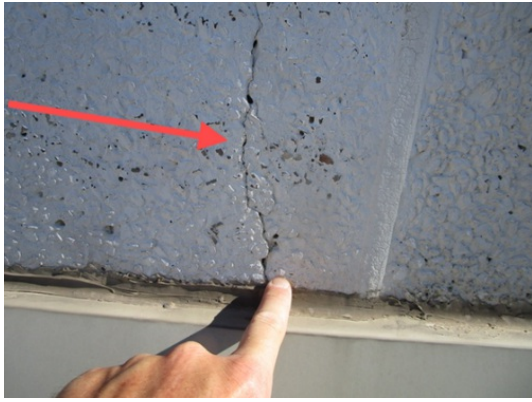
*Photo 8*

The precast wall has a few cracks

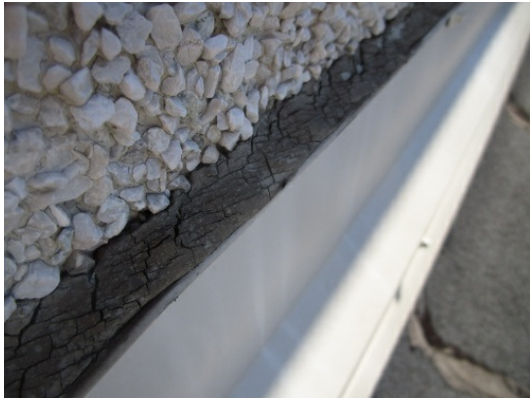
*Photo 12*

The caulking above the metal counter flashings should be re-caulked as it has dried out

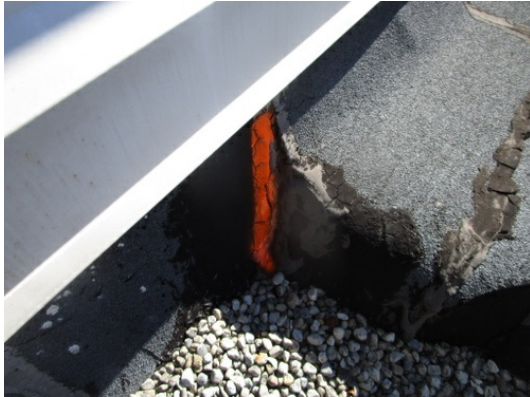
*Photo 13*

View of open seam along the platform

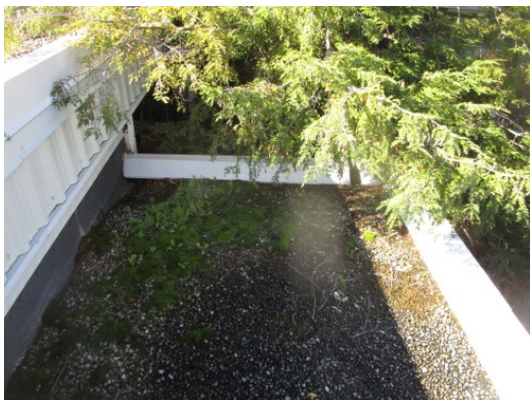
Photo 1

**Vegetation Growth:** Vegetation often occurs when dirt and debris collect on roof systems. Over time this creates a perfect medium for plant and weed growth. When seeds take hold the roots will often penetrate through the membrane causing immediate leaks and damage internally.

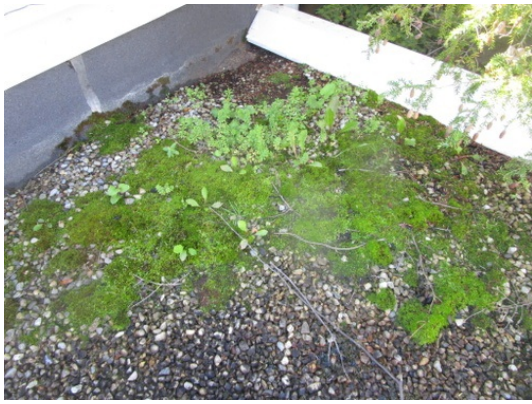
*Photo 2*

Close up view of the moss growth

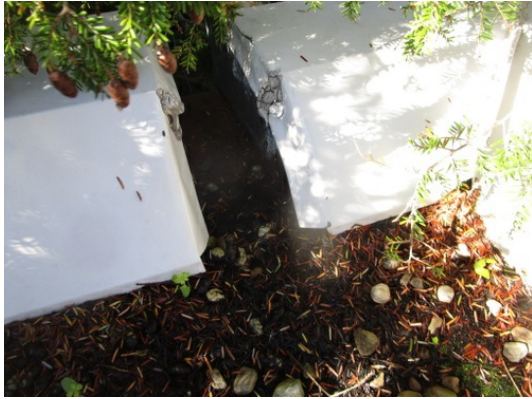
*Photo 3*

The scupper needs to be cleaned out as it is very small in size

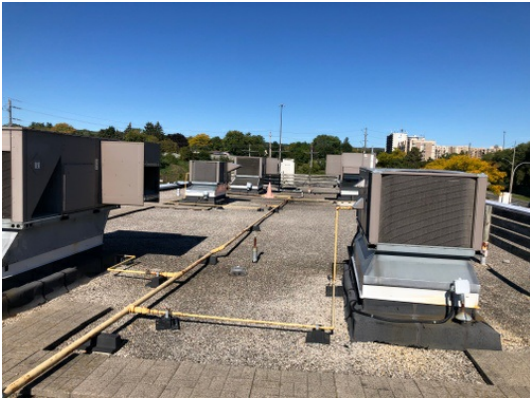
*Photo 1*

<b>Rating</b>	Invalid Lookup Rating ()
<b>Condition</b>	The roof system located on the north side of the building appears to be in good condition except for a few areas that require maintenance. It was surprising that the core cut revealed damp fiberboard which confirms there is a breach in the system. The roof should be scanned to confirm the extent of the potential wet insulation. There are a number of maintenance items required around the HVAC units from the seams to the cones that need to be reinforced.

View of the roof between the HVAC units

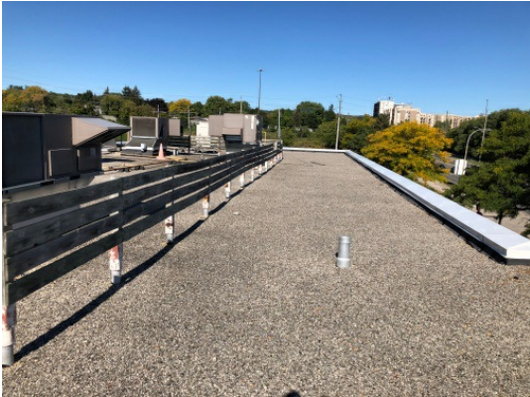
*Photo 2*

The field of the roof is performing well.

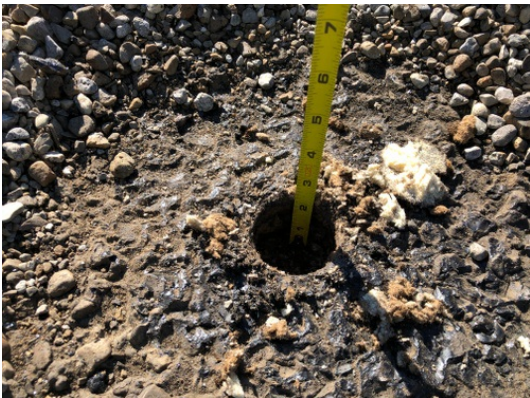
*Photo 3*

The core cut reveals polyisocyanurate and fiberboard insulation.

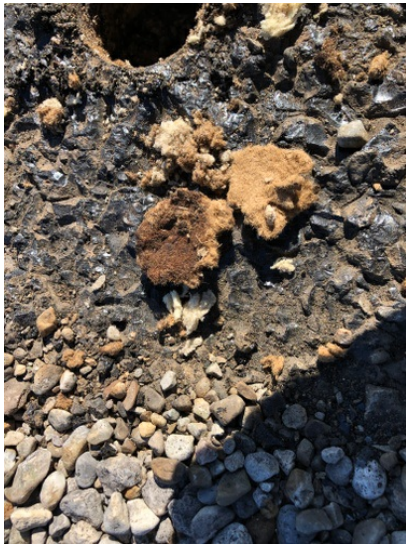
*Photo 4*

The fiberboard was damp as seen in the photo

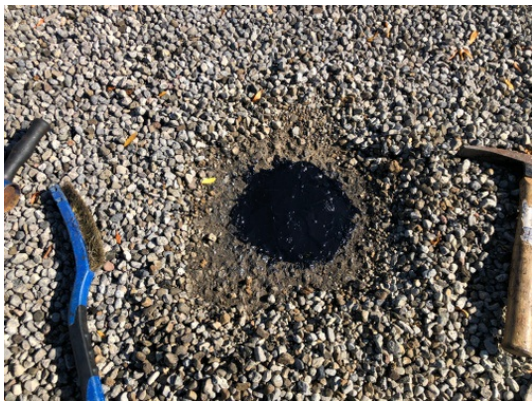
*Photo 5*

The core cut was repaired with rubberized mastic and fiberglass mesh

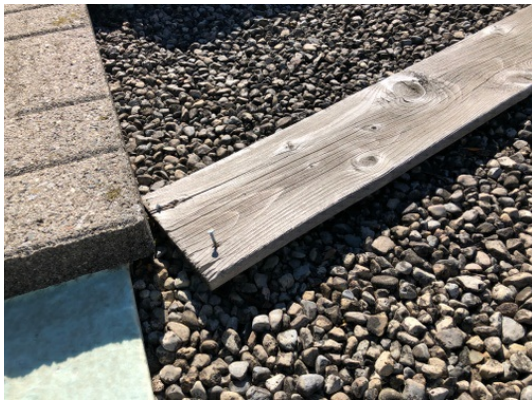
*Photo 6*

Loose wood debris with nails should be removed from the roof

Solution Option:	Maintenance	Action Year:	2021
Square Footage:	6,150	Expected Life (Years):	-
Budget:	-		
Reinforce 3 vertical seams and coat silver one Hvac unit Caulk 4 collar opening on second unit Remove wood Repair blister on Hvac curb flashing

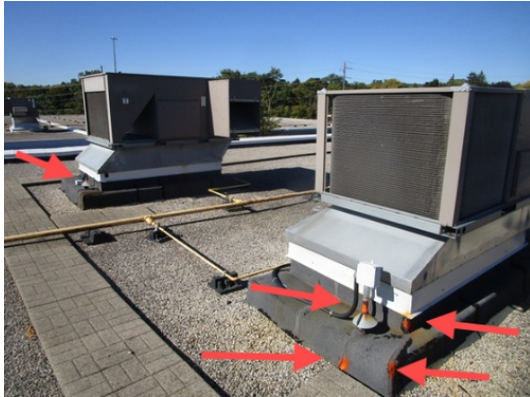
*Photo 8*

Open seams along the flashings need to be repaired, including the cone where the wires run.

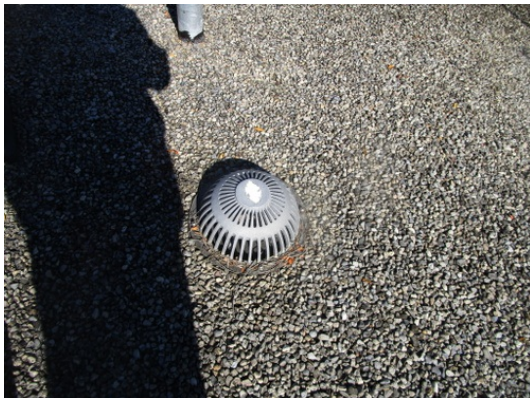
*Photo 9*

Debris should be removed from the drain strainer

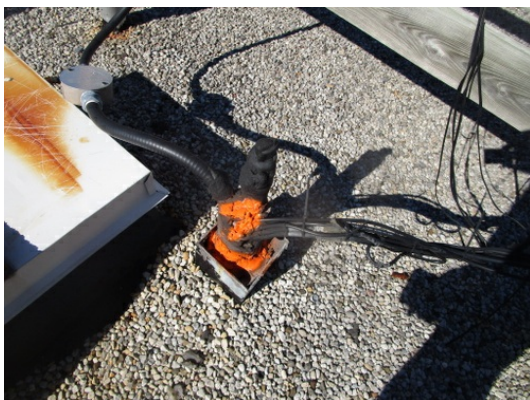
*Photo 10*

**Pitch Pocket Deterioration:** Metal protrusions that penetrate the roof system to allow conduits to run from the rooftop into the building. Movement from the protrusion can break the waterproofing compound, creating cracks. Over time, the release of solvents from the compound can cause the material to shrink, leaving gaps along the edges of the pan and around structural support. Water can enter through a defective pitch pan and find its way into the interior of the building. Moisture can also penetrate into the roof system leading to premature failure.

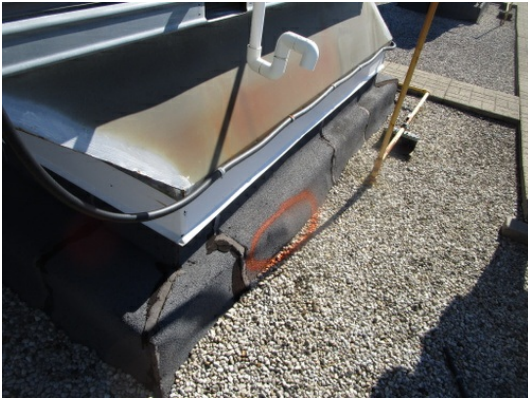
*Photo 11*

**Blisters:** Soft spongy pockets or swellings in the roofing material. They occur between layers of felt or between the roof membrane and substrate. Air or moisture vapor entrapped within a blister expands as the roof and outside air temperatures rise. This results in sufficient pressure to push the roofing felts upwards and apart. Blisters may be ruptured by roof traffic, expanding frozen water, or hail (especially during colder weather). Some blisters may become so large as to affect drainage, which may then cause ponding water. Laps could also be pulled apart, resulting in leakage. A ruptured blister will immediately allow water to penetrate and damage the roof system.

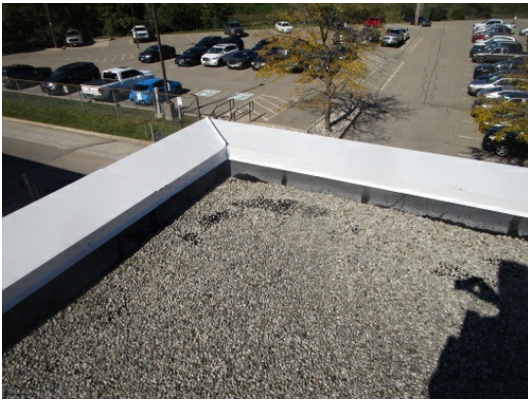
*Photo 12*

**Bare Felts:** Weathering causes the roofs surfacing materials to oxidize and wear away after a period of time. Loss of protection from the surfacing material results in accelerated deterioration of the primary waterpoofer asphalt, along with the systems reinforcement plies which provide the strength for the system. The exposed reinforcement will begin to absorb and wick moisture into the built up layers of the roof system. This condition leads to accelerated damage via blisters and interlayer delamination.

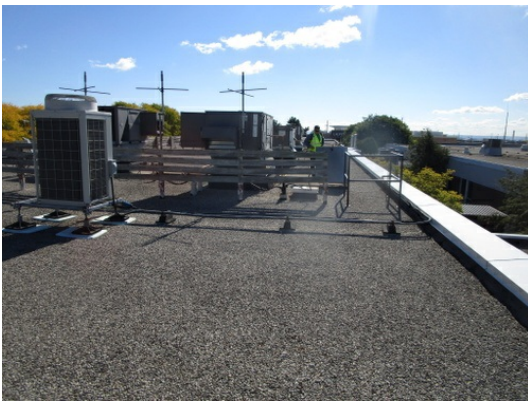
*Photo 13*

The field of the roof appears to be in good condition

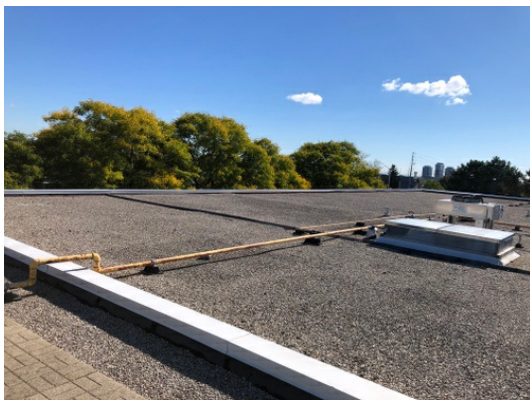
Photo 1

View of very small roof section

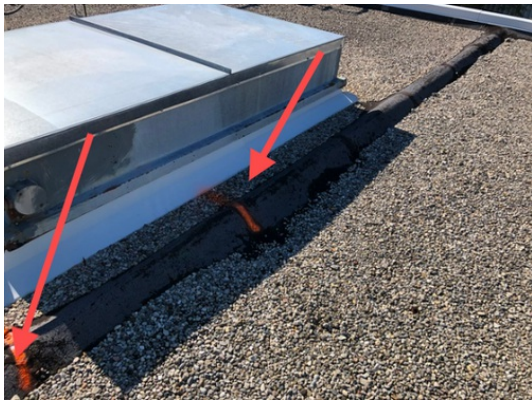
*Photo 2*

The area divider requires some repairs

Solution Option:	Repair	Action Year:	2021
Square Footage:	1,100	Expected Life (Years):	-
Budget:	-		
18 seams (12") to be reinforced with rubberized mastic and coat expansion joint silver Clean drain strainer

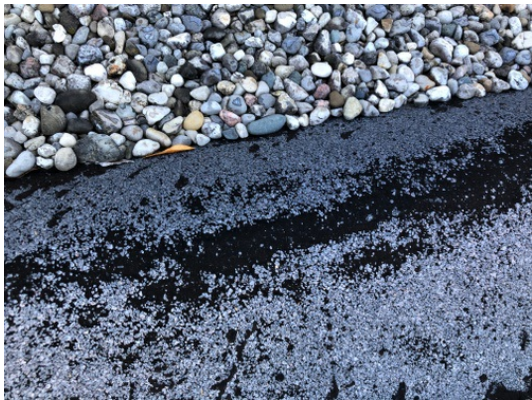
*Photo 3*

Mineral loss along the expansion joint.

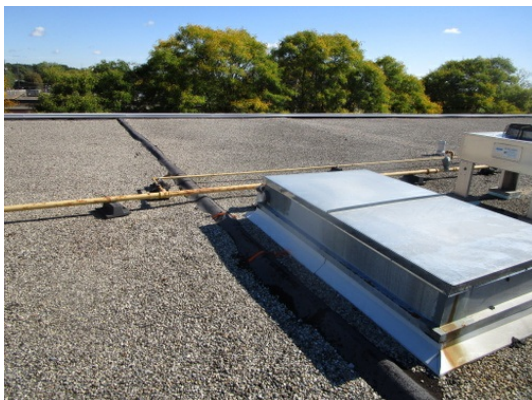
*Photo 4*

View of expansion joint located towards the south that requires maintenance

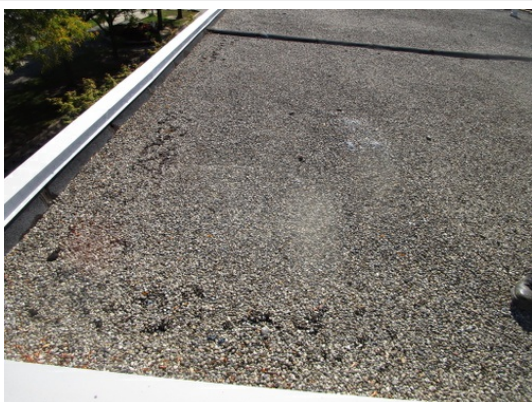
*Photo 5*

The field looks to be in good condition

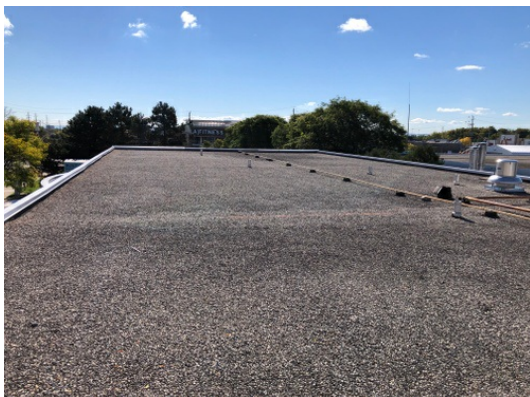
*Photo 1*

View of the field of the roof which is in fair condition

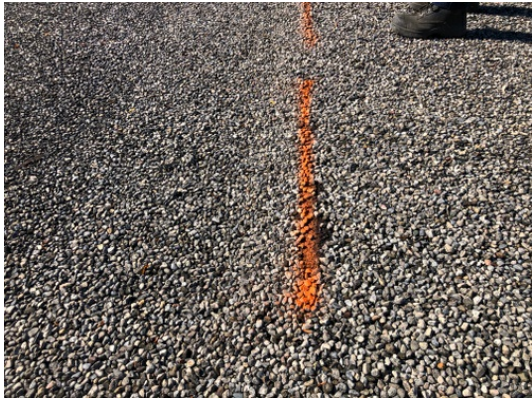
*Photo 2*

**Ridges:** These show up on the surface of built up roofs as linear buckling felt lines protruding upward through the surface layers of asphalt and aggregate. Ridges are formed by either thermal changes expanding and contracting the roofing felts or by gaps in the underlying insulation that allow vapor to migrate upwards through the roof system. Over a period of time ridges will grow and erode until they are stripped of their protective asphalt. These exposed ridges, through repeated weather cycling, will eventually crack and split to allow water into the roof system.

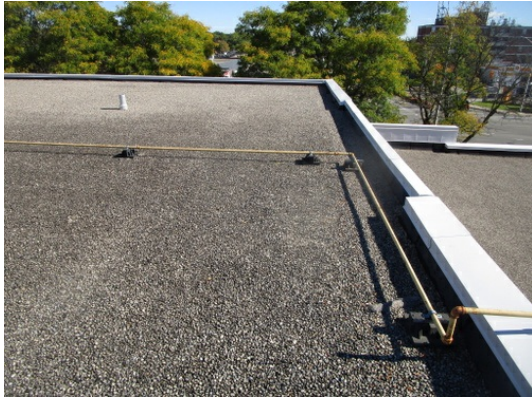
*Photo 3*

View of the south side perimeter looking down to roof section 5.0

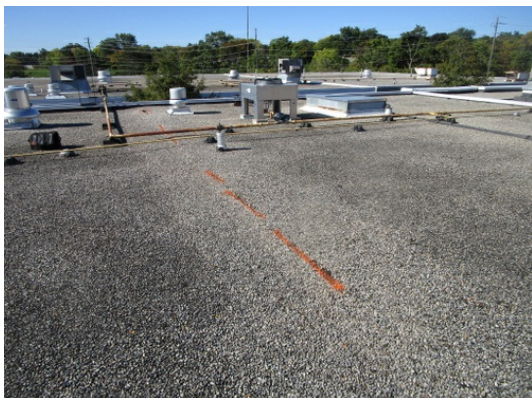
*Photo 5*

**Ridges:** These show up on the surface of built up roofs as linear buckling felt lines protruding upward through the surface layers of asphalt and aggregate. Ridges are formed by either thermal changes expanding and contracting the roofing felts or by gaps in the underlying insulation that allow vapor to migrate upwards through the roof system. Over a period of time ridges will grow and erode until they are stripped of their protective asphalt. These exposed ridges, through repeated weather cycling, will eventually crack and split to allow water into the roof system.

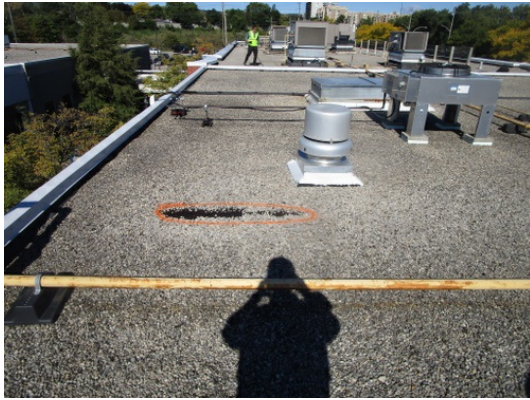
*Photo 6*

**Bare Felts:** Weathering causes the roofs surfacing materials to oxidize and wear away after a period of time. Loss of protection from the surfacing material results in accelerated deterioration of the primary waterpoofer asphalt, along with the systems reinforcement plies which provide the strength for the system. The exposed reinforcement will begin to absorb and wick moisture into the built up layers of the roof system. This condition leads to accelerated damage via blisters and interlayer delamination.

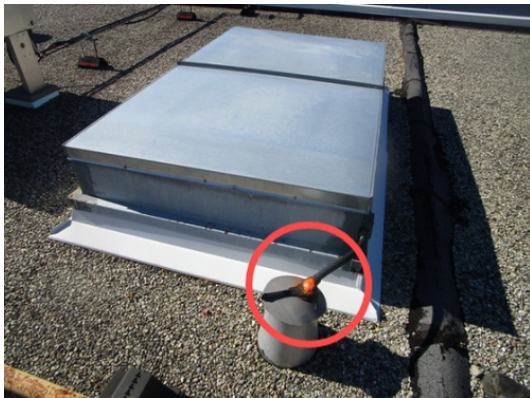
*Photo 8*

Cone should be sealed and coated silver

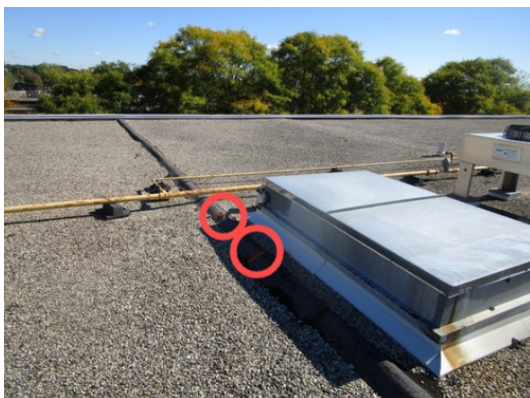
*Photo 9*

Open seams need to be repaired with rubberized mastic and mesh.

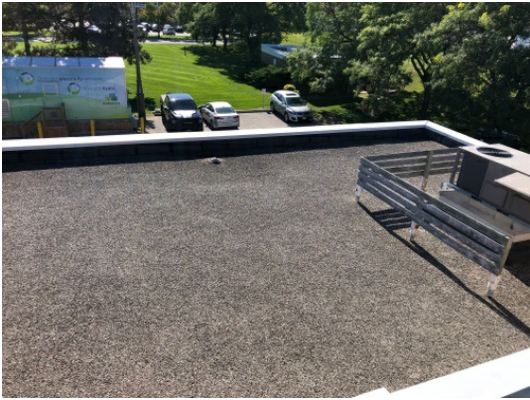
*Photo 1*

View of lower office roof

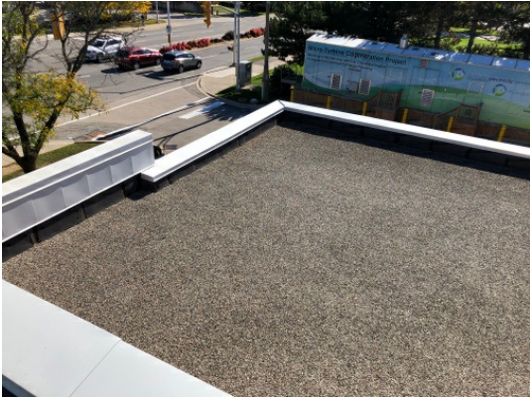
*Photo 2*

The field is in good condition

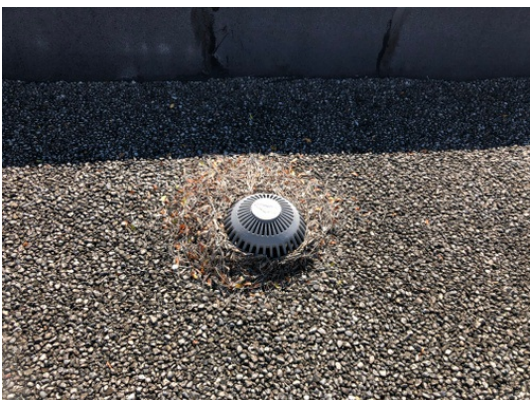
*Photo 4*

Debris should be removed from the drain strainer

Solution Option:	Restore	Action Year:	2021
Square Footage:	2,500	Expected Life (Years):	-
Budget:	-		
4 wall blisters to be repaired Reinforce 4 corner seams for one curb Clean moss and strainer

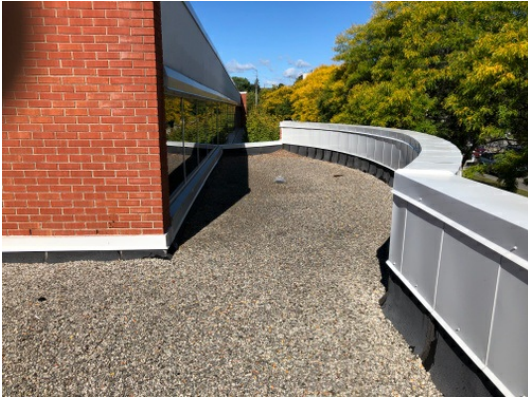
*Photo 6*

<b>Rating</b>	Invalid Lookup Rating ()
<b>Condition</b>	The roof system in the field is in good condition, however, the flashings have numerous issues where there is water in the flashings that needs to be repaired, especially along the east side wing.

View of the east side of the roof

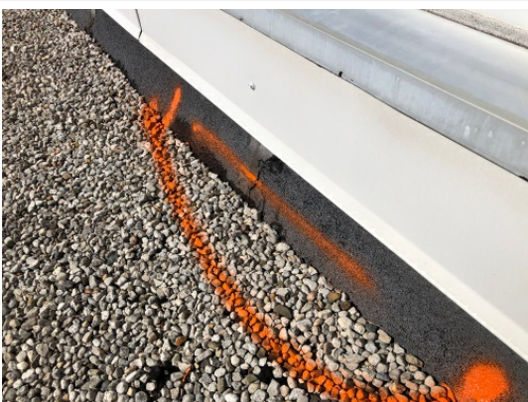
*Photo 7*

Caulking has dried out along the top of the metal counter flashings

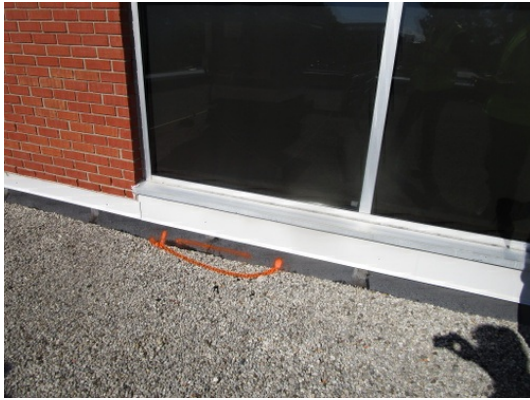
*Photo 8*

**Blisters:** Soft spongy pockets or swellings in the roofing material. They occur between layers of felt or between the roof membrane and substrate. Air or moisture vapor entrapped within a blister expands as the roof and outside air temperatures rise. This results in sufficient pressure to push the roofing felts upwards and apart. Blisters may be ruptured by roof traffic, expanding frozen water, or hail (especially during colder weather). Some blisters may become so large as to affect drainage, which may then cause ponding water. Laps could also be pulled apart, resulting in leakage. A ruptured blister will immediately allow water to penetrate and damage the roof system.

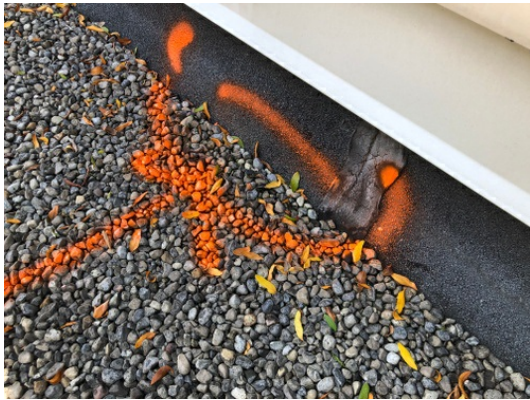
*Photo 9*

**Blisters:** Soft spongy pockets or swellings in the roofing material. They occur between layers of felt or between the roof membrane and substrate. Air or moisture vapor entrapped within a blister expands as the roof and outside air temperatures rise. This results in sufficient pressure to push the roofing felts upwards and apart. Blisters may be ruptured by roof traffic, expanding frozen water, or hail (especially during colder weather). Some blisters may become so large as to affect drainage, which may then cause ponding water. Laps could also be pulled apart, resulting in leakage. A ruptured blister will immediately allow water to penetrate and damage the roof system.

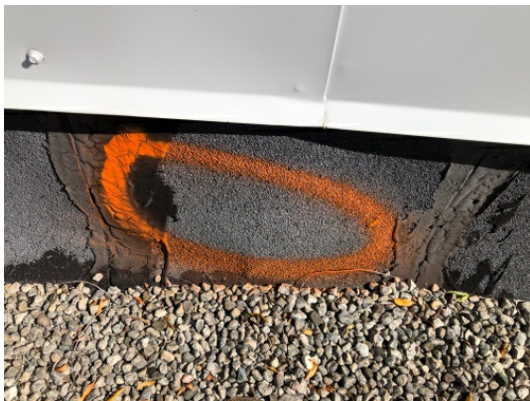
*Photo 10*

The flashings may have water in the system

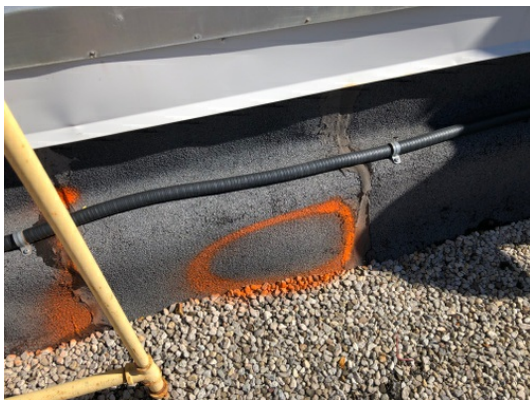
*Photo 11*

A number of blisters and potential water in the flashings that need to be repaired

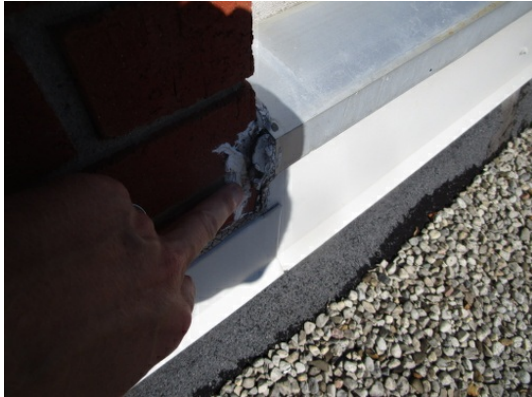
*Photo 13*

View of the blisters in the flashings

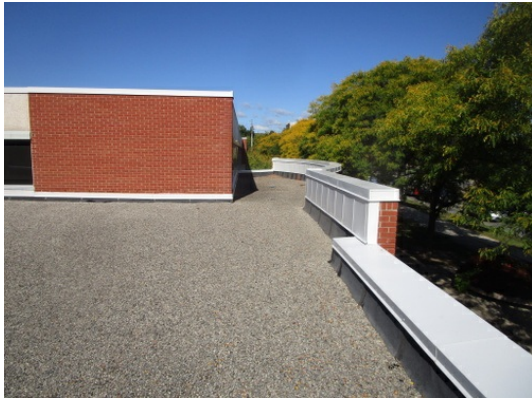
*Photo 16*

The wall looks to be in good condition

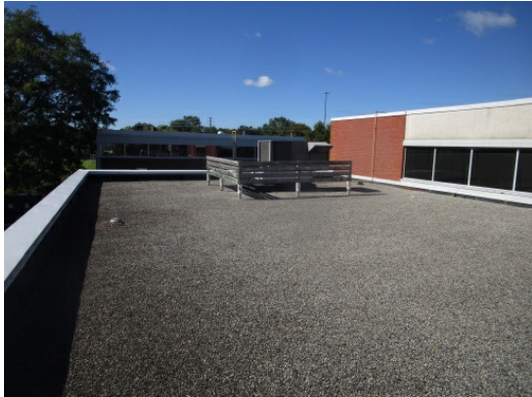
*Photo 17*

The field is in good condition

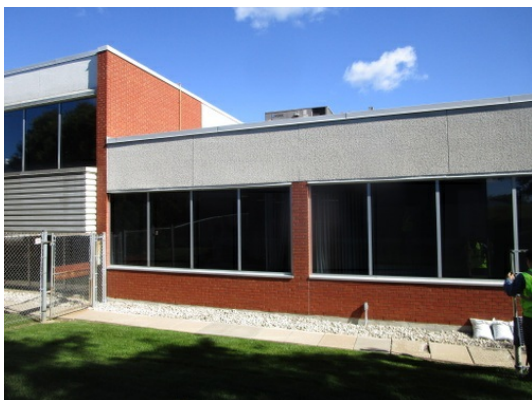
*Photo 19*

The walls appears to be in fair condition and will need the expansion joint to be repaired in the near future.

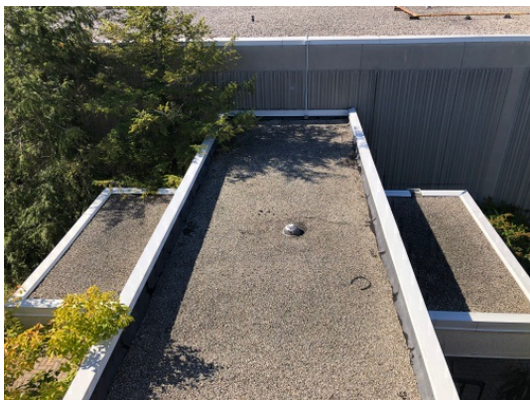
*Photo 1*

View of the three small roof sections. The trees should be pruned back and any debris should be removed from the various roof sections. All debris should be removed from the scuppers and drain strainer.

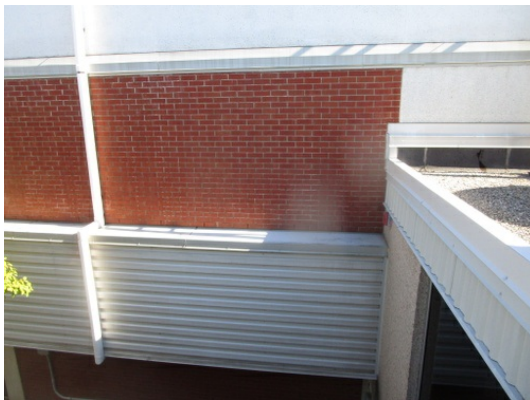
*Photo 1*

Red bricks appear to be in fair condition

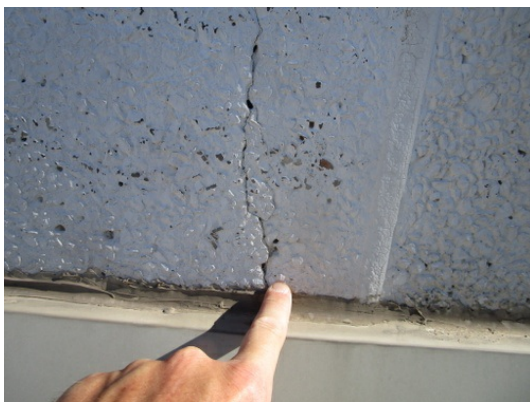
*Photo 2*

Cracks above roof section 2.0 needs to be repaired.

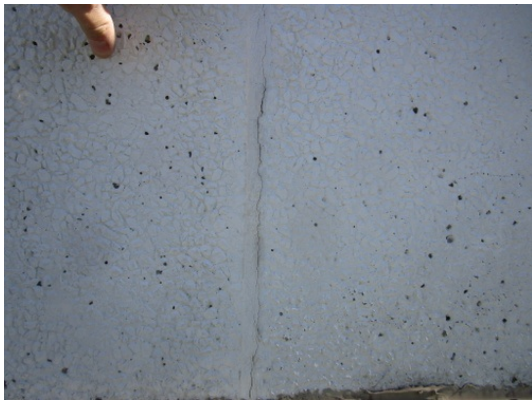
*Photo 5*

Failed caulking along the wall between 2.0 and 4.2

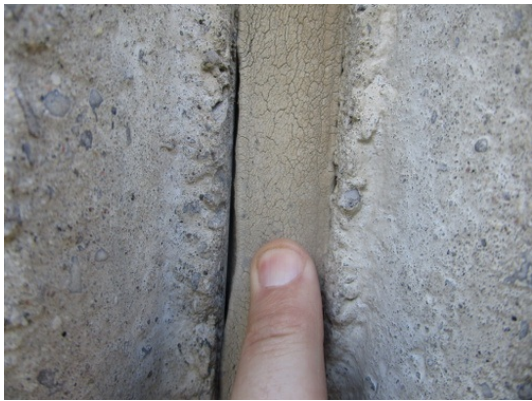
*Photo 6*

Open caulking seams between the precast around section 1.0

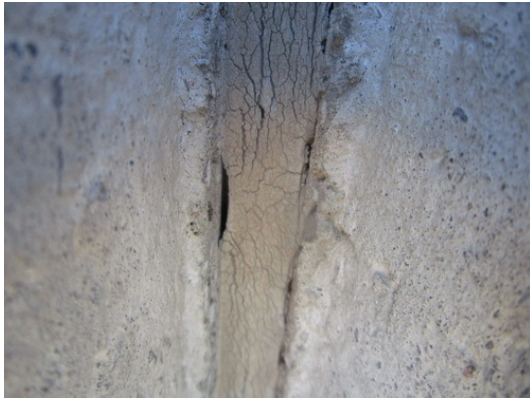
*Photo 8*

Dried and failed seam caulking between the precast panels
