Burlington **hydro** inc.

# Appendix L

## Fleet Management Plan

Fleet Management Plan

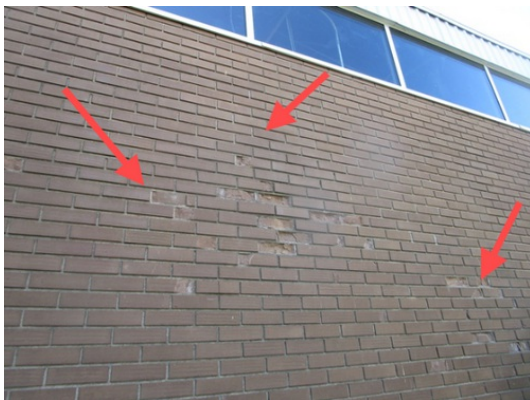
*Photo 10*

Failed bricks need to be repaired below roof section 1.1

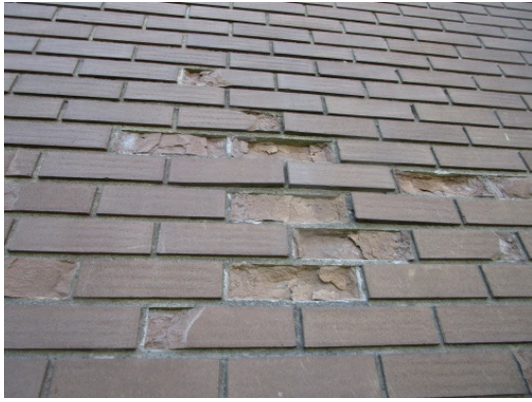
*Photo 12*

Closer view of the failed bricks

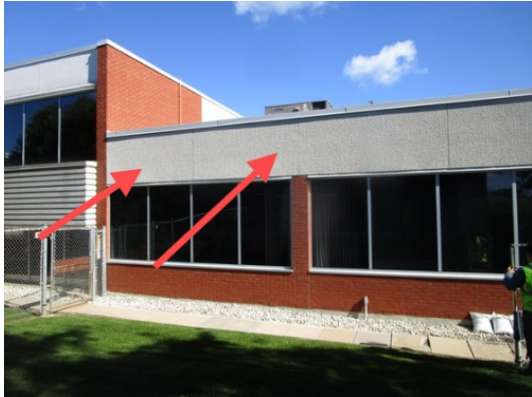
*Photo 13*

The office walls appear to be in good condition however, it is noted that some of the panels above the windows may have asbestos depending on the age of the building.

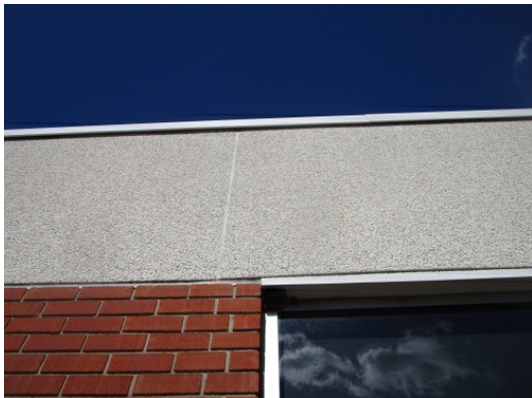
*Photo 14*

Seams between the panels are still in fair condition

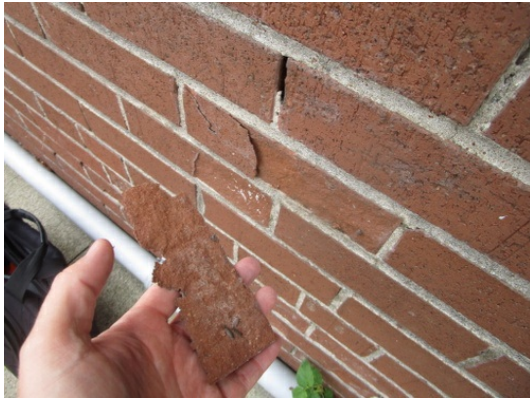
*Photo 16*

The face of the brick is coming apart and should be replaced

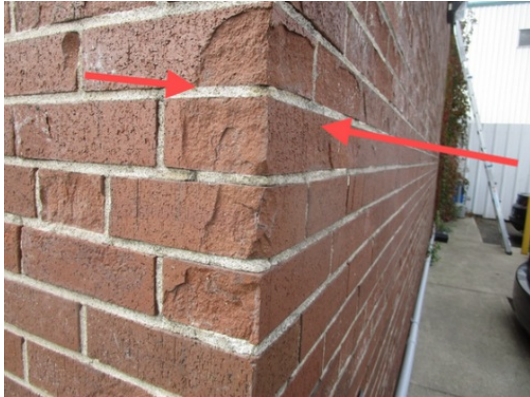
*Photo 17*

View of damaged bricks that should be replaced

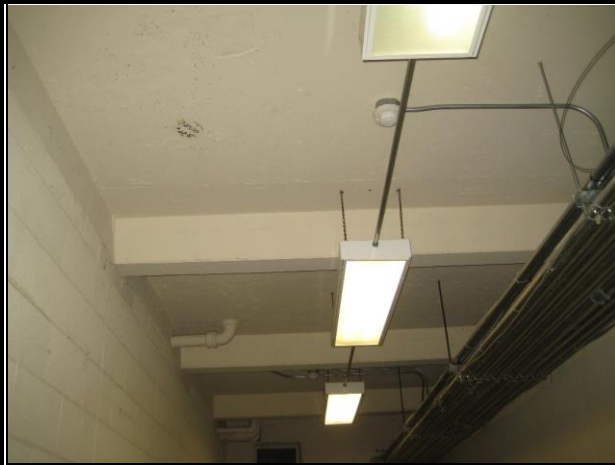
**Photo #3: Office Building Ground Floor Concrete Framing**

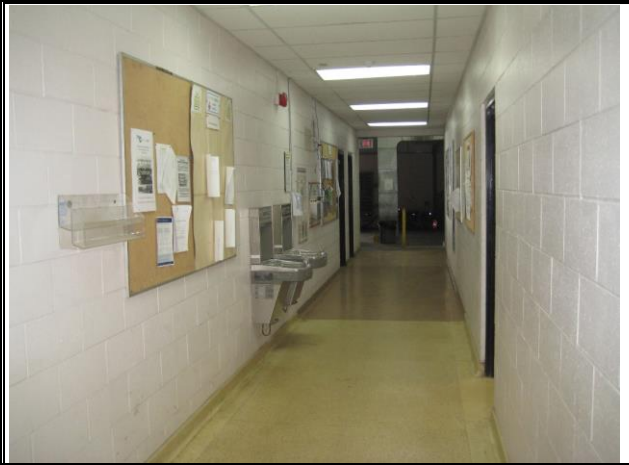
**Photo #4: Corridor connecting Office Building to Service Centre**

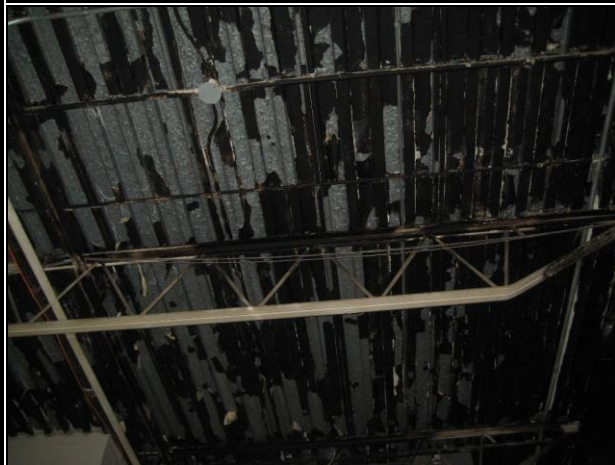
**Photo #5: Stockroom Roof Steel Framing**

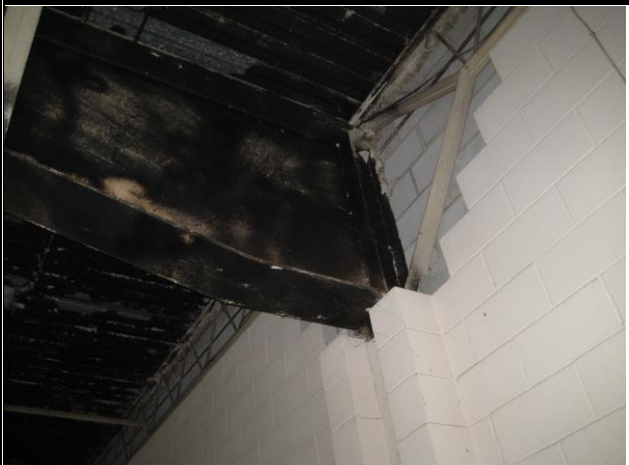
**Photo #6: Stockroom Steel Beam Supported by Column**

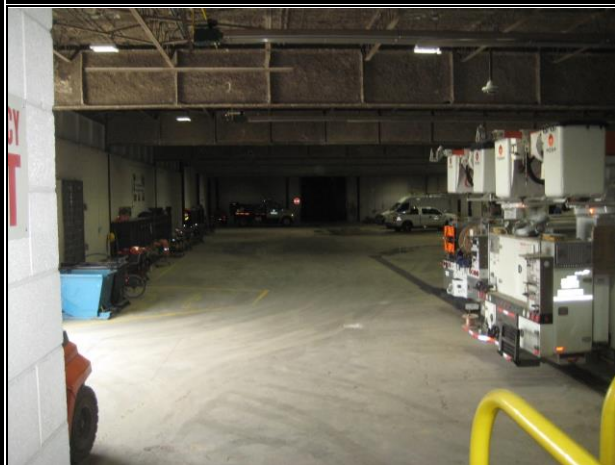
**Photo #7: Service Centre Roof Steel Framing**

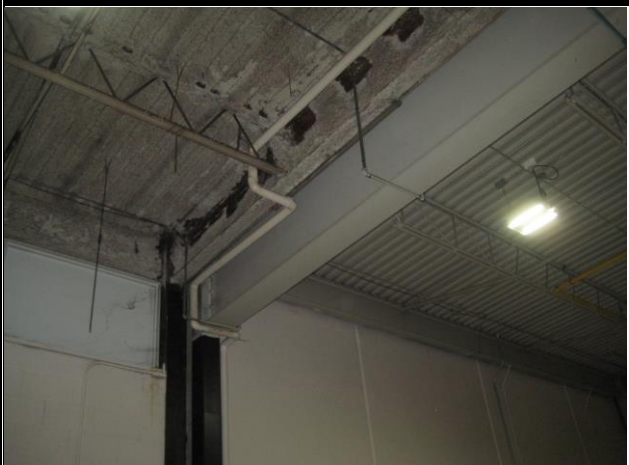
**Photo #8: Expansion Joint between Original Service Centre and Addition**

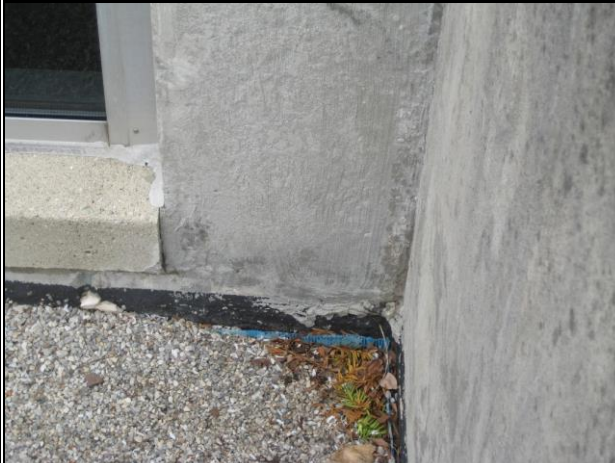
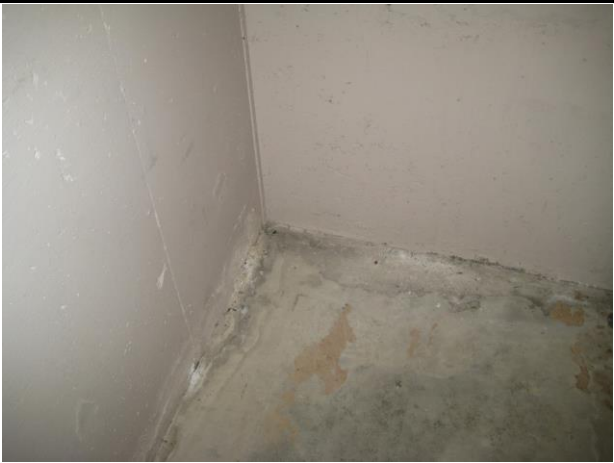
<b>Photo #9: Office Building Foundation Wall Waterproofing</b>	<b>Photo #10: Office Building Concrete Foundation Walls and Slab-on-Grade</b>

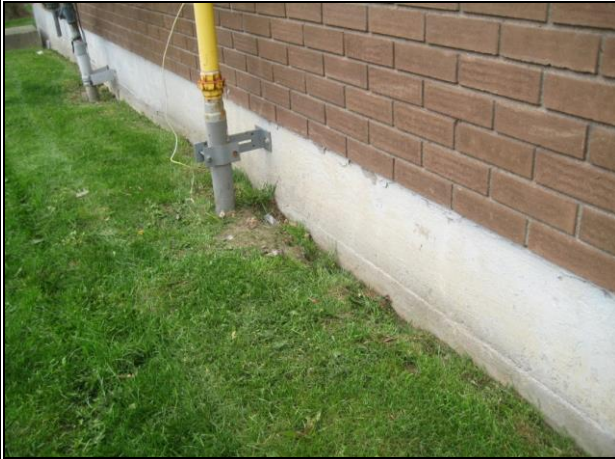
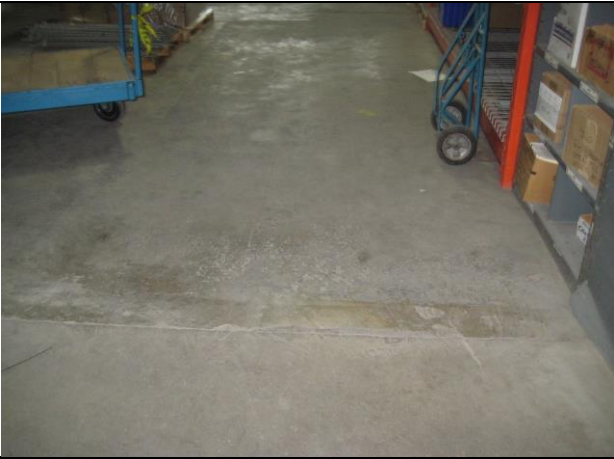
Description	
<p>The building foundations are conventionally reinforced cast-in-place concrete. We expect that the foundation walls are supported by conventionally reinforced concrete strip footings. The office building foundation walls are waterproofed with damp-proofing and drainage board. The buildings' lower floors are concrete slab-on-grade.</p>	
Observations and Recommendations	
<p>The foundation walls are in good condition where visible and reviewed above grade. We noticed some localized, small cracking. At the present time, none of the cracking is a structural concern and there is no evidence of leakage. We don't anticipate repairs within the term of this report.</p> <p>The concrete slab-on-grade is cracked at various locations due to concrete shrinkage and scaled at some locations in the service centre due to wear from traffic. The deterioration is not a structural concern; however, it will worsen with wear. We recommend local repairs as part of the building maintenance.</p>

<b>Photo #11: Service Centre Concrete Foundation Wall</b>	<b>Photo #12: Cracked Slab-on-Grade at Stockroom</b>

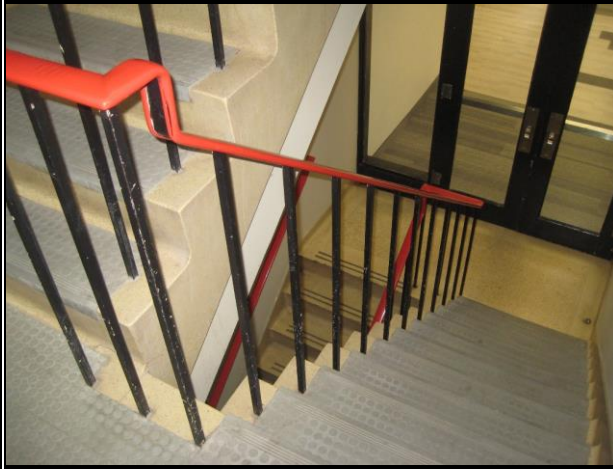
**Photo #15: Interior Stairs**

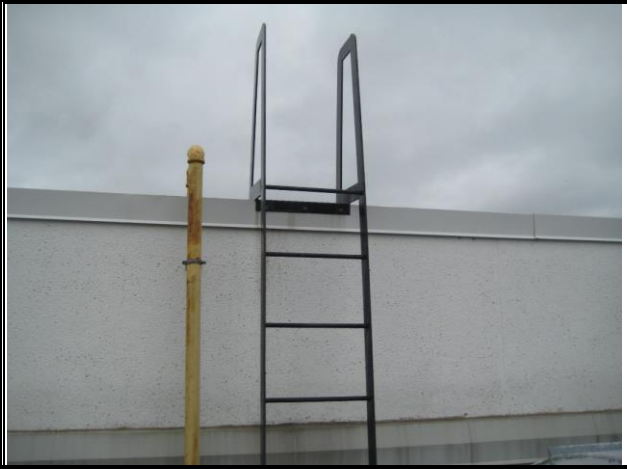
**Photo #16: Roof Access Ladder**

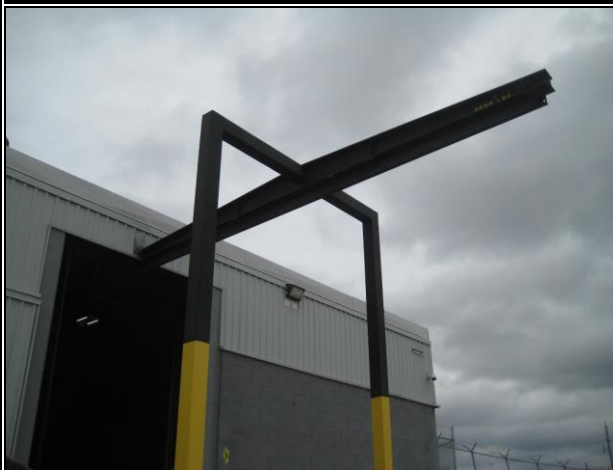
**Photo #17: Lifting Steel Frame**

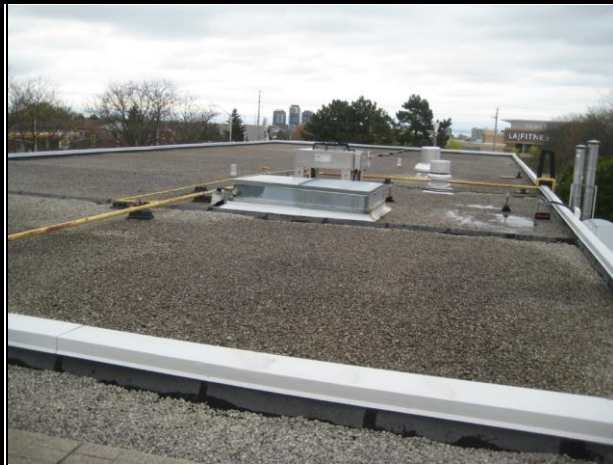
**Photo #19: Original Office Building Roof**

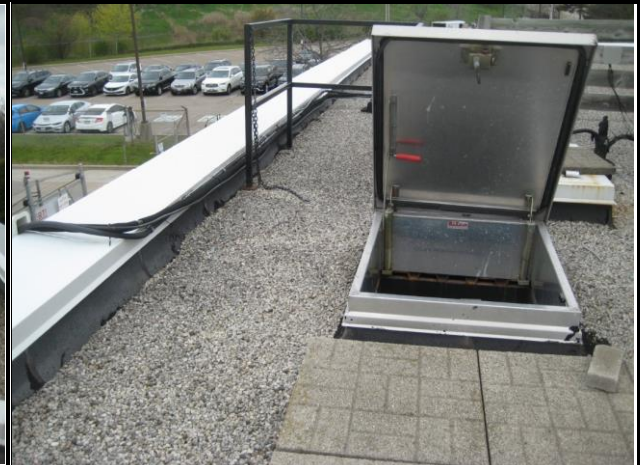
**Photo #20: Roof Access Hatch less than 6 feet from Roof Edge**

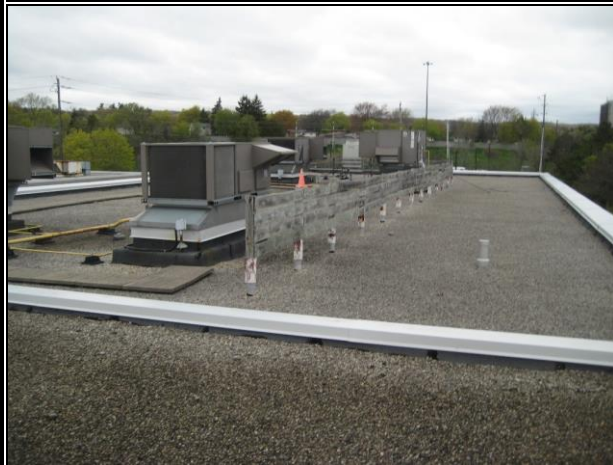
**Photo #21: Office Building North Addition Roof**

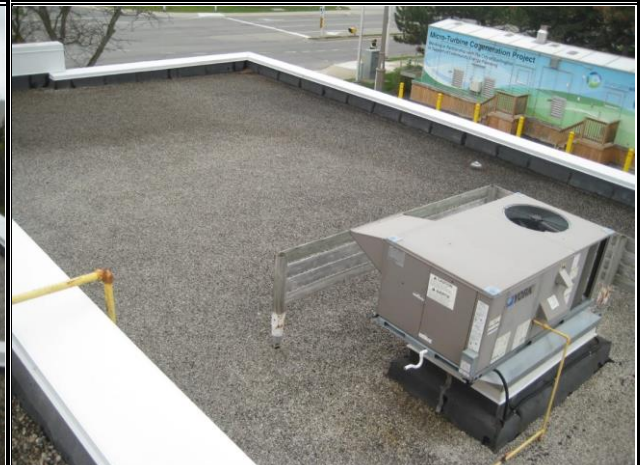
**Photo #22: Office Building South Addition Low Roof**

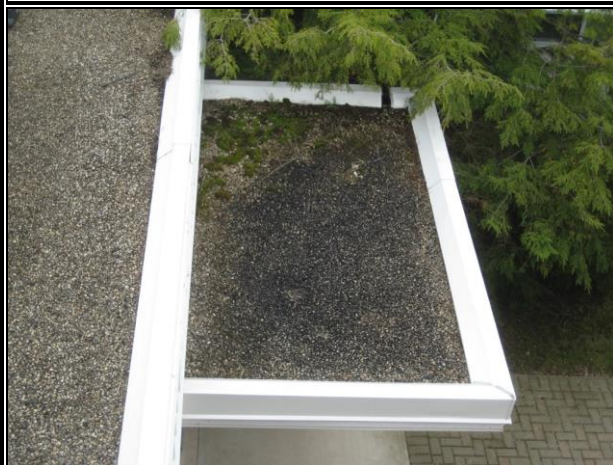
**Photo #23: Vegetation Growth at Secondary Entrance Low Roof**

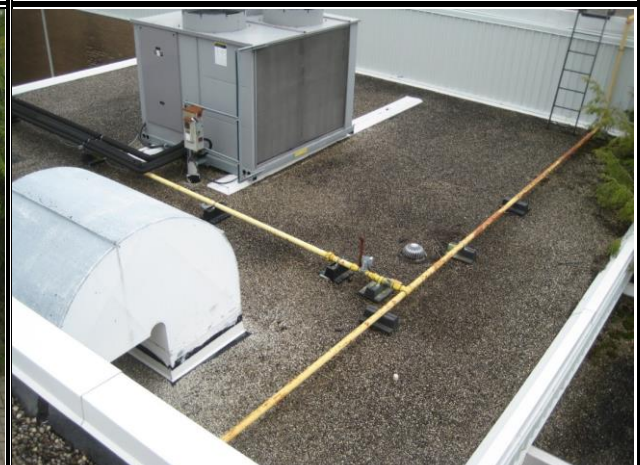
**Photo #24: Low Roof at South Link between Office and Service Centre**

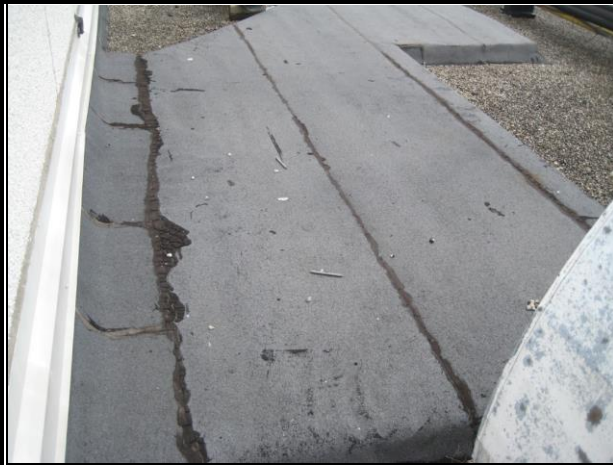
**Photo #25: Mod-Bit Roofing at South Link**

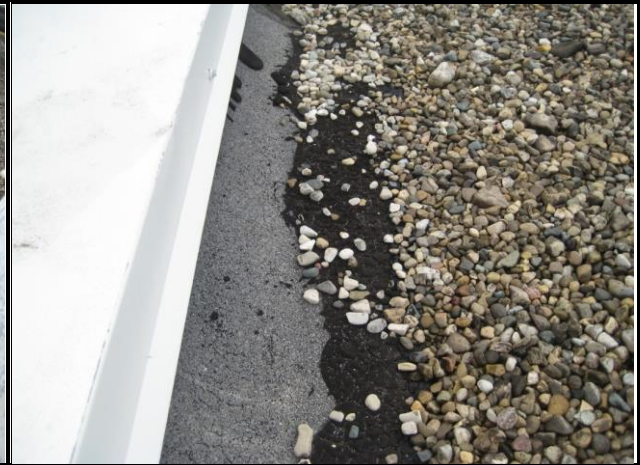
**Photo #26: Mod-Bit Upturn at Parapet**

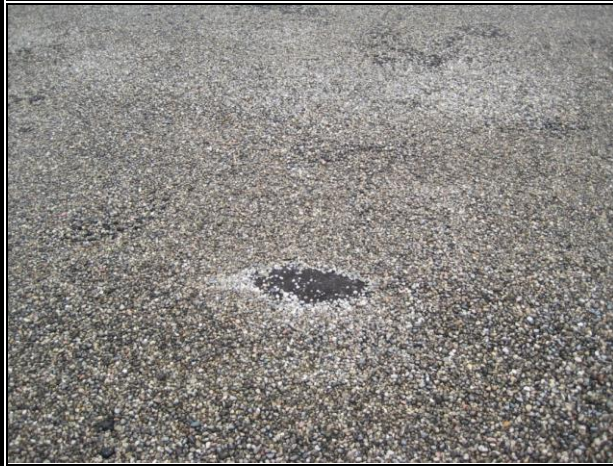
**Photo #27: Blueberrying**

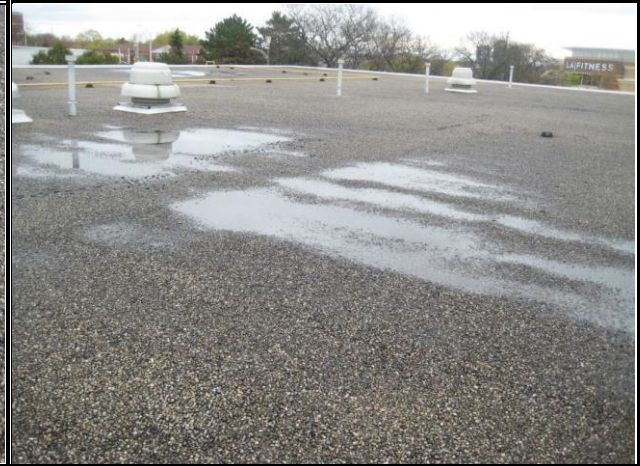
**Photo #28: Water Ponding**

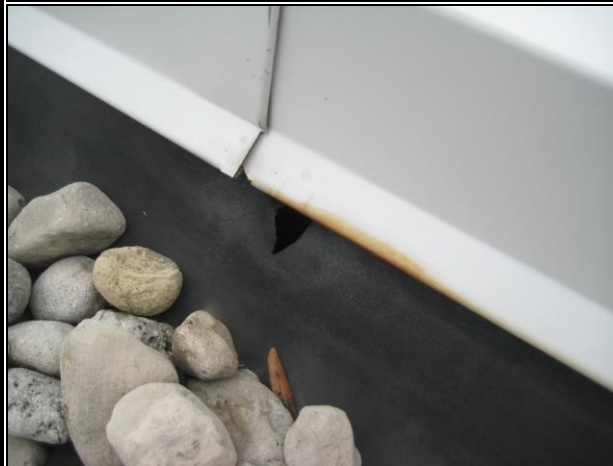
- The office building roof screen is damaged and requires replacement.
- The roof over the service centre addition requires immediate repairs. The flat roof assemblies will reach the end of their service life and will require replacement within the term of this report.
- The building sealants are generally cracked and started to split. We recommend sealant replacement.
- The building clad is deteriorated at some locations; the steel lintels are corroded. They require repairs and/or replacement.
- The windows and exterior doors will reach the end of their service life. They require repairs and/or replacement.
- Some of the mechanical will require repairs and/or replacement as needed.
- The emergency generator is original. It requires replacement.
- The site pavements are deteriorated and require repair and/or replacement.
- [REDACTED]

**Photo #29: Ripped EPDM Membrane at Service Centre Addition Roof**

3.2.1	Repair Service Centre Addition EPDM Membrane (Year 2021)	\$20,000.00		
3.2.1	Inspect and Scan Roofs	\$4,000.00		
3.2.1	Replace Service Centre Addition EPDM Membrane and Links Roof (Year 2022)		\$500,000.00

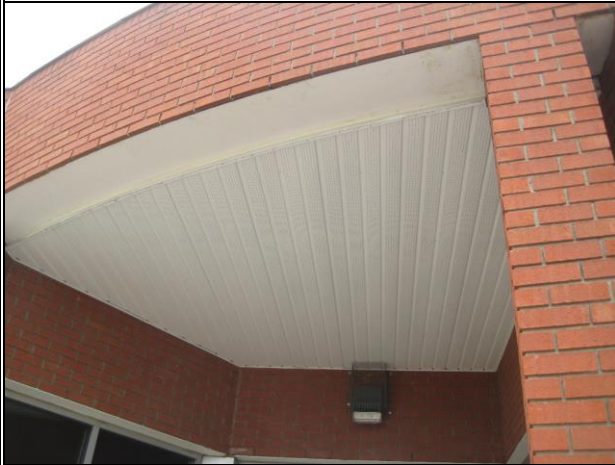
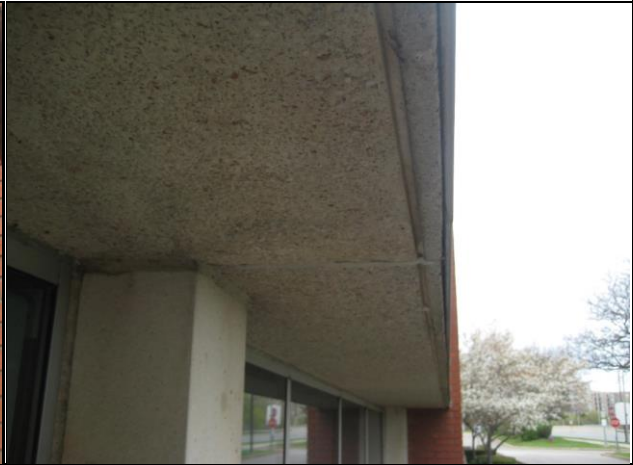
Description	
There are building overhangs and soffits, along the east elevation and entrances of the office building. The soffits consist of perforated metal panels and precast concrete.	
Observations and Recommendations	
The soffits are in good to fair condition. We noticed some stained and faded areas that may be an indication of water exposure and aging. We recommend cleaning and/or painting as part of the building maintenance.

Photo #31: Perforated Metal Soffit at Emergency Exit	Photo #32: Precast Soffit at Front Elevation

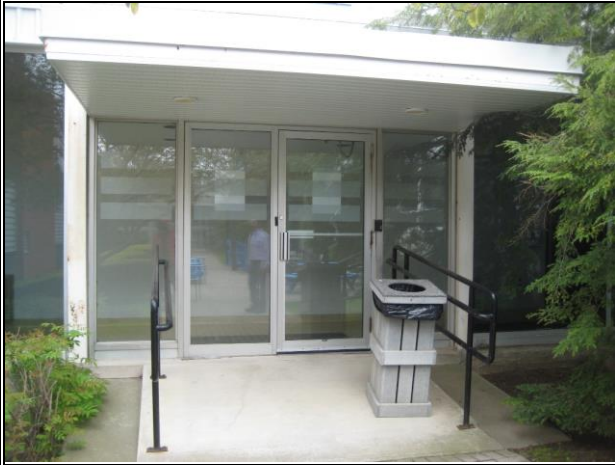
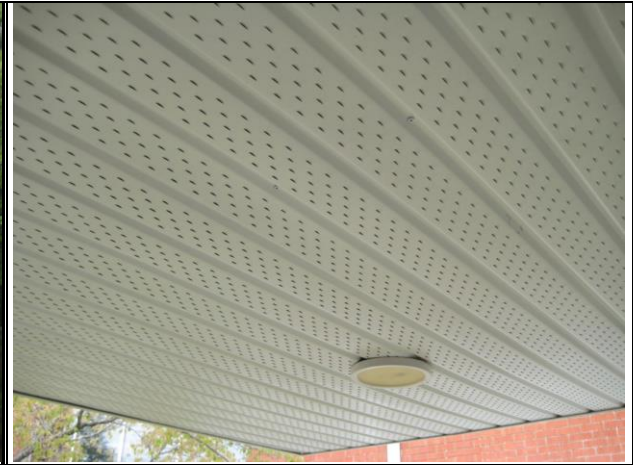
Photo #33: Perforated Metal Soffit at Secondary Entrance Canopy	Photo #34: Perforated Metal Soffit at Secondary Entrance

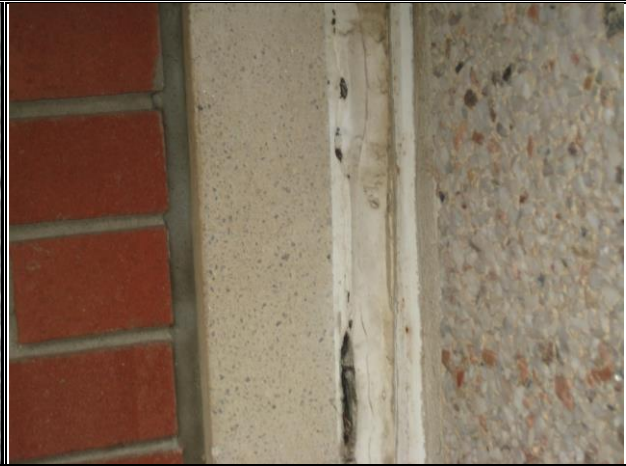
Description	
Building sealants are located at the perimeter wall openings and penetrations, including windows and doors, roof penetrations and sheet metal flashings.	
Observations and Recommendations	
<p>The sealants vary between fair to poor condition. Some of the sealants have been replaced while others are starting to crack and/or de-bonding from the substrates.</p> <p>Sealant replacement typically occurs with the replacement of other building elements, like windows and doors, and should be expected to be replaced at least once more within a typical life cycle for those elements, in order to maintain flexibility and water-tightness.</p> <p>We have not included an allowance for future sealant replacement as it is expected sealants will be replaced in conjunction with a window replacement project. An allowance for general sealant repairs has been included to account for sealants that are not associated with windows.</p>

Photo #35: Cracked Caulking at Metal Flashing	Photo #36: Split Caulking at Precast Cladding

3.2.3	Replace Building Sealants		\$10,000.00	
3.2.4	Repair Masonry (Year 2021/2022)		\$17,000.00	
3.2.5	Paint Office Building Metal Cladding		\$20,000.00

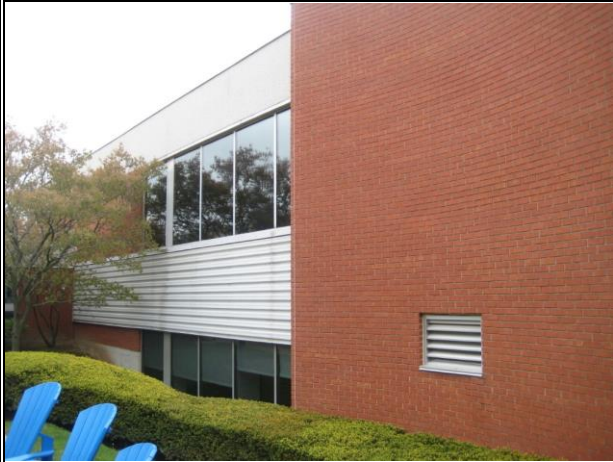
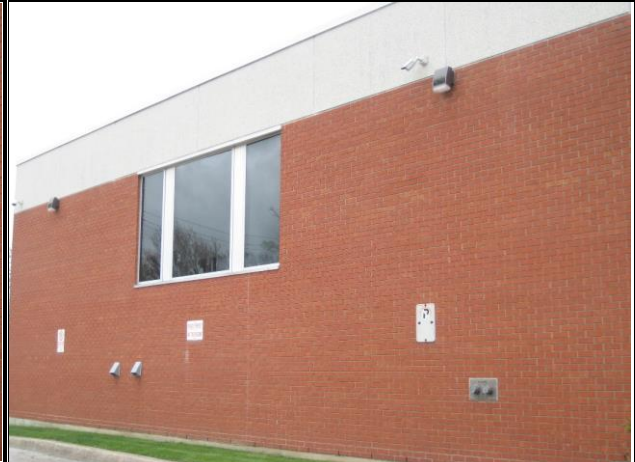
<b>Photo #39: Office Building Partial Rear (West) Elevation</b>	<b>Photo #40: Office Building Side (North) Elevation</b>

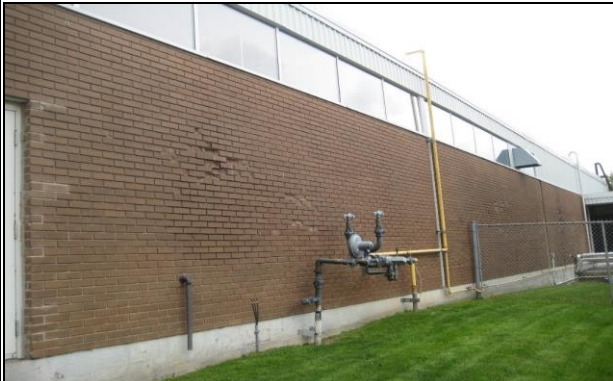
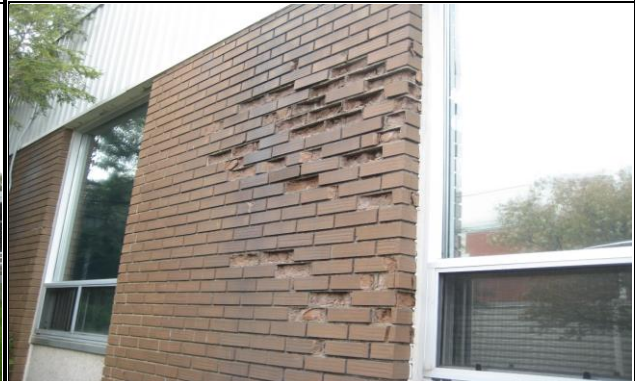
Description	
<p>Both buildings exterior walls are partially clad with brick veneer. Weep vents are placed at window and door heads as well as at overhangs and bottom of walls. There are steel lintels above windows, doors and overhangs. The window sills are metal flashings.</p>	
Observations and Recommendations	
<p>Our review of the exterior walls was limited as it was performed from grade.</p> <p>The exterior walls are generally in good to fair condition. The brick faces are generally sound and the mortar joints are devoid of cracks and gaps. However, we noticed several locations on the service centre rear walls where brick units were missing, cracked and/or spalled. The brick will further deteriorate with timing and exposure to weathering. We recommend further assessment of the masonry in this area be completed and localized repairs such as repointing and replacing/installing damaged/missed brick units be undertaken.</p> <p>The steel lintels are in good to fair condition. However, they have started to corrode. We recommend cleaning, priming and painting.</p> <p>We included an allowance for brick works and steel lintel repairs in the Capital Expenditures.</p>

<b>Photo #41: Service Centre Partial Rear (East) Elevation</b>	<b>Photo #42: Brick Cladding Deterioration</b>

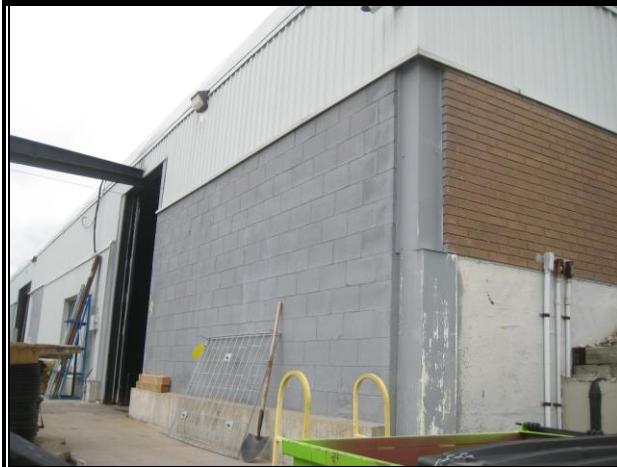
**Photo #43: Service Centre Partial Front (West) Elevation**

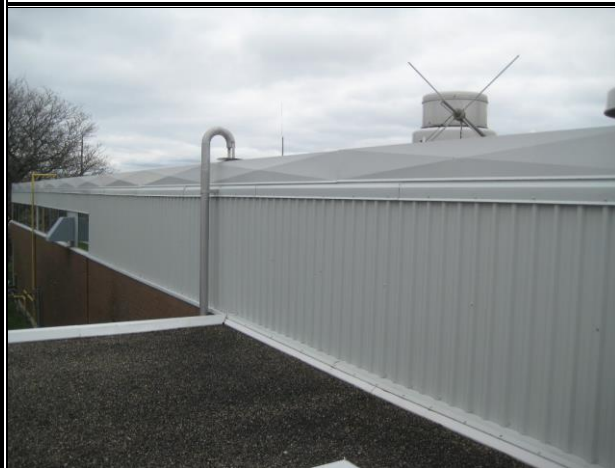
The corrugated metal siding is in good condition. However, we noticed that the paint is starting to fade at the metal cladding in the office building. This is not impacting the cladding structurally at this time as the metal has not started to corrode. You may wish to repaint the metal cladding as the finish continues to age and wear. We included an allowance for painting in the Capital Expenditures.

**Photo #45: Service Centre Upper Wall Metal Cladding**

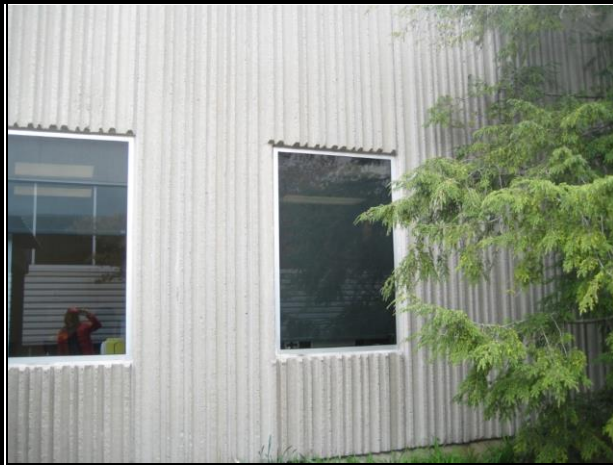
**Photo #51: Precast Panels at Service Centre Windows**

Description	
The service centre addition exterior walls consist of insulated fluted precast concrete panels in a face-sealed system configuration.	
Observations and Recommendations	
The precast concrete panels are generally in good condition. However, we observed that panels have cracked and spalled off at a couple of locations at grade. We recommend repairing these damaged areas as part of the building maintenance. We do not anticipate major capital expenses towards this item.	
<b>Photo #49: Service Centre Side (North) Elevation</b>	<b>Photo #50: Service Centre Rear (East) Elevation</b>

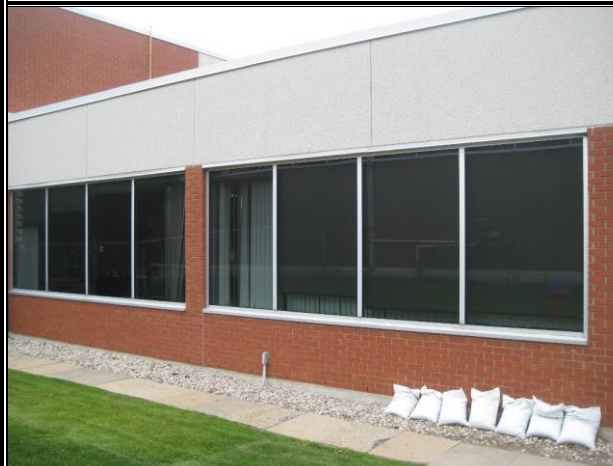
**Photo #53: Exposed Aggregate Panels at Office Addition**

The composite panels are generally in good to fair condition. However, the cladding is stained and it has cracked at some locations. We recommend repairing cracked areas and recoat the panels. We included a repair allowance in the Capital Expenditures.

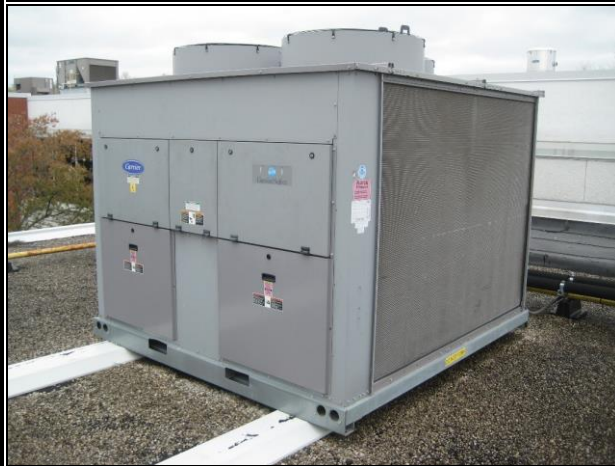
**Photo #71: Roof HVAC Unit**

The most northern service centre roof top unit is reportedly decommissioned. The remaining units appeared to be in good to fair working condition. The older roof top units may contain R-22 refrigerant which has been phased out through federal legislation. Compatible refrigerants are available on the market, depending on the unit. We recommend that you discuss this with the service contractor to determine if you will be able to continue servicing the units or if premature replacement will be required due to the refrigerant.

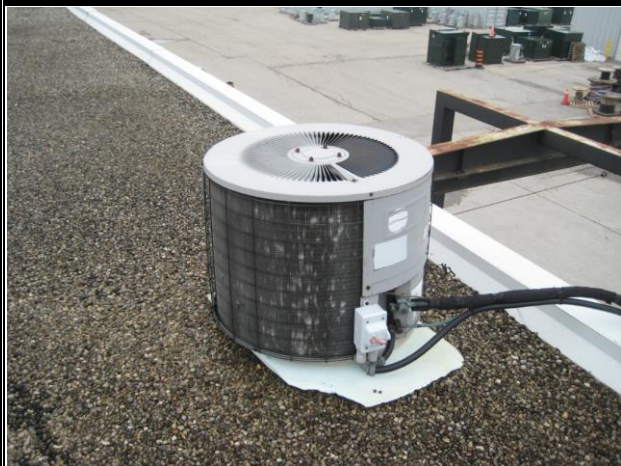
**Photo #74: Service Centre Office Air Conditioner Unit**

Additional cooling for the service centre building is supplied by an air conditioner unit. Make, model and age is unknown as the labels on the unit were faded.

The additional heating and cooling equipment service life varies, depending on the type of unit, service condition, and maintenance practices. No issues were observed or reported to us by management. However, the service life of the units is 15 to 20 years. We included an allowance in the Capital Expenditures to replace the air conditioner unit within the term of the report.

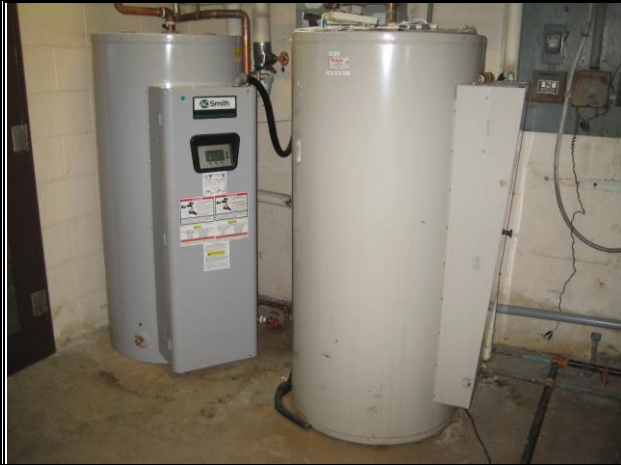
**Photo #80: Domestic Water Heaters**

The domestic hot water tanks are in good condition. They are different vintage as one seems less than 5 years old and the second one seems to be over 10 years old. Based on observed condition and estimated age, we anticipate one water heater to be replaced within the term of this report. An allowance was included in the Capital Expenditures.

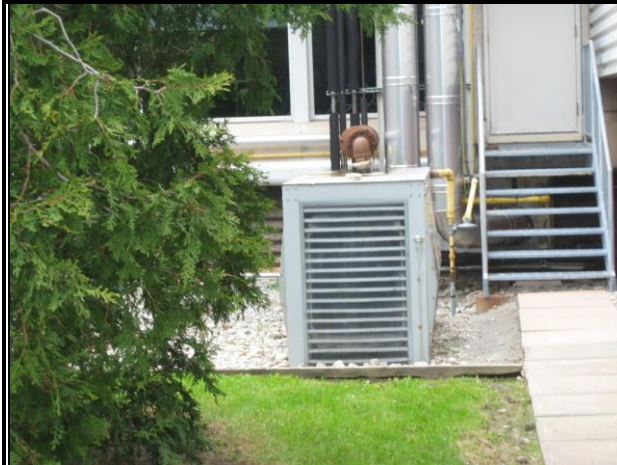
**Photo #97: Emergency Propane Generator**

Description
Emergency power is supplied to the building by a natural gas powered generator (80kW, 600V N/G) located outside, between the office building and the service centre. The generator provides power through an automatic transfer switch to exit signs, emergency lighting, lift and the fire alarm system.
Observations and Recommendations
The generator is original to the building. Management reported that the generator is to be replaced in year 2021. The outer metal case is starting to corrode and the generator is outdated. We included an allowance in the Capital Expenditures for generator replacement with a new diesel generator.

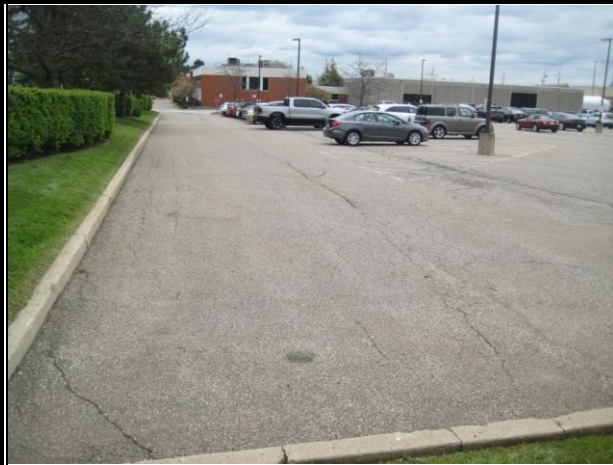
**Photo #99: North (Side) Asphalt Parking Lot**

Description
<p>Access to the property is from Brant Street via three asphalt driveways. There are asphalt-paved driving aisles and on-grade parking spaces surrounding the office building and the service centre. Drainage is directed to catchbasins and landscaped areas.</p> <p>Some sections of the asphalt pavements are lined by cast-in-place concrete curbs.</p>
Observations and Recommendations
<p>The asphalt pavement is in good to fair condition. We observed areas in the asphalt pavement with cracking, pot holes and localized settlement that is consistent with age and wear. Pavement markings have started to wear out and require repainting. The concrete curbs are cracked and have spalled at some locations. Asphalt renewal and concrete curb replacement is expected within the term of this report. We included an allowance in the Capital Expenditures to replace 50% of the asphalt pavement within the term of this report. We have also included a budget to repair potholes and locally seal cracks to mitigate risk and prolong the pavement service life.</p>

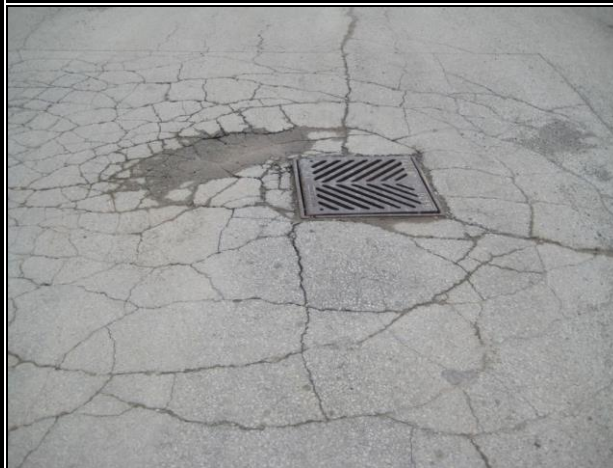
**Photo #103: Asphalt Pavement Settlement at Catchbasin**

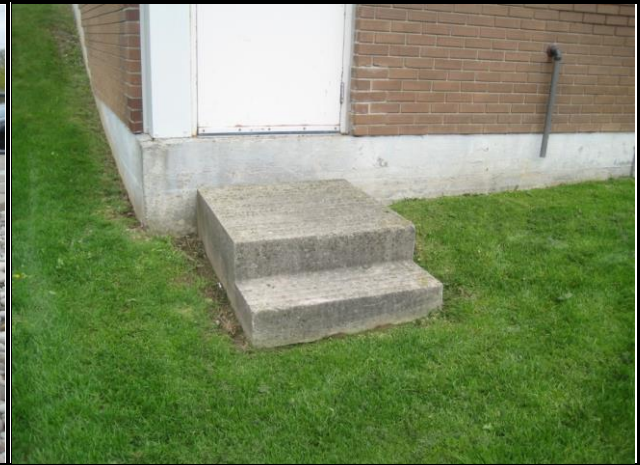
Description	
<p>There are concrete sidewalks and concrete slabs providing access to the building entrance. There are concrete pads providing an outdoor area for storage of electrical transformers.</p> <p>There is a concrete stair between high and low levels of the asphalt parking lot. The stairs and concrete are equipped with metal handrails.</p> <p>There are precast concrete steps at the stockroom rear exit.</p>	
Observations and Recommendations	
<p>The concrete pavements are in good condition. However, we anticipate the concrete will begin to show sign of deterioration as they continue to age. The concrete hardscapes adjacent to the building are sloped to drain away from the building foundations.</p> <p>We observed that the precast steps, outside the stockroom exit door, have settled resulting in the upper step to be higher, not compliant with OBC.</p> <p>We have included a general allowance for localized repairs and replacement of the precast concrete steps in the Capital Expenditures.</p>

**Photo #110: Precast Concrete Steps at Stockroom Exit Door**

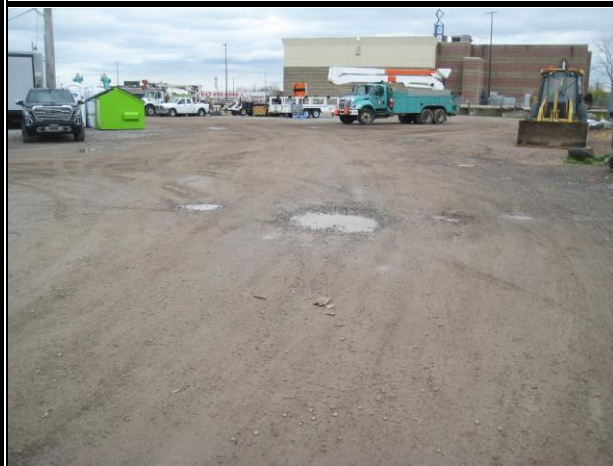
Description	
There is gravel pavement at the rear of the property.	
Observations and Recommendations	
The gravel pavement is in good to fair condition. We noticed localized settlement and pot holes. We recommend local repairs such as fill in pot holes with new gravel, locally re-grade and re-compact. We have carried an allowance in the Capital Expenditures.

<b>Photo #111: Rear Gravel Pavement</b>	<b>Photo #112: Potholes in Gravel Pavement</b>

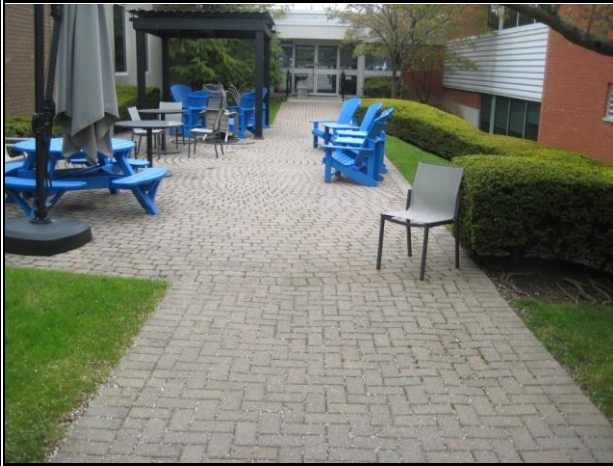
Description	
There are interlocking pavers at the courtyard.	
Observations and Recommendations	
The pavers are in good condition. However, some pavers are unlevelled resulting in tripping hazards. We recommend repairs such as repositioning and replacement of concrete pavers. We included an allowance for this work in the Capital Expenditures.

<b>Photo #113: Concrete Pavers at Courtyard</b>	<b>Photo #114: Settled Concrete Pavers</b>

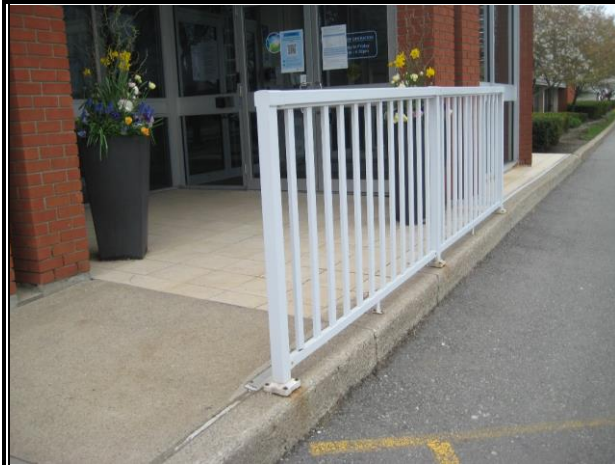
**Photo #115: Aluminum Railings at Front Entrance**

Description
<p>There are various types of guardrails throughout the property. The guardrails are located at the front and secondary entrances, at the exterior concrete stairs and in the service centre.</p> <p>Main Entrance – Prefinished aluminum picket-style railings.</p> <p>Secondary Entrance – Painted Metal railings.</p> <p>Interior Stairs – Painted Metal Railings.</p> <p>At Concrete Steps in Parking Lot - Painted Metal Railings.</p>
Observations and Recommendations
<p>The metal railings are in good to fair condition. Some of the guardrails have started to corrode due to exposure to de-icing salts. We recommend cleaning, priming and painting as part of the building maintenance.</p> <p>At end of service life, we recommend replacement with prefinished aluminum which has lower maintenance requirements (not painting needed, more corrosion resistant).</p>

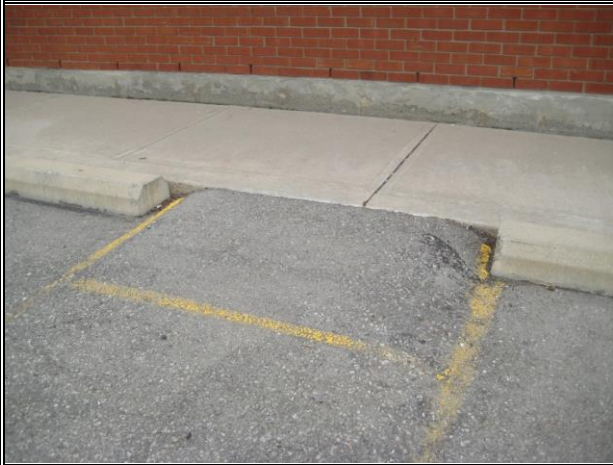
<b>Photo #127: Asphalt Ramp</b>	<b>Photo #128: Sidewalk Width reduced by Garbage Can</b>

Description	
<p>There are two asphalt ramps providing access from the accessible parking stalls to the concrete sidewalk. The concrete sidewalk provides access to the office building front (south) entrance.</p>	
Observations and Recommendations	
<p>There are no exterior tactile walking indicator surfaces at changes in the paths (i.e. asphalt ramp/concrete sidewalk and concrete sidewalk/ceramic floor tile).</p> <p>There is a garbage can on the sidewalk resulting in reduced width of the sidewalk. The sidewalk widths in general, are compliant with AODA requirements.</p> <p>We recommend installing surface-mounted tactile walking indicators (preferably a high contrast plastic) at surface changes and relocating the garbage can to increase the width of the sidewalk. These improvements are below threshold amount for this report and were not included in the Capital Expenses.</p> <p>At the time of asphalt replacement, you may consider including a roll-mount curb in front of the accessible parking stalls to allow for greater access.</p>

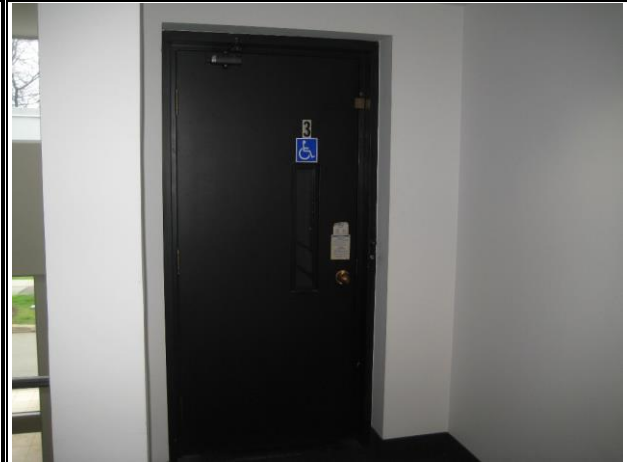
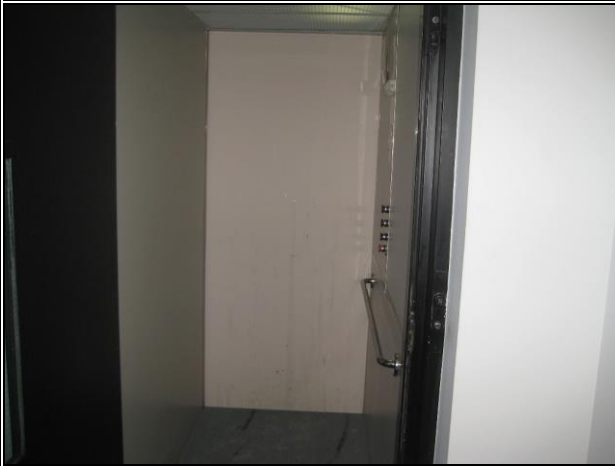
Photo #137: Lift Lobby at Ground Floor	Photo #138: Lift Lobby at Upper Floor

Description	
<p>The office building is equipped with one lift passenger that contains a handrail. The lift has a 454 kg or 2 persons and wheelchair capacity.</p>	
Observations and Recommendations	
<p>The cab size appears to be undersized when comparing to the dimensions required by the City of Burlington standards. However, it seems technically infeasible to retrofit the lift to be compliant. The signage at the lift is inadequate and should be larger and have braille.</p> <p>The lift door is not push-button operated as it should be due to the outswing. The door does not remain open for a period of time. The door is not equipped with a door re-opening device in the cab or an emergency call system. The lift cab finishes are in good to fair condition with minor damage; however, does not fully comply with City standards and/or AODA and it is outdated. There is no braille on the interior control panel and there are no audible beeps. We included an allowance for lift upgrades in the Capital Expenditures.</p>
